FINAL REPORT

**Accident
on 24 July 2014
near Gossi (Mali)
to the McDonnell Douglas DC-9-83 (MD-83)
registered EC-LTV
operated by Swiftair S.A.**

Approved on 22 April 2016

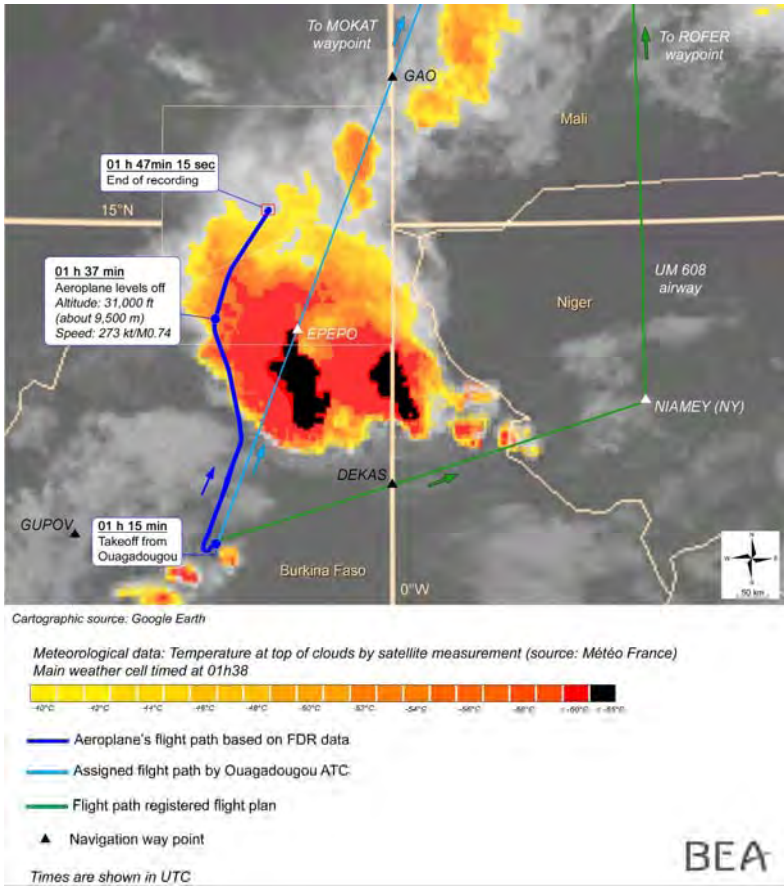
Figure 1 - Overall flight path

The last values were recorded at 1 h 47 min 15:

- Pressure altitude: 1,601 ft, (in relation to the 1013 hPa isobar)
- Calibrated airspeed: 384 kt
- Pitch: 58° nose-down
- Bank: 10° to the left
- Magnetic heading: 099°

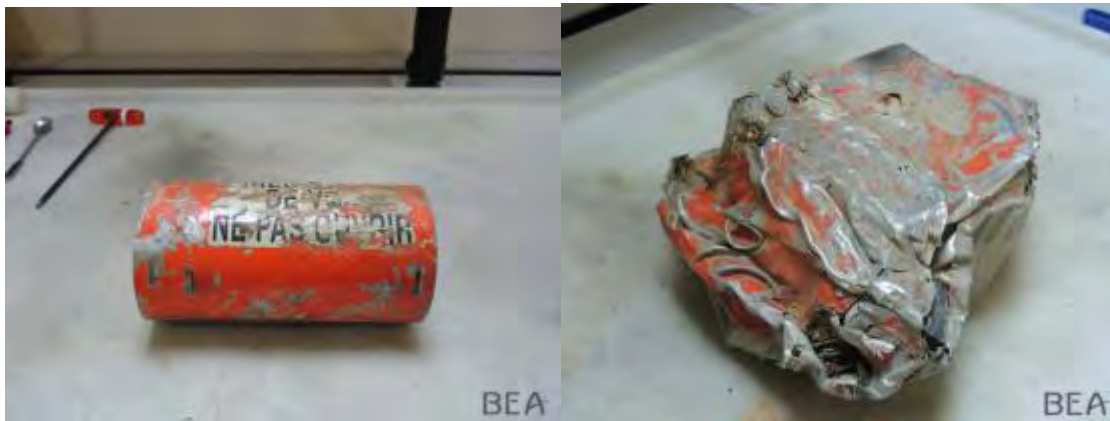
Figure 24 - FDR protected module (on the left) and CVR (on the right)

Only the protected module (CSMU) was sent to the BEA. This module contains the electronic card that records the flight data. The protected casing was separated from its frame and the underwater locator beacon (ULB) was not present. It was slightly damaged and showed some signs of impacts.

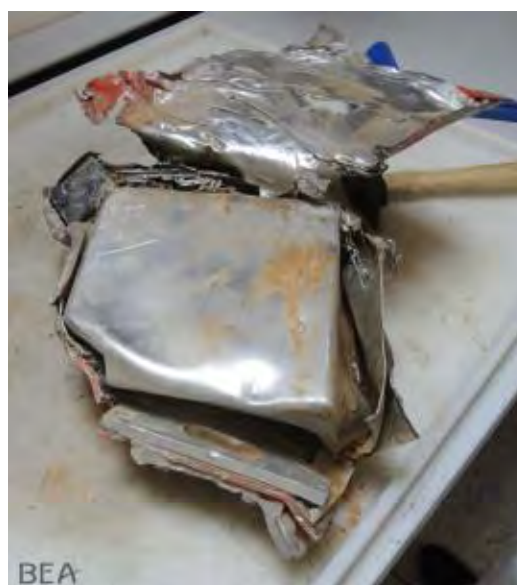
Figure 29 - Opening the chassis

Given the condition of the recorder, access to the protected memory module via a standard opening operation was not possible. The chassis had to be cut open.

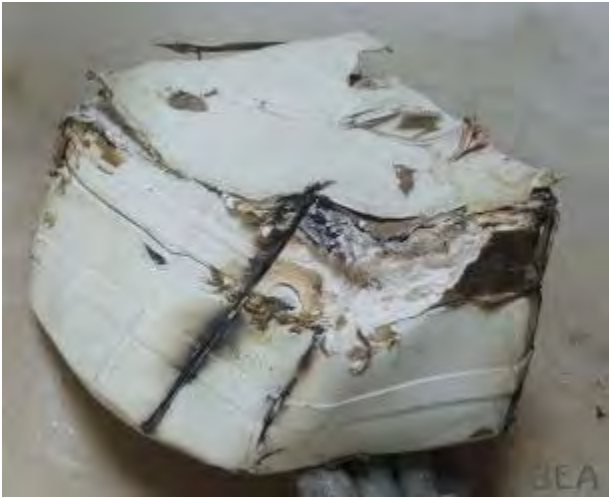
Figure 31 - Data carrier heat protection

After opening the protected module and taking out the heat protection, visual inspection showed that the tape mechanism was destroyed and that the magnetic tape was damaged. The tape was broken in several places.

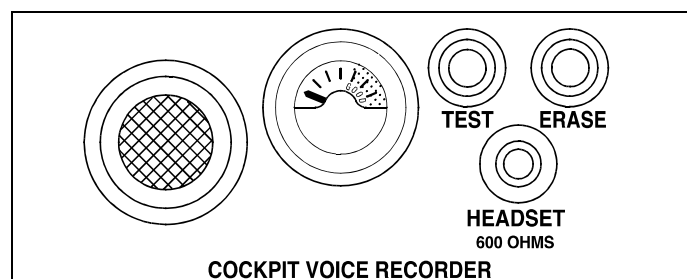
Figure 37 - CVR control panel

The operator's procedures ensure that the crew conduct a CVR test before each flight during cockpit preparation. The test, conducted on duty, consists of keeping the control panel TEST button pressed down and checking that the indicator needle, called galvanometer, reaches and remains within the green arc, with the exception of short interruptions caused by transitions from one track to another.

Laboratory tests have shown that the audio content recorded on the magnetic tape of the event, sent to the amplification and filter card of the A100 CVR, systematically causes the incorrect movement of the galvanometer needle in the green section. Consequently, it was not possible for the crew to identify the erase function failure of this CVR with the aid of the pre-flight test.

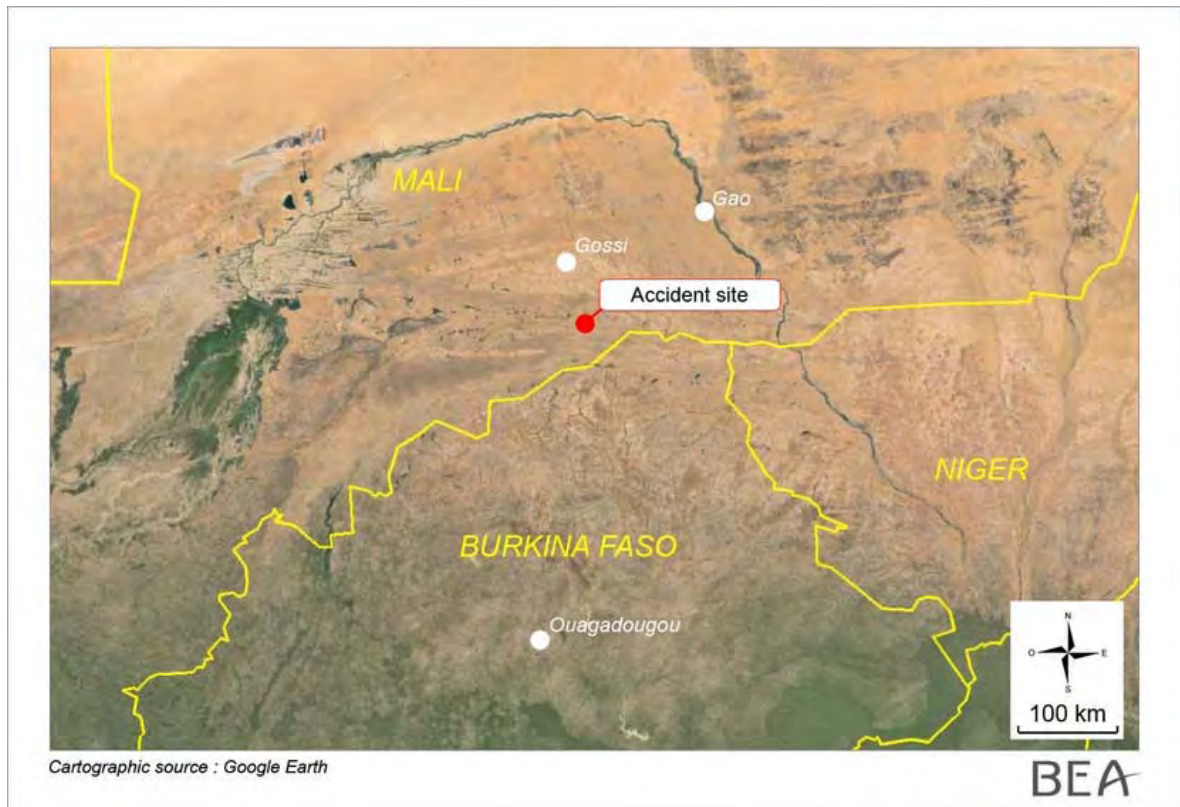
Figure 38 - Location of crash site

The area is flat, located at an average altitude of 270 m and the only visible obstacle consists of sparse vegetation of a height not exceeding 5 m. The natural terrain consists of bedrock covered by a 50 cm layer consisting of a mixture of sand and clay, in varying proportions.

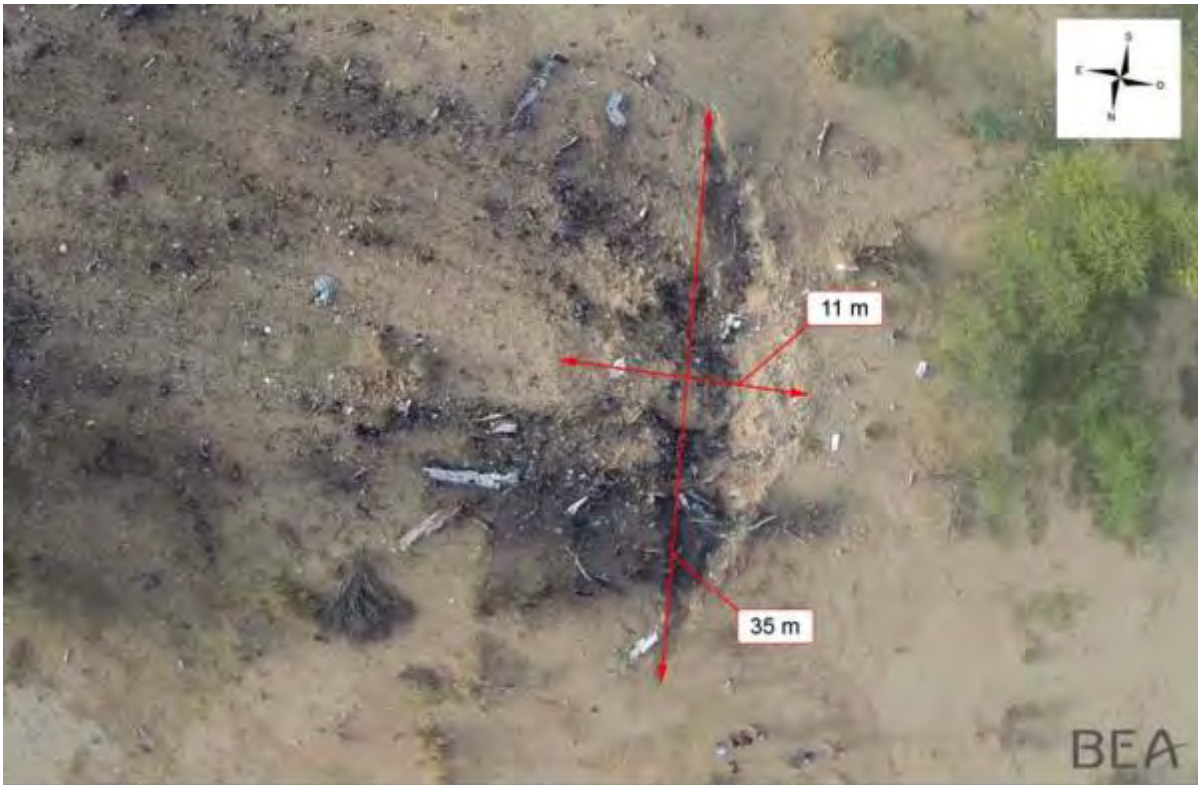
Figure 39 - Top view of the crater

On aeroplane impact with the ground, a crater approximately 35 m wide, 11 m long and 1 m deep was formed²².

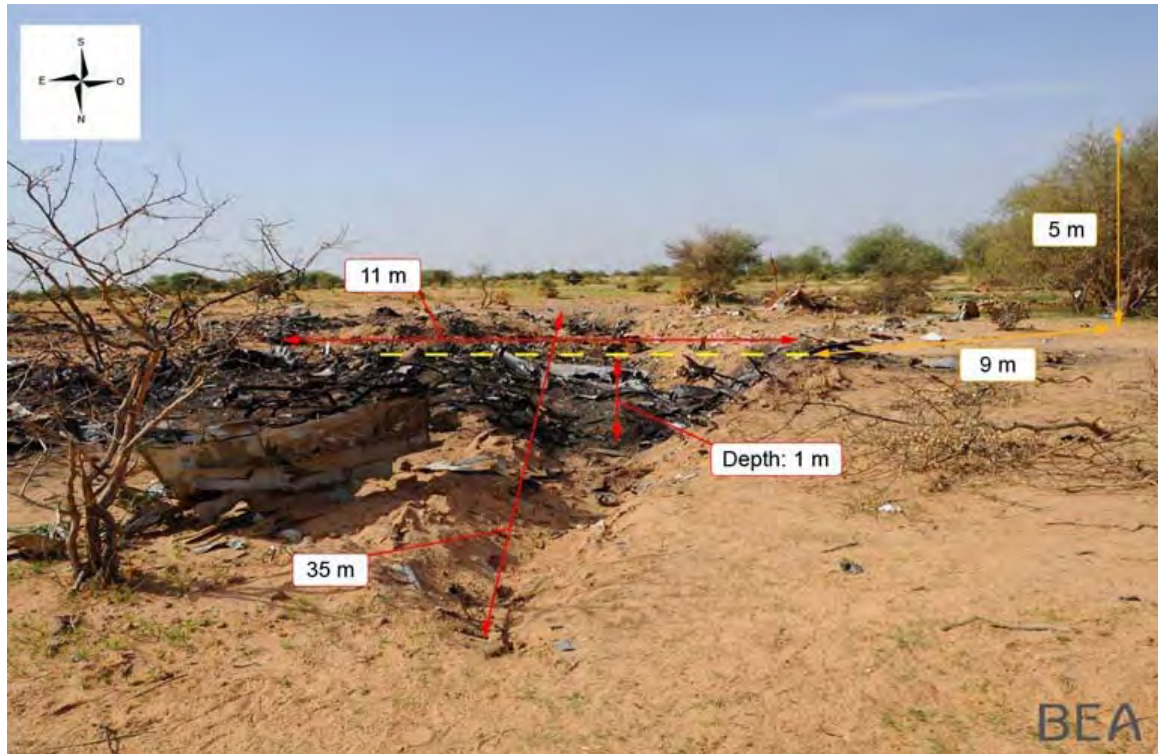
Figure 40 - Side view of the crater

The wreckage was spread over a triangular area with a length of 420 m, the summit²³ of which was the point of impact, which spread out to a width of 340 m. The general distribution of the debris was along a mean axis oriented at 090°.

Trees, about 5 m high and located about ten metres before the impact point, were not cut off. A few elements of the tail section, as well as the rear door and the tail skid, were discovered near these trees.

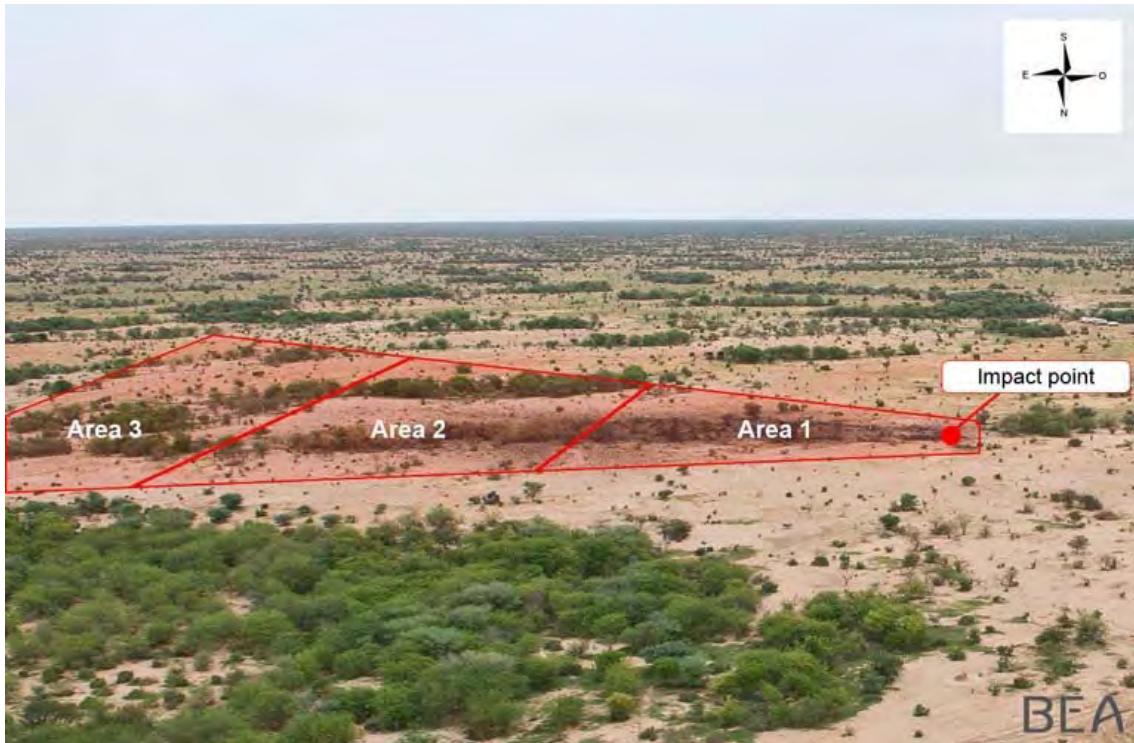
Figure 41 - Aerial view of the debris field

From the impact zone and moving eastward, three debris distribution areas were defined:

- The first area mainly had a concentration of large pieces of wreckage (around one metre or more) and of average density. The debris was mainly parts from the engines, the wings, the fin, the nose gear and the upper parts (shafts) from the main landing gear;
- In the second area, the size (of a few dozen cm) and density of debris were lower than previously observed, most of the elements from the instrument panel and the windshield being found in this area;
- Finally, in the third area, the debris was medium volume (decametric to metric) and high density. It consisted of engine pieces and lower parts (axles) of the main landing gear.

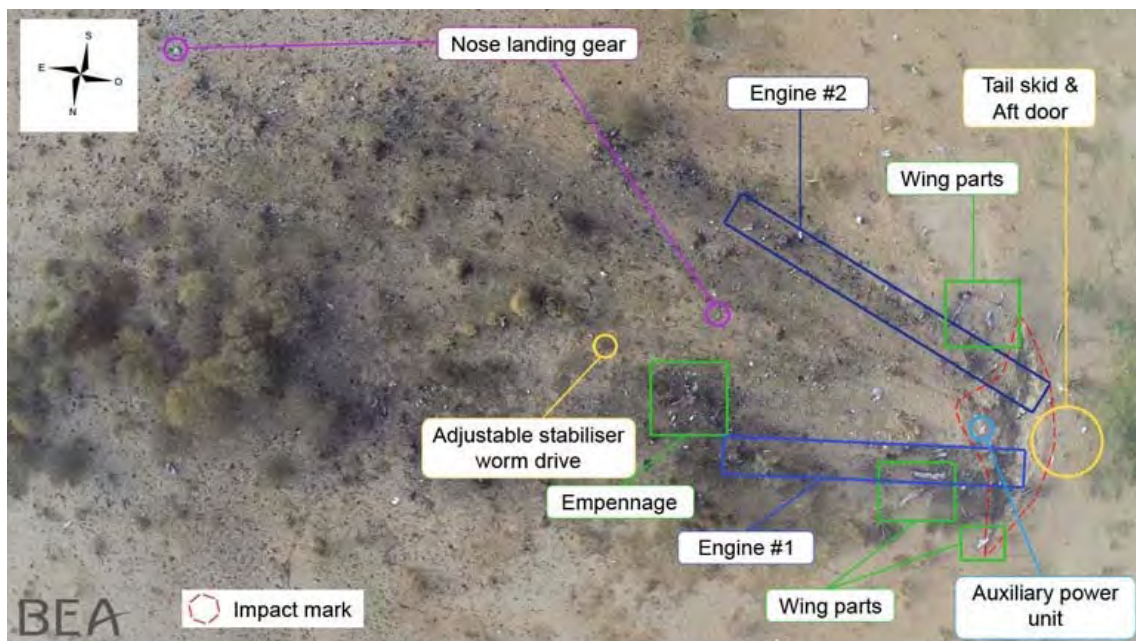
Figure 42 - Distribution of debris in the first area

The debris found in the impact crater was mainly pieces from the wings, from the auxiliary power unit, as well as from the nacelles and engine accessories.

The upper parts of the nose gear were found 50 m away and its lower part, 125 m from the impact crater.

The fin was about 50 m away and the trimmable horizontal stabilizer (THS) jackscrew was about 65 m away.

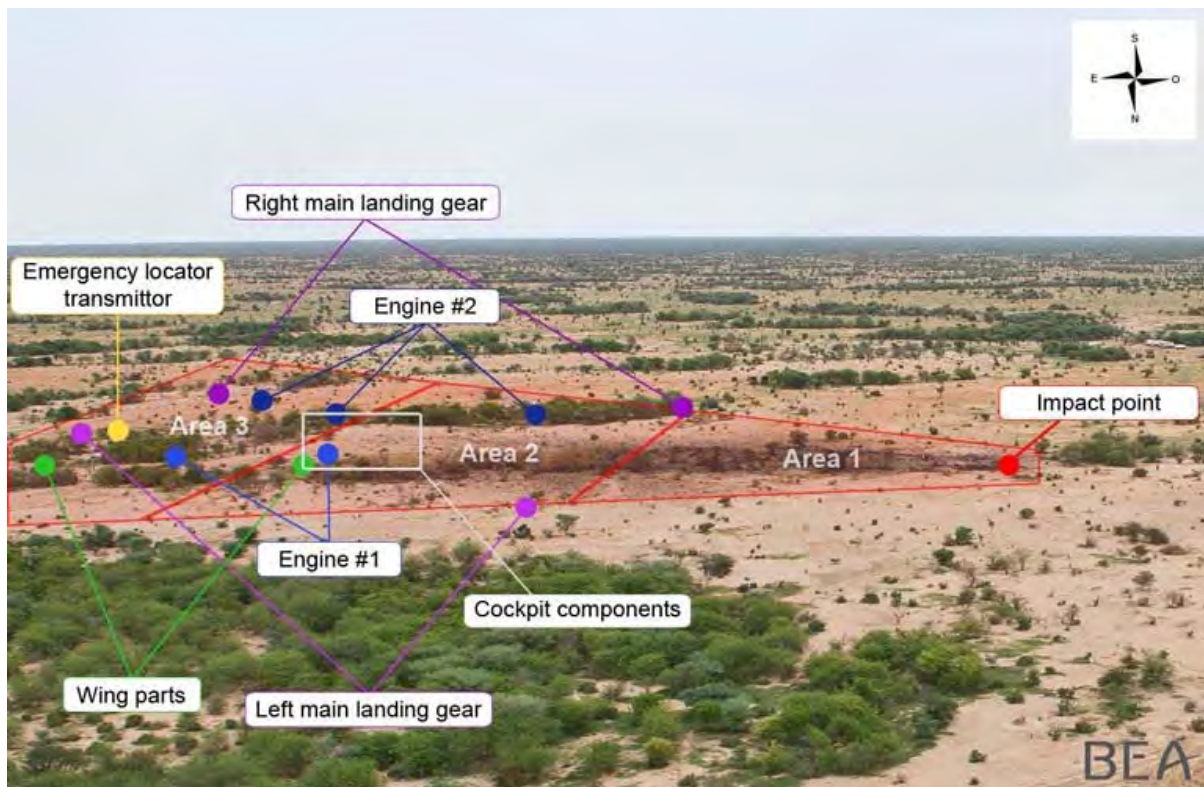
Figure 43 - Distribution of wreckage in areas 2 and 3

The upper parts of the main landing gear were found 120 m from the impact crater for the left gear and 205 m away for the right gear.

From 130 m away, the smallest debris was found.

Parts from engine n°1 were found 160 m and 230 m away. Parts from engine n°2 were found 185 m, 260 and 300 m away.

Two pieces of the wing were found 140 m and 240 m away. The final parts belonged to the lower parts of the main landing gear; the left main landing gear was 295 m and the right 375 m away.

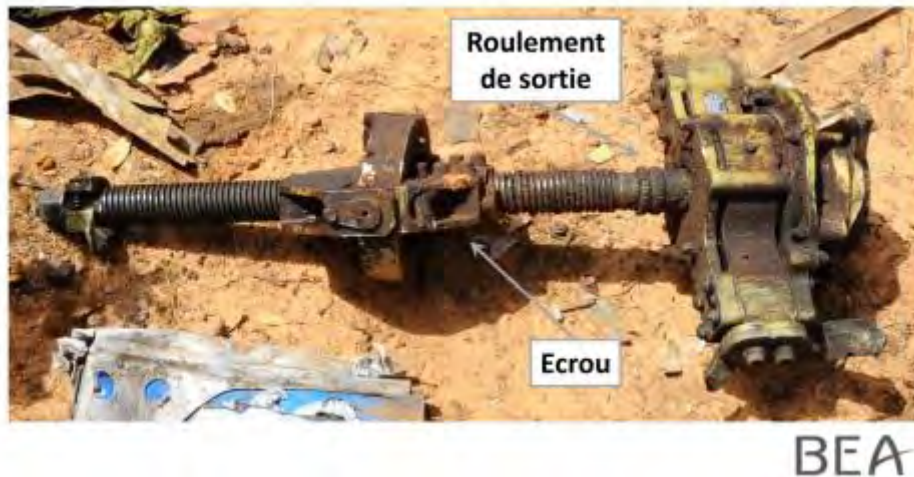
Figure 46 - THS control mechanism

The jackscrew, which enables the THS to be moved, was found. The position of the nut on the jackscrew that enables the THS to move corresponded to a pitch-up deflection angle of 6°, which coincided with the last recorded values on the FDR.

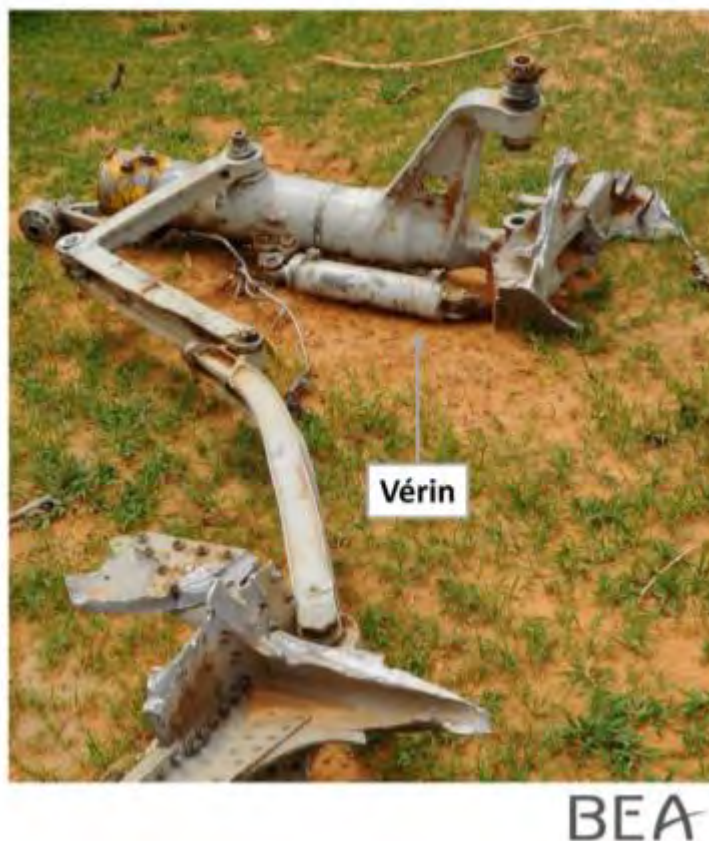
Figure 47 - Right main landing gear

The right landing gear actuator was found.

Examination showed that it was likely in the retracted position.

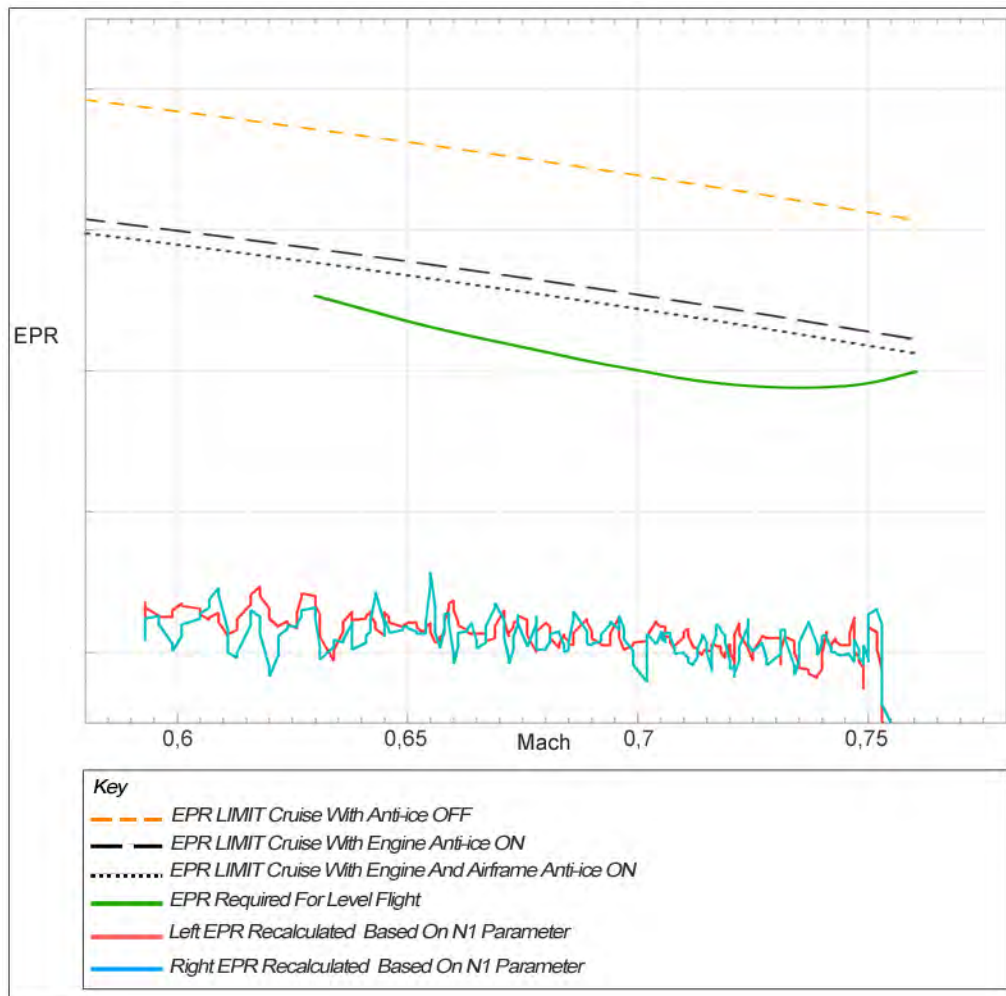
Figure 49 - Comparison of the EPR required, the EPR available and the EPR produced by the engines

When the recorded EPR values became erroneous, the EPR effectively produced by engines 1 and 2 remained around 1.6, whilst the EPR required to maintain flight level 310 under the event conditions was about 1.8. Under these conditions the aeroplane could not maintain stable, level flight at flight level 310 and the aircraft speed start to drop. However flight in cruise with autopilot engaged was possible at this flight level since the EPR LIMIT in CR (Cruise) setting was higher than the EPR required, including when the anti-icing systems were activated.

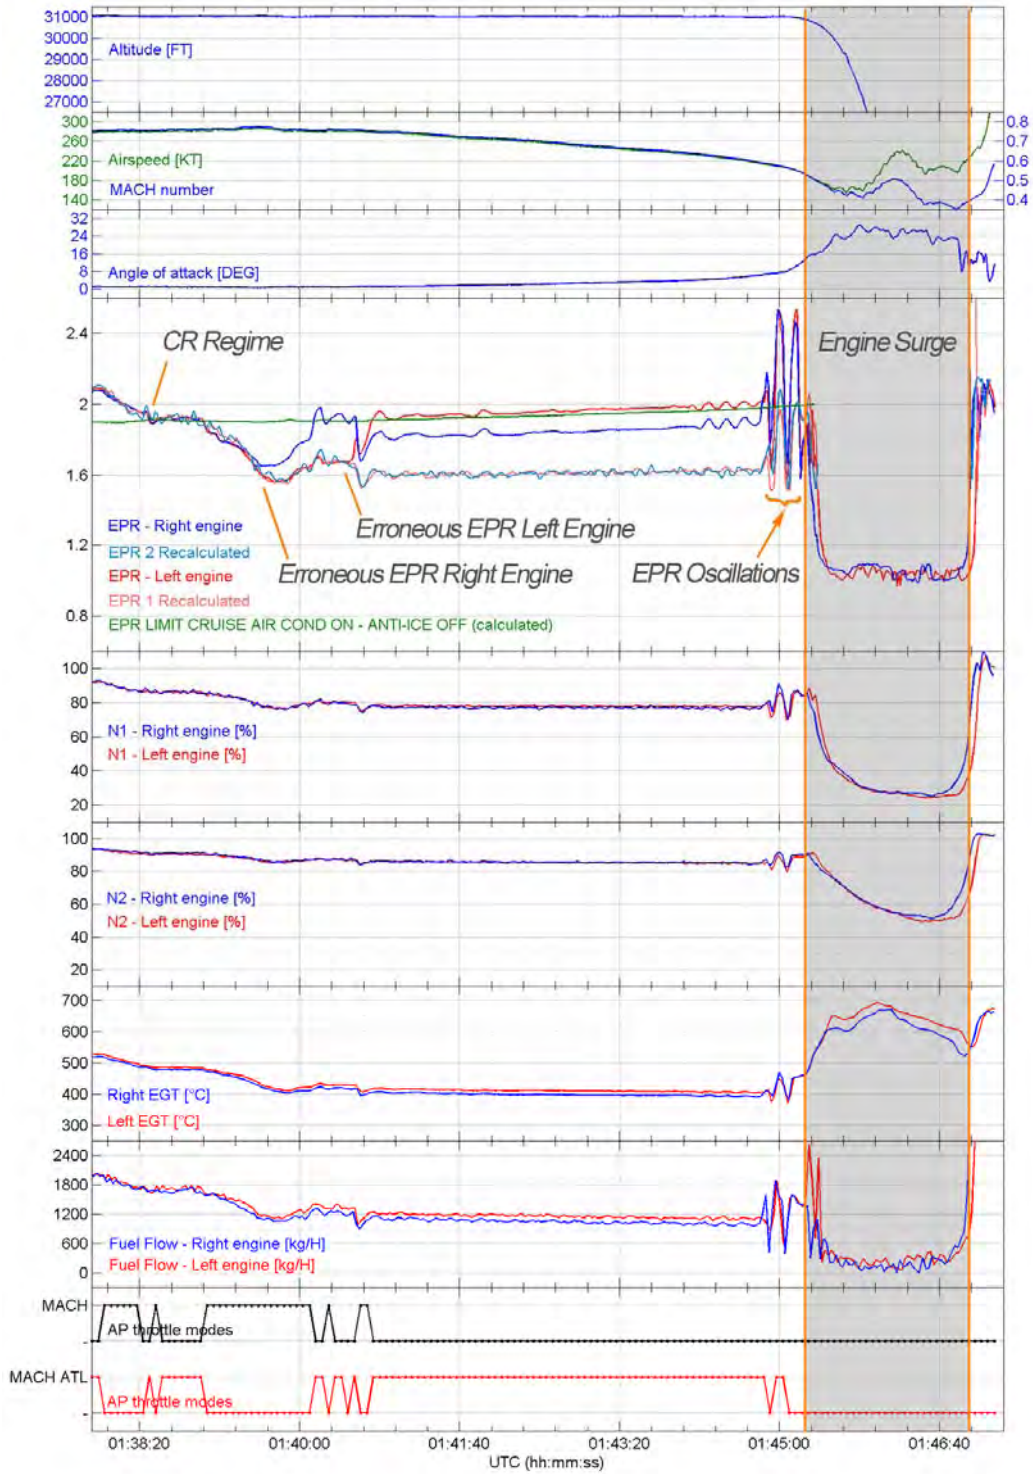
Figure 50 – Evolution of engine parameters during the event

The crew thus selected the CR setting at 01 h 38 min 26 at the latest. Figure 50 provided in 1.16.3.4 illustrates this point.

The excessive angle of attack was likely the cause of the surge on both engines.

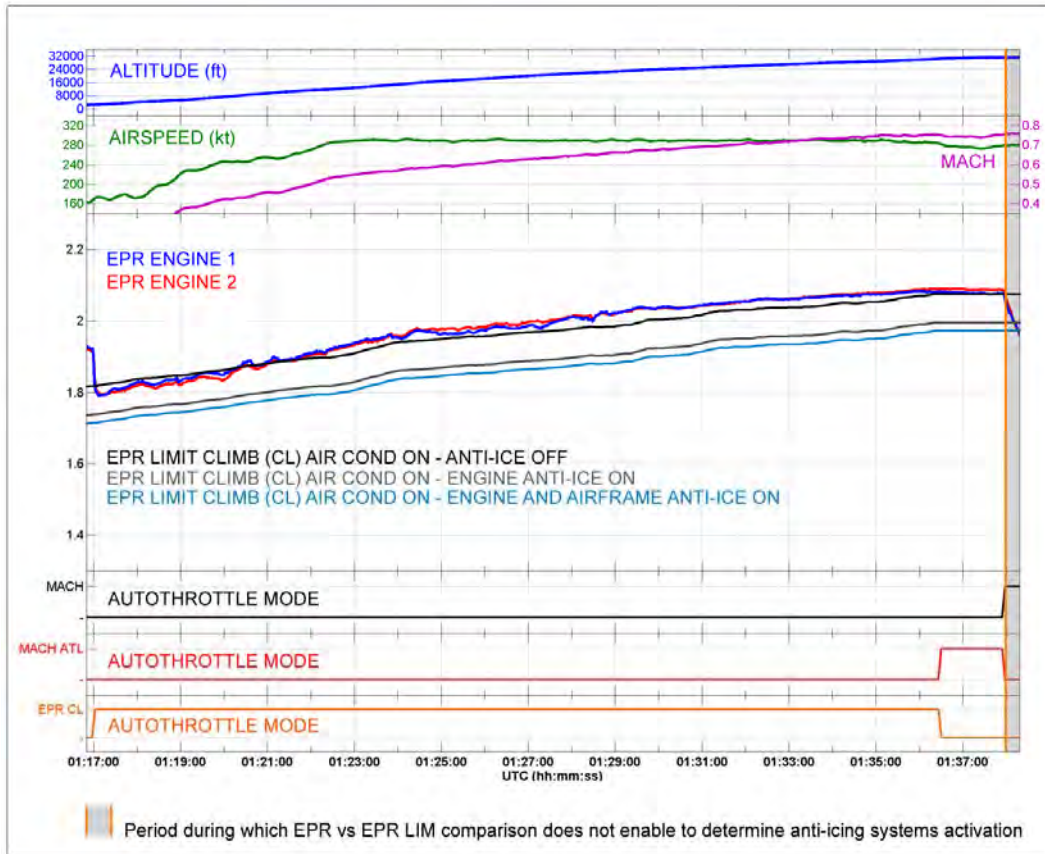
Figure 52 - EPR/EPR LIMIT comparison in climb

During the climb the EPR values on both engines remained close to the EPR LIMIT values without anti-icing protection activated and significantly higher than the EPR LIMIT values with anti-icing. This indicates that the engine and airframe anti-icing systems were not activated during the climb.

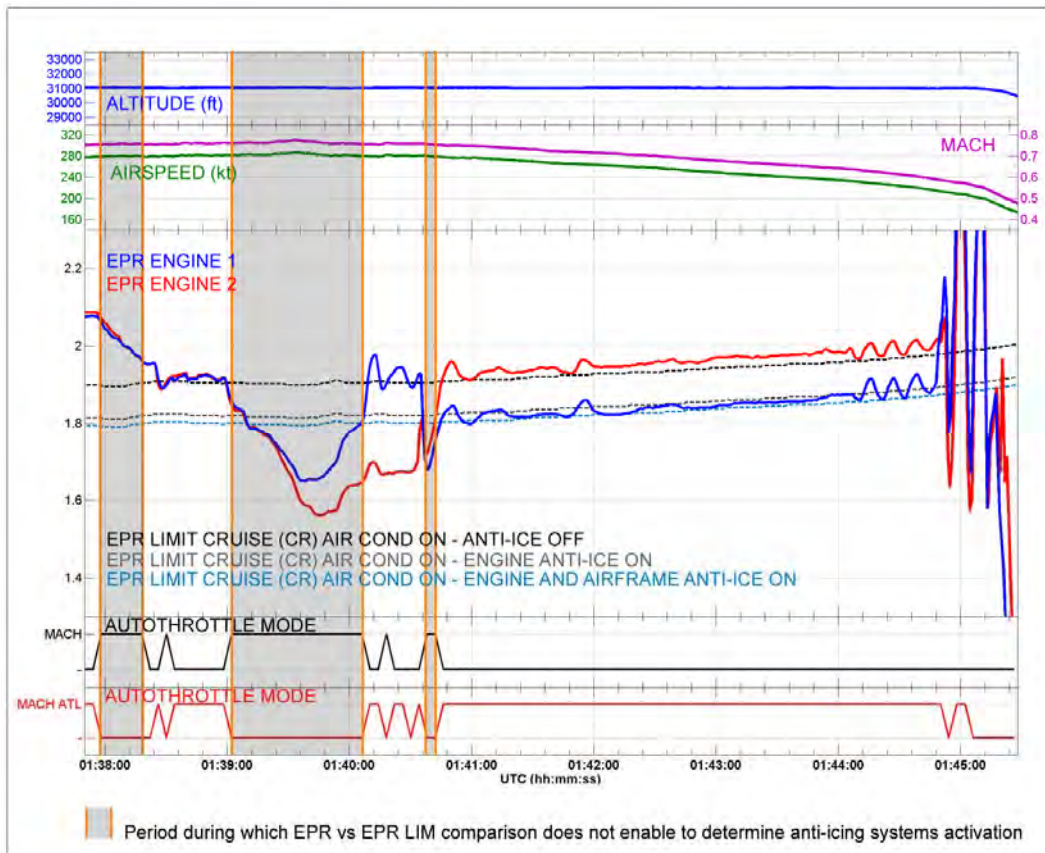
Figure 53 - EPR / EPR LIMIT comparison in cruise

During cruise the error in the EPR measurement caused differences between the left engine's EPR and the right engine's EPR (see paragraph 1.16.2.1). By design, the EPR LIMIT is necessarily the same for both engines. In addition, the autothrottle having only one servo control, it regulates the two engines in an identical manner. Consequently, in case of a gap between the EPR values of the left and right engines, the autothrottle adjusts the thrust on both engines to prevent the higher EPR from exceeding EPR LIMIT. In the case in point, the EPR value of the other engine is subject to regulation by the autothrottle. The previous graph shows that when the autothrottle is in MACH ATL mode there is always at least one engine whose EPR is consistent with EPR LIMIT without anti-icing system activated.

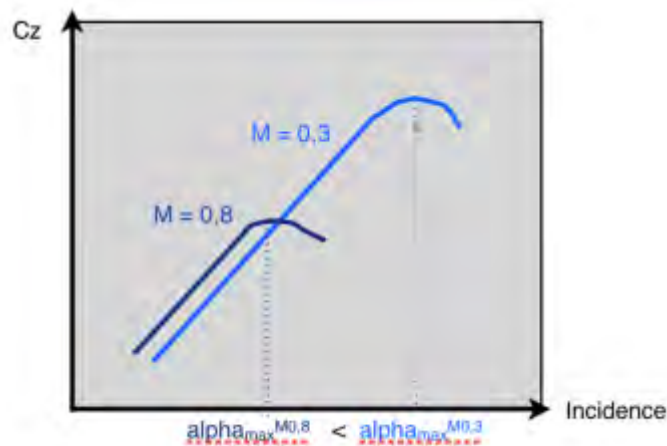
Figure 54 - Graph of lift at low and high Mach

The aerodynamic characteristics of a wing, thus the shape of the $C_z = f(\alpha)$ curve, are different between the lower levels (low Mach, subsonic air flow) and high altitudes (higher Mach, air flow close to trans-sonic).

This leads to a lower stall angle of attack at a higher Mach level.

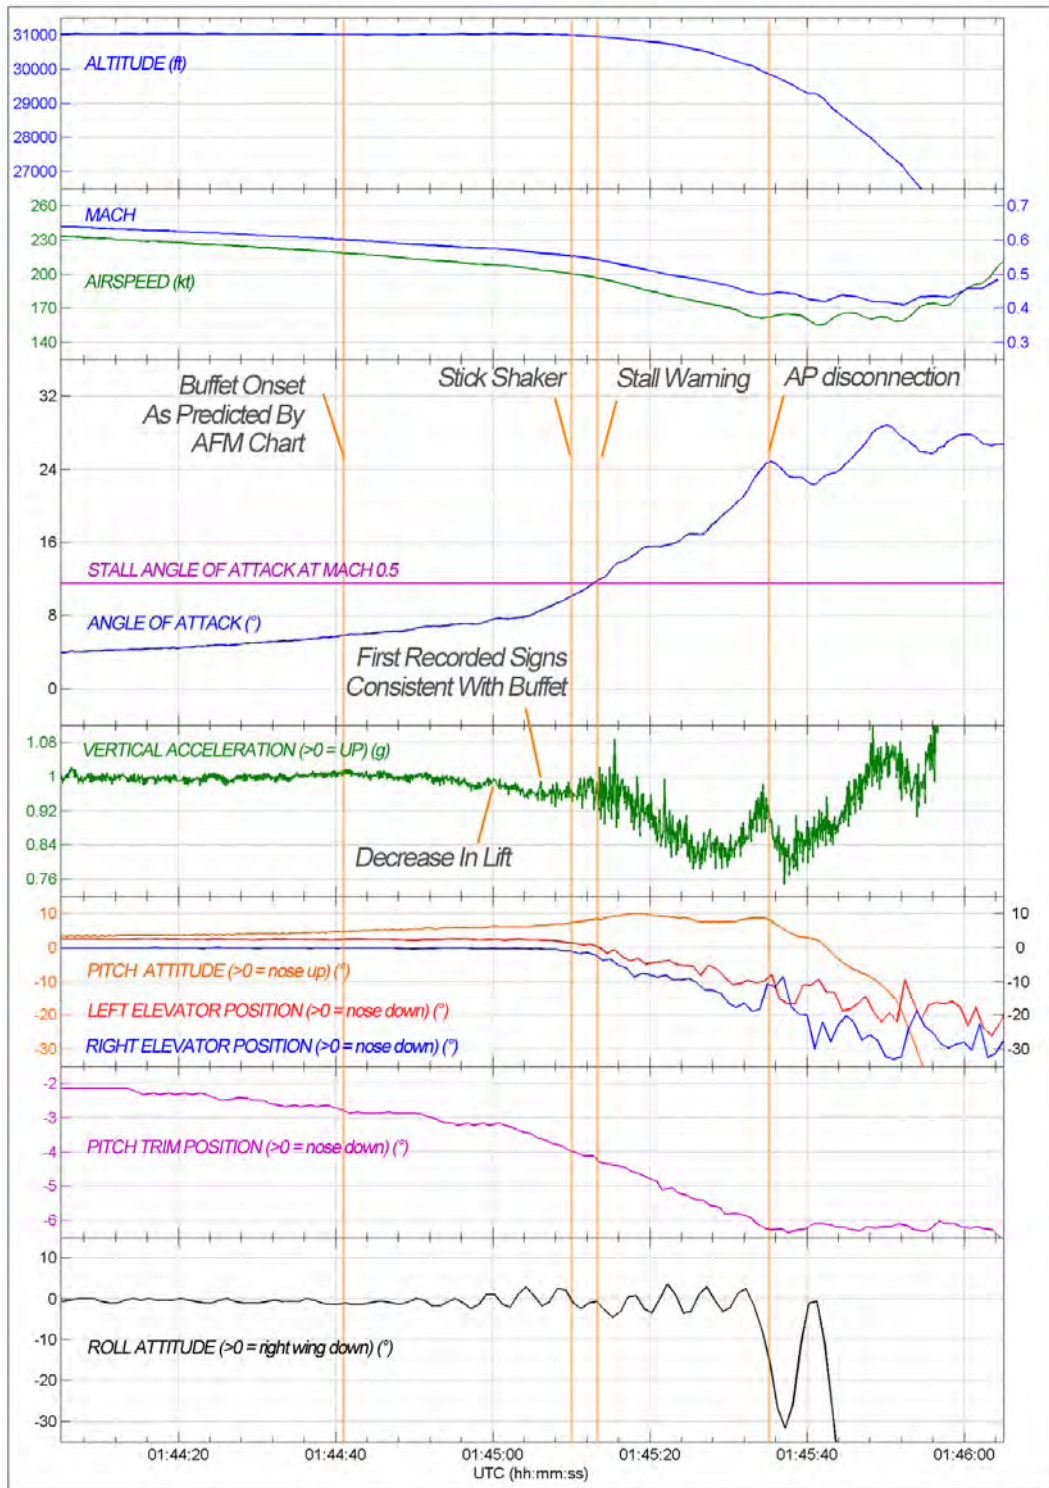
Figure 55 - Flight parameters relating to stall

Before that, at 01 h 45 min 00, while the autopilot was engaged in altitude hold mode, the load factor went below 1, which indicates that the lift was insufficient to completely balance the aeroplane's mass. The autopilot commanded a continuous nose up evolution of the trimmable horizontal stabiliser. The aeroplane's deceleration also increased. These phenomena indicate that the autopilot did not manage to compensate for the aeroplane's decrease in speed and maintain level flight.

UTC time	Phenomenon	Speed (kt)	Angle of attack (°)
01 h 45 min 00	Decrease in lift	208	7.5
01 h 45 min 6	Probable Buffet	203	9
01 h 45 min 10	Stickshaker	200	10
01 h 45 min 13	Stall warning	197	12
01 h 45 min 35	AP disconnection	162	25
