COMMISSION D'ENQUETE SUR LES
ACCIDENTS ET INCIDENTS
D'AVIATION CIVILE

INTERIM REPORT

Accident
on 24 July 2014
in the region of Gossi in Mali
to the MD-83 registered EC-LTV
operated by Swiftair S.A.

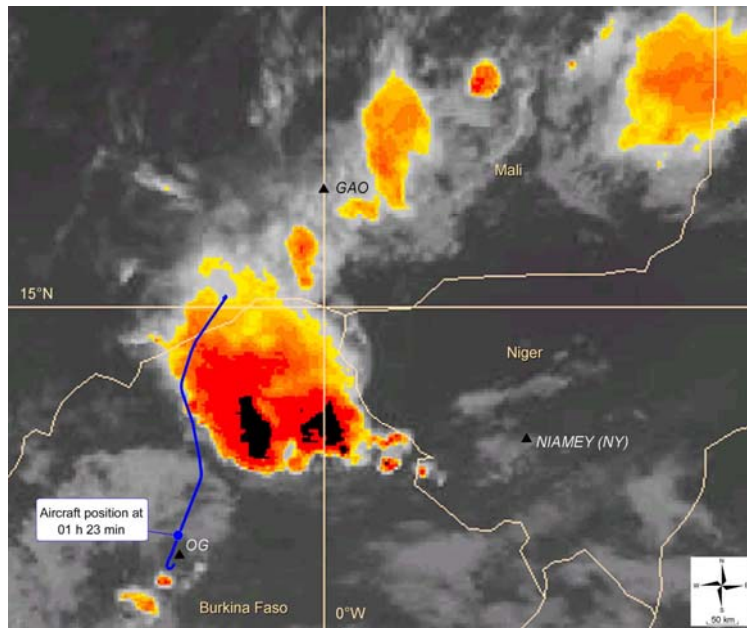
Satellite observations of the night of July 23 to 24 showed a convection zone that grew from 20 h 00 over northern Burkina Faso as it moved to the southwest. On the following image, two black areas can be seen representing the two coldest zones which are therefore the highest and most dynamic. They culminate well above the level of FL 400. The highest number of lightning strikes occurs in these zones.

After takeoff from Ouagadougou, the crew changed heading. The aeroplane passed along the western edge of the convection zone. From 1 h 30 to 1 h 45 the aeroplane was flying in a saturated environment, probably in the cloud layer between 24,000ft and 31,000ft.

Meteorological data: Temperature at top of clouds by satellite measurement (source: Météo France)
Main weather cell timed at 01h23

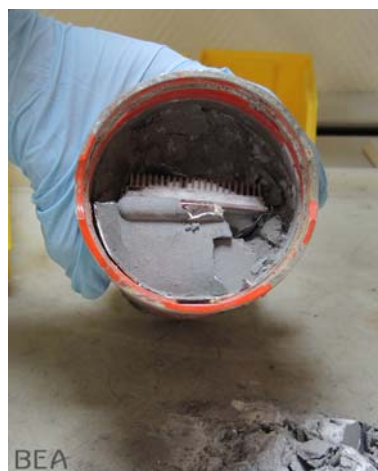
Electronic card in the CSMU

Visual examinations showed no apparent damage to the card. Entry impedance measurements on the electronic card were made. The values recorded were in accordance with Honeywell specifications.

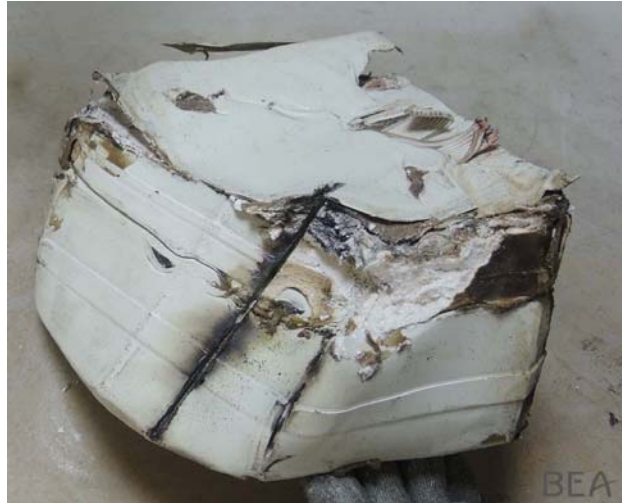
Heat protection of the data media

After removing the heat shield, it was noted that the tape mechanism had been destroyed and the tape was damaged. It was broken in several places.

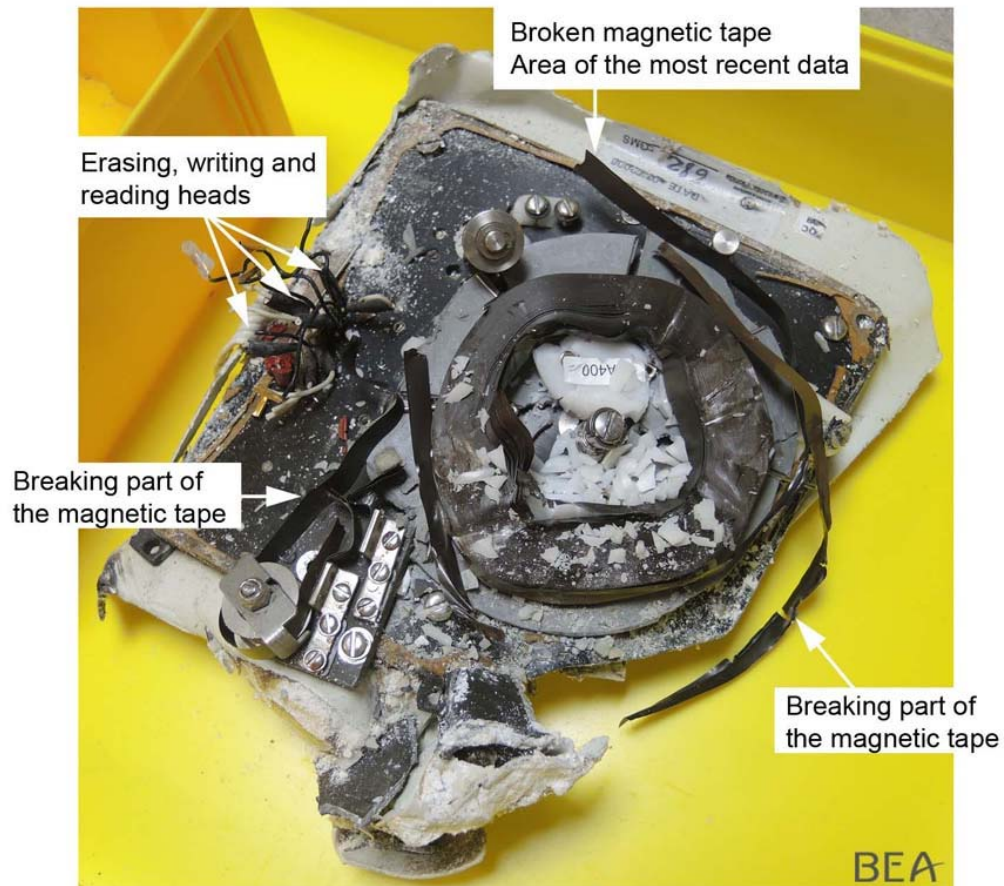
Magnetic Data storage

The various pieces of tape were identified and numbered. To read the tape in its entirety, repair operations were necessary.

These operations consisted in reinforcing the magnetic tape at the locations where damage was greatest.
