**Loss of Pitch Control During Takeoff
Air Midwest Flight 5481
Raytheon (Beechcraft) 1900D, N233YV
Charlotte, North Carolina
January 8, 2003**

Aircraft Accident Report
NTSB/AAR-04/01

Loss of Pitch Control During Takeoff

Air Midwest Flight 5481

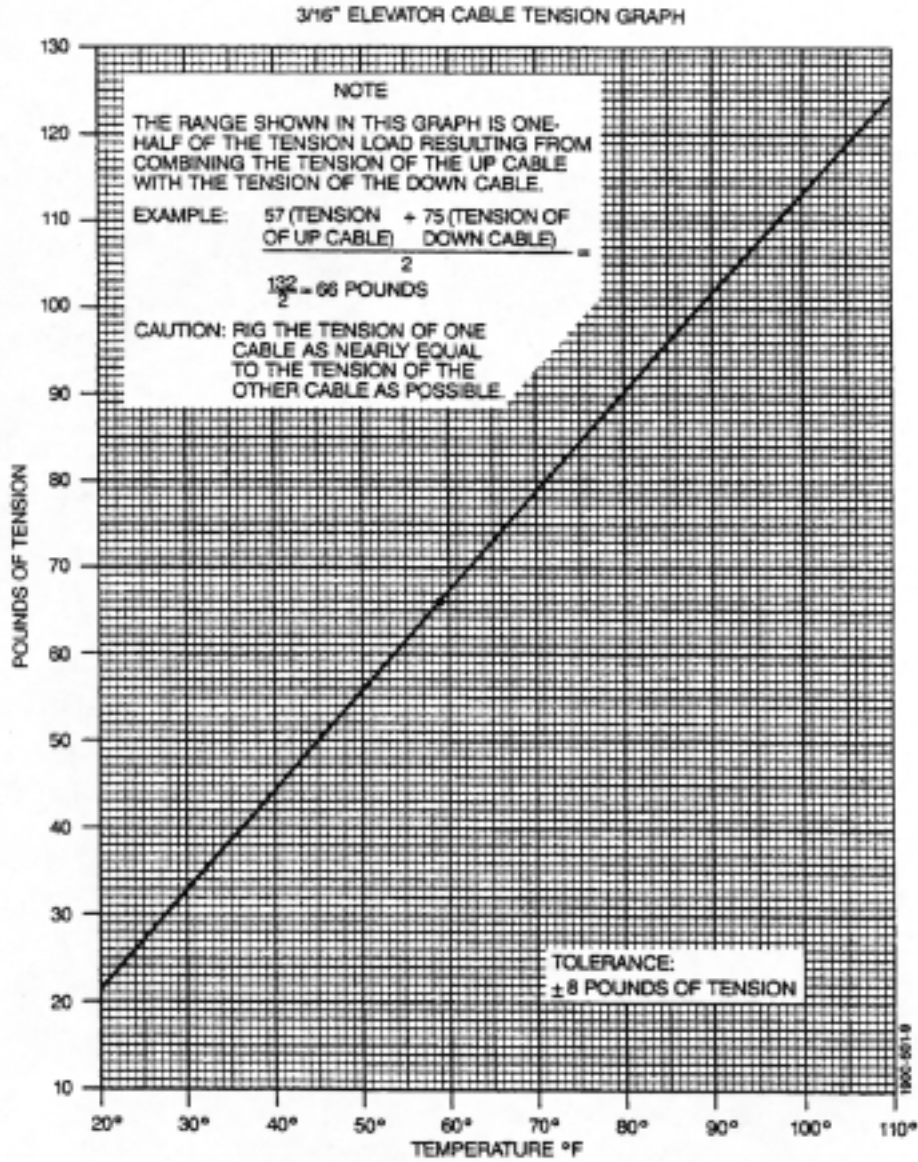
Figure 203 - Elevator Cable Tension Graph

³² Figure 203 was an elevator cable tension graph included in section 27-30-02 of the Beech 1900D AMM. The graph did not contain instructions on how to take a temperature reading.

- Step q refers the mechanic to the elevator cable tension graph (figure 203) in section 27-30-02 for performing cable tensioning, but no instructions were given regarding whether the airframe, outside air, or cable temperature was to be taken when determining the amount of cable tension; whether the flight compartment cabin temperature gauge or an outside air temperature gauge was to be used in determining the temperature; and what type of device was to be used to measure cable tension.

Regarding the Air Midwest accident, the elevator cable tension graph (figure 203) in the elevator control system rigging procedure did not contain instructions on how to take a temperature reading, which was needed to determine the tension values at which the cables should be set. Regarding the Colgan Air accident, the elevator trim system rigging procedure showed an incorrect illustration of the forward elevator trim cable drum. This error could have resulted in the incorrect installation of the elevator trim cable and elevator tab operation in the direction opposite of that commanded by the trim wheel. Regarding the CommutAir incident, the Beech 1900D AMM did not contain a procedure for replacing a thrust lever detent pin.¹⁵³
