**Report on the accident to
Airbus A-320-231, G-MEDA
On approach to Addis Abeba Airport,
Ethiopia
31 March 2003**

Registered Owner and Operator: British Mediterranean Airways Limited

Aircraft Type: Airbus A-320-231

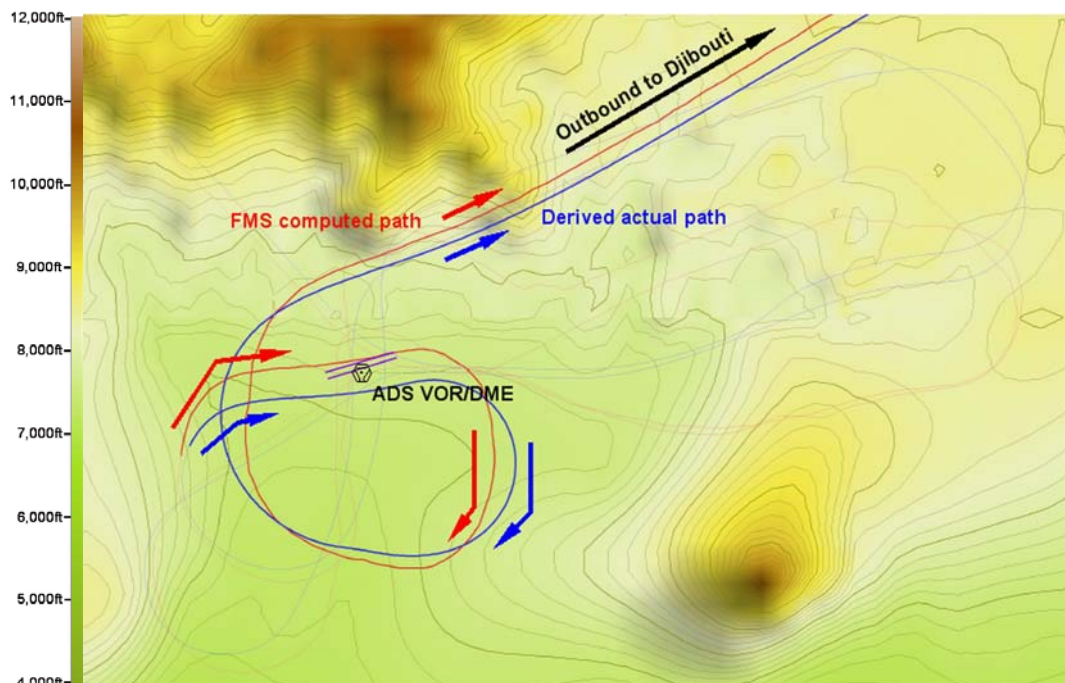
Figure 17 shows the subsequent departure from Addis Abeba, approximately 35 minutes after arriving. The aircraft landed at Ambouli airport, Djibouti at 0042 hrs.

FMS computed path v derived actual path - hold and diversion to Djibouti
