----- SYSTEMS GROUP CHAIRMAN'S FACTUAL REPORT -----

Location: Memphis, Indiana  
Date: November 30, 2018  
Time: About 1028 EST  
Aircraft: Cessna Citation 525A  
Serial Number: 525A0449  
Registration: N525EG

### **3 SUMMARY**

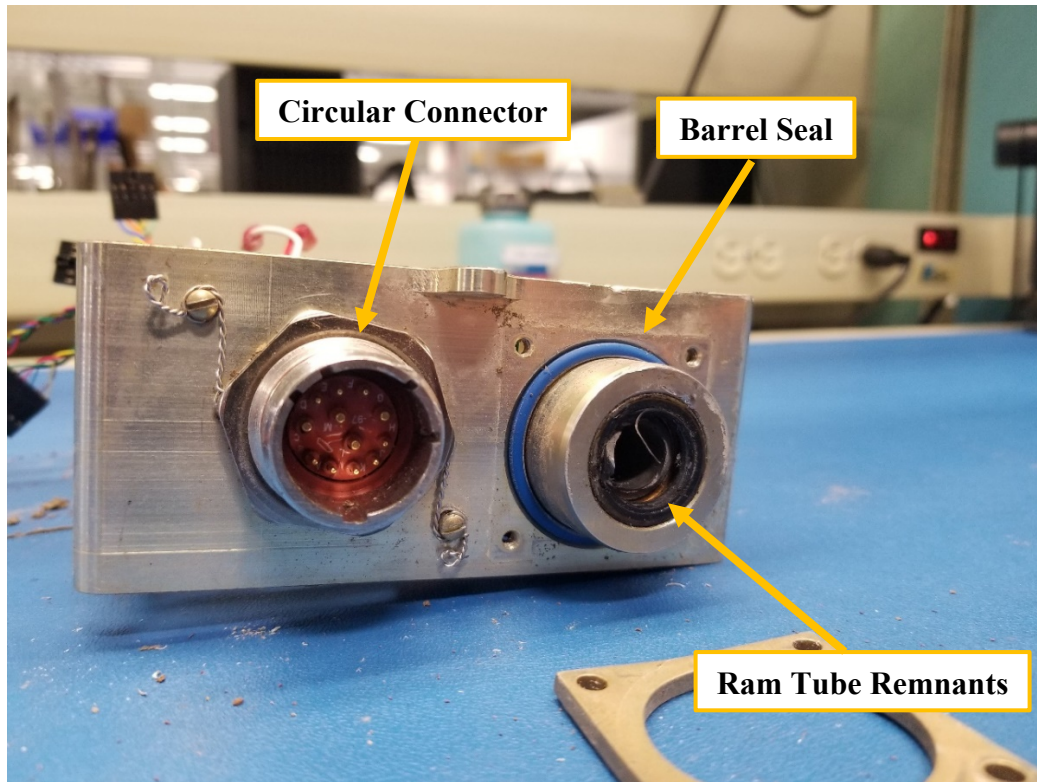
**Figure 13 - View of circular connector and barrel seal with mounting plate removed**

The TCU case was deformed and twisted with the upper cover partially separated from the unit consistent with impact damage. The ram tube was fractured at the barrel seal face.<sup>9</sup> The circular electrical connector and grounding wires from the aircraft wiring harness were not present with the unit when it was found.

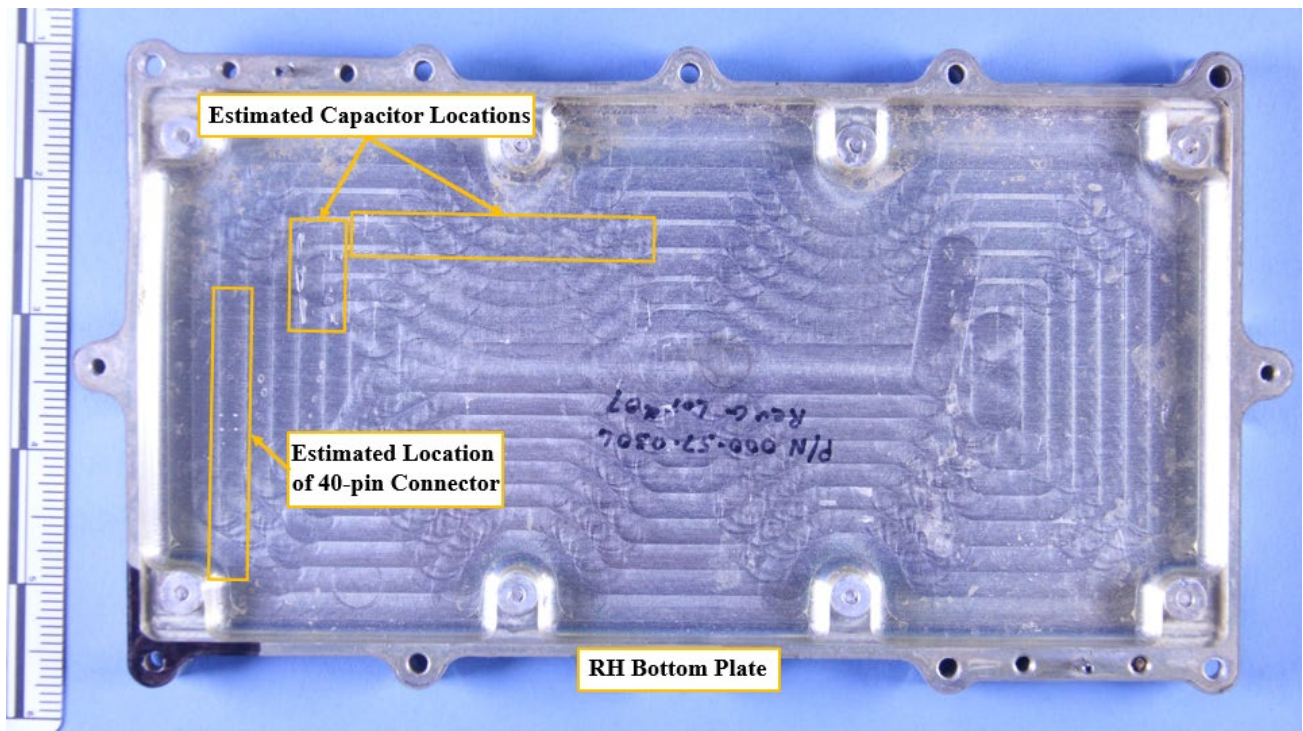
Figure 19 - The RH TCU bottom plate with approximate locations of 40-pin connector and stacked capacitors

Additional images of the backside of the main PCB and the bottom plate show the extent of damage to the components. Figure 18 highlights damage to the J-frames of three stacked capacitors, exhibiting signs of crushing. Figure 19 contains the bottom plate of the RH TCU and approximations of the locations of the 40-pin connector and stacked capacitors.

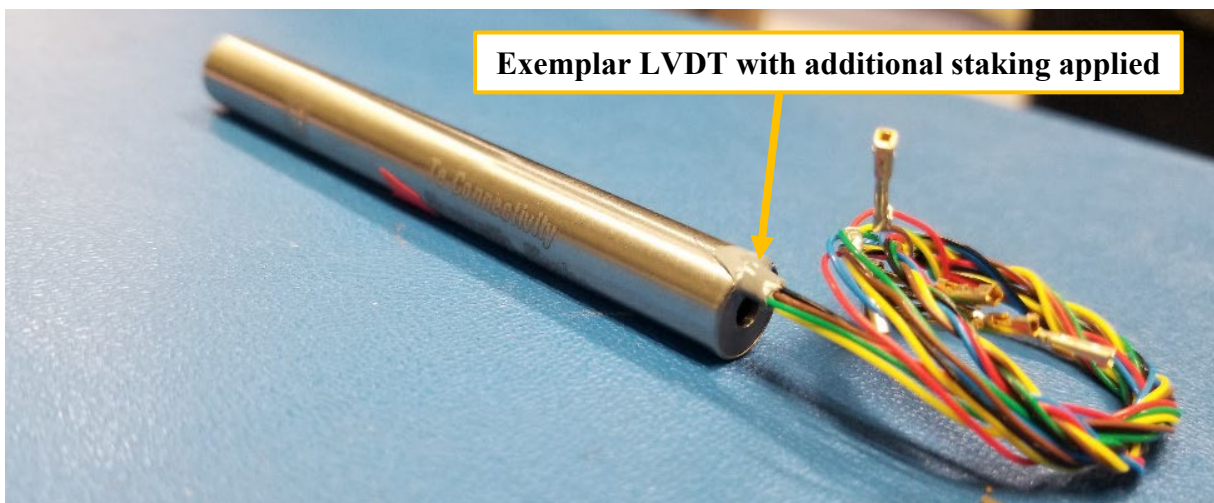
Figure 25 - Exemplar LVDT with staking applied to signal wires

During the production of the units, Tamarack requested that additional staking compound be added to the signal wires, as a general product improvement, to improve stability where they exit the LVDT, ref Figure 25<sup>11</sup>. The additional staking was implemented by the manufacturer in the beginning of 2019 for new production units and previously produced units would have the additional staking applied per SB CAS/SB1480. The LVDTs for the accident unit did not have additional staking where the signal wires exit the unit, ref Figure 26.

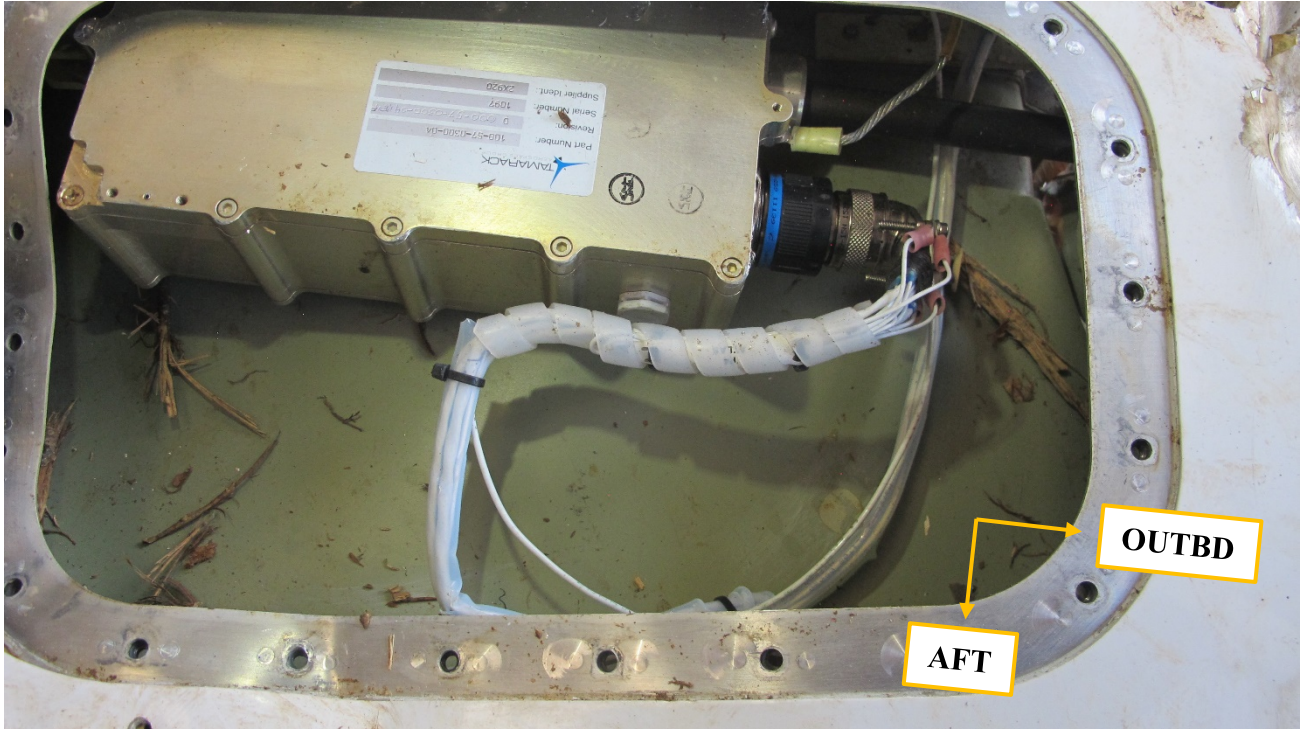
Figure 27 - LH TCU as found in wing tip structure with access panel removed, view looking at underside of wing

The TCU was located in the recovered wreckage and was found in a section of wing tip structure where it is mounted, ref Figure 27. The section of wing tip structure where the TCU was mounted still had the access panel attached. Due to impact forces, an outline consistent with the TCU, was impressed into the access panel, ref Figure 28. The TCU was removed from the wing structure.

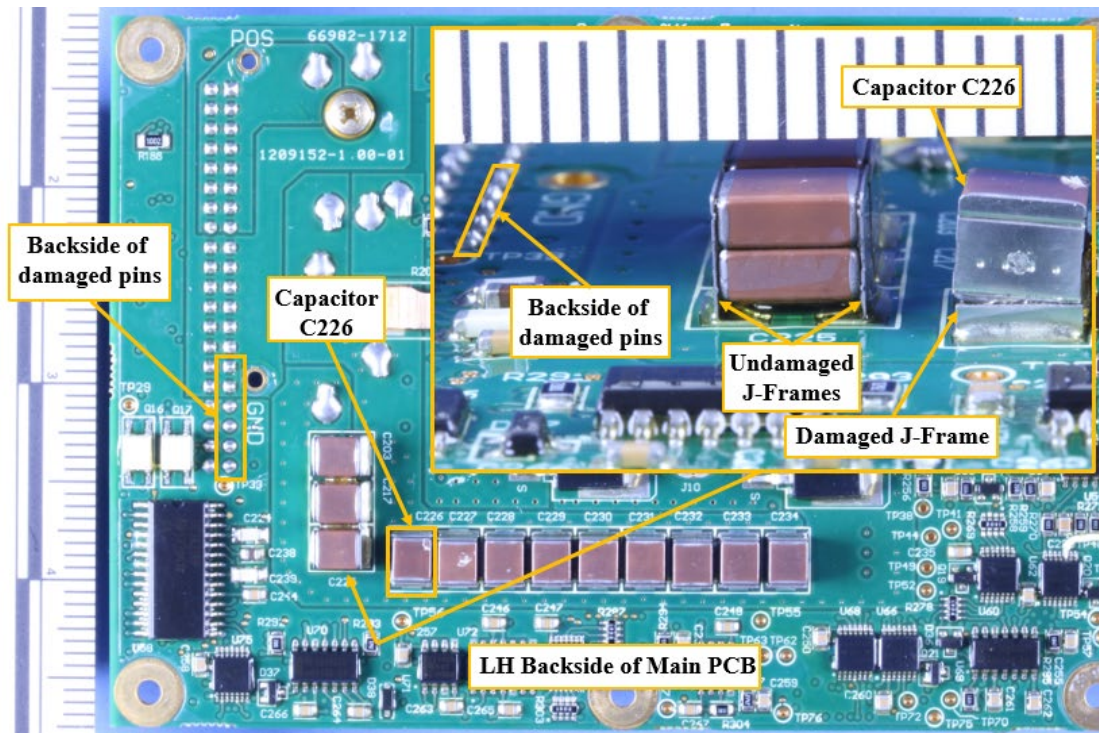
Figure 39 - View of back side of main PCB of the LH TCU in area of 40-pin connector

The main PCB was removed from the bottom case to check for any marks or damage. No components appeared to be missing from the backside of the main PCB. There were no marks or patterns consistent with bending or flexure on the PCB. One capacitor, C226, was misaligned with respect to the adjacent capacitors, ref Figure 39. One J-Frame, attached to C226, was fractured across a majority of the width near the base of the J-Frame, but appeared to remain in electrical contact with the capacitors and PCB. An area on the top of capacitors C226 and C227 had noticeable damaged to the conformal coating and the corner of the J-Frame, ref Figure 40. Additionally, the J-Frame exhibited signs of buckling near the PCB attach point.

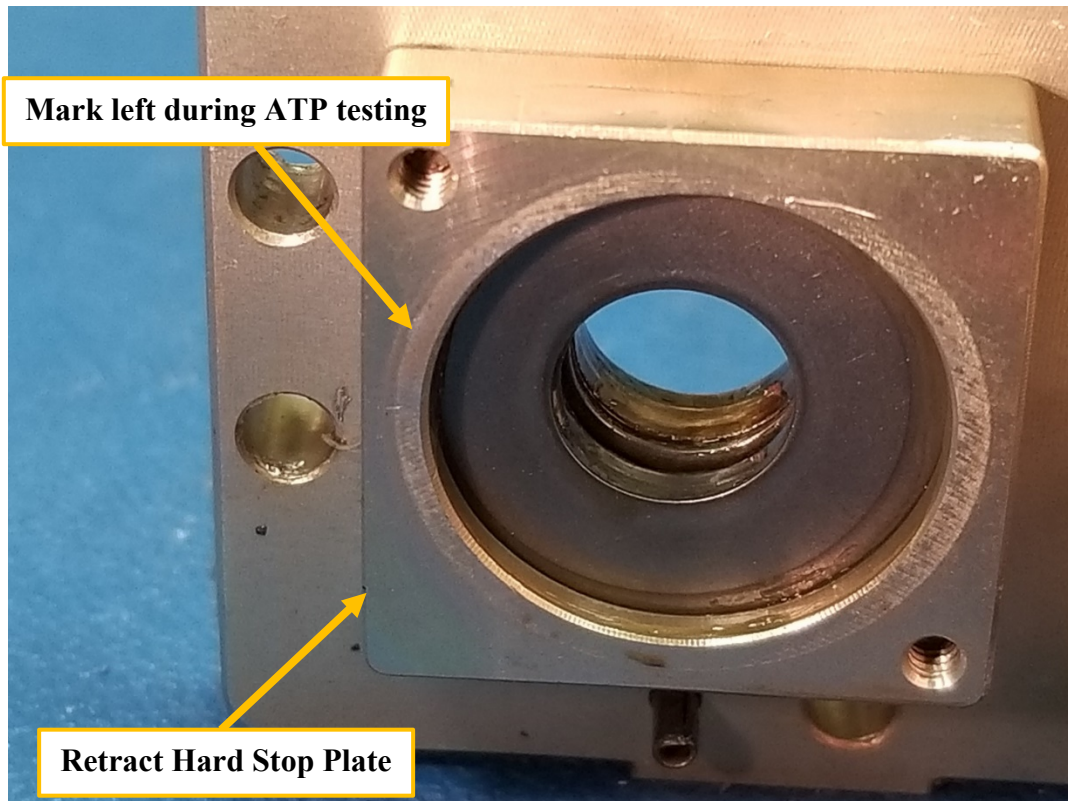
Figure 45 - LH TCU retract back plate

The ram tube was bent and could not be removed using normal disassembly procedures without applying excessive force. There were no visible marks on the retract hard stop to indicate a high-force impact. Minor marks, similar to the RH TCU, consistent with backdrive force tests during ATP were visible, ref Figure 45. There were witness marks on the extend hard stop consistent with a high energy impact, ref Figure 46.

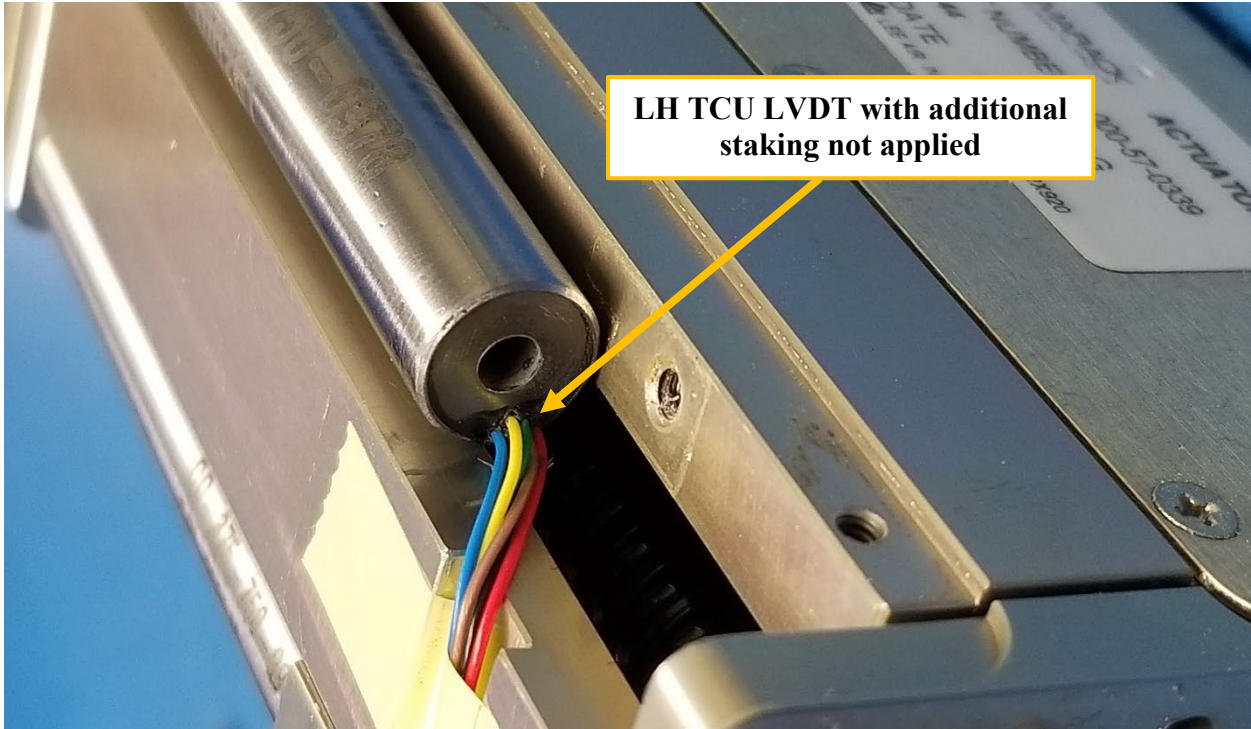
**Figure 49 - One LVDT on LH TCU linear actuator**

Both LVDTs were in their original mounting positions. The LVDTs did not have additional staking (potting) where the signal wires exit the unit<sup>13</sup>. Wiring from each LVDT to the main PCB was intact and secure.

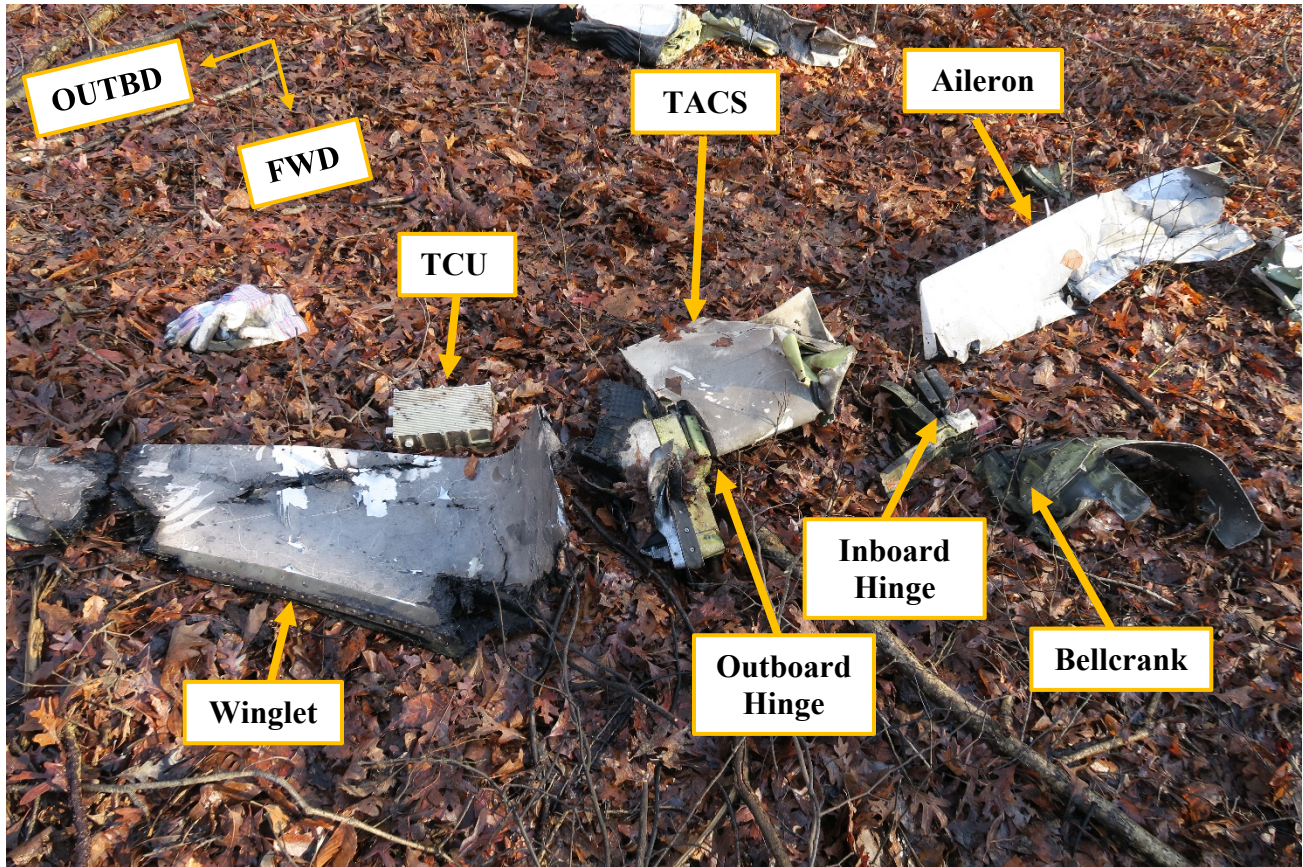
Components from the RH TACS and RH aileron were laid out at the accident site, ref Figure 50. Components, except for the aileron, were covered in residue consistent with soot from the post-crash fire.

**Figure 50 - RH TACS and aileron components found and laid out at accident scene by on-scene investigators (photo courtesy of Textron Aviation)**

The recovered control linkages exhibited failures consistent with overload. All attachment and securing hardware were present on recovered rod ends. A visual inspection of the trailing edge down mechanical stop revealed that the bolt/stop was deformed and the nut and cotter pin were not present and could not be located, ref Figure 51. The damage to the bolt was consistent with shear loading at the lower attachment fitting. Additional damage consistent with over deflection was noted to the inboard hinge fitting, ref Figure 52.

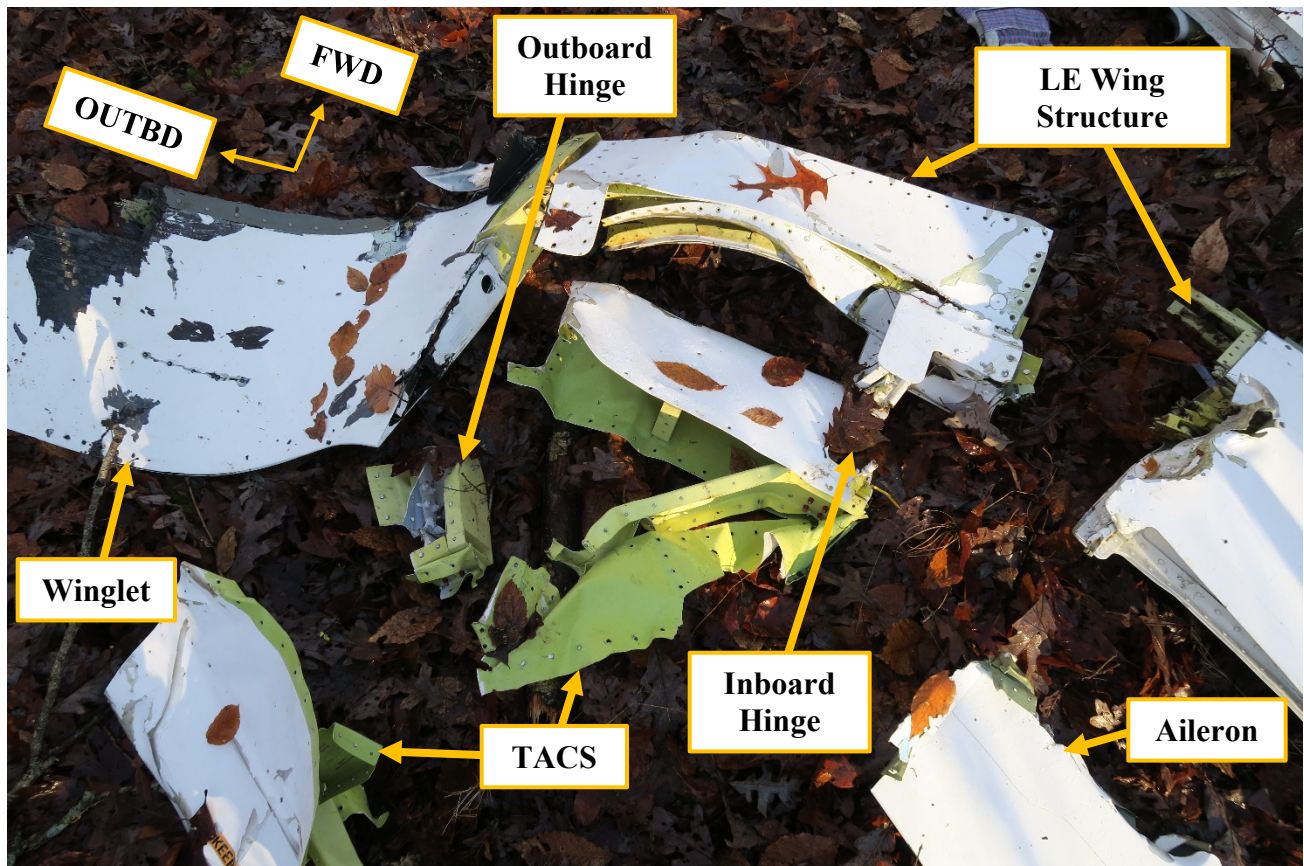
Components from the LH TACS, wing structure and LH aileron were laid out at the accident site, ref Figure 53.

Figure 53 - LH TACS, wing structure and aileron components found and laid out at accident scene by on-scene investigators (photo courtesy of Textron Aviation)

The recovered control linkages exhibited failures consistent with overload. All attachment and securing hardware was present on recovered rod ends. A visual inspection showed a witness mark on the bellcrank, which was consistent with contact with the trailing edge up mechanical stop, ref Figure 54. Additional damage consistent with over deflection was noted to the inboard hinge fitting, ref Figure 55.

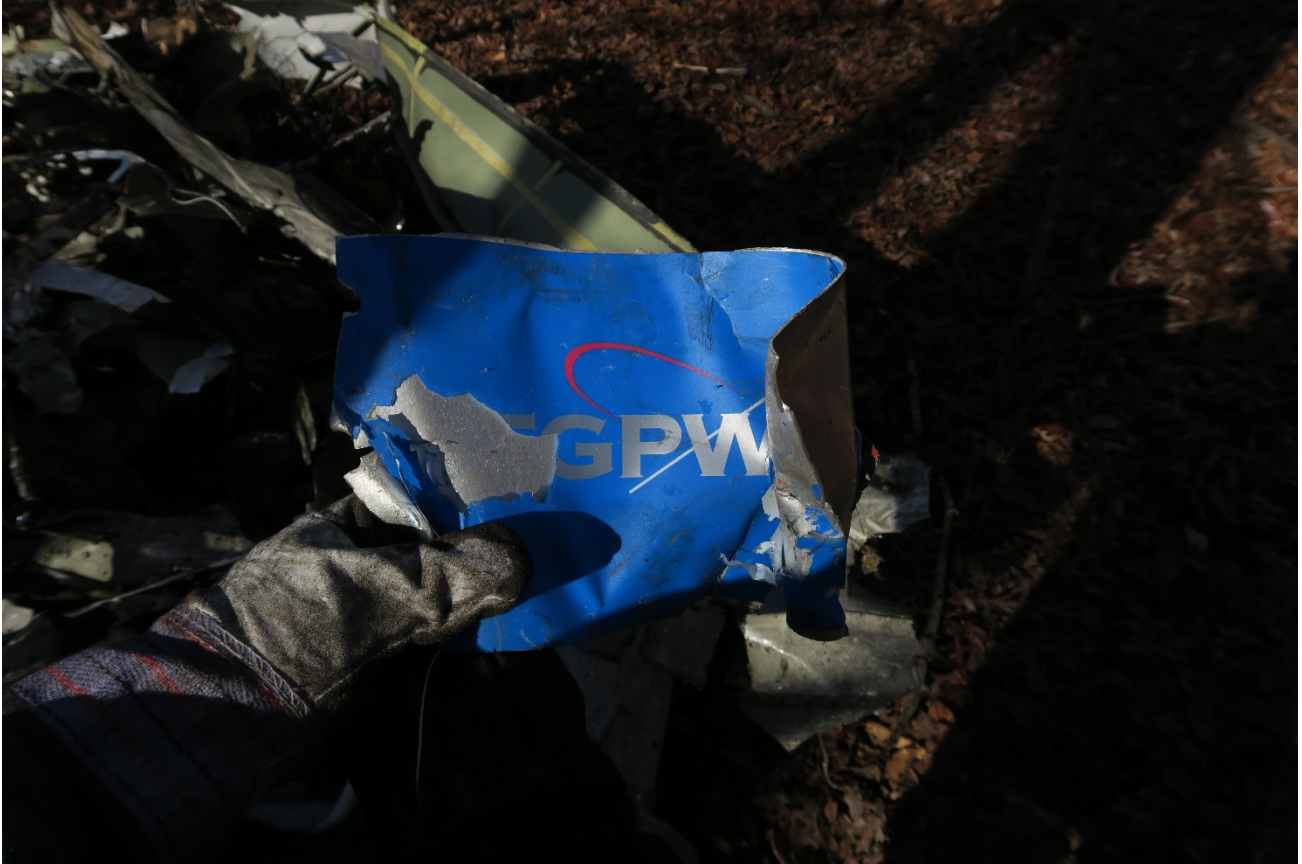
On scene the team was able to locate a portion of the outer case of the EGPWS, ref Figure 56. On scene, the team was unable to locate any of the internal circuit cards associated with the EGPWS.

**Figure 56 - Portion of outer cover of EGPWS unit (photo courtesy of Textron Aviation)**

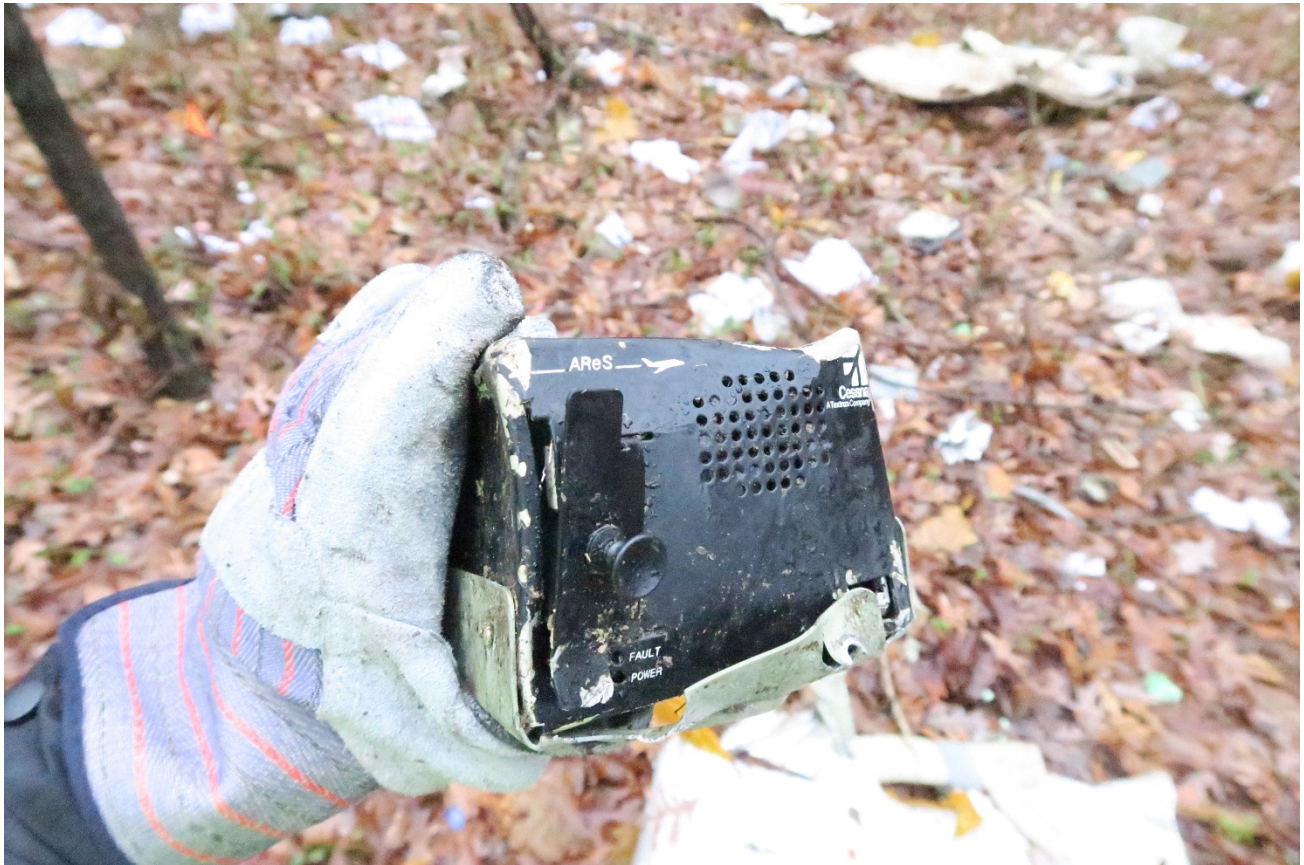
On scene the team was able to locate the AReS unit, ref Figure 57. The exterior of the units showed signs of damage consistent with an impact. The outer case of the unit was compromised, exposing the internal circuit cards and compact flash (CF) card. The outer case of the CF card, was breached, exposing the internal circuit cards. The memory chip was not attached to the CF card circuit board and could not be located.

**Figure 57 - AReS unit as recovered on-scene (photo courtesy of Textron Aviation)**

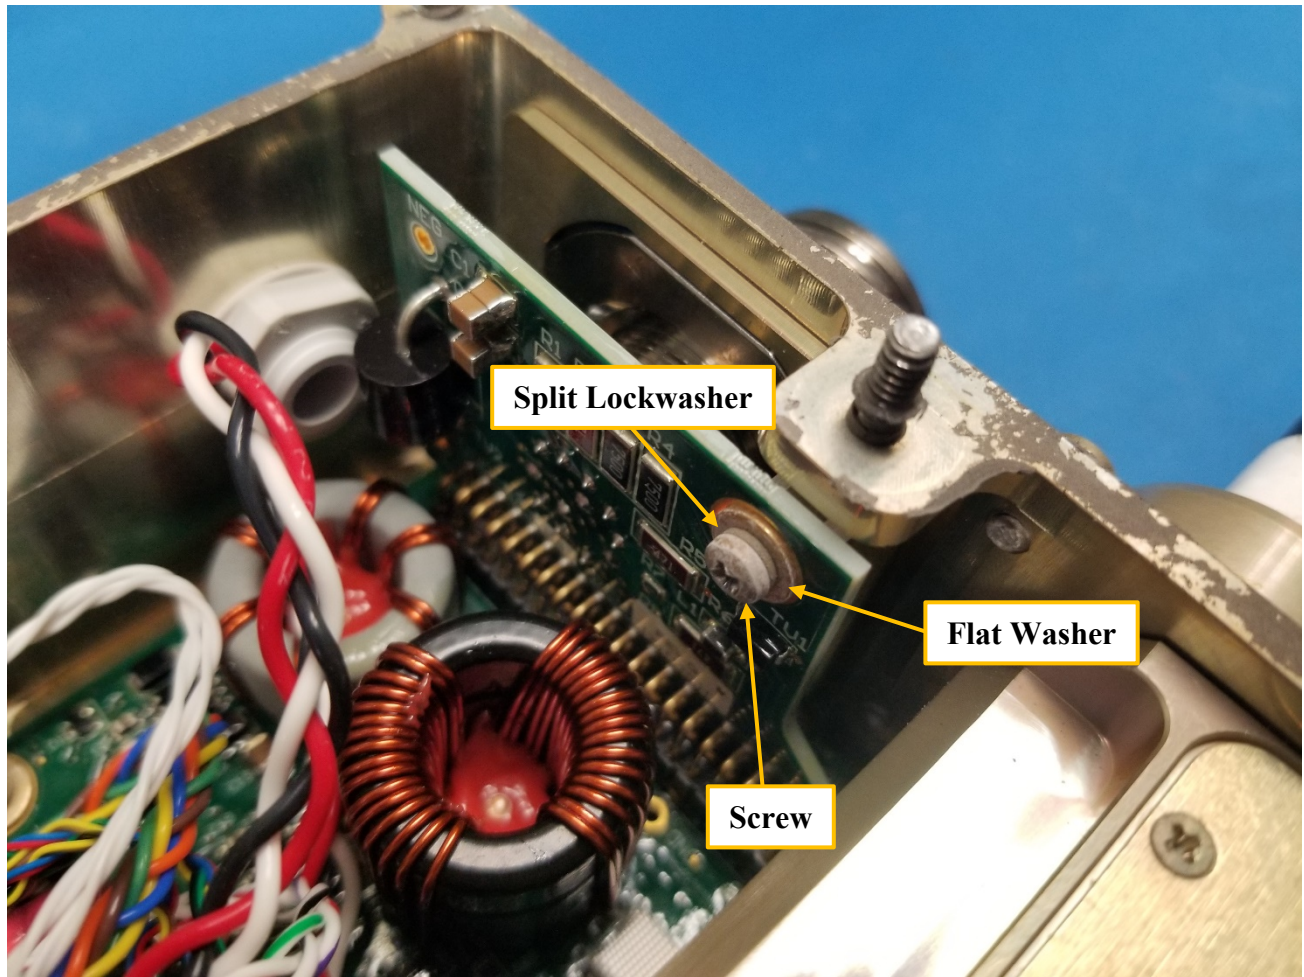
The ground screw, subject of service bulletin CAS/SB1467, was present and secure along with the spring/flat washer combination, ref Figure 30. An additional image showing the SB installation can be seen in Figure 59.

On April 25, 2018 CAeS/Tamarack originally issued CAS/SB1467 and revised on August 1, 2018. The SB was applicable to TCUs with a serial number prior to 1101. The SB was due to previous occurrences in service of the screw/lockwasher securing the connector PCB to the spacer and center case was loosening and, in some occurrences, detaching. Operator compliance with the service bulletin was “*Category 2: Do as soon as possible without effect on service or by 150 flight hours or 1 year from the date of receipt of this service bulletin, whichever occurs first.*” The SB required the removal of the TCUs and returning them to an approved facility for rework. Upon completion of the rework, the TCUs would be reinstalled in the aircraft. The rework required the TCU to be opened and existing screw and split lockwasher to be removed and discarded. A new screw, split lockwasher and flat washer was installed to improve securing of the PCB to the spacer, ref Figure 59. Both TCUs installed on the accident aircraft complied with this SB on July 13, 2018. The SB rework was accomplished by Lee Air Inc. on July 6, 2018 and both units passed ATP tests and were returned to service.

Figure 59 - LH TCU showing SB installation.

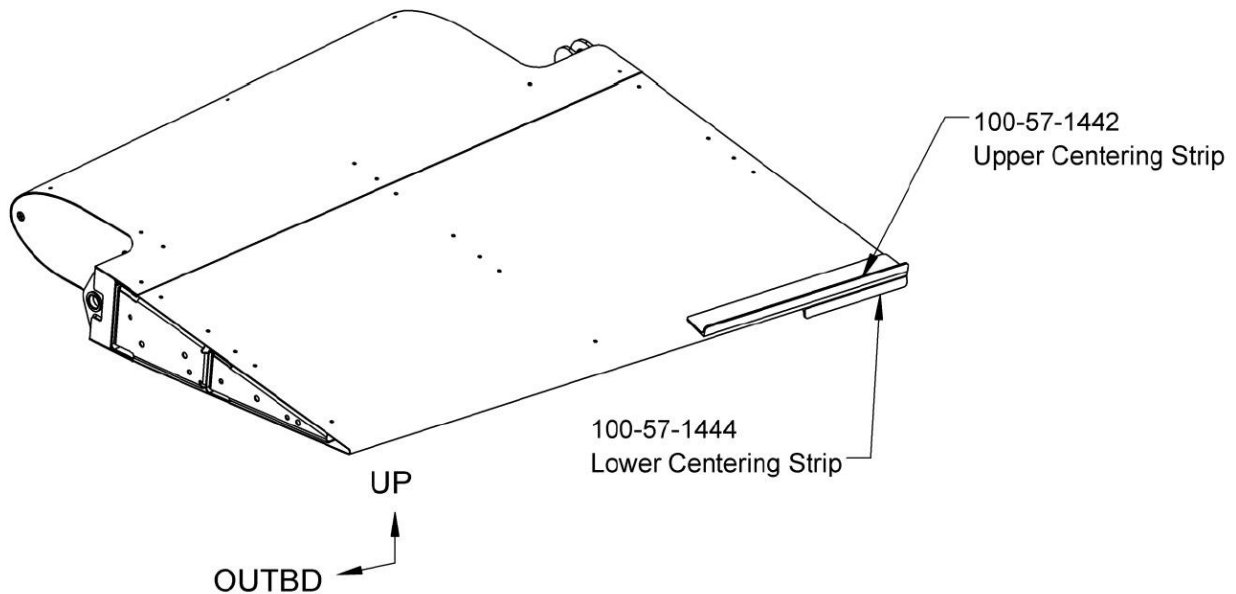
On March 1, 2019 CAeS/Tamarack issued CAS/SB1475. The SB was in response to “*three uncommanded roll events related to Tamarack ATLAS failures*”. The SB stated that the aerodynamic overbalance of the TACS allowed for the TACS to remain deployed when power was removed from the TCU while the TACS are deployed or if unique aerodynamic conditions were encountered causing the TACS to deploy with the TCUs in an unpowered state. The SB was applicable to all TACS units. Operator compliance with the service bulletin was “*Category 7: Do at customer convenience*”. The SB accomplished the installation of centering strips on the trailing edge of each TACS, ref Figure 60. The SB was released after the accident. The accident aircraft did not have centering strip installed on either TACS.

Figure 60 - SB drawing showing the installation of the centering strips (courtesy Tamarack)
