Tamarack Aerospace Group Submission to the National Transportation Safety Board

**Collision of Cessna 525A (N525EG) With Terrain Near
Memphis, IN, November 30, 2018**

CEN19FA036

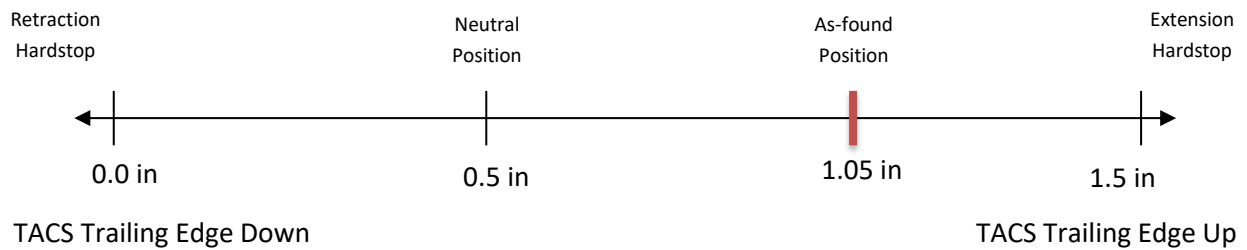
Figure 2-7 Distance from ball nut to retracted hard stop (nominal)

The CT revealed that the distance from the retracted hard stop of the actuator to the ball screw face was approximately 26.7 mm (1.05 in). When the actuator is in its neutral position (*i.e.*, the TCU is not responding to any gust), the distance between these two faces would nominally be approximately 0.5 in. The distance would be slightly greater than 1.5 in if the actuator were fully extended.

Further teardown of the actuator found witness marks on the upper and lower ball screw guides within the actuator, corresponding to the ball screw position recorded by the CT scan.

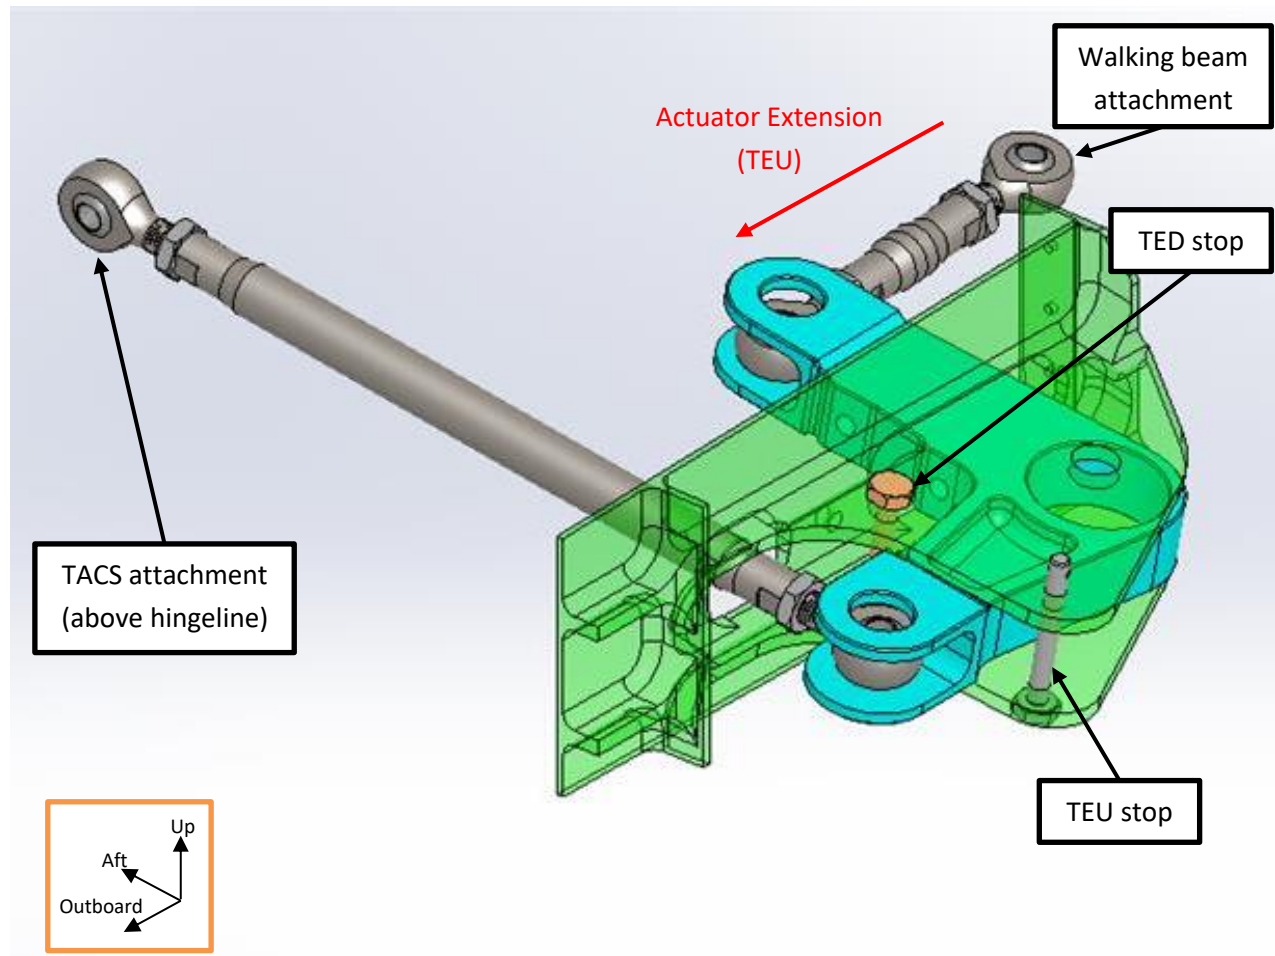
Figure 2-10 Bell crank assembly view (simplified, RH shown)

Damage to the right wing extension, specifically the bell crank and the hinge bracket, presents a disparity between the witness marks within the actuator and witness marks on the hinge hardware. The bell crank

bracket contains stops, to prevent overdeployment of the TACS. A simplified CAD view of the bell crank bracket assembly is presented in Figure 2-10 for context.

The stop corresponding to a trailing edge down deployment is a sleeved AN3-14A bolt installed through the bell crank bracket. The trailing edge down stop was severely deformed the as-found condition of the right wing extension. This does not match the position of the ball nut and the witness marks found within the actuator, which indicate an extended condition (corresponding to a trailing edge up deployment). The deformation of the trailing edge down bell crank stop most likely happened during impact after the actuator ram tube was separated from the TCU, as the actuator is not capable of producing the force required to deform this bolt to the extent it was found.

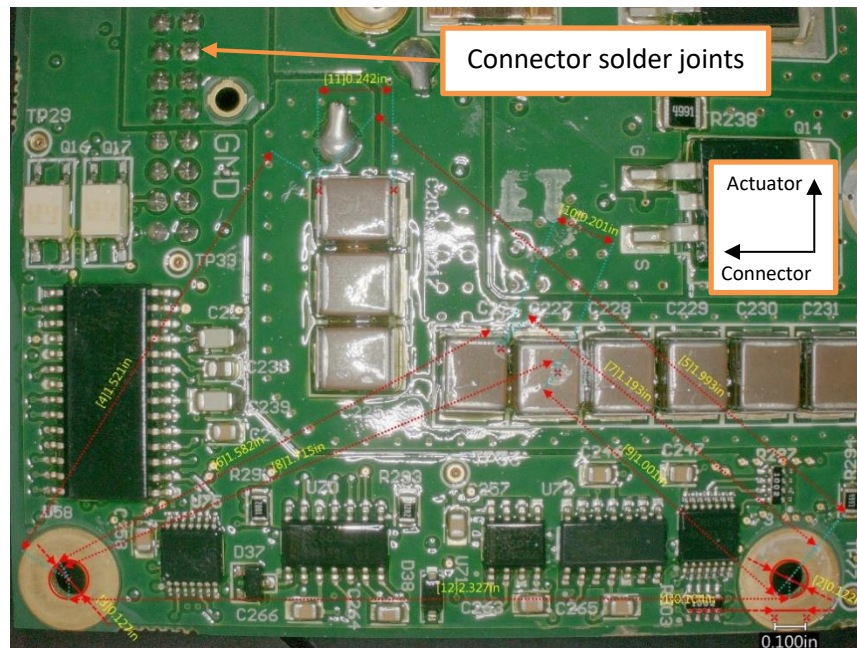
Figure 2-19 TCU control board lower surface view with key features annotated

Initial electrical testing of the LH TCU found that pins 33 and 35 were open. Pin 33 connects to pin A of the external connector, carrying a discrete enable signal from the ACU. Pin 35 connects to pin D of the external connector, carrying the analog actuator command signal.

There is evidence to suggest that the pins were bent by a substantial flexure of the PCBA during the impact event. The lower surface of the PCBA is populated in part with two rows of capacitors, visible in

Figure 2-19. Witness marks were discovered on the interior of the lower TCU housing, corresponding to the positions of the capacitors installed on the PCBA. These witness marks are visible in Figure 2-20.

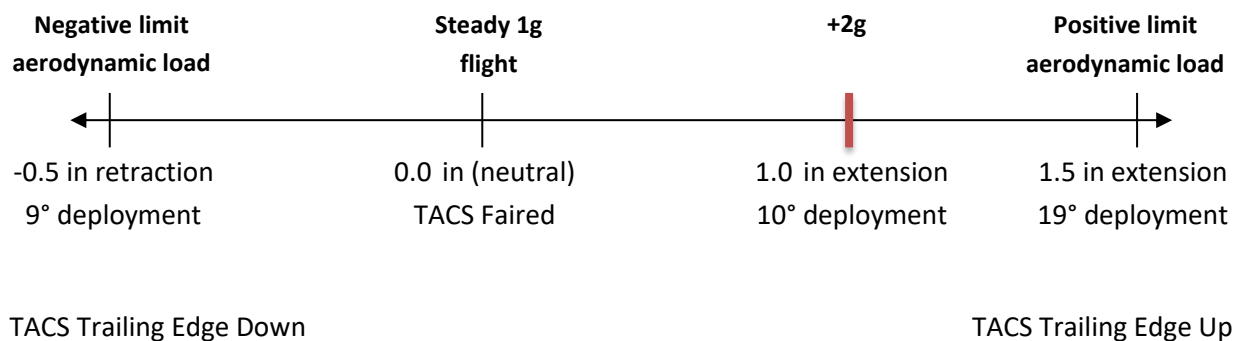
Figure 2-23 525A simplified TACS deployment schedule

A TACS deployment schedule relating the nominal TACS deployments to actuator positions and load factors for ATLAS as installed on the 525A is presented in Figure 2-23 for reference.

A ball nut position of 0.45 in from the extended hard stop on the LH actuator corresponds with approximately a 0.55 in extension from the TACS faired position. Similarly, the RH actuator position of 0.55 in from the extended hard stop corresponds to an approximate extension of 0.45 in from the TACS faired position. These positions nominally correspond to TACS deployments of 9° (LH) and 10° (RH). This is

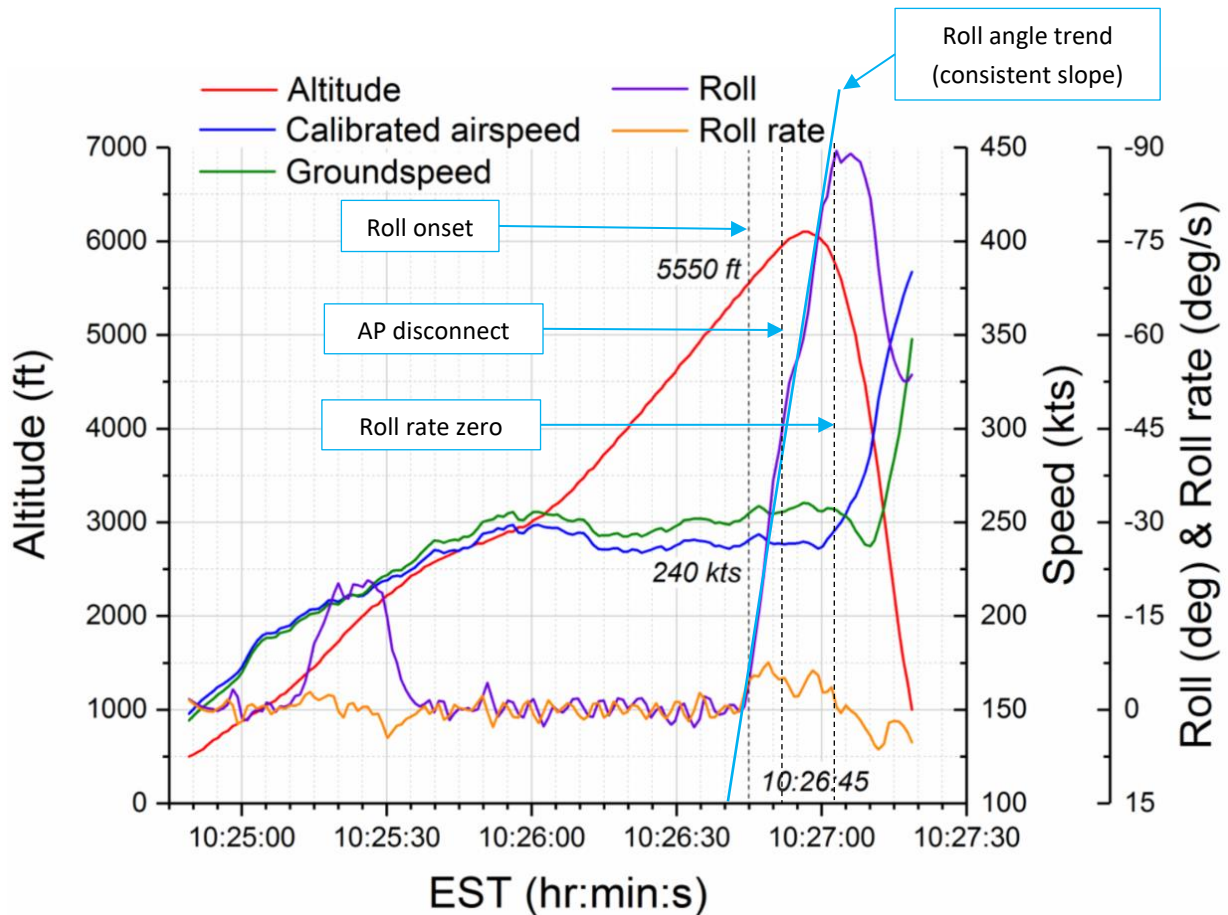
Figure 3-3 Annotated performance survey excerpt

Tamarack notes two important contributing factors evident in the data which directly affected the flight condition of the airplane: the amount of time between the onset of the roll event, and the likely throttle

position during recovery. A time history of the airplane performance data collected in the Performance Study [2] is presented in Figure 3-3 for reference.

The onset of the roll event occurred just before 10:26:45, indicated in Figure 3-3. The roll onset is easily identified by the start of a steady increase in roll angle. Based on the performance survey, it is apparent that the roll angle increased for approximately twenty seconds, until approximately 10:27:04. At this point, the bank angle stabilized for 3-5 seconds before starting to reverse.

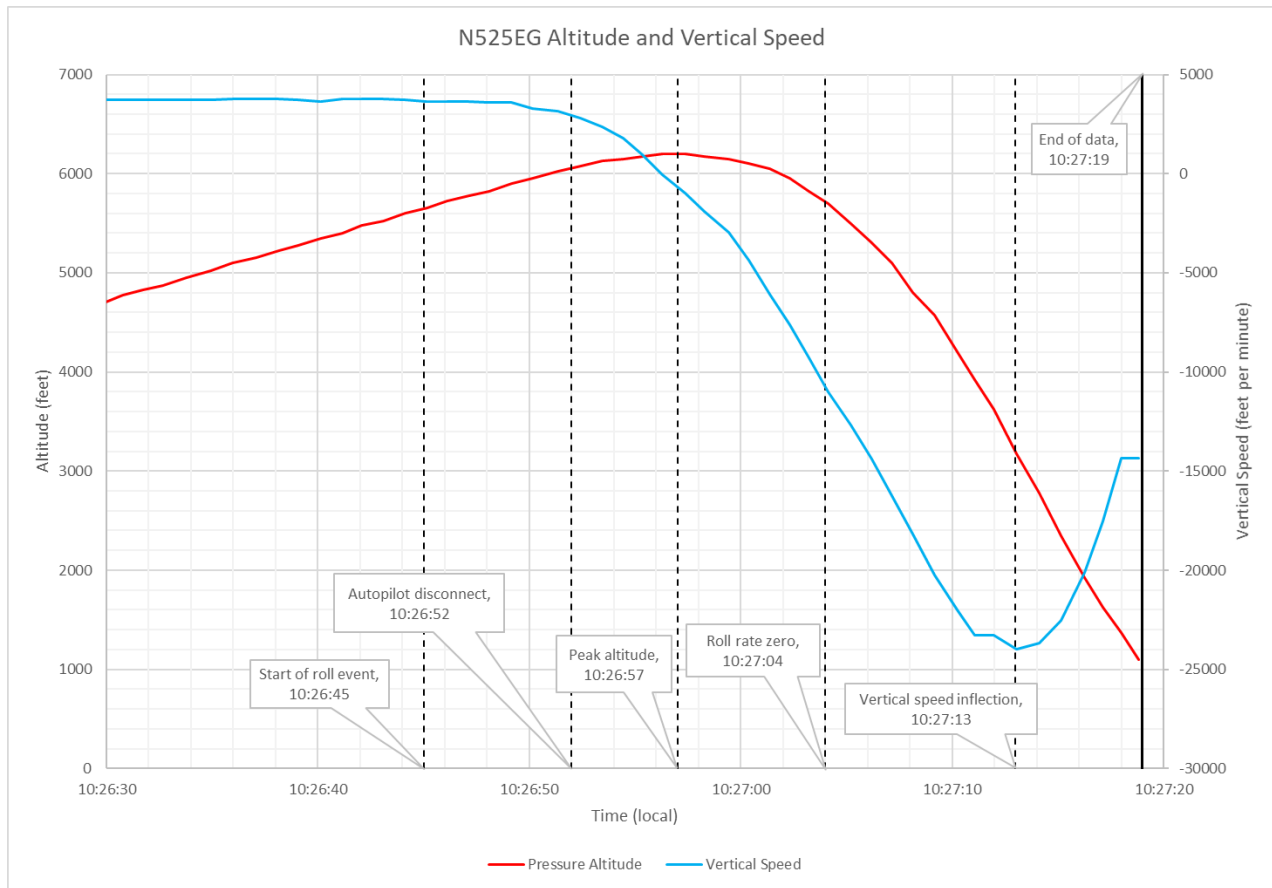
Figure 3-4 Altitude and vertical speed time history, detail view

A supplemental Tamarack analysis of the time history of altitude and vertical speed recovered from the ADS-B data indicates that an attempt to raise the nose of the airplane was initiated just before 10:27:13, nearly 30 seconds after the roll onset. At 10:27:13, the trend of the vertical speed reverses, reaching a

peak descent rate of 24,000 fpm. The rate of descent was reduced to approximately 14,000 fpm in the final seconds before impact. A section of the altitude and vertical speed data is presented in Figure 3-4.

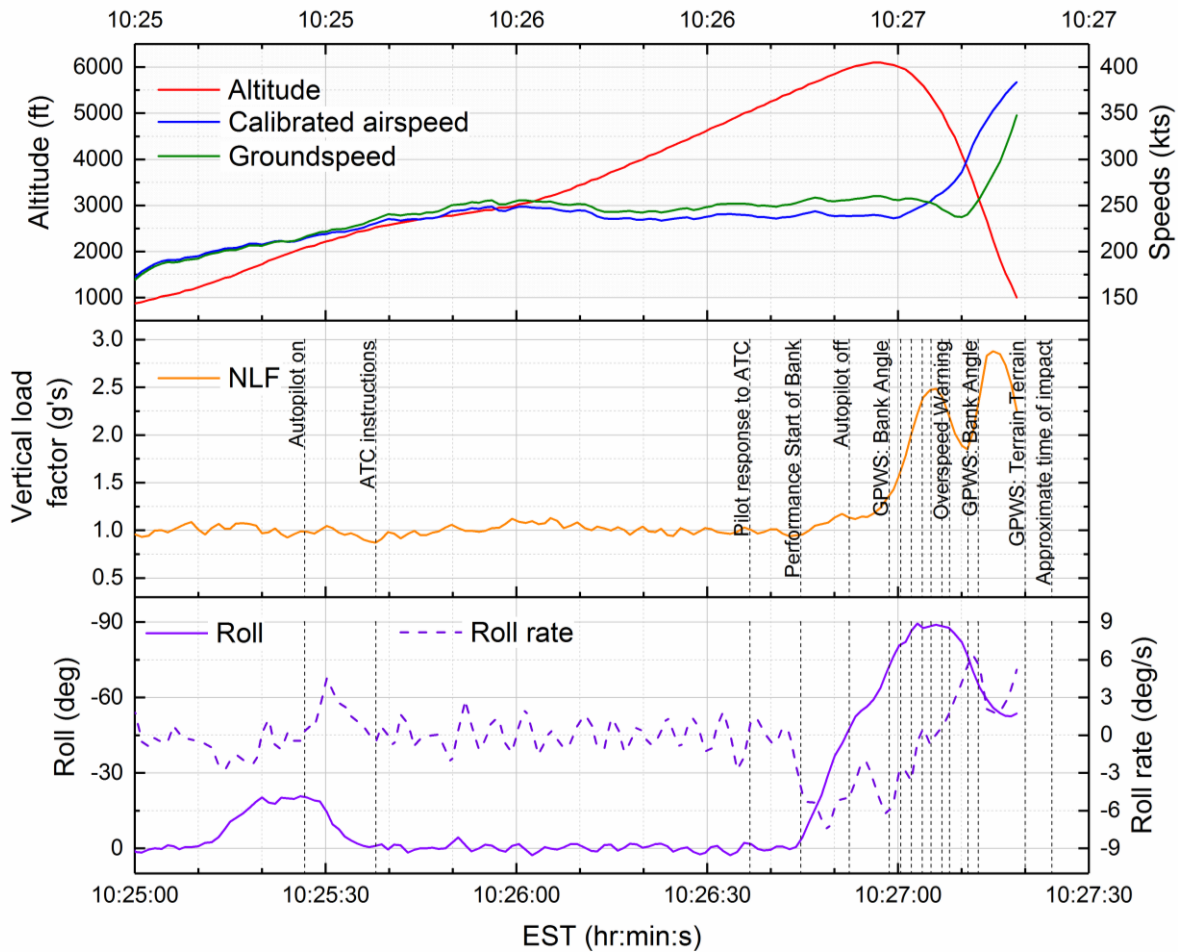
Figure 3-5 Comprehensive view of NTSB performance survey data

A flight condition of this type is generally an elevated load factor maneuver due to the elevated aerodynamic forces required to cause a significant rate of change of heading and change in vertical speed. An email exchange with Marie Moler [7] subsequent to the initial release of the Performance Survey provided additional clarification on the calculated load factor underlying the NTSB analysis of the event.

This data is provided in Figure 3-5, described as “NLF” and presented as the orange trace in the middle chart.

It is important to note that this data is based on ADS-B data, taken at one second intervals. Therefore, transient load factors acting on the airplane on very short timeframes would not be calculable. The trend of load factor indicates a peak at approximately 3g at a timestamp of 10:27:13, corresponding to the minimum vertical speed. This is expected, as this is the point at which the largest forces would be acting on the airplane to reverse the rate of change of vertical speed while still at a large bank angle.
