SERIOUS INCIDENT

Aircraft Type and Registration:	Cessna Citation CJ1+, N680KH	
No & Type of Engines:	2 Williams FJ44-1AP turbofan engines	
Year of Manufacture:	2008 (Serial no:525-0680)	
Date & Time (UTC):	13 April 2019 1422 hrs	
Location:	Bournemouth Airport	
Type of Flight:	Private	
Persons on Board:	Crew - 1	Passengers - 3
Injuries:	Crew - None	Passengers - None
Nature of Damage:	None reported	
Commander's Licence:	Airline Transport Pilot's Licence	
Commander's Age:	73 years	
Commander's Flying Experience:	4,400 hours (of which 3,200 were on type) Last 90 days - 17 hours Last 28 days - 13 hours	
Information Source:	AAIB Field investigation

Synopsis

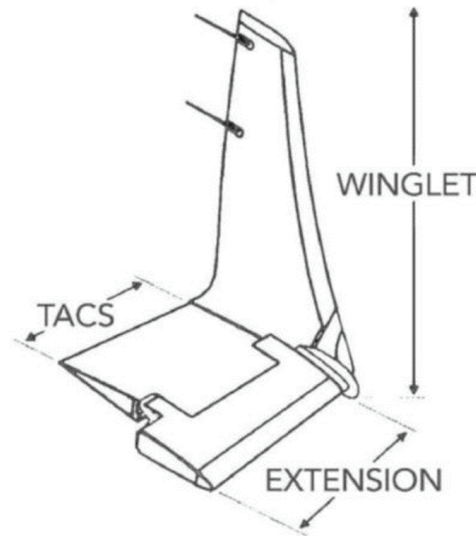
Figure 1

The pilot had recently bought the aircraft, which had been fitted during its previous ownership with 'Active Technology Load Alleviation System'¹ (ATLAS) wing extensions and winglets (Figure 1). He was intending to fly himself and three friends from Bournemouth to Rotterdam. The pilot, who operated the aircraft in a single pilot² capacity, occupied the front left seat. One friend occupied the front right seat, and the other two were seated in the passenger cabin.

Overview of ATLAS winglet installation

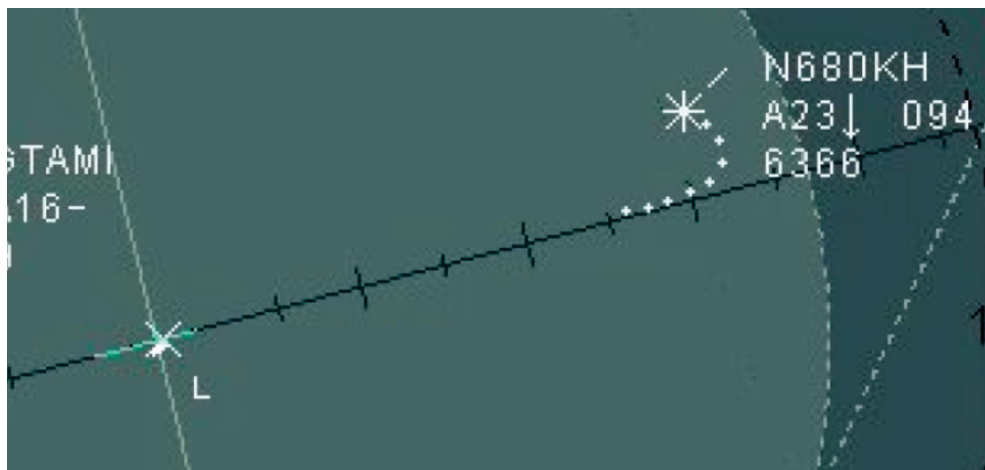
Figure 3

The pilot recalled feeling light vibration, then a button on the left of the instrument panel labelled 'ATLAS' illuminated (Figure 2), displaying the text 'ATLAS INOP LIMIT 140 KIAS' in red. At 1418:39 hrs, when the aircraft was around 6 nm east of the airport, at 3,000 ft amsl and 258 KIAS, the aircraft rolled left with a rate the pilot described as "very quick"⁴. ATC described N680KH turning "sharply... left and descending" (Figure 3)⁵. As it rolled through 45° the autopilot disengaged automatically.

ATC radar screenshot at 1419:14 hrs⁶

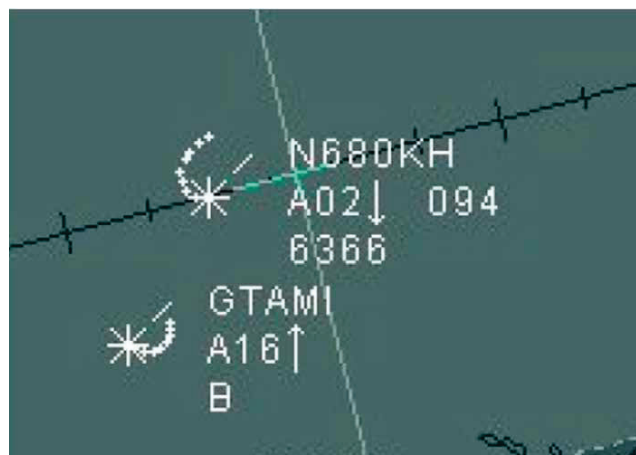
Figure 4

After descending from 900 ft to 300 ft amsl during the downwind leg, the aircraft turned on to base leg above a sports field. The pilot reported using continuous full right aileron and some right rudder until landing. Less right rudder was required as airspeed reduced, and he achieved lateral control by modulating his right foot pressure. By reducing that pressure the aircraft turned continuously through left base on to a 1 nm final approach, right of the runway centreline at 200 ft amsl (Figure 4). The tower controller described the turn as so tight that the aircraft appeared to be "on its side". He and several colleagues believed the aircraft would crash short of the airfield. At the landing speed of 105 KIAS the pilot believed he could land the aircraft straight so used "less right foot" to straighten the approach and, when over the runway, applied full flap. The aircraft landed at 1423 hrs.

ATC radar screenshot at 1422:31 hrs

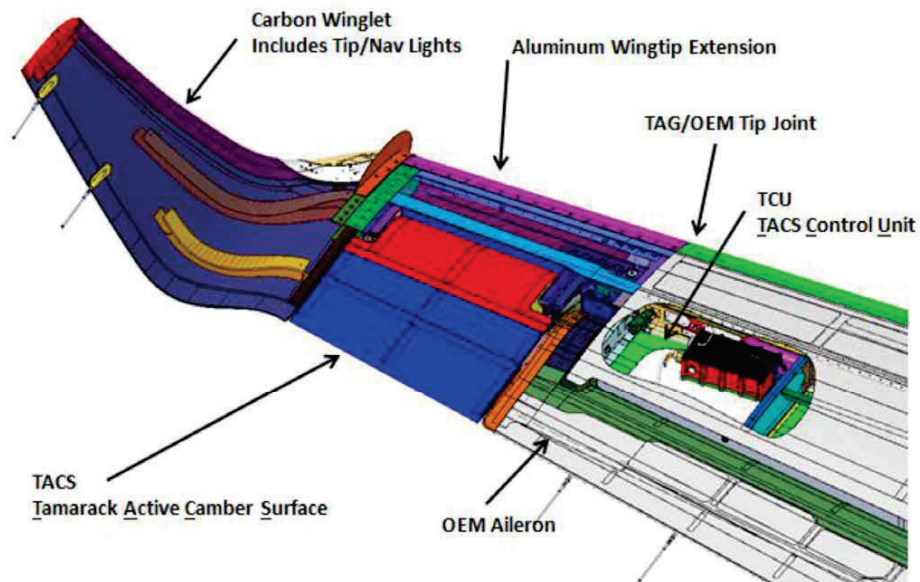
Figure 6

To install the system on a Cessna Citation CJ1+, the original wing tips are removed and 22 inch extensions, incorporating the winglets, are attached (Figure 6). Active aerodynamic control surfaces are positioned in the horizontal section of these extensions. These control surfaces (known as Tamarack Active Camber Surfaces, or TACS) are automatically activated in high positive or negative g situations to unload the wing and keep the wing loading within the original envelope.

Cessna 525 wing with ATLAS installed

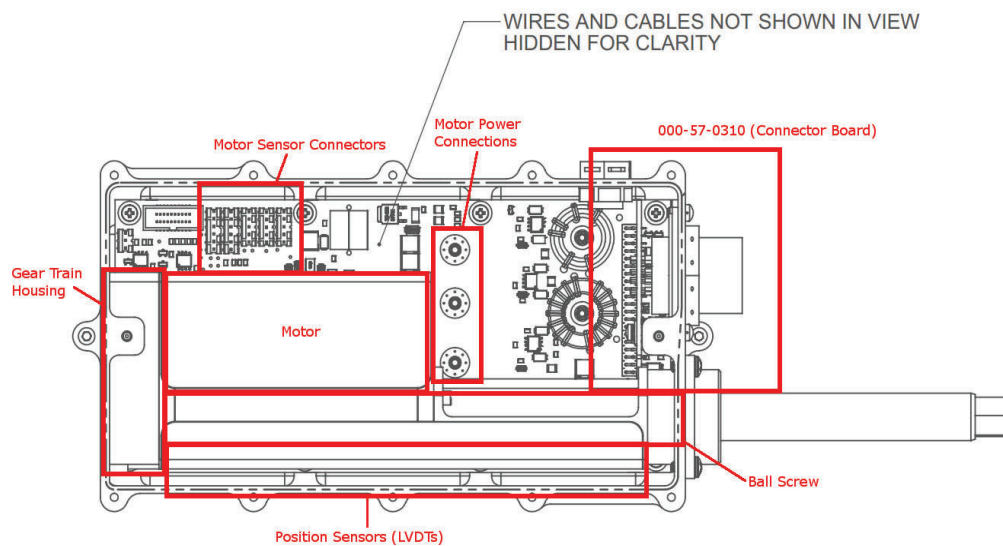
Figure 7

A TACS Control Unit (TCU) is mounted in each wing. The TCU comprises analogue control circuitry, an electric motor, gearing and a ball screw actuator module (Figure 7). This drives each TACS mechanically as shown in Figure 8. The TCUs are controlled by an ATLAS Control Unit (ACU), which is mounted close to the aircraft centre of gravity. The ACU houses two accelerometers which monitor the aircraft's movement in the vertical axis. When aircraft vertical acceleration exceeds specified positive or negative values, the ACU activates both TCUs symmetrically to aerodynamically unload the wings.

Internal layout of TCU

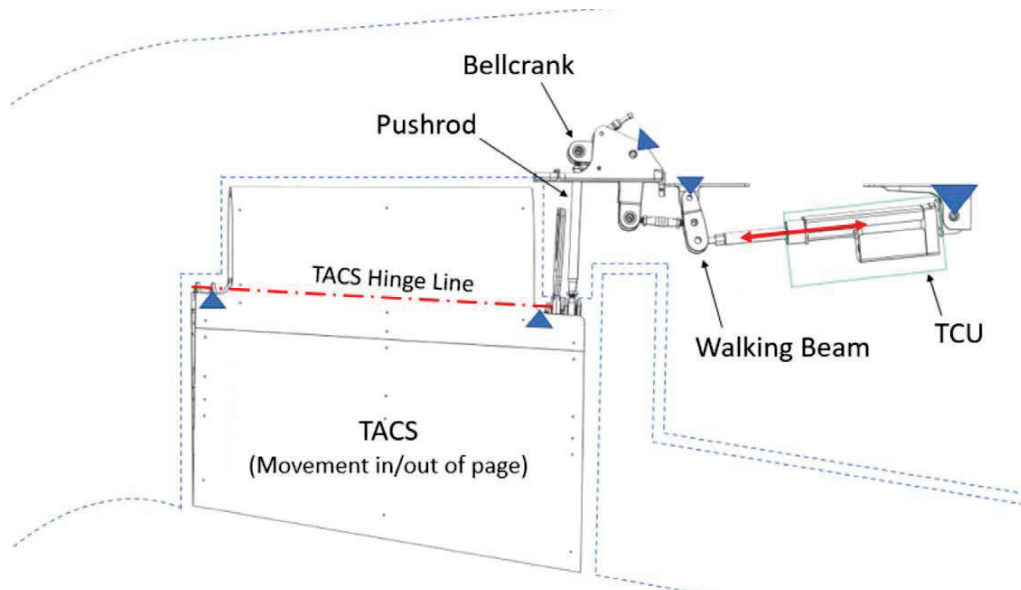
Figure 8

Top view of mechanical linkages of ATLAS.
Note: blue triangles indicate hinge points

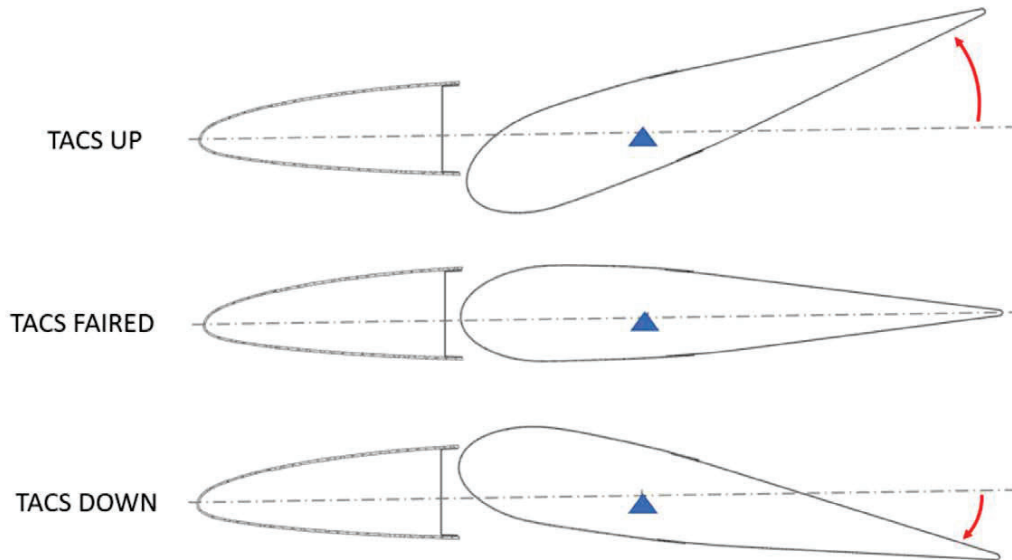
Figure 9

The TACSs are designed to travel above and below the neutral point (faired) to relieve both positive and negative wing loads (Figure 9) and will travel to these positions in 0.1 seconds when commanded. The actuators can be back driven by hand when de-powered.

Section view of TACS positions
