# AIRCRAFT ACCIDENT REPORT 1/2020

Report on the accident to  
**Piper PA-46-310P Malibu, N264DB**  
22 nm north-north-west of Guernsey  
on 21 January 2019

Published 13 March 2020

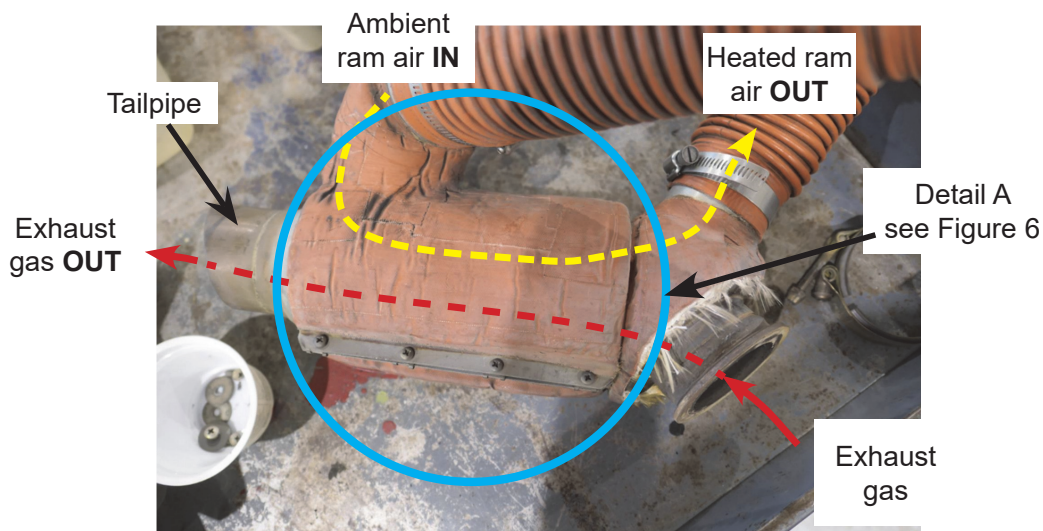
**Figure 5**

A heater muff is attached via spot welds to the right exhaust tailpipe. Ram air ducting and a removable shroud are placed over the heater muff to provide hot air for cabin conditioning (Figure 5). The shroud is secured in place by four fasteners. Figure 6 shows another tailpipe from a PA-46-310P aircraft with the shroud unfastened and slid to the end of the tailpipe to allow it to be inspected. The 'heated ram air out' and 'exhaust gas in' ducts are spot welded and brazed onto the tailpipe and covered with a fixed cover.

In Figures 5 and 6 the red arrows show the flow of exhaust gas through the tailpipe. The yellow arrows show ambient ram air, which flows in the space between the tailpipe and the heater muff.

Right tailpipe and heater assembly removed from a PA-46-310P aircraft

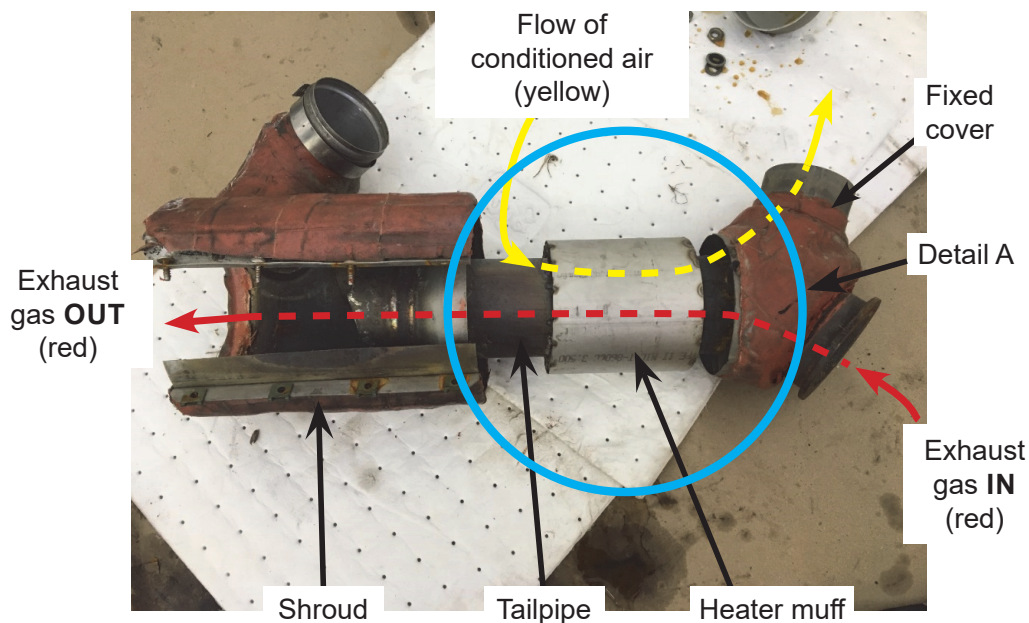
**Figure 6**

Ram air shroud removed from exhaust tailpipe / heater muff from a PA-46-310P tailpipe

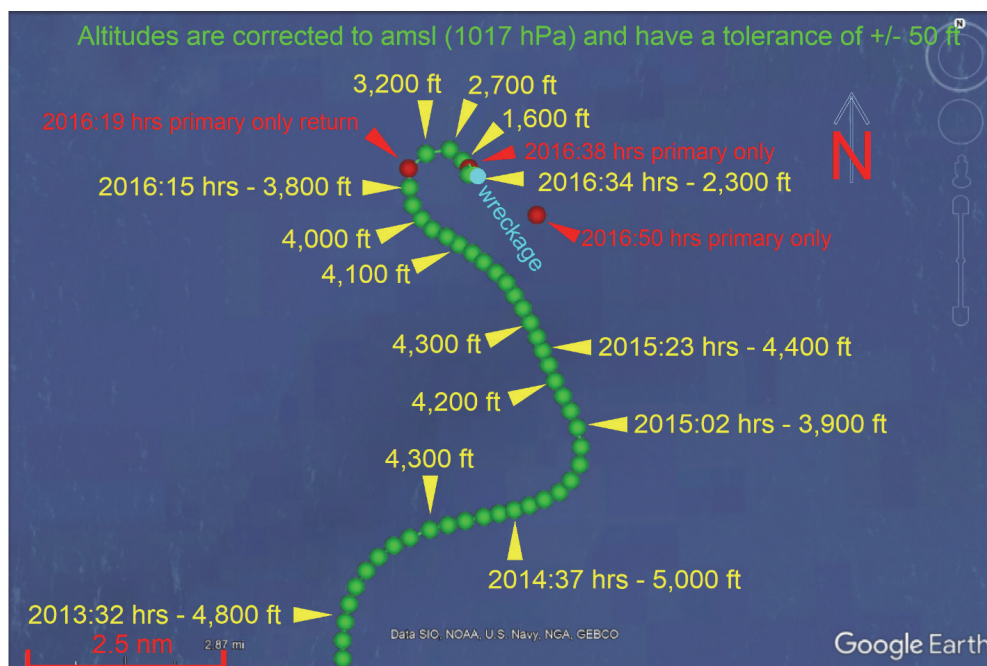
**Figure 12**

Radar track of final section of flight  
(created from a combination of data from  
Jersey (Les Platons) and Guernsey radars)

During the right and left turns which started at 2013:32 hrs (Figure 12), it was calculated that the aircraft's roll attitude reached maximums of about 36° right and 56° left. The pitch attitude reached about 10° nose up as the aircraft initially climbed at up to 3,000 fpm, and about 15° nose down as it descended at up to 5,000 fpm. The calculated airspeed also varied between about 150 KIAS and 200 KIAS during these manoeuvres.

At 2012 hrs, when the aircraft was about 11 nm north of Guernsey, ATC gave permission for the pilot to descend below FL50, and this was the last communication with him. Shortly afterwards (Figure 12), a right, followed by left turn was flown, during which the bank angle reached about 56°, while the aircraft descended, climbed and then descended again at a vertical speed of about 5,000 fpm. This series of turns lasted about 90 seconds, and it was likely that they were flown to remain in, or regain VMC, but they resulted in a flightpath that was unstable and inconsistent with normal cruise flight or with use of the autopilot. The investigation concluded that the aircraft was being flown manually during this period, which was shortly before it entered the final descending turn to the right.

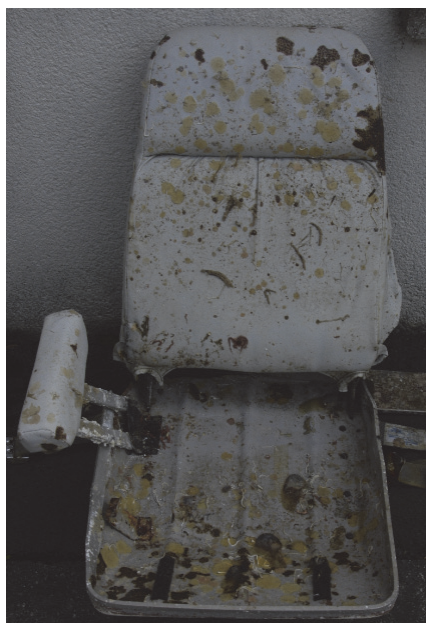
**Figure B-2**

On 26 September 2019, the crew of a trawler informed the French authorities that they had brought up what they believed to be an aircraft seat while conducting a trawl approximately 7 km to the west of the location of the main wreckage site. The seat was assessed by the AAIB as the left middle passenger seat from N264DB (Figure B-2).

Passenger seat from N264DB

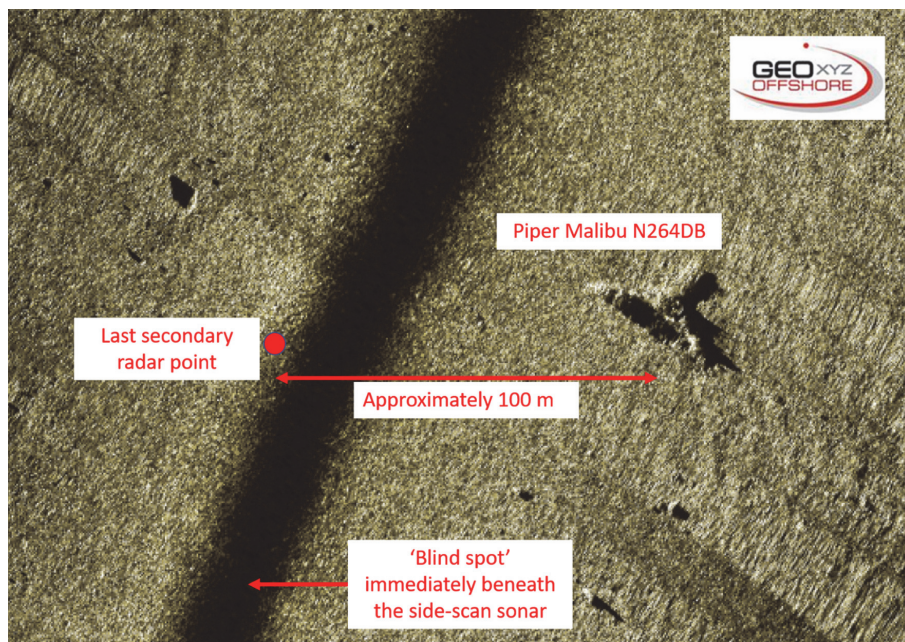
Figure B-5

Both vessels began their side-scan survey of the seabed on the morning of 3 February 2019. Early in the search, the FPV Morven identified an object of interest at a depth of approximately 68 m and cleared the immediate area. The Geo Ocean III subsequently used its own side-scan sonar to observe the object (Figure B-5).

Side-scan sonar image of N264DB

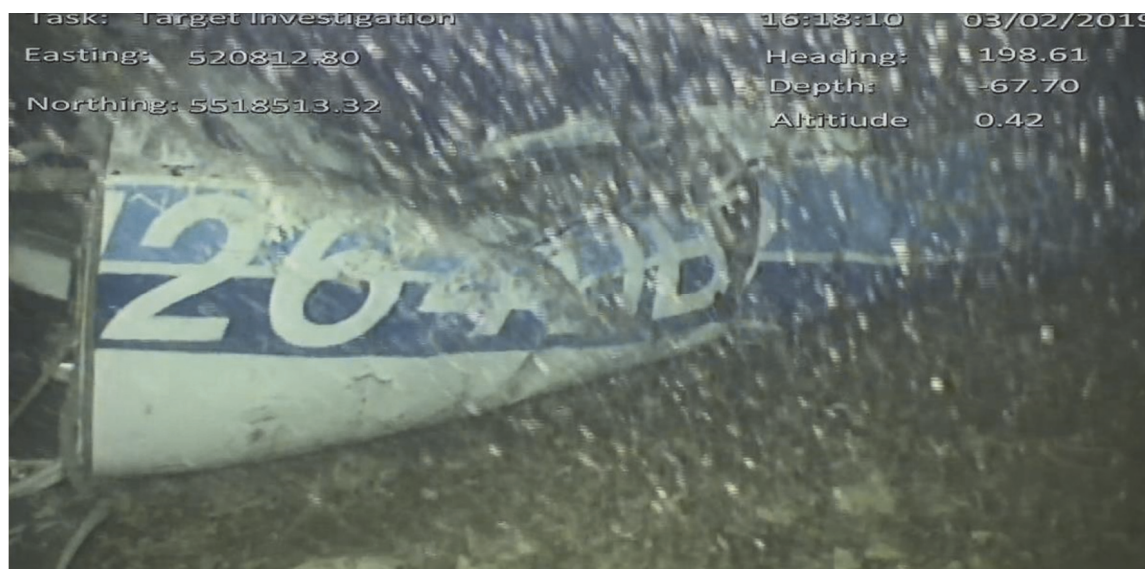
**Figure B-6**

The Geo Ocean III began a search of the seabed near the object of interest using its ROV, which was equipped with a video camera, and the object was identified as the wreckage of N264DB (Figure B-6).

Tail section of N264DB on seabed at a depth of 68 m

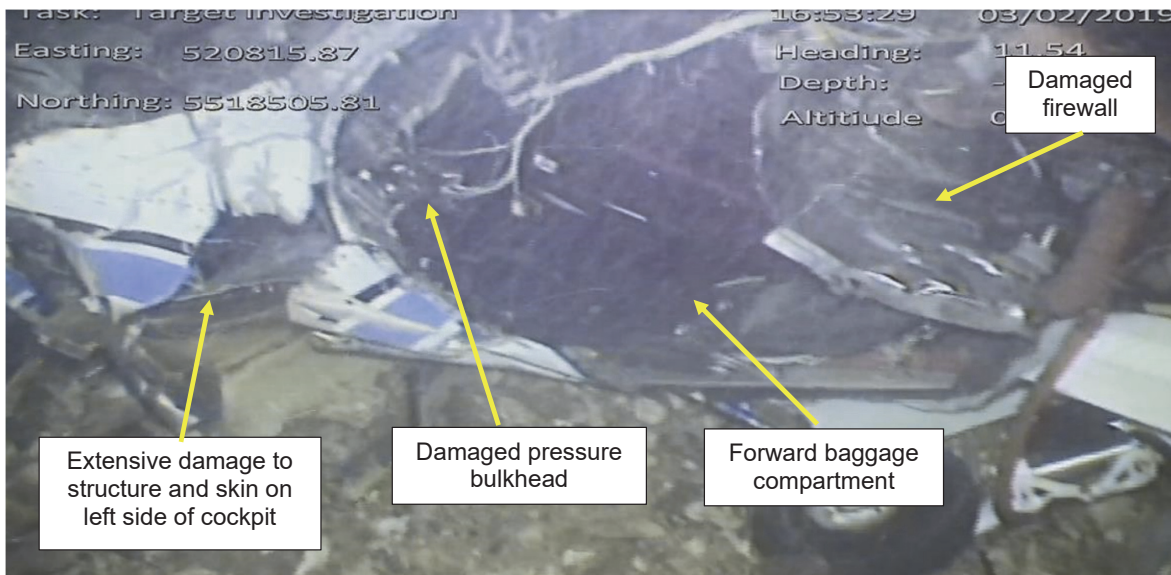
Figure B-9  
Forward of cockpit
