# Air Accident Investigation Sector

- Final Report -

AAIS Case N°: AIFN/0008/2016

## Runway Impact during Attempted Go-Around

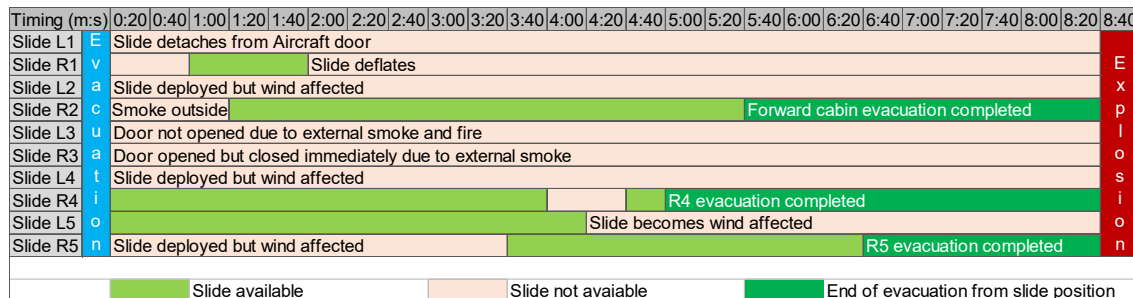
Figure 19. Timeline for emergency exit availability during evacuation

Except for the Commander and the senior cabin crewmember who evacuated after the center wing tank explosion, all of the other occupants evacuated via the operational escape slides in approximately 6 minutes 40 seconds.

Figure 19 shows an approximate timeline illustrating the availability of the emergency exits during the evacuation.

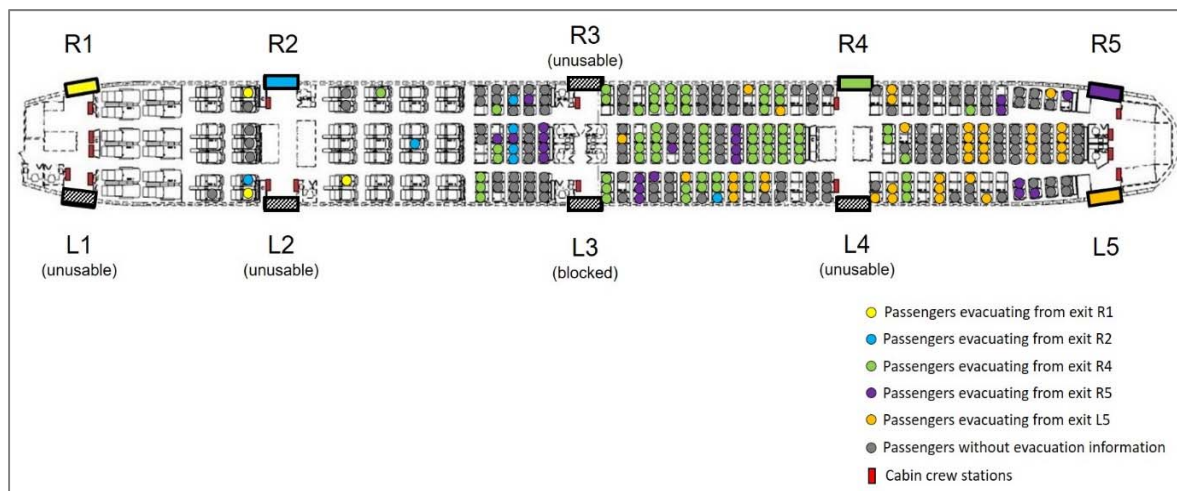
**Figure 20.** Passenger seating allocation and emergency exit status

- At the end of the evacuation, except for the senior cabin crewmember, all of the cabin crewmembers evacuated from the right side doors.
- 86 percent of all occupants evacuated through the three exits R4, R5 and L5.

Figure 20 shows the seat locations and exits used. Passengers who did not respond to the questionnaire are represented by grey dots.

One passenger, seated next to the right side over-wing exit (R3), stated that he was directed to the front of the cabin to evacuate from one of the forward exits, but he was then directed back because the forward exits were blocked. This passenger passed through dense smoke in the center cabin on his way to exit from the R4 door.
