PB93-910408
NTSB/AAR-93/07

AIRCRAFT ACCIDENT REPORT

INADVERTENT IN-FLIGHT SLAT DEPLOYMENT
CHINA EASTERN AIRLINES FLIGHT 583
McDONNELL DOUGLAS MD-11, B-2171
950 NAUTICAL MILES SOUTH OF SHEMYA, ALASKA
APRIL 6, 1993

Adopted: October 27, 1993
Notation 6180

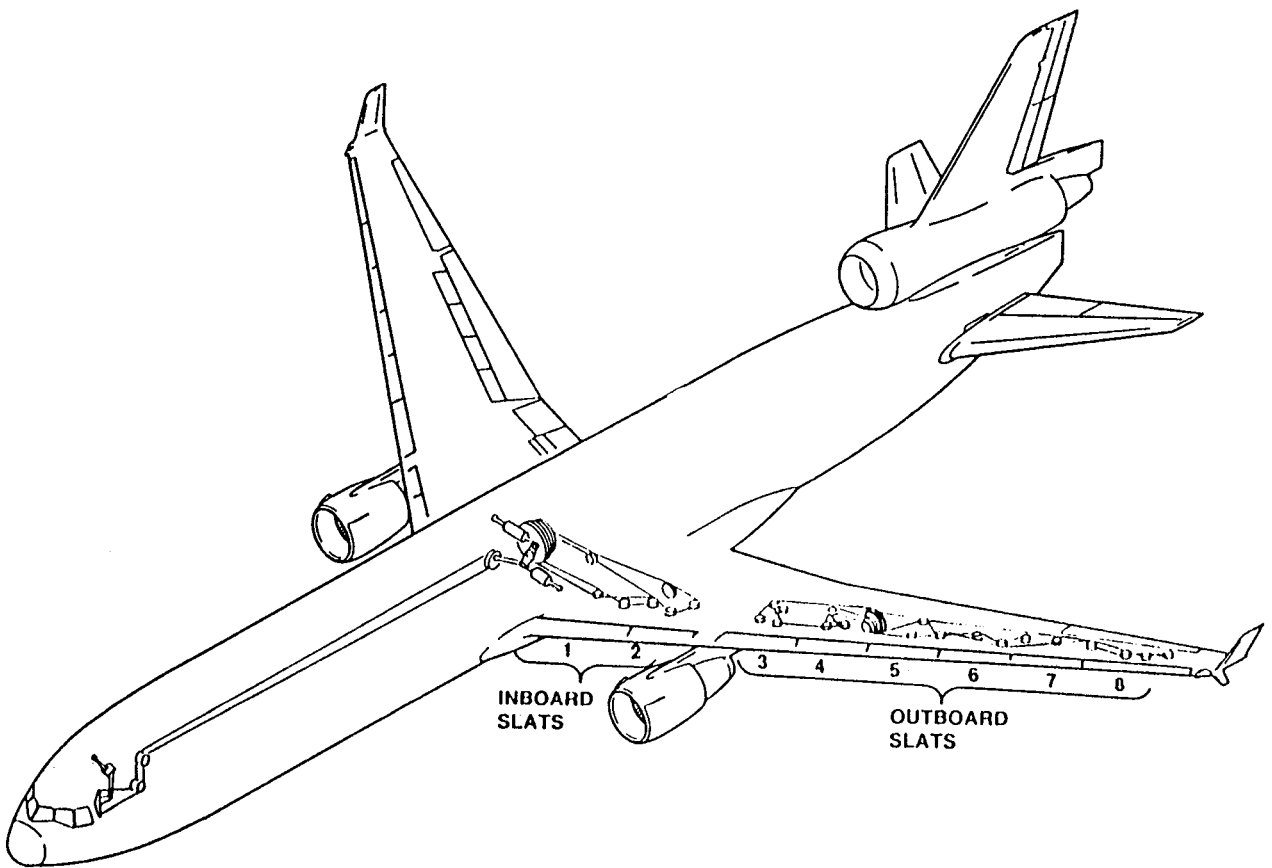
Figure 1.--Slat cable system.

The flap/slat handle moves a closed-loop control cable system (see figure 1) to operate the inboard slat control valve. The inboard slat control valve supplies hydraulic pressure to two inboard slat actuators. These actuators rotate the inboard cable drive drum to extend or retract the inboard slats. As the inboard slats extend or retract, follow-up cables and mechanical linkages move the outboard slat control valve.

The outboard slat control valve supplies hydraulic pressure to four outboard slat actuators. These actuators rotate the outboard drum to extend or retract the outboard slats. The slats are supplied pressure by two completely

separate and independent hydraulic systems. If one system should fail, the second system will operate the slats.

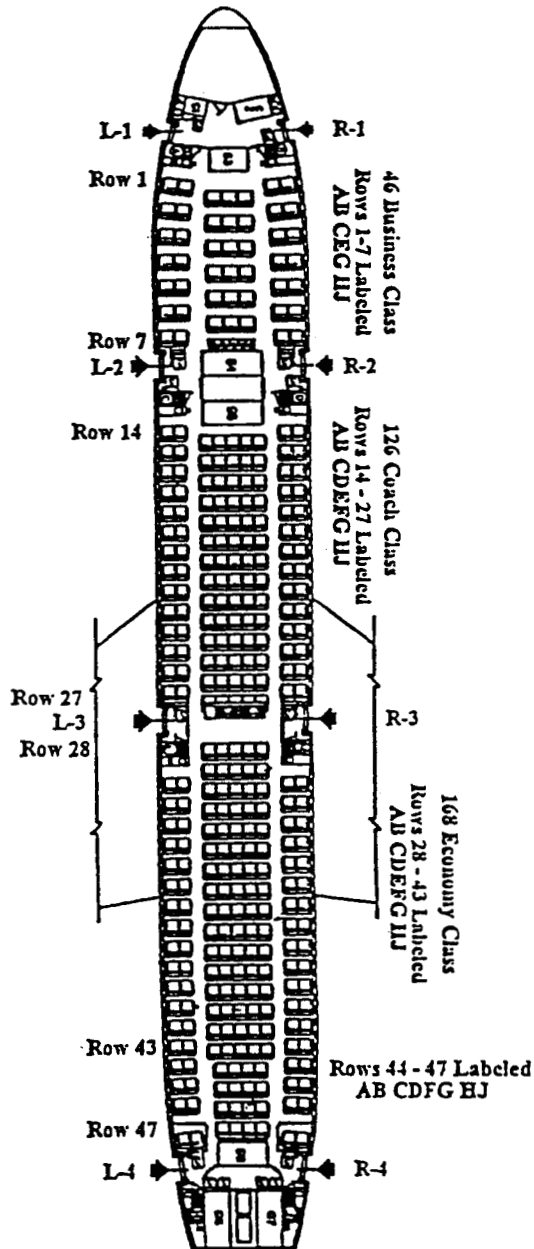
Figure 6.--Passenger cabin configuration.

The passenger cabin was configured for 46 business and 294 coach class seats. (See figure 6).
