A1. Factual information

A1.12 Information on the wreckage, impact and accident site

A1.12.3 Technical findings on the wreckage

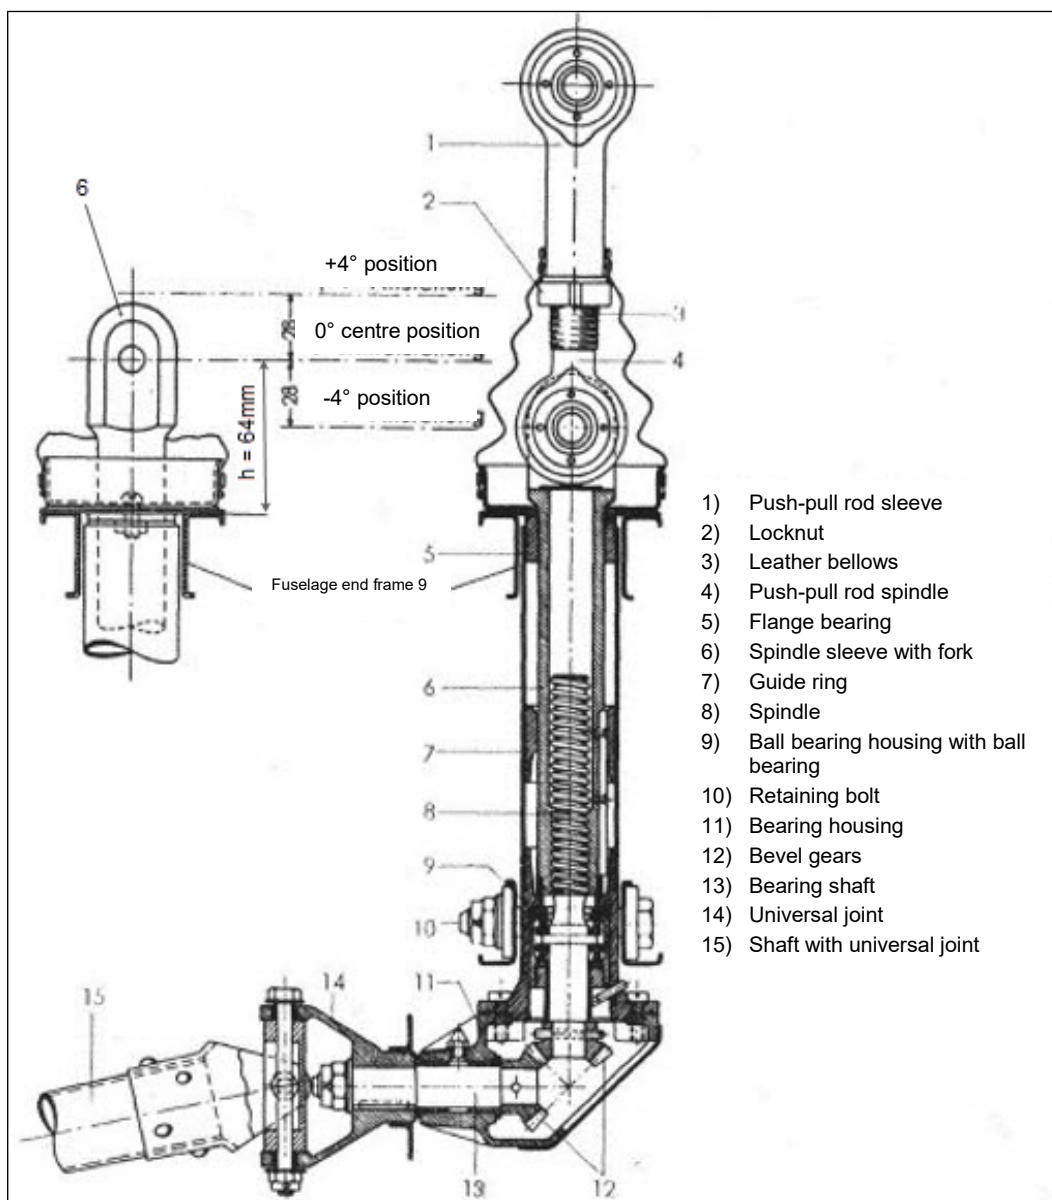
Figure 22: Dimensioned drawing for determining the horizontal stabiliser's angle. Source: "Betriebsanweisung Ju 52/3m g4e" (operating instructions).

The adjustment spindle and the bevel gear were not damaged in the accident. In order to determine the condition and position of the horizontal stabiliser at the time of the accident, the adjustment spindle – including bevel gear – was first removed from the tail of the wreckage, measured and dismantled. A functional check was also carried out.

- The assembly was in working order.
- No damage could be identified.
- No abnormal wear and tear was found.
- The axial play of the spindle was 0.2 mm.

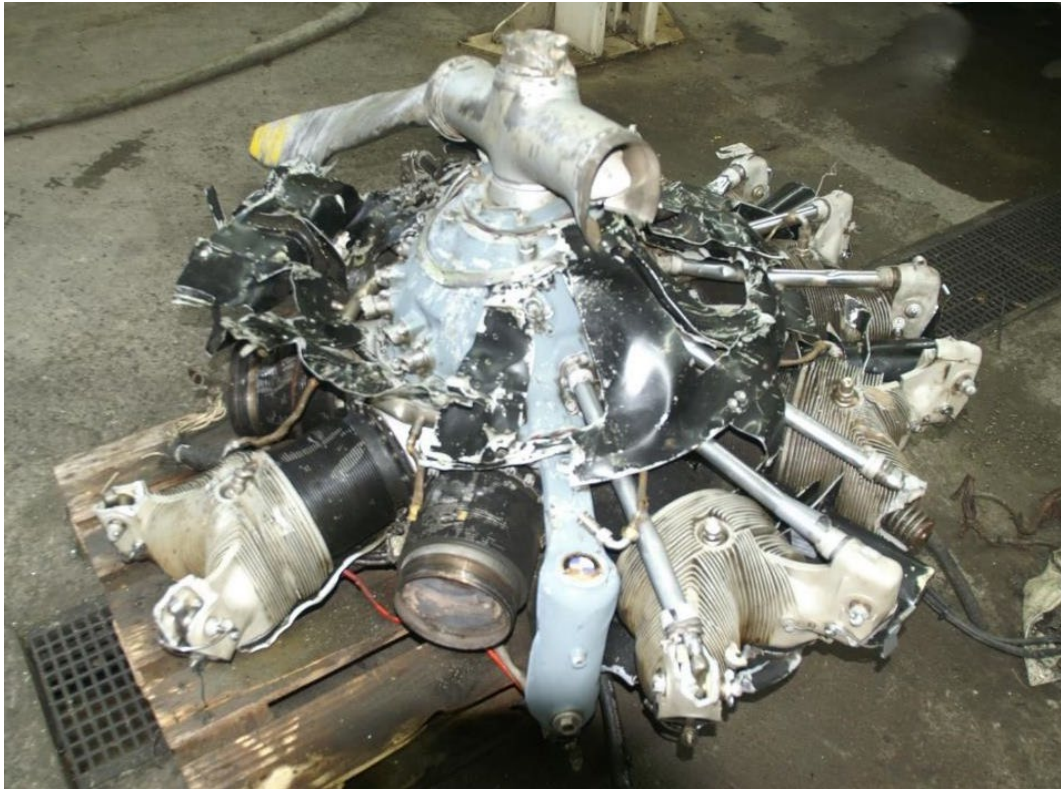
Prior to the investigation, the engines were cleaned whilst still assembled using dry-ice blasting (see figure 24). The advantage of this minimally abrasive and non-corrosive process is the low amount of damage to the material being cleaned.

Figure 24: Engine cleaned using dry-ice blasting.

Due to the high degree of damage, dismantling some parts of the engines was difficult. Nevertheless, their condition before the accident could still be assessed. However, it was not possible to check the function of the magnetos from any of the engines as they had been destroyed.

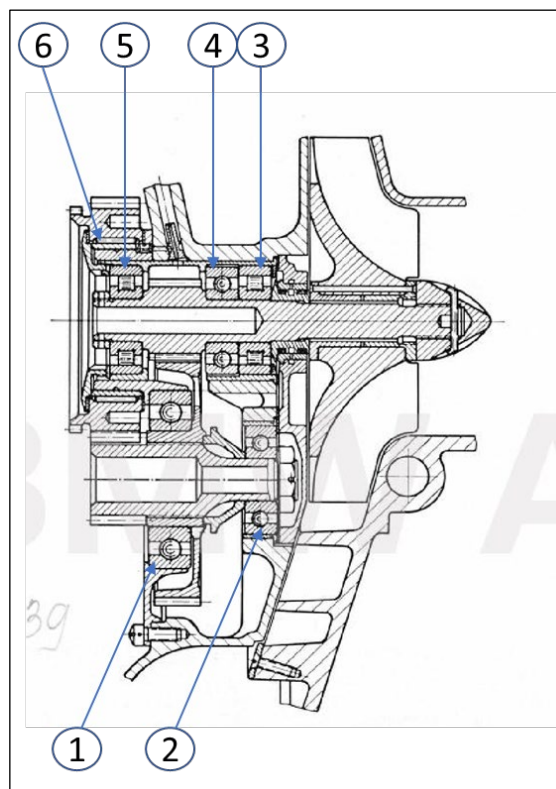
The bearings installed in the superchargers were of different origins and were also marked differently. None of the supercharger bearings were broken. Bearings number 3, 4 and 5 (see figure 29) of the high-speed supercharger shaft from the left engine were subjected to metallurgical investigations (see annex [A1.16](#)).

Figure 29: Cross-sectional diagram of the supercharger with bearing nos 3, 4 and 5 on the supercharger shaft. Source: BMW 132-A3 engine operating instructions.

The bearings used in the supercharger had different speed ratings, but none of the three supercharger-shaft bearings met the necessary specifications for speeds of up to 20,500 rpm, which the shaft can be subjected to when running.

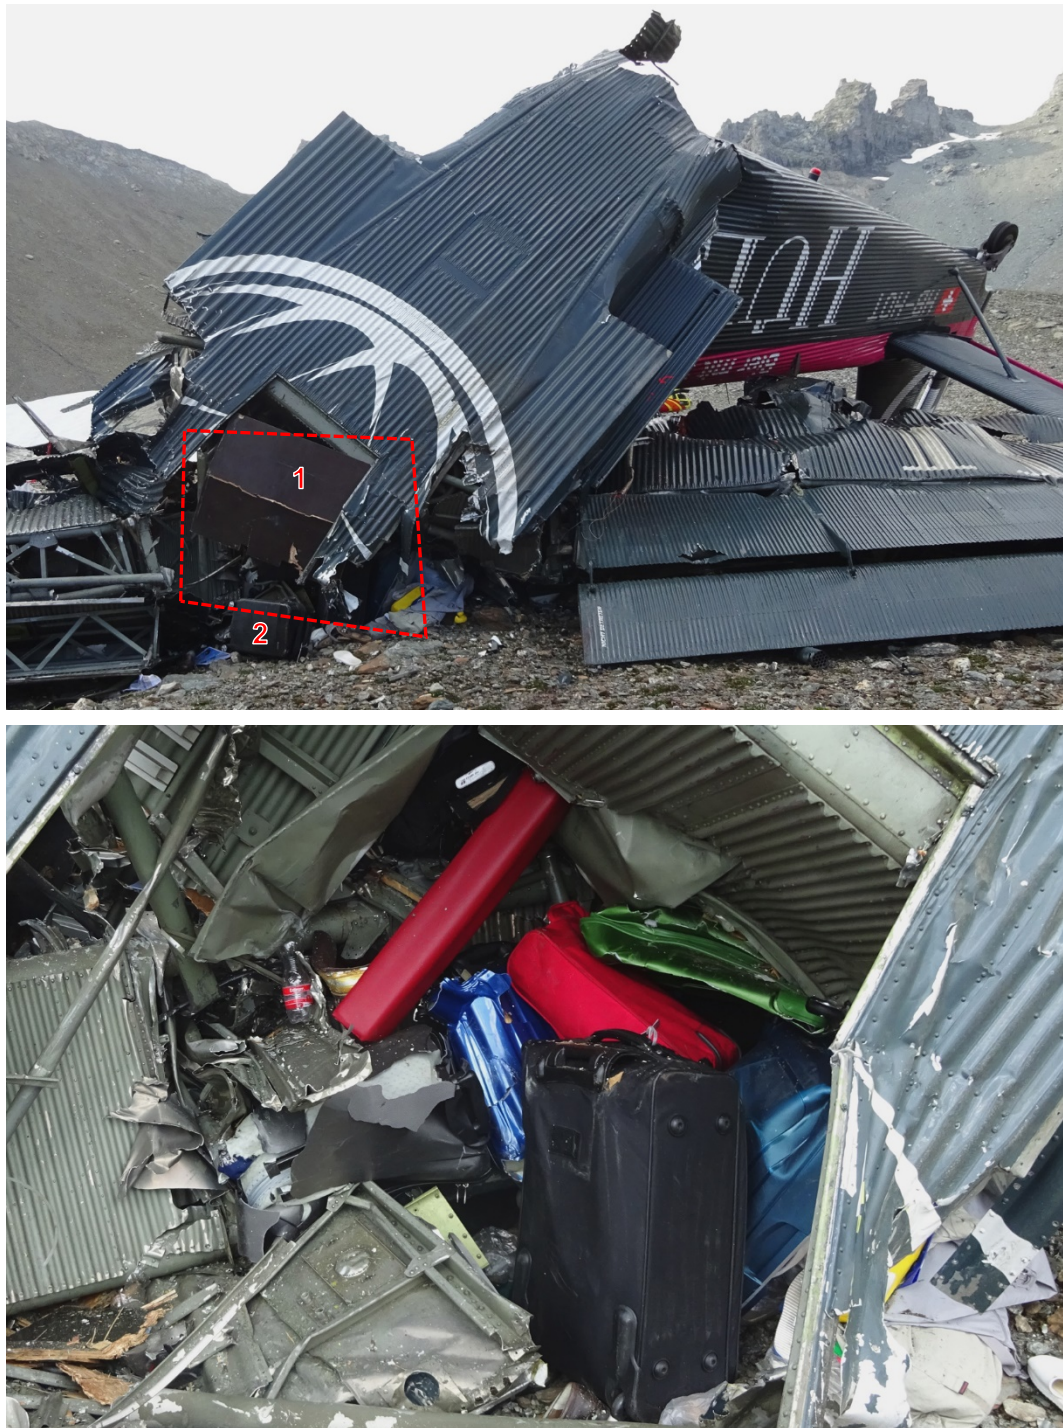
36 pieces of luggage were recovered in the wreckage of HB-HOT – ranging from small handbags to large wheeled suitcases. It could be determined that 12 of these pieces of luggage (a total of 106 kg) had been stowed as ‘checked luggage’ in the rear underfloor storage compartment (see figure 40). Furthermore, it could be ascertained that a 15-kg wheeled suitcase, also ‘checked luggage’, had been stowed in the front rear-storage compartment during the flight (see figure 41). The remainder (around 40 kg of hand luggage) was spread across the passenger compartment and in the cockpit during the flight.

Figure 40: View of the HB-HOT wreckage – underside of the fuselage at the wing root, and luggage in the rear underfloor storage compartment.

Above – red box: Approximate section shown in the lower photo. 1: Wooden storage-compartment floor panel (removed for lower photo). 2: Wheeled suitcase (removed for lower photo).

Below – view into HB-HOT's rear underfloor storage compartment at the scene of the accident after removing the wooden storage-compartment floor panel. The corrugated paneling of the rear underfloor storage compartment had already been ejected during impact. Seven larger pieces of luggage can be identified in particular: six wheeled suitcases (grey, shiny royal blue, red, green, matt blue, black) and a travel bag (black with white print).

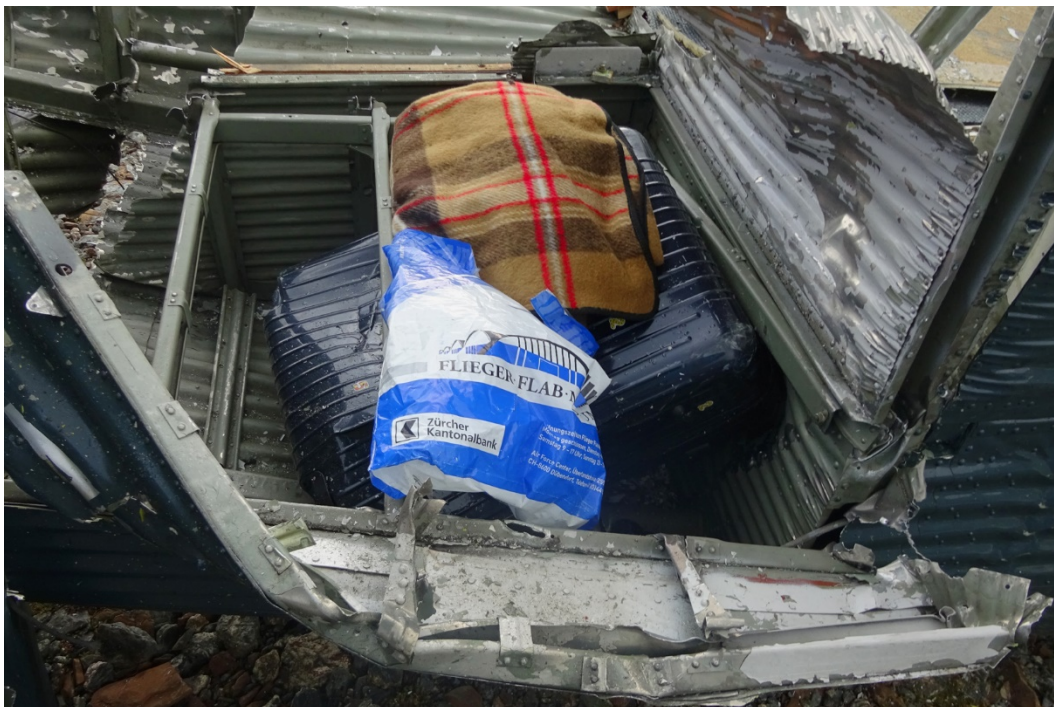
Figure 41: View into the fuselage structure below the toilet. A 15-kg dark-blue wheeled suitcase can be seen under a blue and white plastic bag and a brown woollen blanket. The wheeled suitcase ended up in this position after having moved from the front rear-storage compartment during impact.
