A1. Factual information

A1.16 Tests and research results

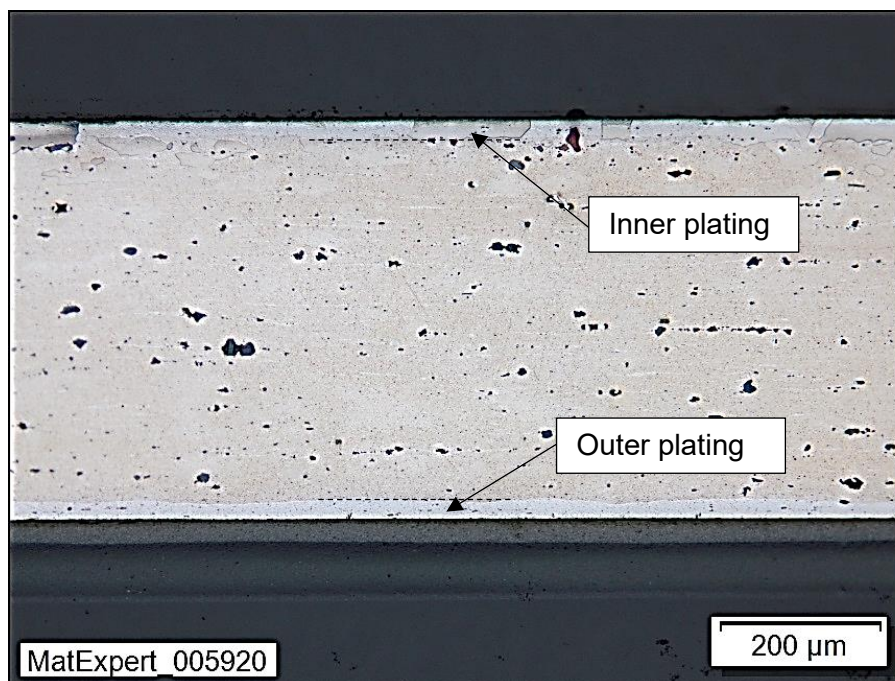
Parts of the cabin floor, stringer sections and structural parts from the aft section of the fuselage were examined. According to the OES analysis, the majority of the examined parts consist of an AlCuMg alloy and correspond chemically and materially to the aircraft manufacturer's specification. Individual parts are made of steel and were riveted to parts made of Duralumin. Sheets were found with plating on both sides (see figure 2).

Figure 2: Microsection of sheet with inner and outer plating.

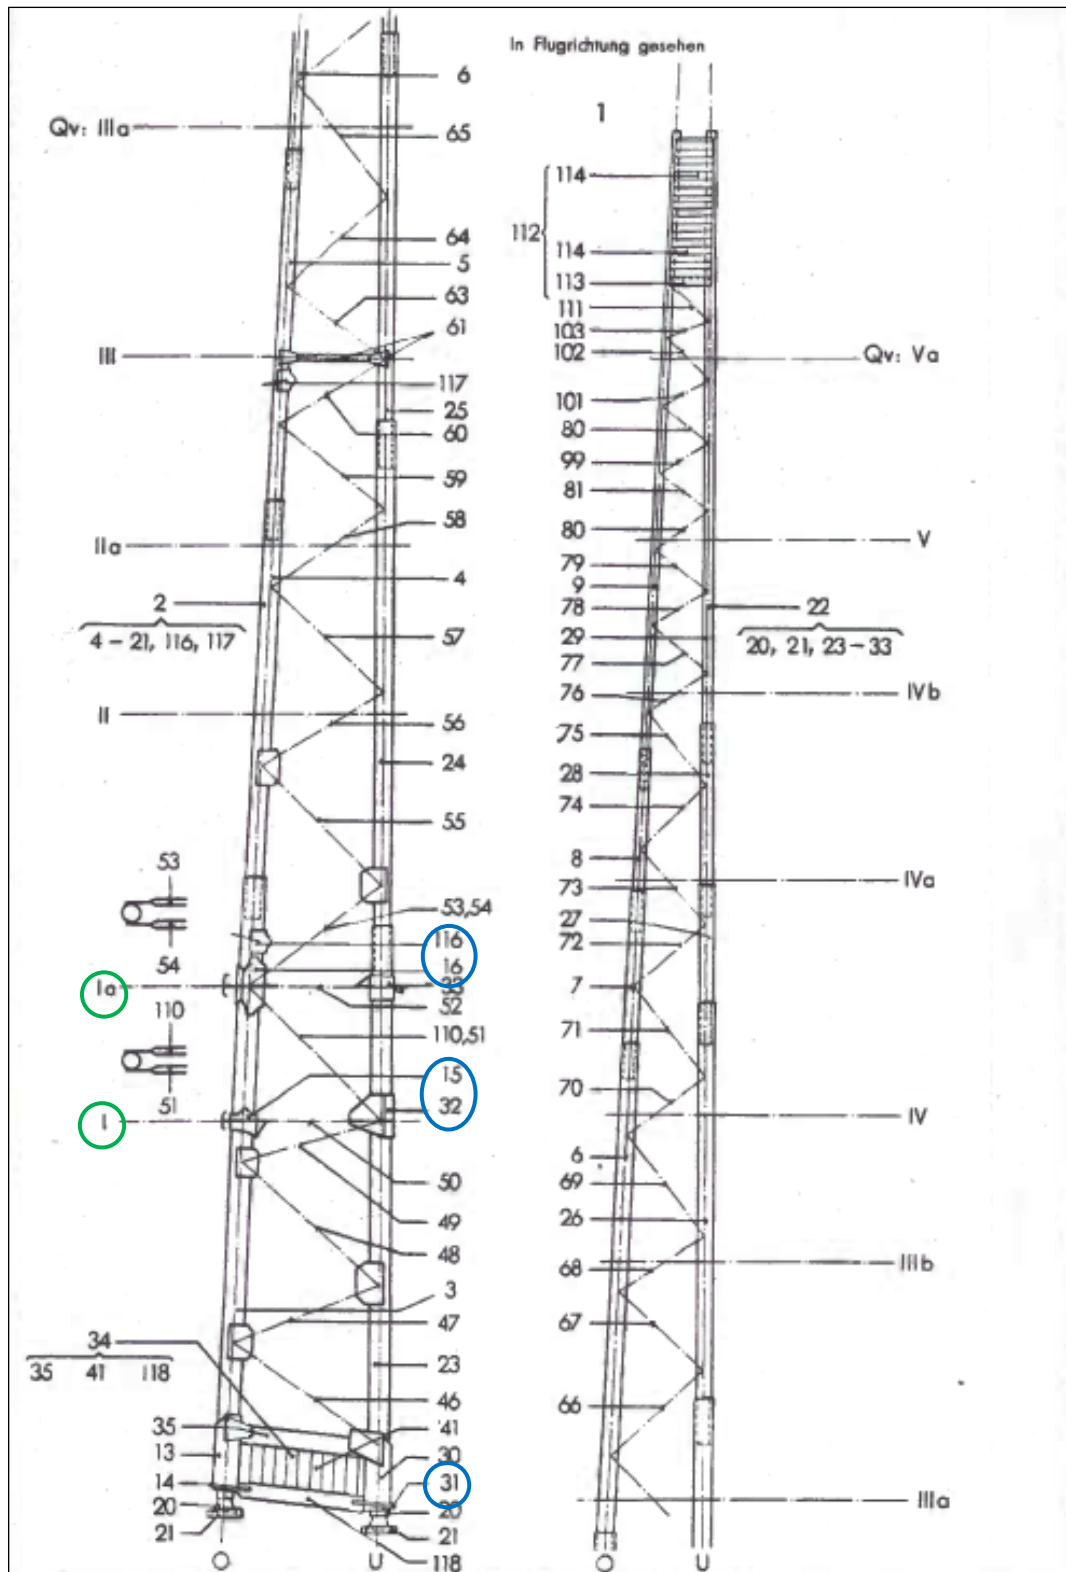
Figure 3: Spar I of the right-hand outer wing – the blue encircled position numbers indicate the examined parts, the green encircled positions I and Ia indicate the ribs. Source: Junkers Ju 52/3m aircraft parts list H.

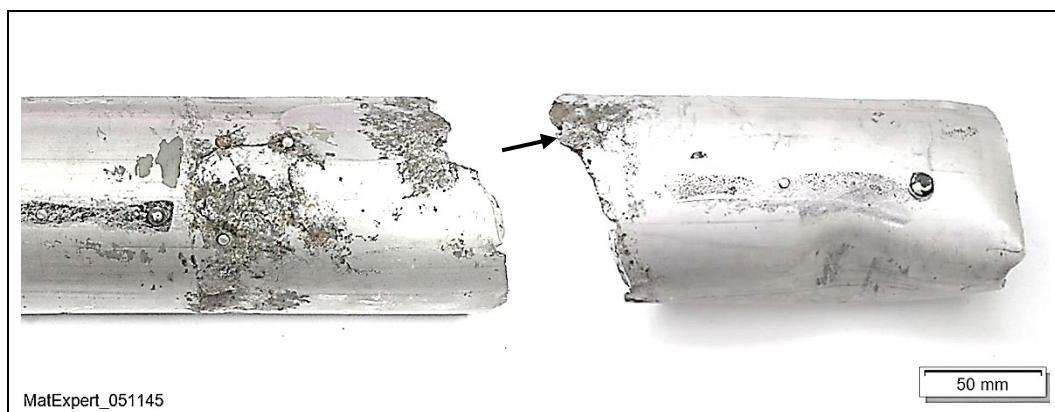
The spar tube below joint 89 was broken (see figure 7). The analysis of this fracture surface using SEM showed a ductile spontaneous fracture and a fatigue fracture with typical striations (see figure 8). The fatigue fracture accounted for approximately 10 % of the total fracture surface. Extensive corrosion damage and further cracks were uncovered in the contact area between joint 89 and the spar tube. This corrosion was intergranular corrosion resulting in a loss of wall thickness (see figures 9 and 10). One of the cracks was exposed and fractographically analysed (see figure 11). This crack was an intergranular fracture with striations, i.e. a fatigue crack (see figures 12 and 13).

Figure 7: Overview of the broken spar section; approximately 10 % of the fracture surface (arrow) is accounted for by fatigue fracture.

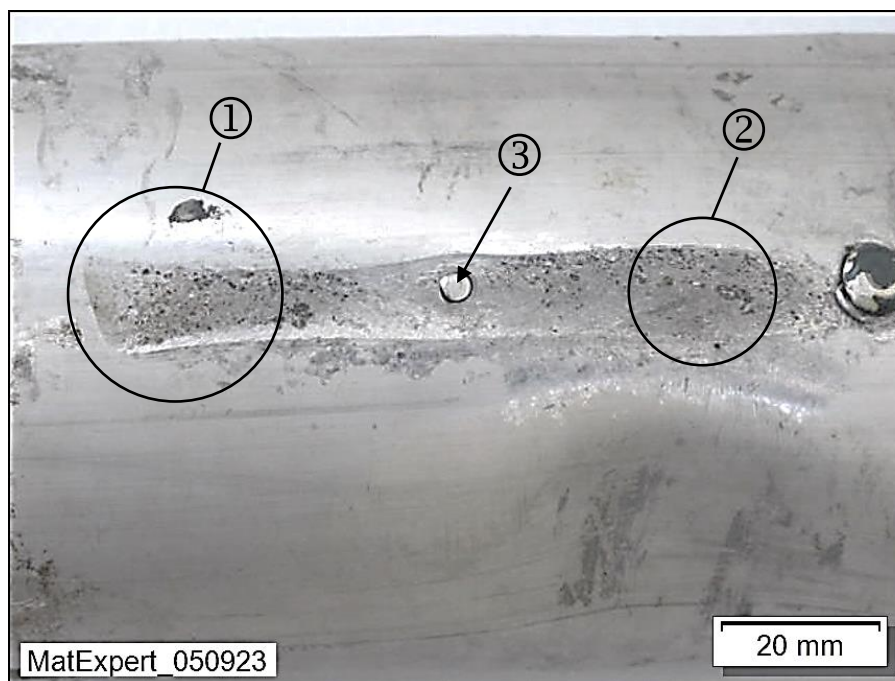
In the area where the panelling was riveted to the spars, damage similar to chafing can be seen (see figure 14). This type of wear attests that the panelling was no longer firmly attached to the spar and that the surface was severely damaged by the panelling's movement and by penetrating liquid (see figure 15). Besides general loss of material, intergranular cracks were also discovered (see figure 16). These cracks were mainly found near the rivet holes, and they can initiate fatigue cracks (see figure 17).

Figure 14: Wear on the lower spar L1 – number (1) see figure 15, number (2) see figure 16, number (3) see figure 17.

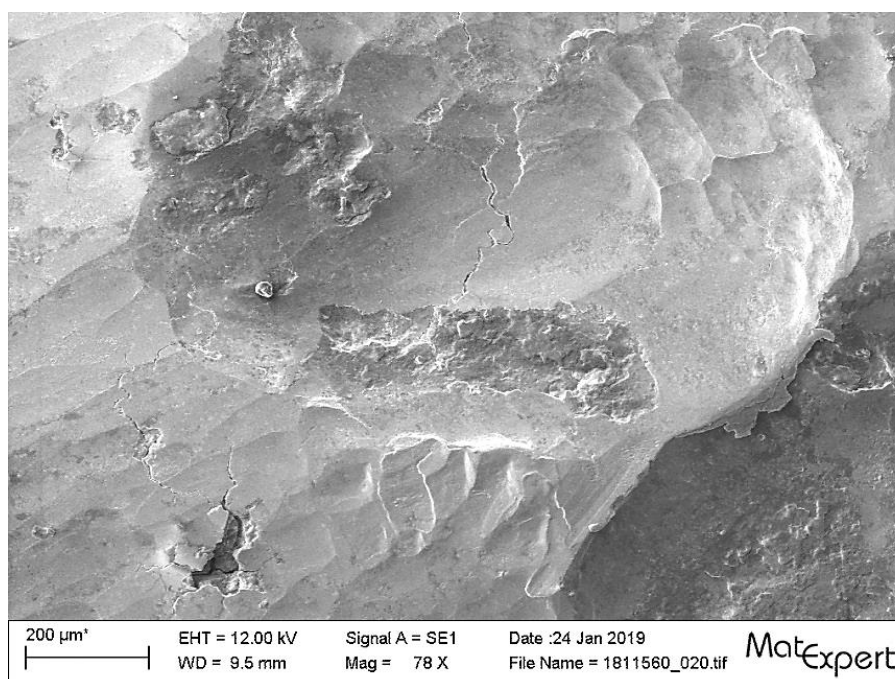
Figure 15: Impact wear on lower spar L1 (close-up of number (1) in figure 14).

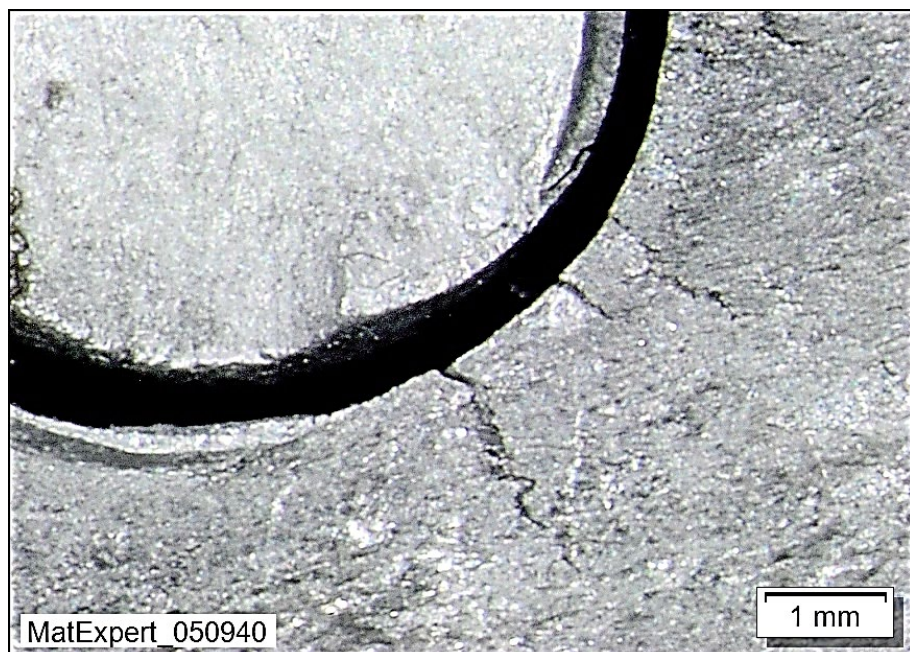
Figure 17: Intergranular incipient cracks at the rivet hole, crack lengths of up to 5 mm (close-up of number (3) in figure 14).

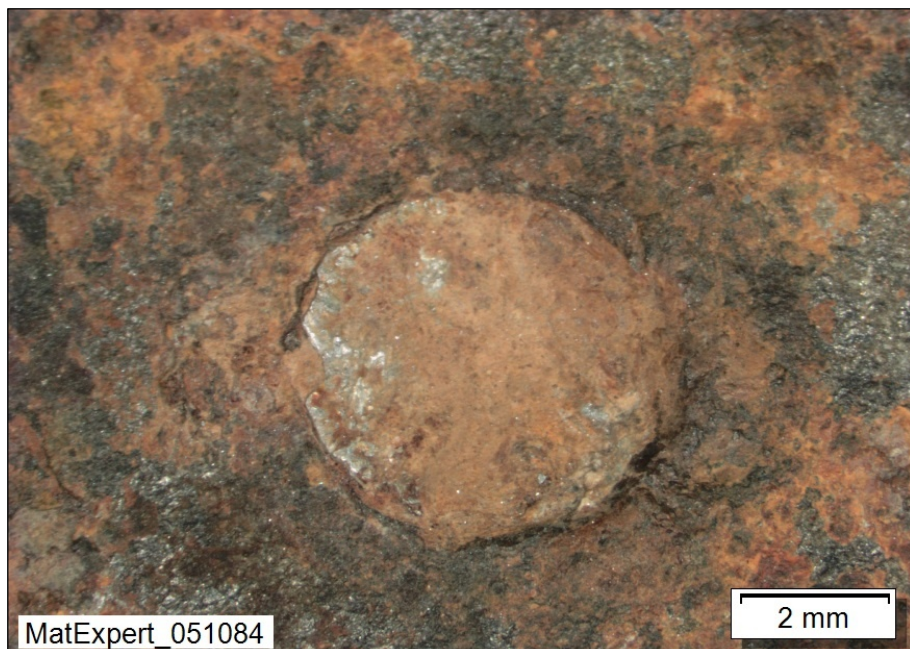
Rivet fractures were discovered which clearly occurred before the accident (see figure 21). They can be easily distinguished from the shear fractures caused by the accident.

Figure 21: Close-up – broken rivet N4 with severe corrosion.

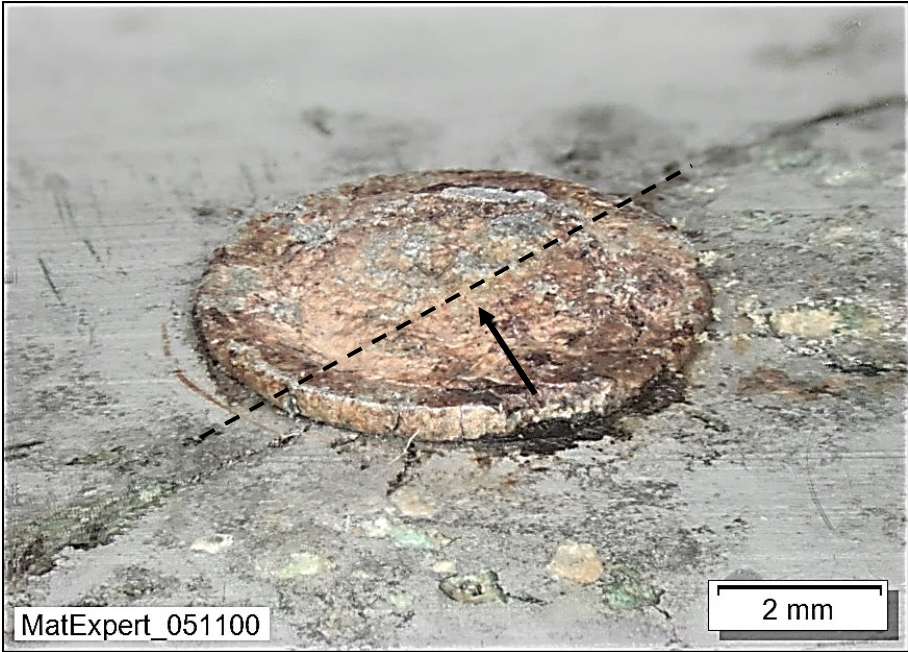
Figure 24: Severely corroded rivet N5. The black dashed line indicates the position of the microsection and the arrow indicates the direction the microsection surface was viewed from.

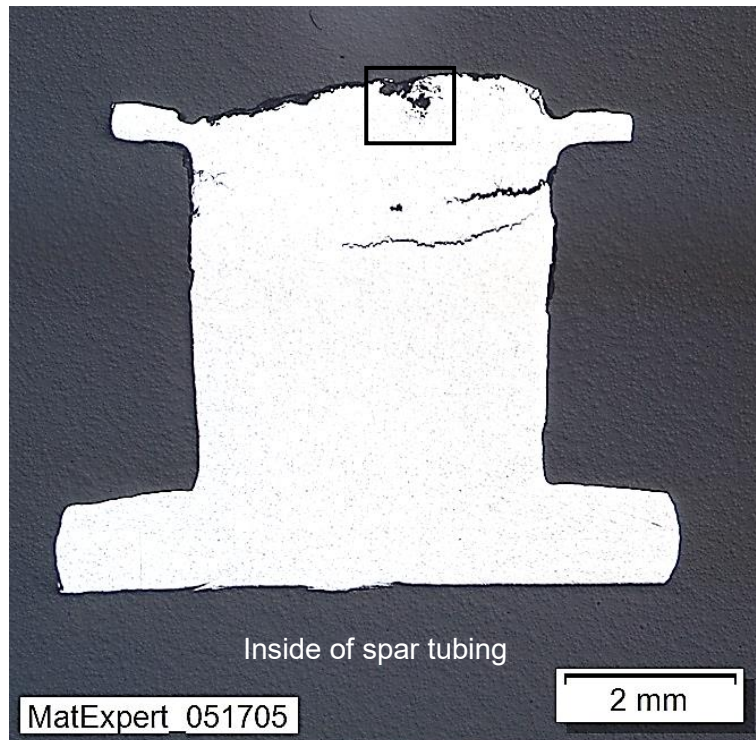
Figure 25: Cross section of broken rivet N5 with intergranular corrosion.

Intergranular corrosion causes cracks to form that give rise to the notch effect and can lead to the total failure of the component. Likewise, intergranular cracks form the ideal conditions for fatigue cracks to develop. This also applies to the connections between the steel joints and the aluminium spar tubes, which have been secured using rivets made of identical material (see figures 25 and 26).

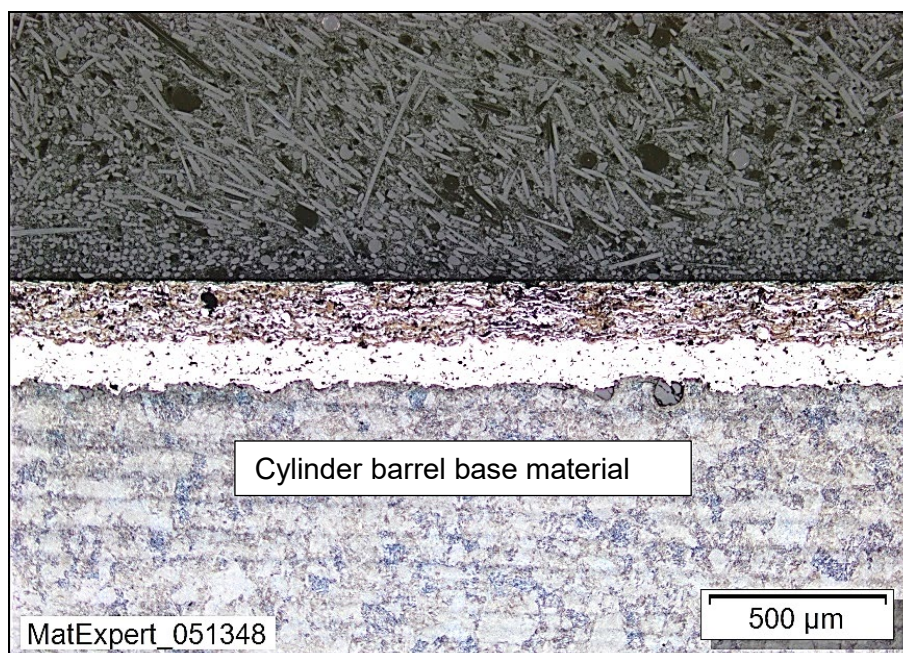
The cylinder from the right engine was plated with a thermal sprayed coating consisting of two different materials (see figure 45). The surface of this plating was porous, cracked and partially discoloured red (see figures 46 and 71).

What is known as a bond coat was found on the substrate, which had been covered by a top coat that featured approximately the same level of thickness as the bond coat. The measured thickness of the bond coat was 0.135 mm and that of the top coat 0.165 mm. The hardness measurement HV0.3 of the bond coat was 160 and that of the top coat 340.

Figure 45: Microsection with two-layer spray coating (right engine, cylinder 1).

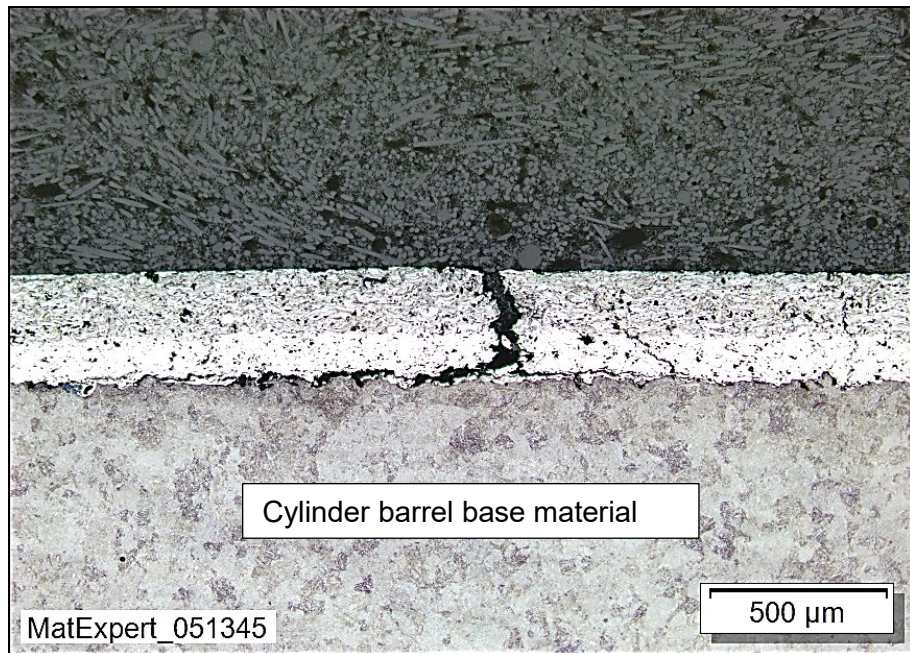
Figure 46: Crack in bond and top coat.

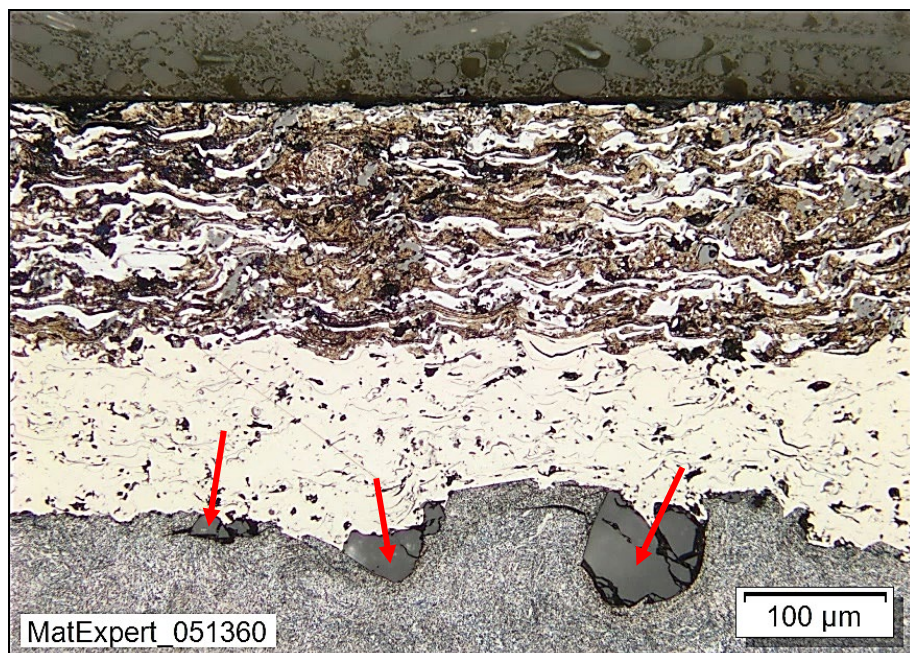
Prior to coating, the cylinder was honed to a diameter of 156.44 mm and the surface was abraded (see figure 47). Honing the cylinder to this diameter is not permitted according to the 1939 operating instructions supplied by the manufacturer of the BMW 132 A3 aircraft engine.

Figure 47: Microsection of the spray coatings with typical abrasive residues on the surface of the base material (red arrows).

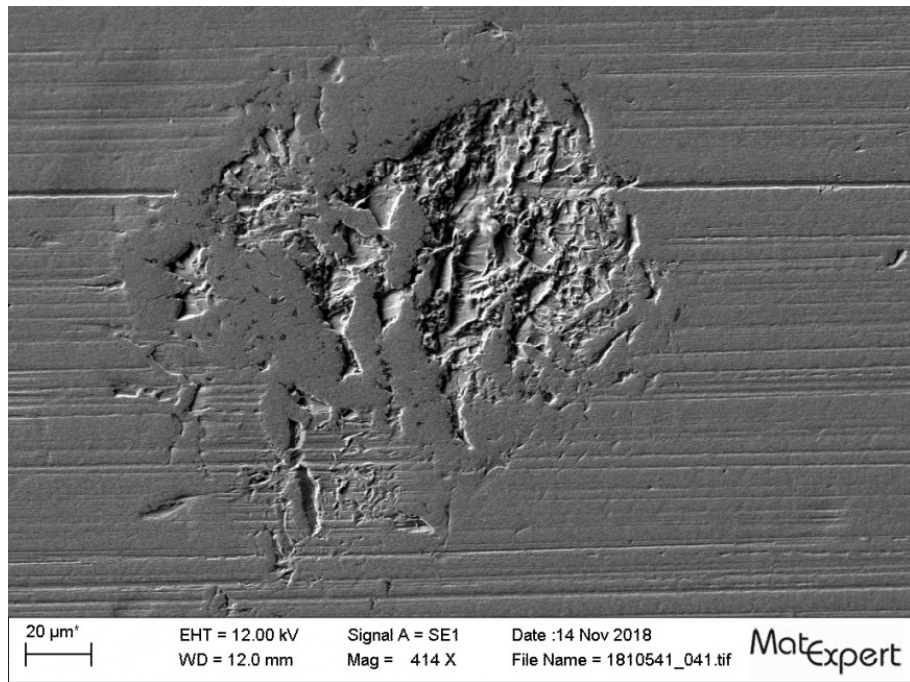
Figure 52: Ball bearing from the centre engine, outer-race bearing track – pitting, possibly due to foreign-body indentations.

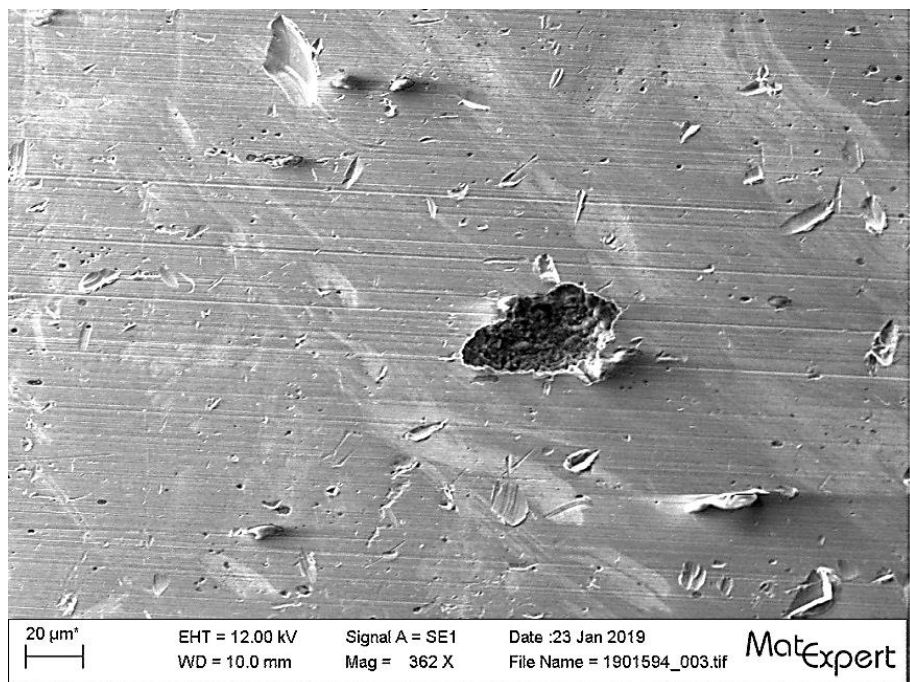
Figure 53: Ball bearing from the centre engine, inner-race bearing track – mechanical indentations, material chipping and pitting.

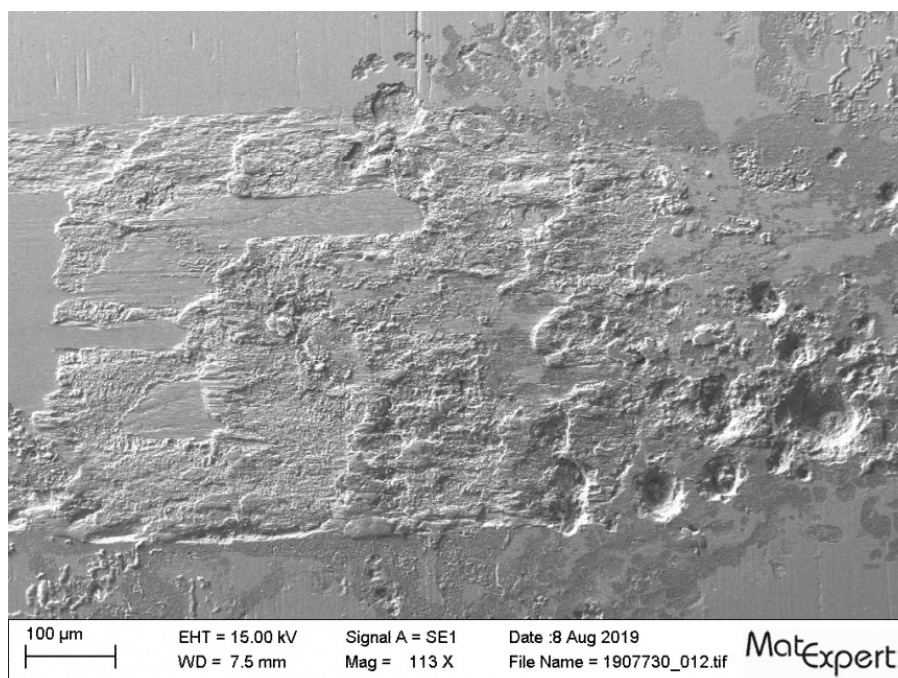
Figure 56: Close-up of the worn area – pitting.

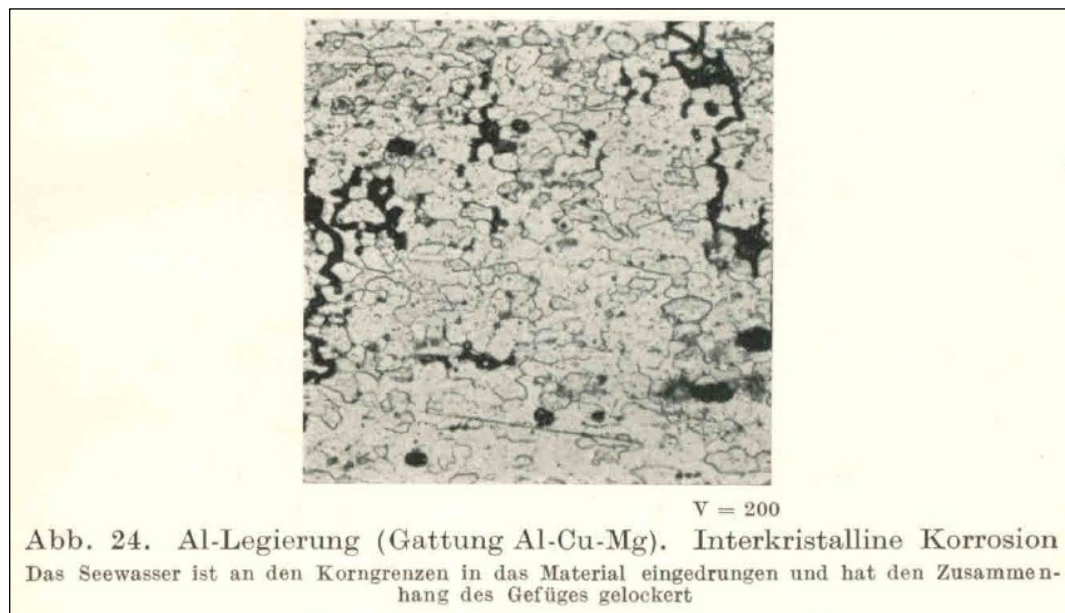
Duralumin's susceptibility to corrosion was already well known during the production period of the Ju 52/3m g4e aircraft. For example, the susceptibility of AlCuMg alloys to intergranular corrosion was described in book 28 of "*Werkstoffkunde für den Flugzeug- und Motorenbau*" (a series of books on material science for aircraft and engine construction), published in 1937 (see figure 61).

Figure 61: Illustration of an AlCuMg alloy with intergranular corrosion from book 28 of "*Werkstoffkunde für den Flugzeug- und Motorenbau*" by Ing. Cl. Böhne.

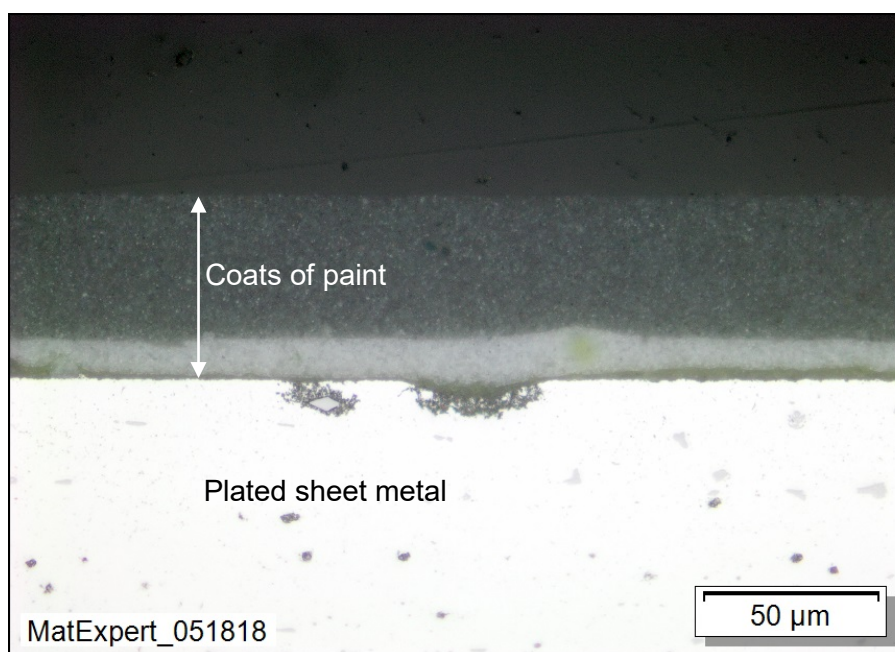
The panelling was also examined in the laboratory for corrosion. Analyses using scanning electron microscopy show that the surface was partially covered with corrosion and exhibited corrosive damage (see figure 69). Metallographically, corrosion spots can be detected in some areas on the surface of the plating, underneath the coat of paint (see figure 70).

Figure 70: Microsection of corroded plated sheet metal under the layers of paint.

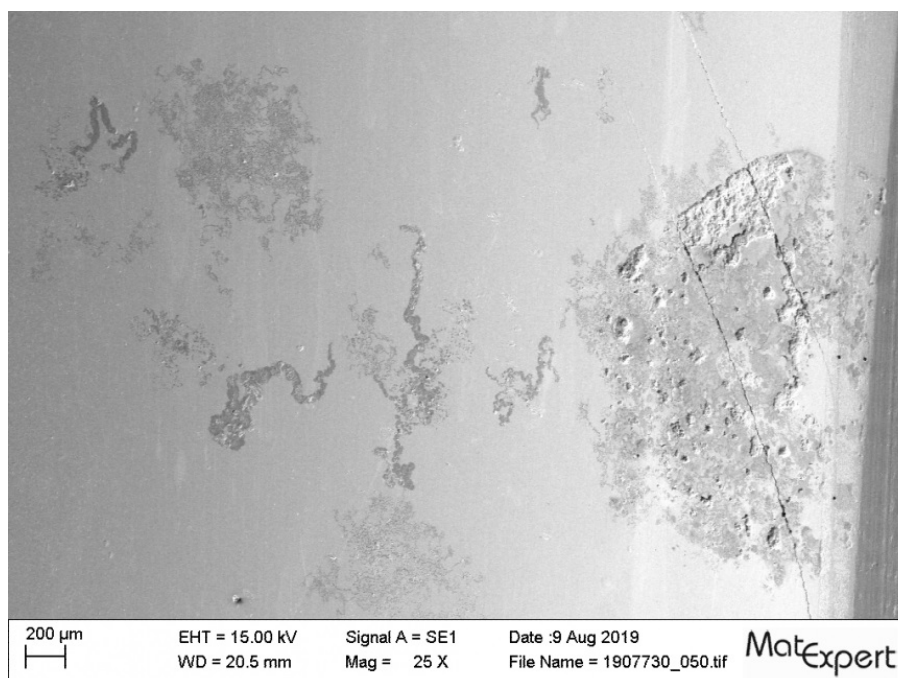
All three bearings were corroded. This corrosion was found on the end faces, the surfaces where the bearings were fitted as well as on the bearing tracks of the inner and outer races and the rolling elements (see figures 76 to 83).

Figure 77: Bearing no. 4, outer-race bearing track – filiform corrosion and pitting with cracks.

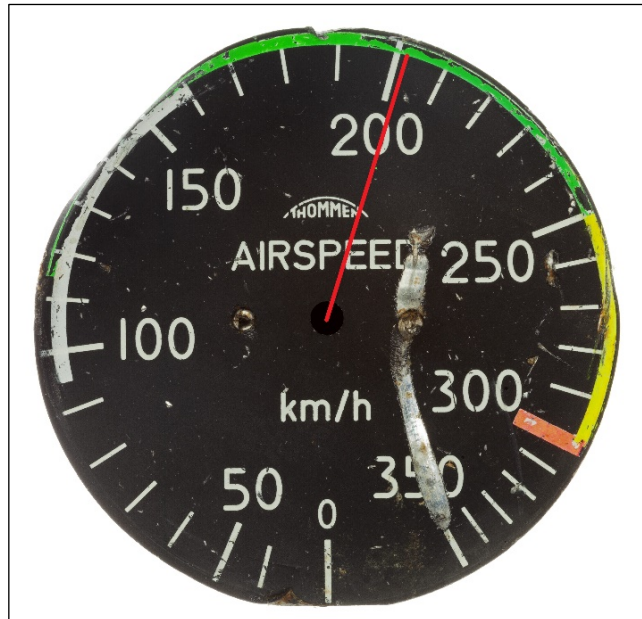
The needle left scratch marks in the range of 200 km/h (see figure 85). The needle's counterweight left a notch above the letter 'k' of the km/h notation. The positioning of a comparable needle in line with the detected marks showed that the instrument needle should have indicated a value of approximately 202 km/h at the point of impact.

Figure 85: Speed indicator dial.

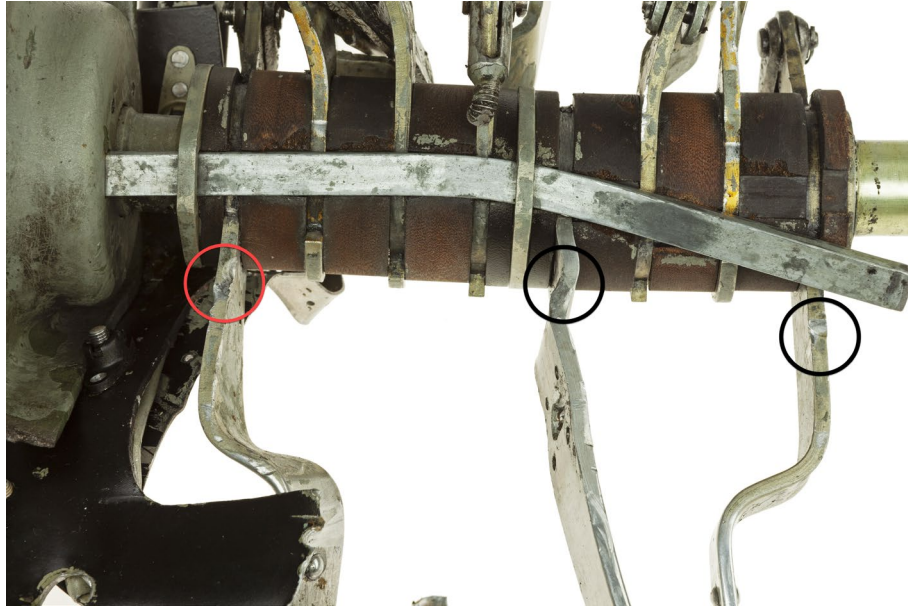
The three circled marks are located in the area where the limit stop bolts touch the front of the main throttle levers when in the 'on' position (see figure 87). Circled in red is the mark on the main throttle lever for the left engine, which was generated by the corresponding limit stop bolt (see figure 88). The direction of movement for the applied force is clearly visible in the image of the curved indentation, or notch.

Figure 87: Front of the three main throttle levers with circled marks.

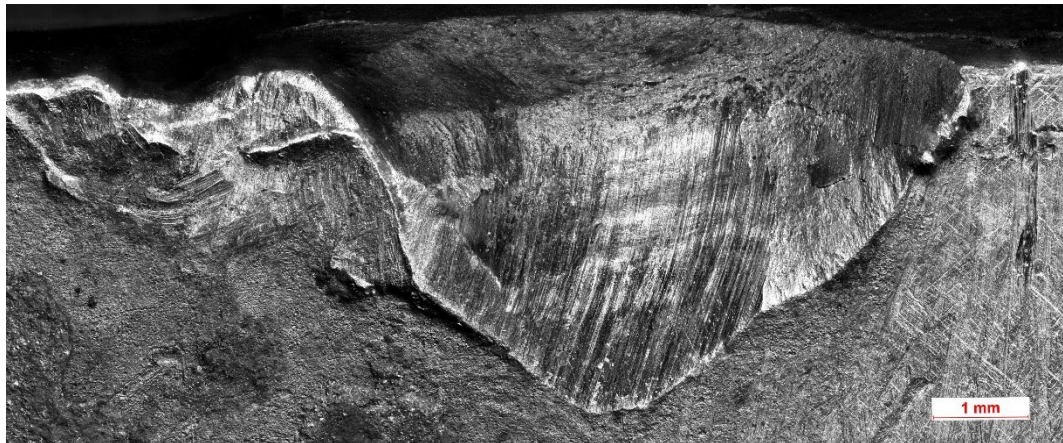
Figure 88: Notch mark on the main throttle lever for the left engine.

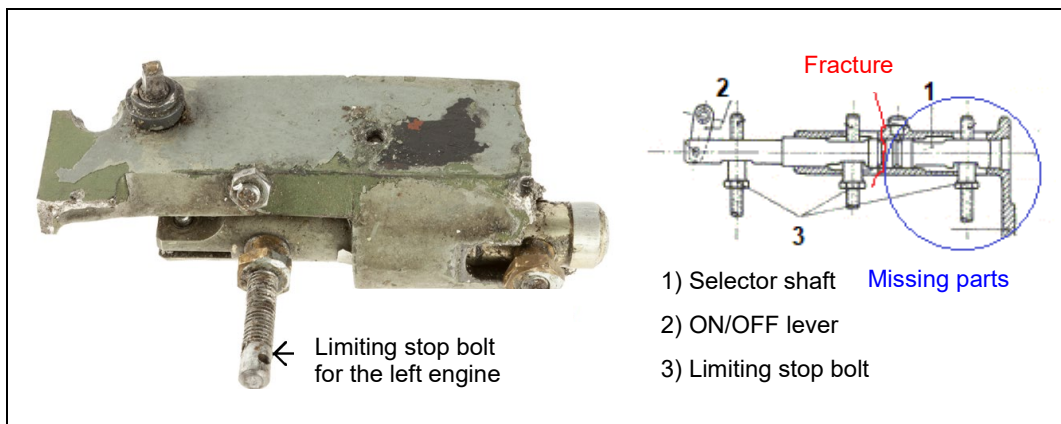
A fragment of the full-throttle limiting mechanism was found in the wreckage (see figure 89). On the limit stop bolt for the left engine, damage was found on 13 turns of the thread (see figure 90).

Figure 89: Fragment of the full-throttle limiting mechanism with limiting stop bolt for the left engine.

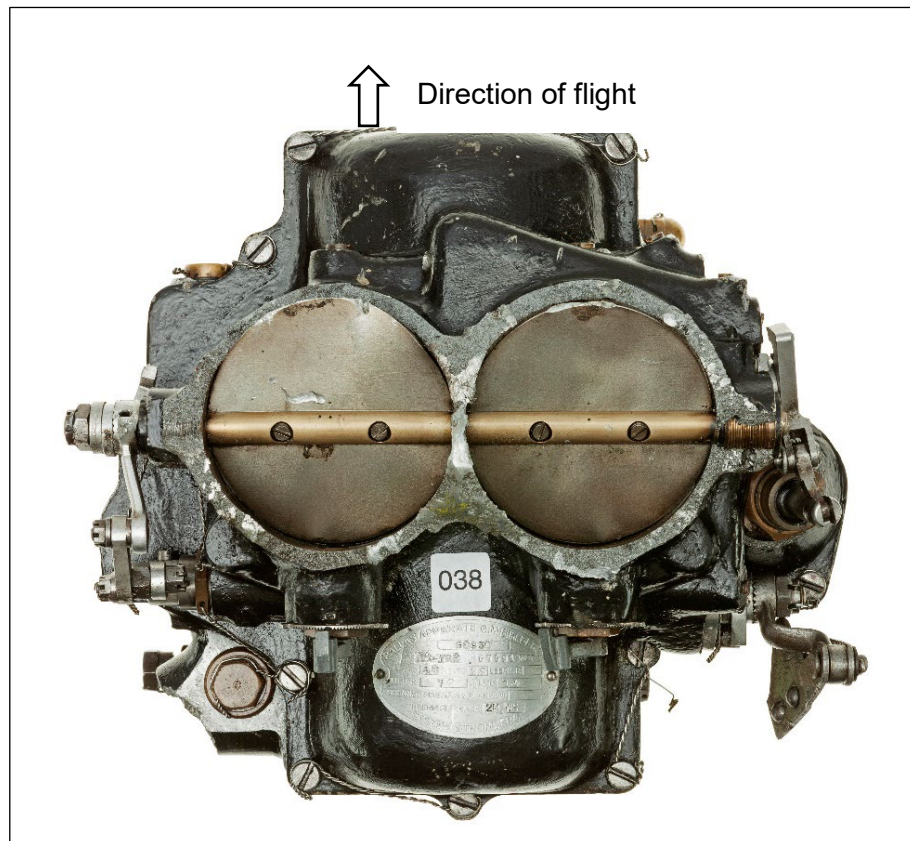
The carburettors exhibited varying degrees of damage. With the carburettors for the left and the centre engines, the flange above the two butterfly valves was broken off (see figure 91).

Figure 91: As an example, the carburettor for the centre engine is shown.

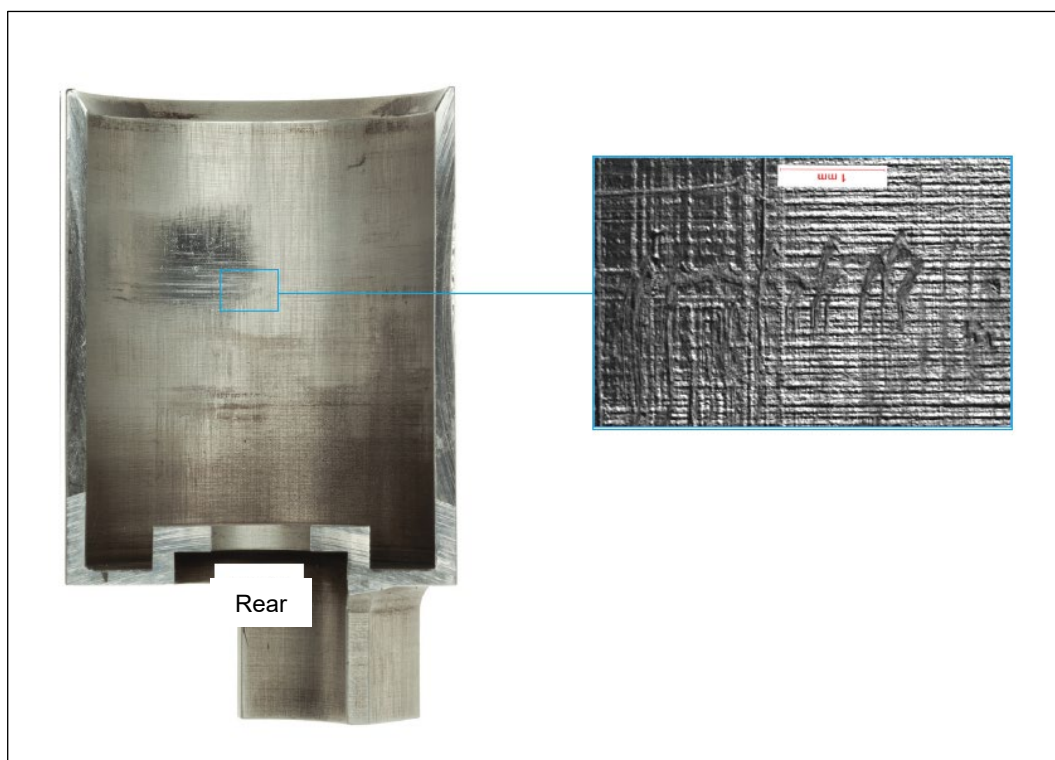
The cylinders in the accelerator pumps were sectioned to allow the bores to be examined under a stereomicroscope. Abrasions that cannot be attributed to conventional wear caused by the piston movements during normal operation were visible on all of the bores (see figures 93 to 95). These abrasions do not run axially in a straight line, but are slightly curved or jagged.

Figure 94: Abrasions in the pump cylinder from the carburettor for the centre engine.

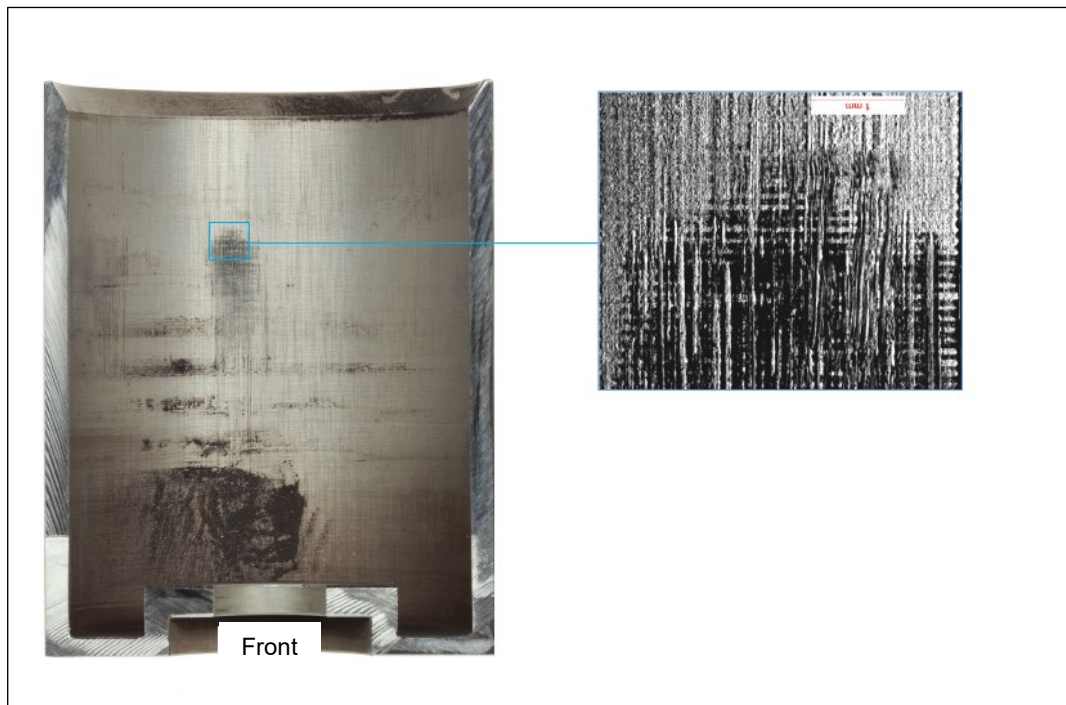
Figure 95: Abrasions in the pump cylinder from the carburettor for the right engine.

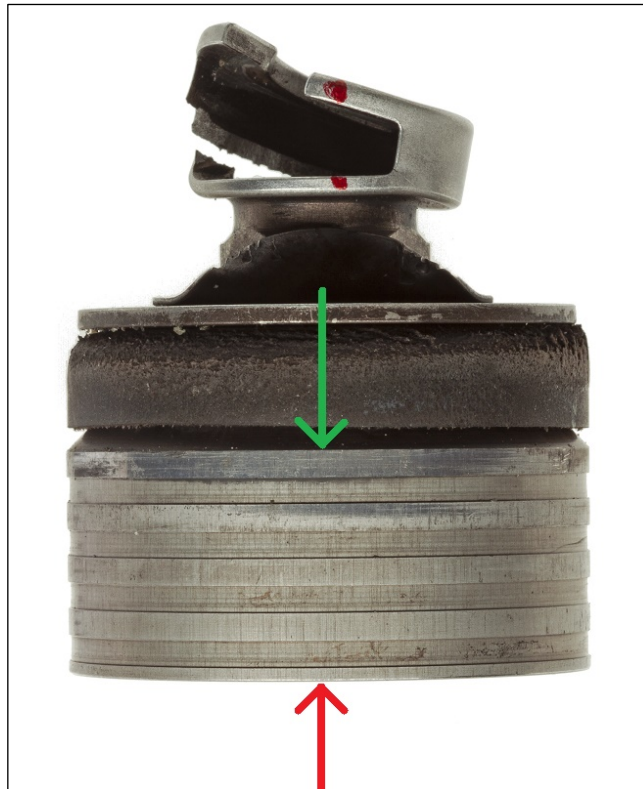
All three pistons were inspected for damage and other abnormalities under the stereomicroscope. This revealed that the chamfer at the lower end of the piston (see red arrow in figure 96) was not damaged on any of the pistons. However, all of the pistons exhibited signs of wear and abrasions on the chamfer where the upper end of the piston skirt (green arrow) transitions into the sealing ring. These abrasions can be plausibly attributed to the corresponding curved and jagged abrasions on the pump cylinder bores.

Figure 96: Accelerator-pump piston from the carburettor for the centre engine.
