**A1. Factual information**

**A1.19 Useful or effective investigation techniques**

A1.19.1 Use of data memories from mobile phones and cameras

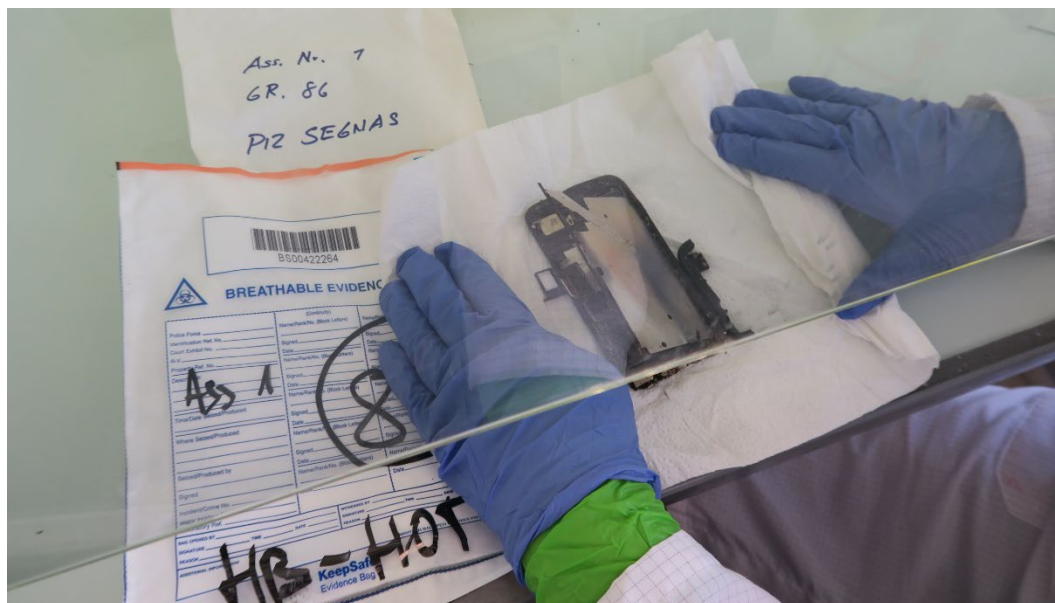
The electronic components were taken apart, cleaned and their data storage units removed in an ESD<sup>3</sup>-protected area in the BEA laboratory in Paris (see figure 1). For certain mobile phones, in addition to the data storage unit, the associated encryption unit had to be removed as well, so that the data could also be read at a later stage. After cleaning, the data storage units were dried in a special oven for approximately 72 hours.

**Figure 1:** Removal of the data storage unit from a damaged mobile phone in the BEA laboratory.

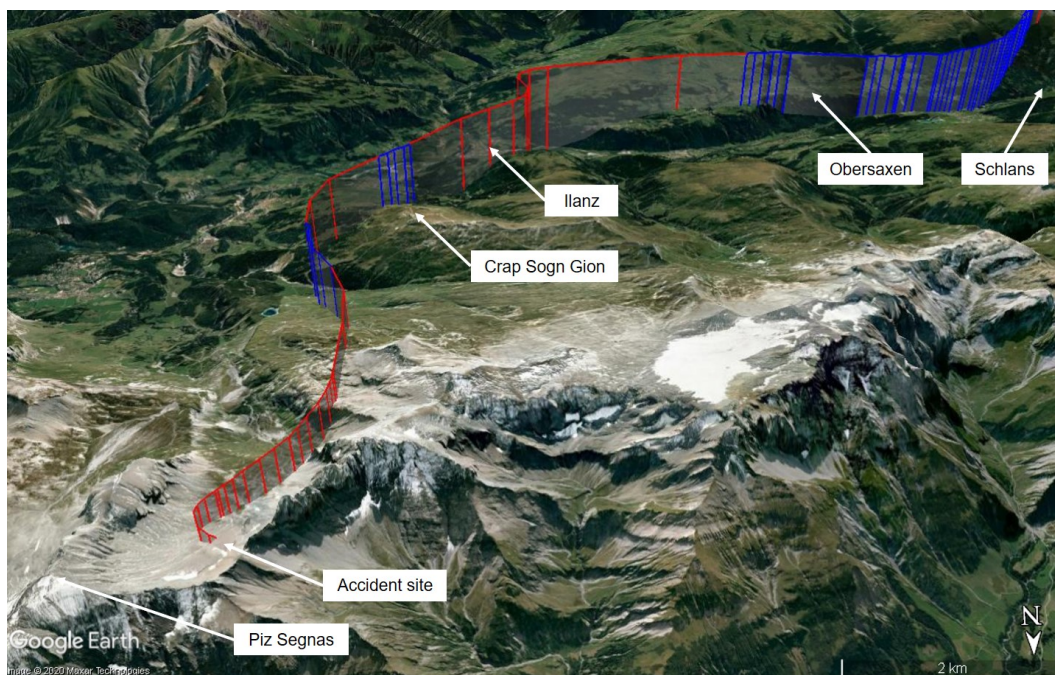
The images and video footage were visually evaluated in the geometry of the terrain. Based on the evaluation of these data and the information obtained, the gaps in the radar flight paths could be filled in most instances, the inaccuracies eliminated to a large extent, and the flight paths reconstructed (see figure 6).

**Figure 6:** Section of the accident flight on 4 August 2018 with stretches derived from radar data (blue) and that have been reconstructed (red). Shown on Google Earth.

The radar data points corrected in height are marked in the sections shown in blue, connecting them to the ground with vertical lines. In addition to position and altitude, MRT also calculates and records the time and ground speed (GS) for each data point. In the absence of radar data points, a missing stretch can be filled in with a straight line between adjacent known positions based on the information available – provided that no alternative flight paths are possible, as was the case near Obersaxen (see figure 6).

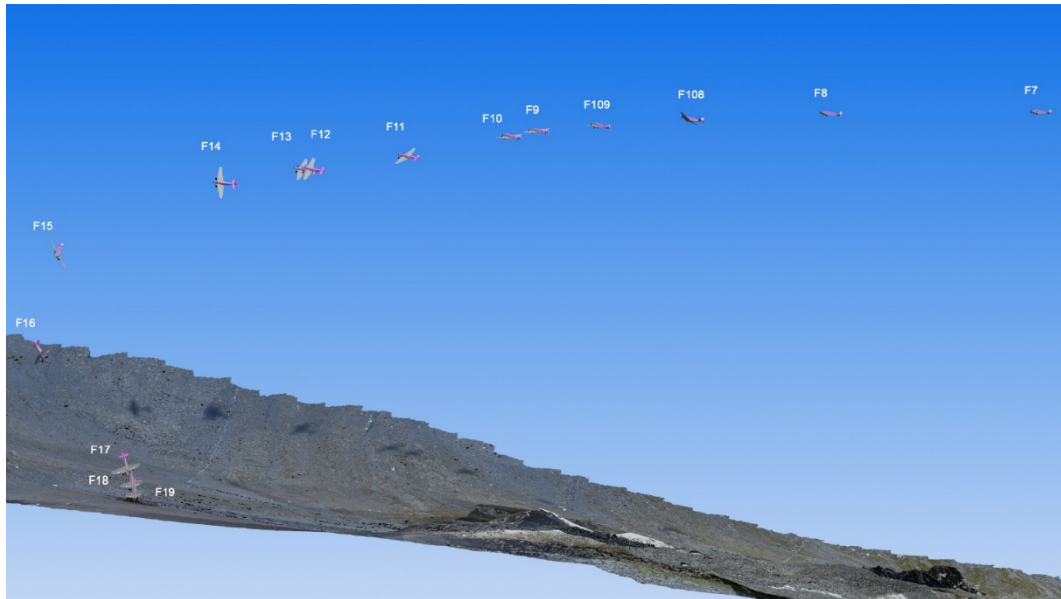
The following model representation exemplifies the result of the photogrammetrically reconstructed positions and flight attitudes of HB-HOT in the last flight phase before the accident.

**Figure 7:** Photogrammetrically reconstructed positions and flight attitudes (F7 to F19) of HB-HOT in the last flight phase before the accident, depicted using the scan data of the terrain.
