Final Report No. 2370

by the Swiss Transportation Safety Investigation Board STSB

on the accident involving
the Junkers Ju 52/3m g4e
commercial aircraft, HB-HOT,

on 4 August 2018

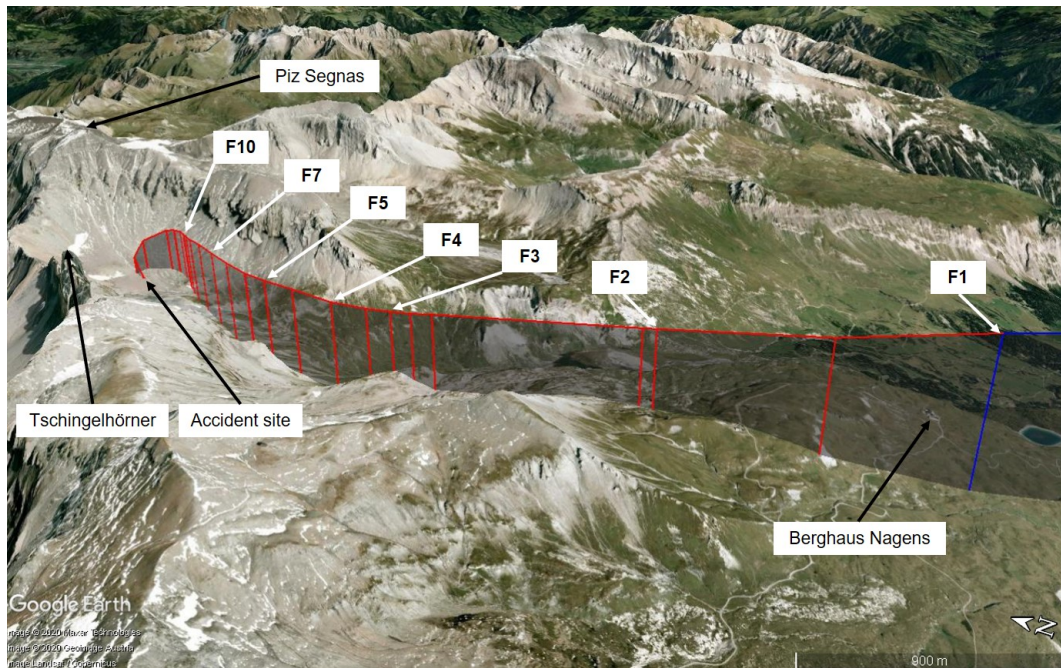
Figure 2: Reconstructed flight path of HB-HOT (red) from the Berghaus Nagens lodge to the site of the accident on 4 August 2018, shown on Google Earth. Point F1 is the first of a total of 29 points determined through photogrammetry. The flight altitude at point F1 was 2,833 m AMSL.

Towards point F3, the aircraft's altitude dropped slightly and the ground speed briefly increased by around 65 km/h to approximately 200 km/h. During this time, its pitch attitude³ was 5 to 7 degrees. Towards the end of this phase, just before point F4, the flight path angle⁴ changed from -3 degrees to approximately -1 degree and the speed of each of the three engines decreased steadily by approximately 20 revolutions per minute (rpm). At point F4, the aircraft was at an altitude of 2,742 m AMSL.

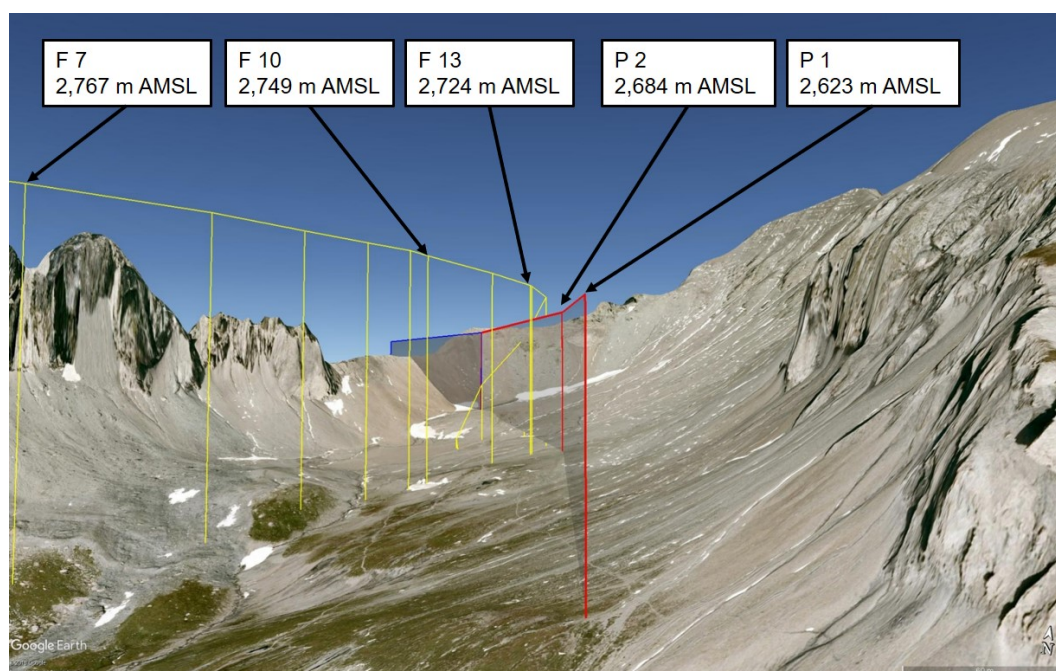
During a climb in sister aircraft HB-HOP on 6 July 2013, pilot B as commander, together with pilot A in the role of co-pilot at the time, entered the basin south-west of Piz Segnas in a similar manner to during the accident flight and flew over the ridge of the Segnes pass at approximately 30 m above ground (see figure 9).

Figure 9: Comparison between the reconstructed flight paths of 6 July 2013 (red, points labelled 'P'), including extension of the flight path (blue), and the accident flight on 4 August 2018 (yellow, points labelled 'F'); shown on Google Earth.

During this flight, a 180-degree turn or an alternative flight path in the northern section of the basin south-west of Piz Segnas would not have been possible.

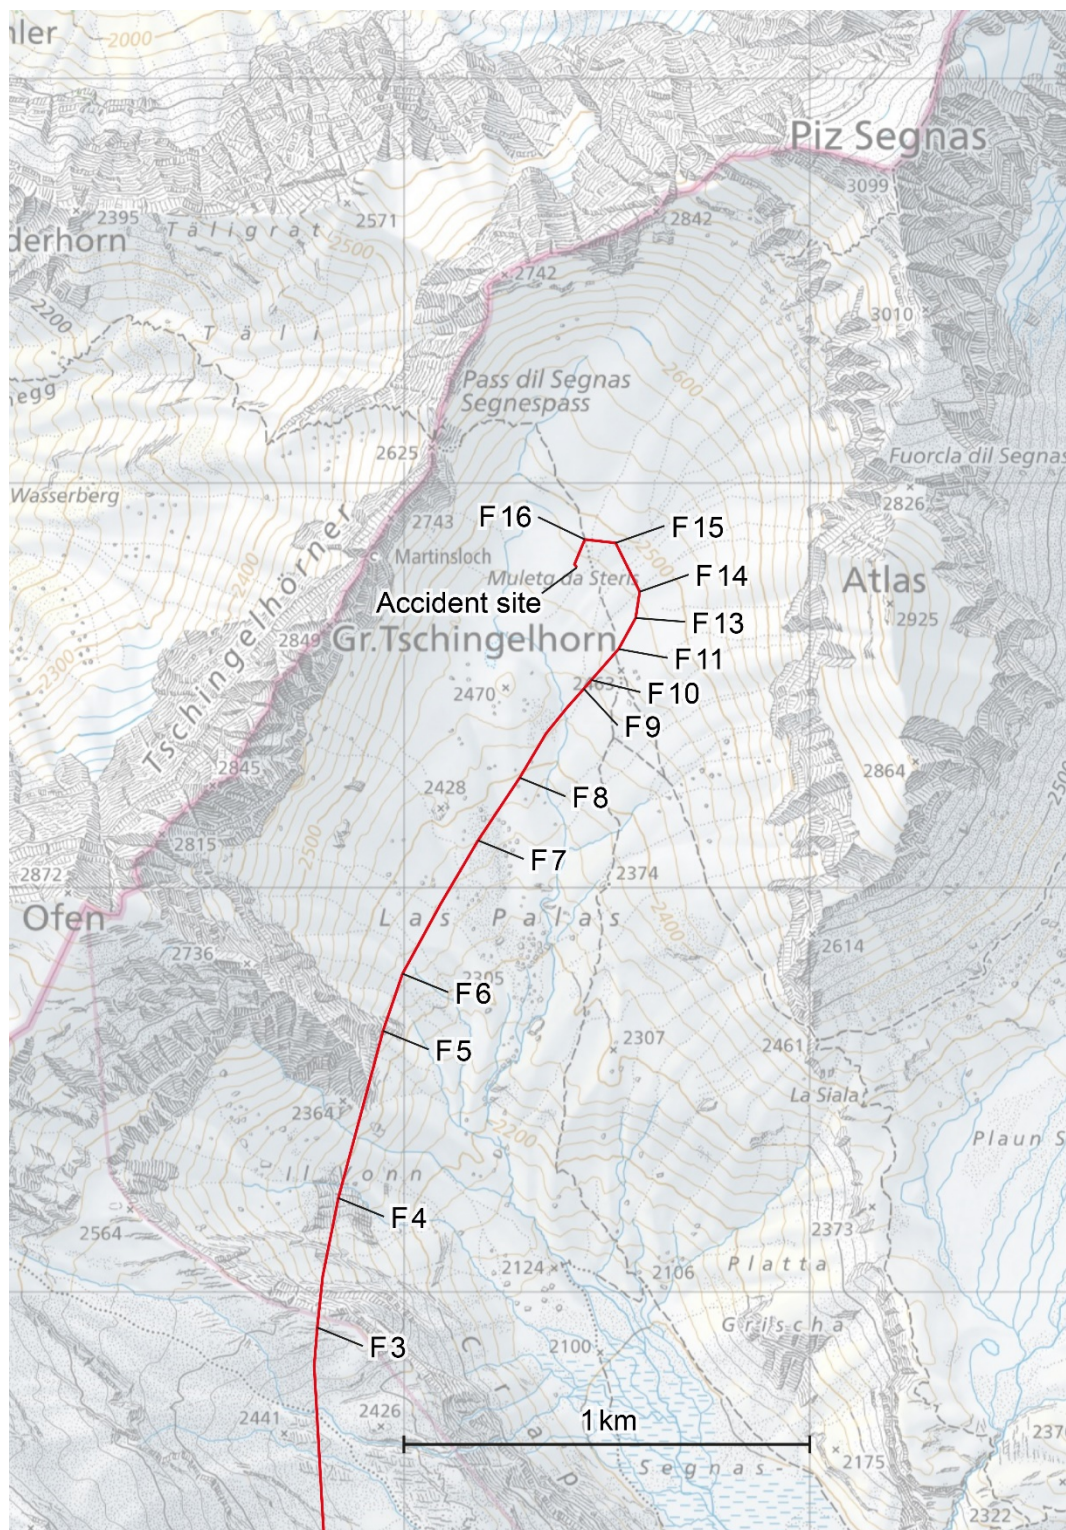
At 16:56:02, shortly after point F4, the speed of each of the three engines increased by approximately 40 rpm. At 16:56:09, HB-HOT entered the basin southwest of Piz Segnas at an altitude of 2,755 m AMSL (point F5, see also figure 14) and was therefore approximately 130 m above the elevation of the Segnes pass. The flight crew then navigated the aircraft on a north-north-easterly heading almost in the centre of the valley. HB-HOT climbed slightly during this phase and its flight path angle was approximately 2 degrees; its pitch angle remained at 5 to 7 degrees. At 16:56:17, the aircraft reached an altitude of 2,767 m AMSL at point F7 and was therefore approximately 140 m above the elevation of the Segnes pass.

Figure 14: Reconstructed flight path of HB-HOT on 4 August 2018 (red) between point F3 and the site of the accident. Source of the base map: Swiss Federal Office of Topography.

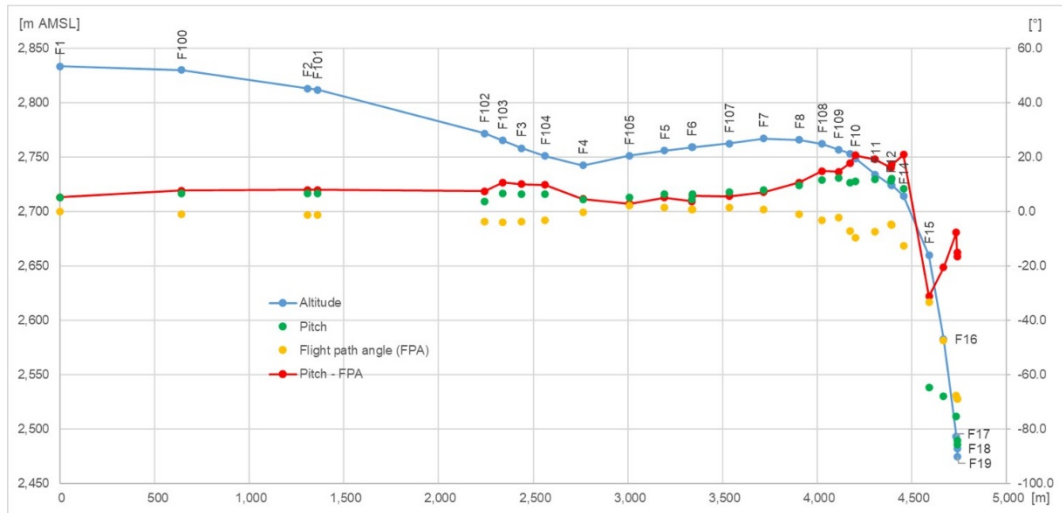
Figure 15 shows the altitude, pitch and flight path angles as well as the difference between these two angles.

Figure 15: Altitude, pitch and flight path angle (FPA) in relation to of the horizontal distance travelled. The left-hand y-axis shows the values for altitude and the right-hand y-axis shows the values for the angles.

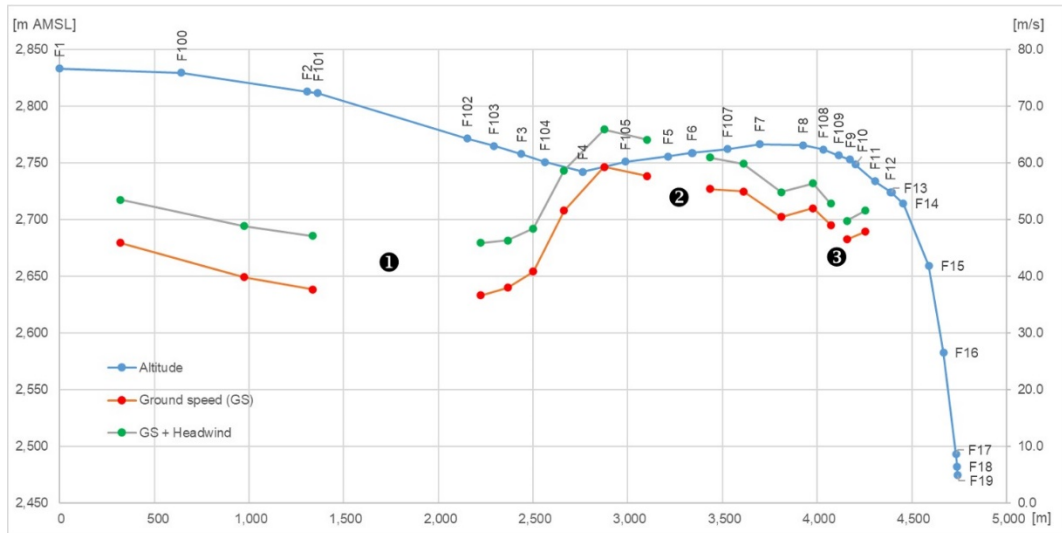
Figure 17: Altitude, calculated ground speed and ground speed + headwind in relation to the accumulated horizontal distance.

In area ❶ (see figure 17) where the ground speed graph is interrupted, no time difference – and thus no ground speed – could be calculated, because the data points were determined using two different, unconnected videos. For the other gaps (areas ❷ and ❸), the points have been determined from other data sources. They are not shown as no runtime can be assigned to them.

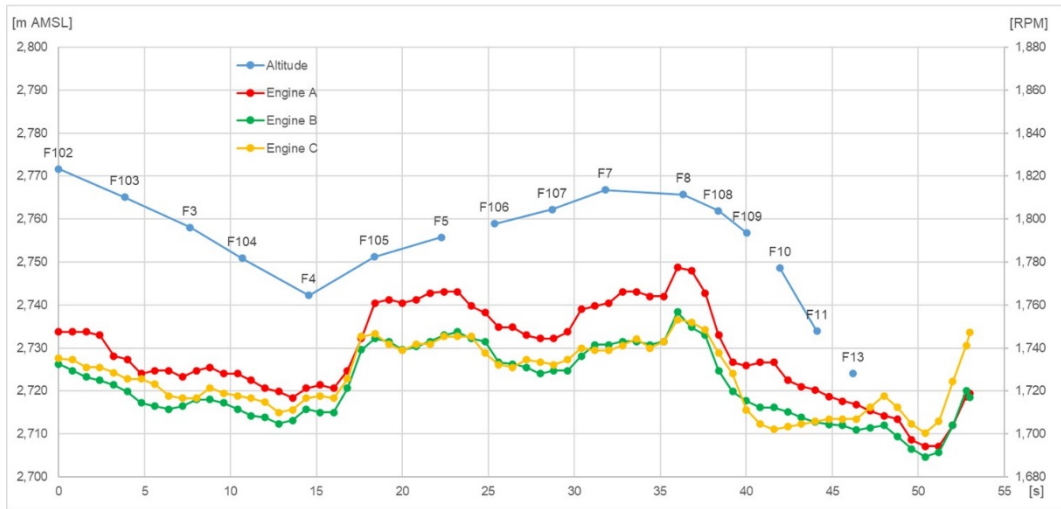
Figure 18 shows the course of the three engine speeds in relation to the video runtime. It was not possible to assign the speeds of engines A, B and C to the position of the engines (left, centre, right).

Figure 18: Altitude and engine speed in relation to the video runtime.

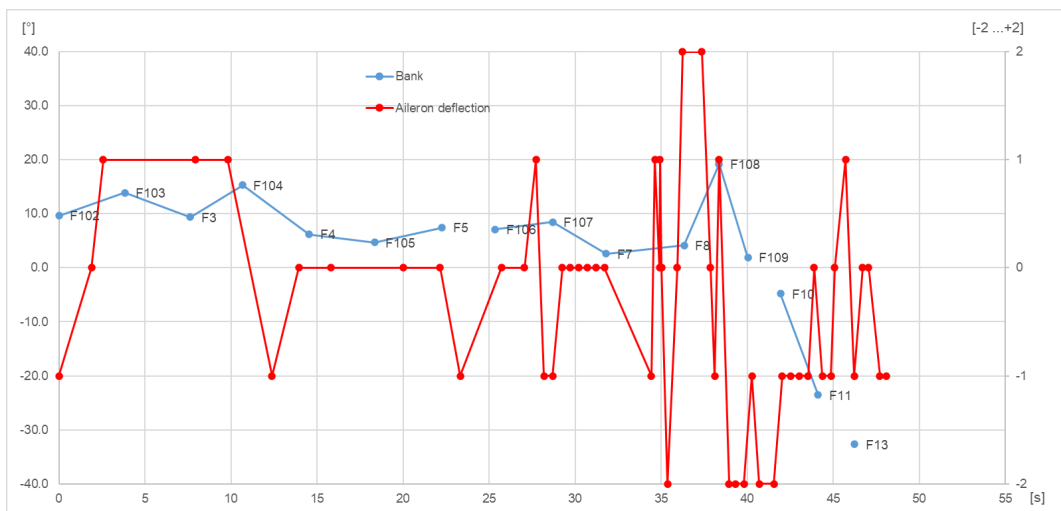
Figure 20: Bank and aileron deflection in relation to the video runtime. Positive values on the y-axis indicate bank to the right and aileron deflections for a right turn respectively. The bank angles were determined photogrammetrically.

The aileron deflections were qualitatively evaluated with values of - 2, - 1, 0, + 1 and + 2 (figure 20, right-hand y-axis) based on a video recorded from inside the aircraft. Positive values indicate an aileron deflection for a clockwise roll as seen in the direction of flight, i.e. for a right turn, whilst negative values indicate an aileron deflection for a left turn and a value of zero means the aileron position was neutral.
