F I N A L R E P O R T

concerning the accident
which occurred on June 26th 1988
at Mulhouse-Habsheim (68)
to the Airbus A 320, registered F-GFKC

November 29th 1989

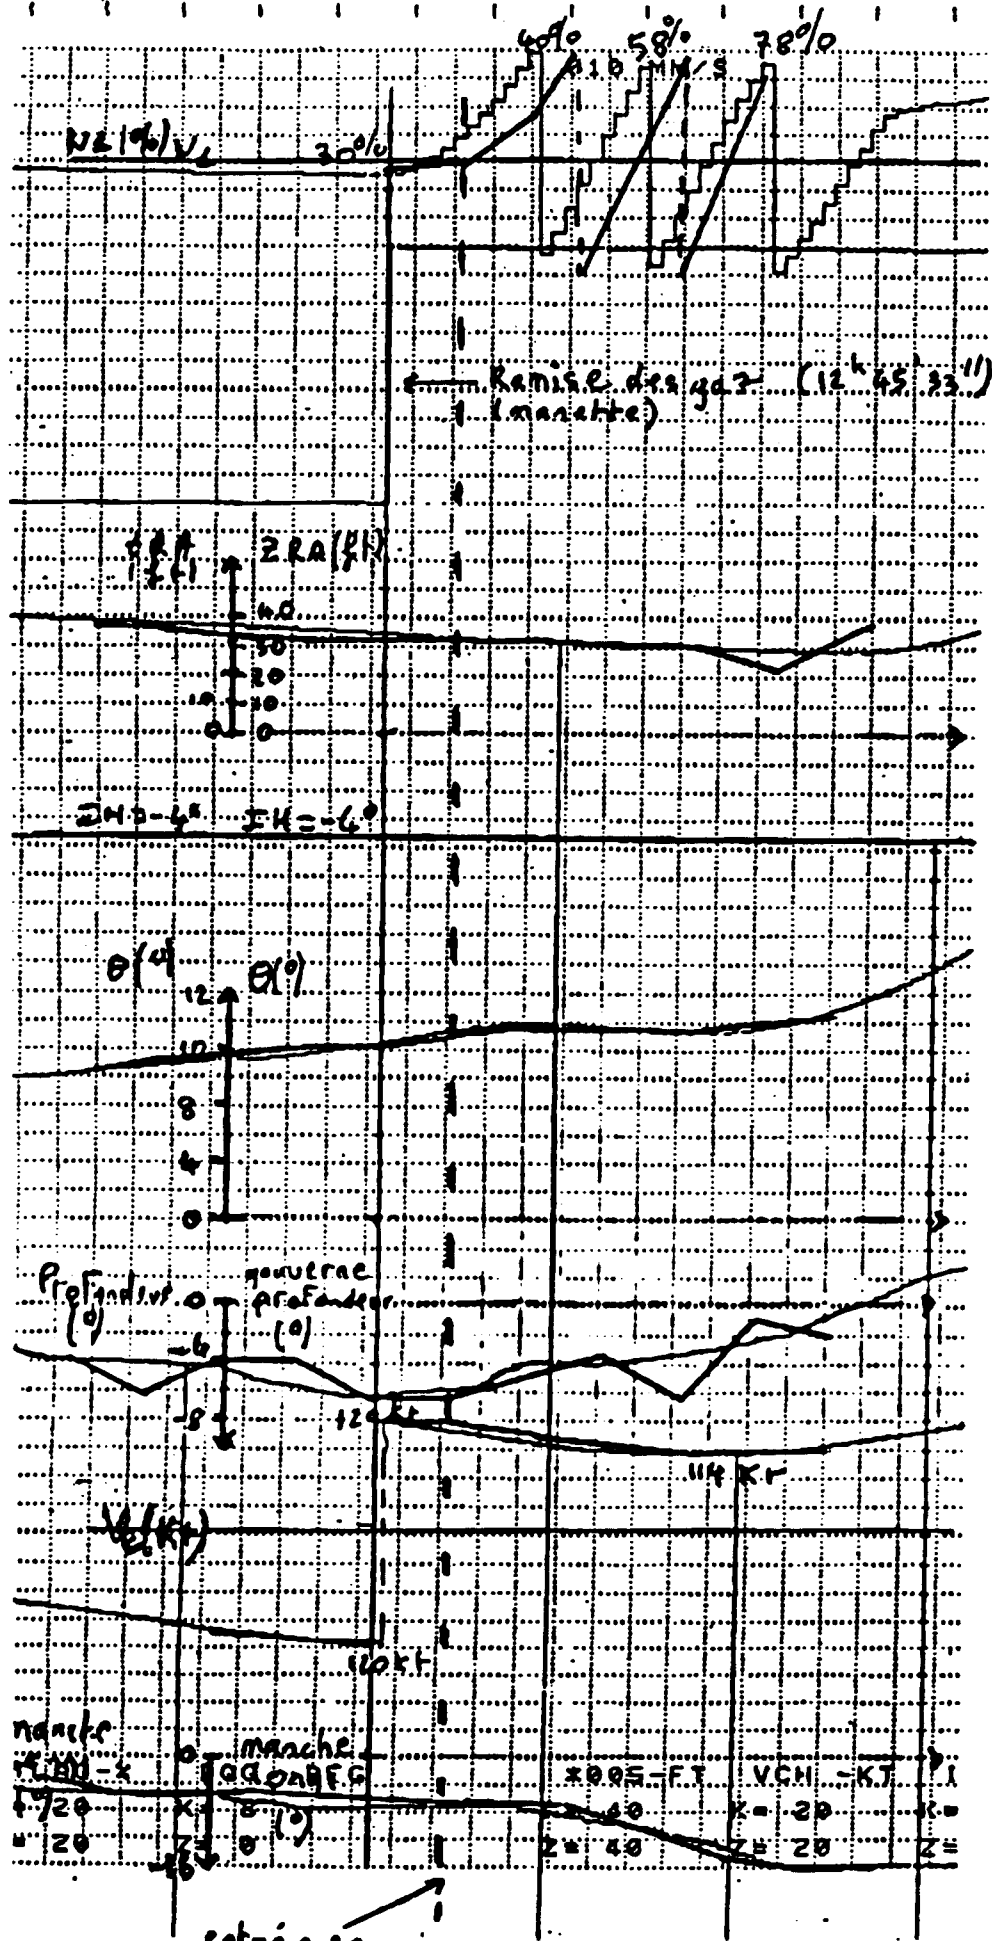
Remise des gaz (12h 45' 33'')

Recapement des dernières secondes de l'accident de l' A320 F-GFKC à Habsheim le 26 juin 1988 (entre t = 12h 45' 31" et t = 12h 45' 39")

Simulateur Aérospatiale S2 le 19/5/89

entrée en protection d'incidence (12h 45' 36'')
