**INCIDENT**

<b>Aircraft Type and Registration:</b>	Boeing 737-500, SP-LKA	
<b>No &amp; Type of Engines:</b>	2 CFM 56-3C1 turbofan engines	
<b>Year of Manufacture:</b>	1992	
<b>Date &amp; Time (UTC):</b>	4 June 2007 at 1007 hrs	
<b>Location:</b>	On departure from London Heathrow Airport	
<b>Type of Flight:</b>	Commercial Air Transport (Passenger)	
<b>Persons on Board:</b>	Crew - 6	Passengers - 89
<b>Injuries:</b>	Crew - None	Passengers - None
<b>Nature of Damage:</b>	None	
<b>Commander's Licence:</b>	Airline Transport Pilot's Licence	
<b>Commander's Age:</b>	55 years	
<b>Commander's Flying Experience:</b>	15,000 hours (of which 9,000 were on type) Last 90 days - 270 hours Last 28 days - 65 hours	
<b>Information Source:</b>	AAIB Field Investigation

**Synopsis**

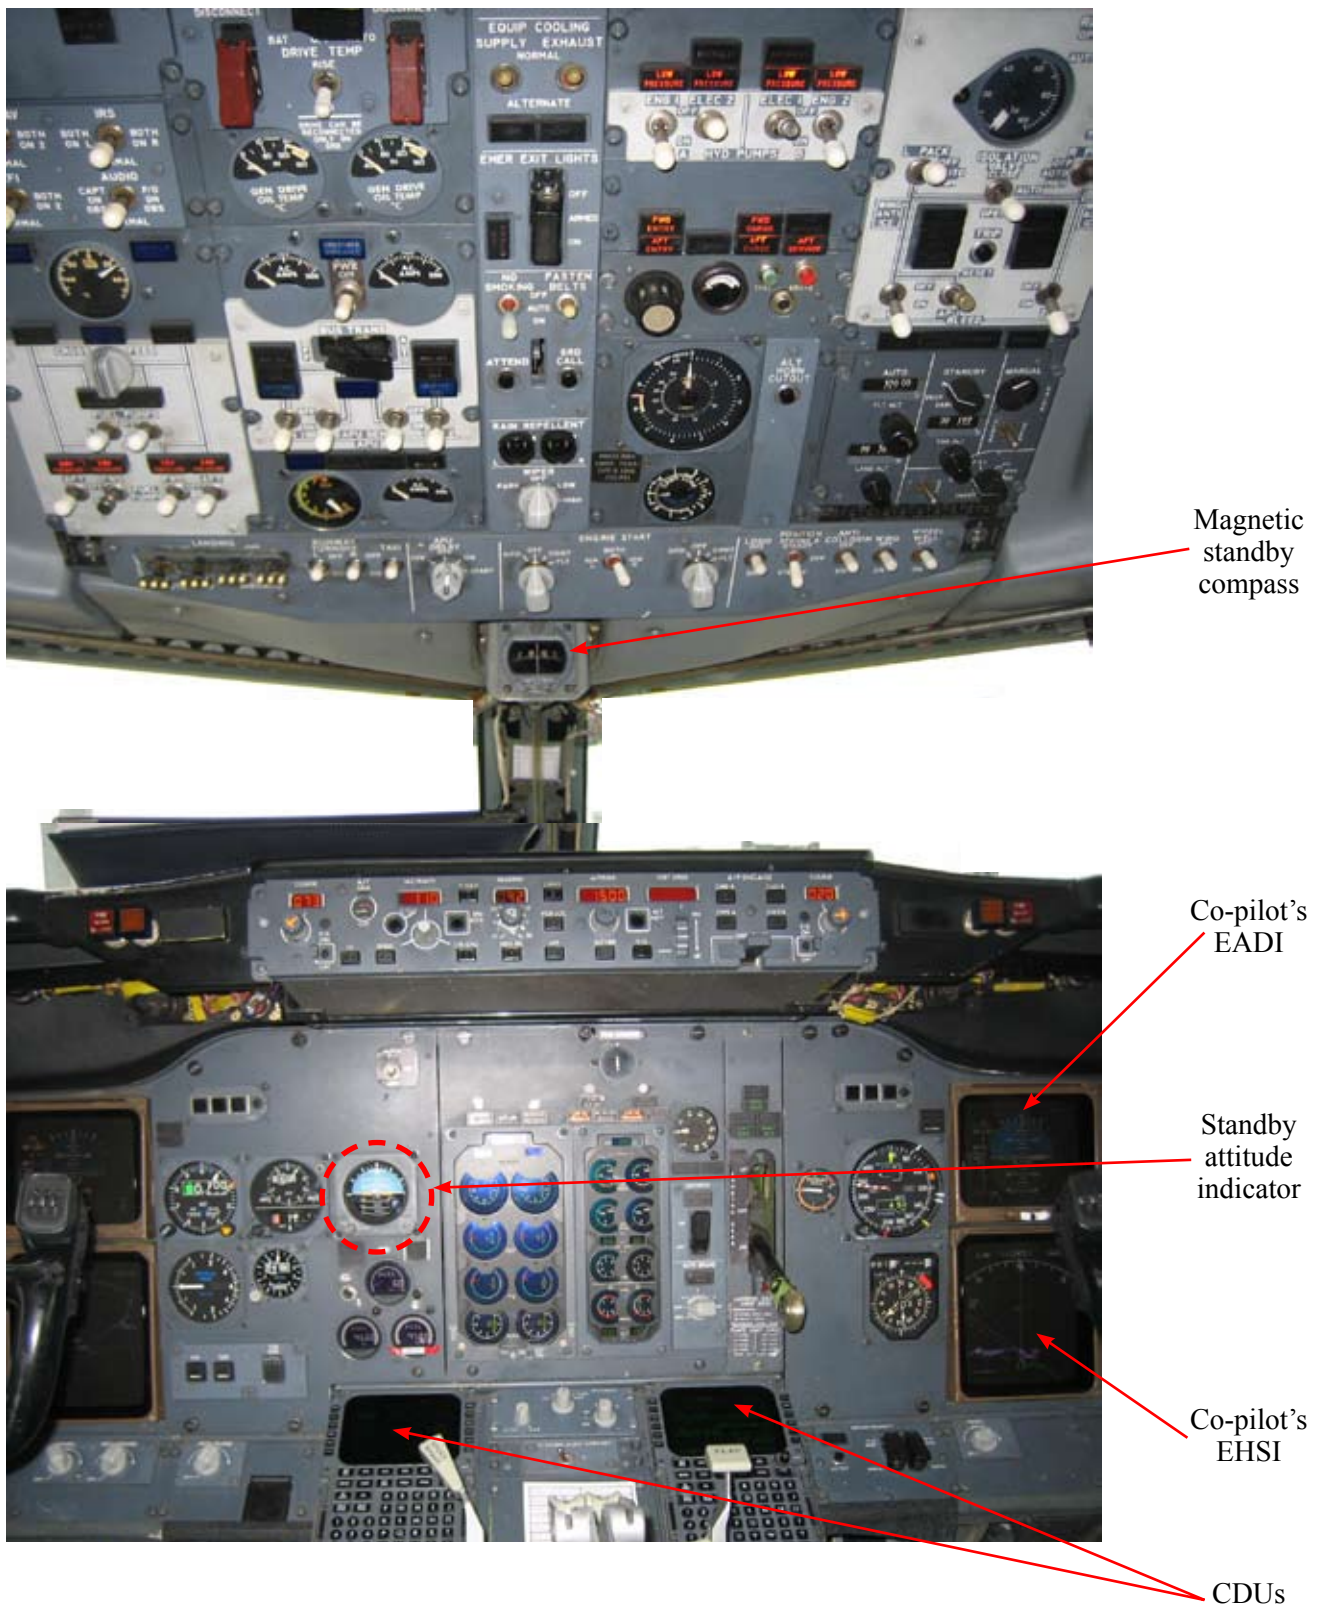
**Figure 1**  
Representation of ‘blank’ EADI

The aircraft was given clearance to line up and was taxied onto the runway. The departure clearance was for a BPK5J Standard Instrument Departure (SID). The co-pilot was the handling pilot. Immediately after takeoff, at 1009 hrs, the pilots noticed that there was almost no information on their EHSIs and EADIs; they described the displays as ‘blank’, Figure 1.

When the IRSs are in ALIGN mode (IRSs data being NCD), the EFIS displays will show very limited information, Figure 1. For approximately two minutes before LOT 282 took off, the pilots' displays were probably in this condition. As the pilots were busy watching for other traffic and lining the aircraft up on the runway, it is possible neither one looked at the displays during this period. As the aircraft accelerated along the runway, it is likely that the commander's attention would have been focussed on his ASI. It was probably only when the aircraft rotated on takeoff that the co-pilot would have looked down or seen that no attitude or navigational information was available.

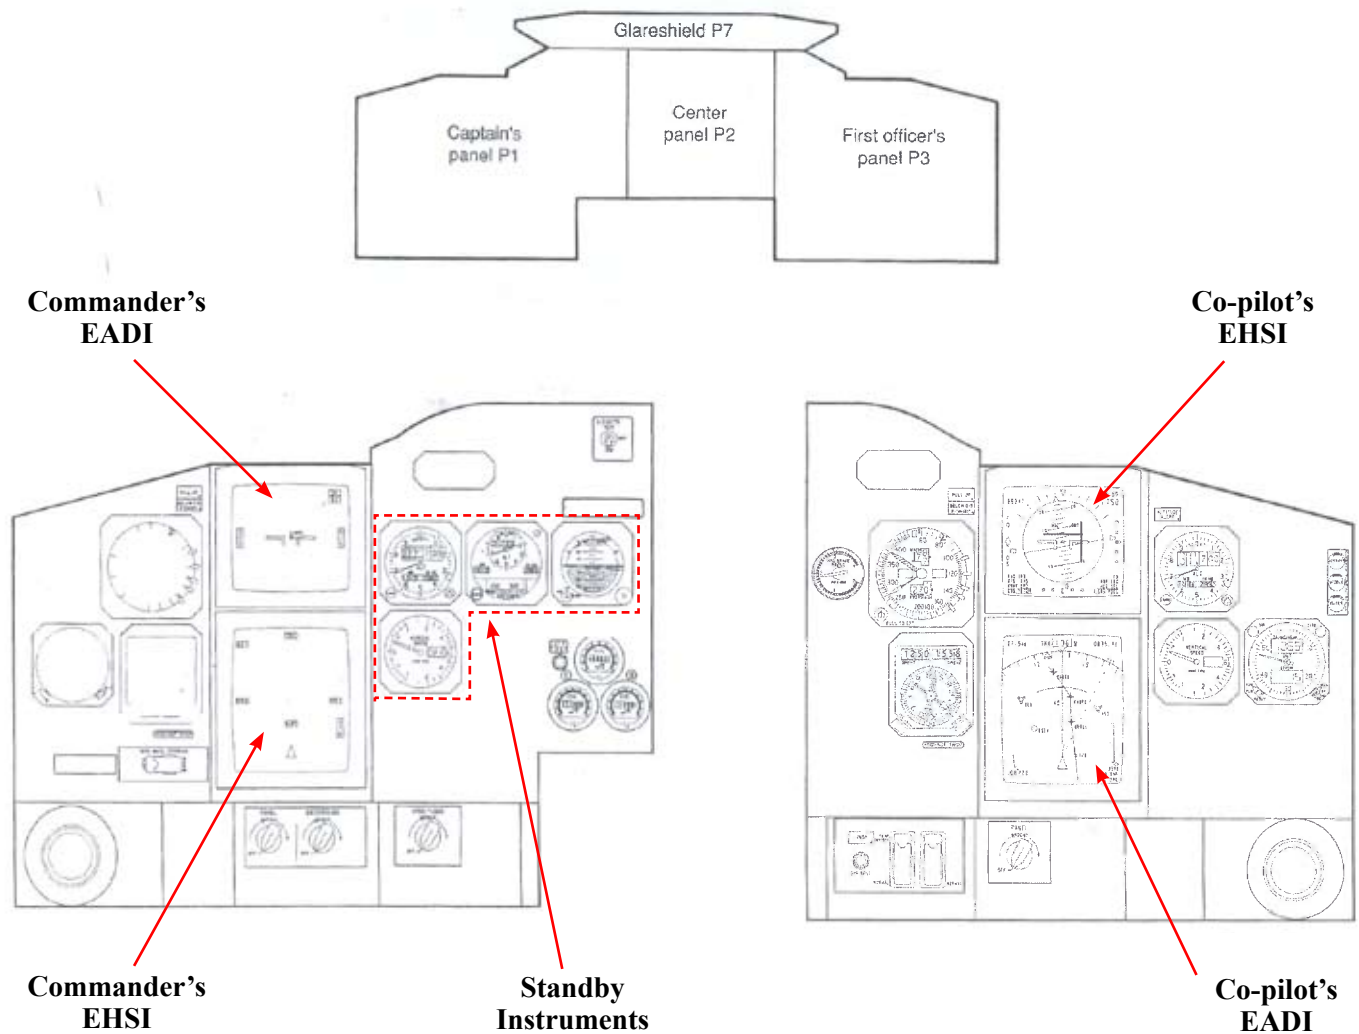
**Figure 2a**  
Flight instruments layout, SP-LKA

The flight deck instrument layout, including the location of the standby instruments, is shown in Figures 2a and 2b.

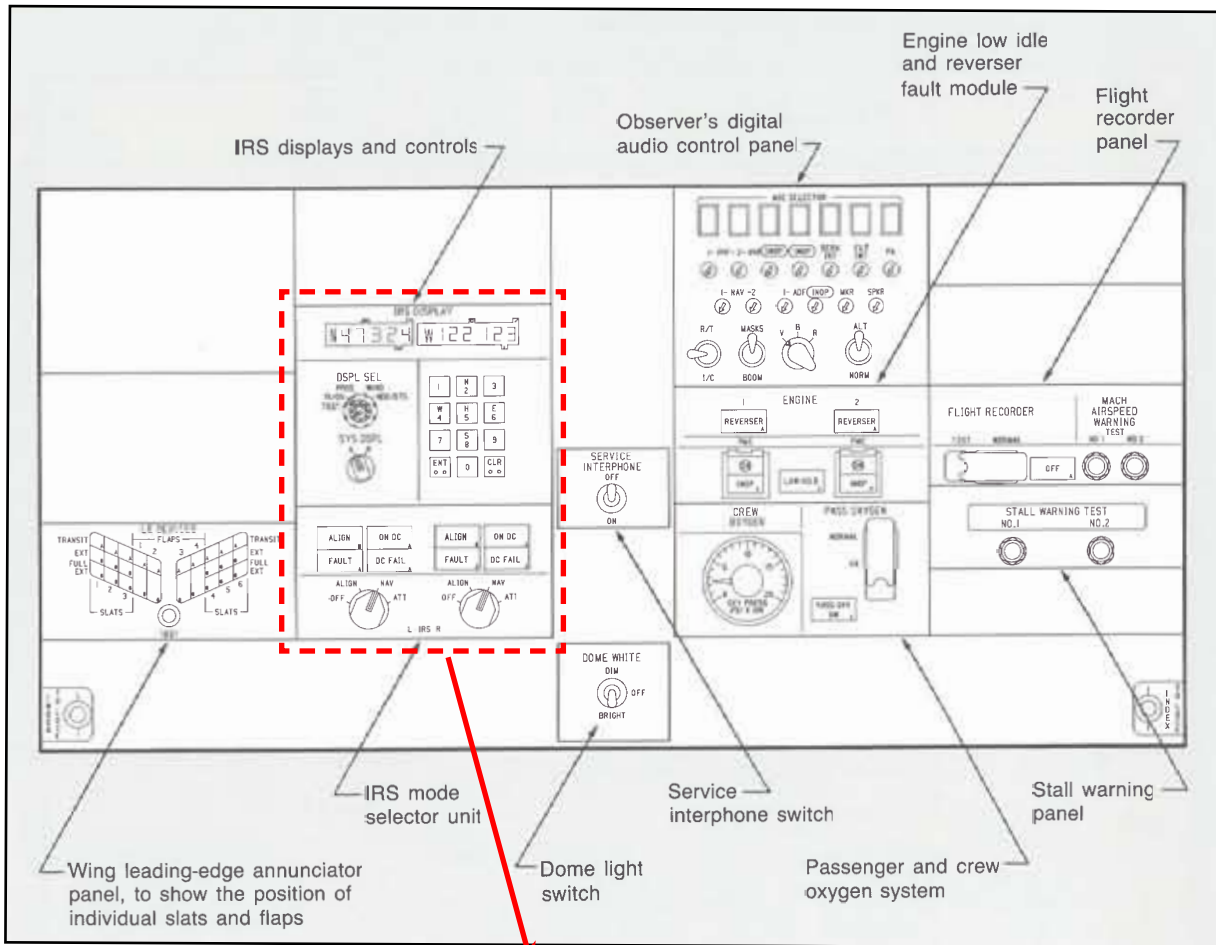
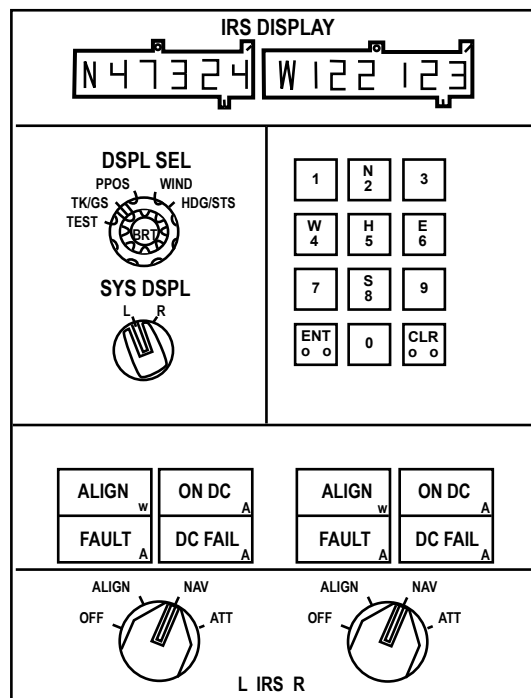
Figure 4

Two independent IRSs are installed and one FMC. IRSs are controlled through a Mode Select Unit (MSU), with system information being displayed on an IRS Display Unit (ISDU) located on the aft overhead panel, Figure 4.

Location of the IRSDU on the aft overhead panel

The commander reported that the IRSDU was not illuminated and appeared not to be powered. There would not usually be any lights showing on this panel during flight, unless a failure light is triggered. However, there is also a display on the IRSDU which shows the aircraft's position in digital form, and this may be selected to a number of different information sources. With the IRSs in ALIGN mode for an extended period, it would be expected that the ALIGN lights would flash.
