National Transportation Safety Board

Human Factors in the Accident Involving Gulfstream Aerospace Corporation G-IV, N121JM Bedford, Massachusetts May 31, 2014

William Bramble, Ph.D.
NTSB Office of Aviation Safety

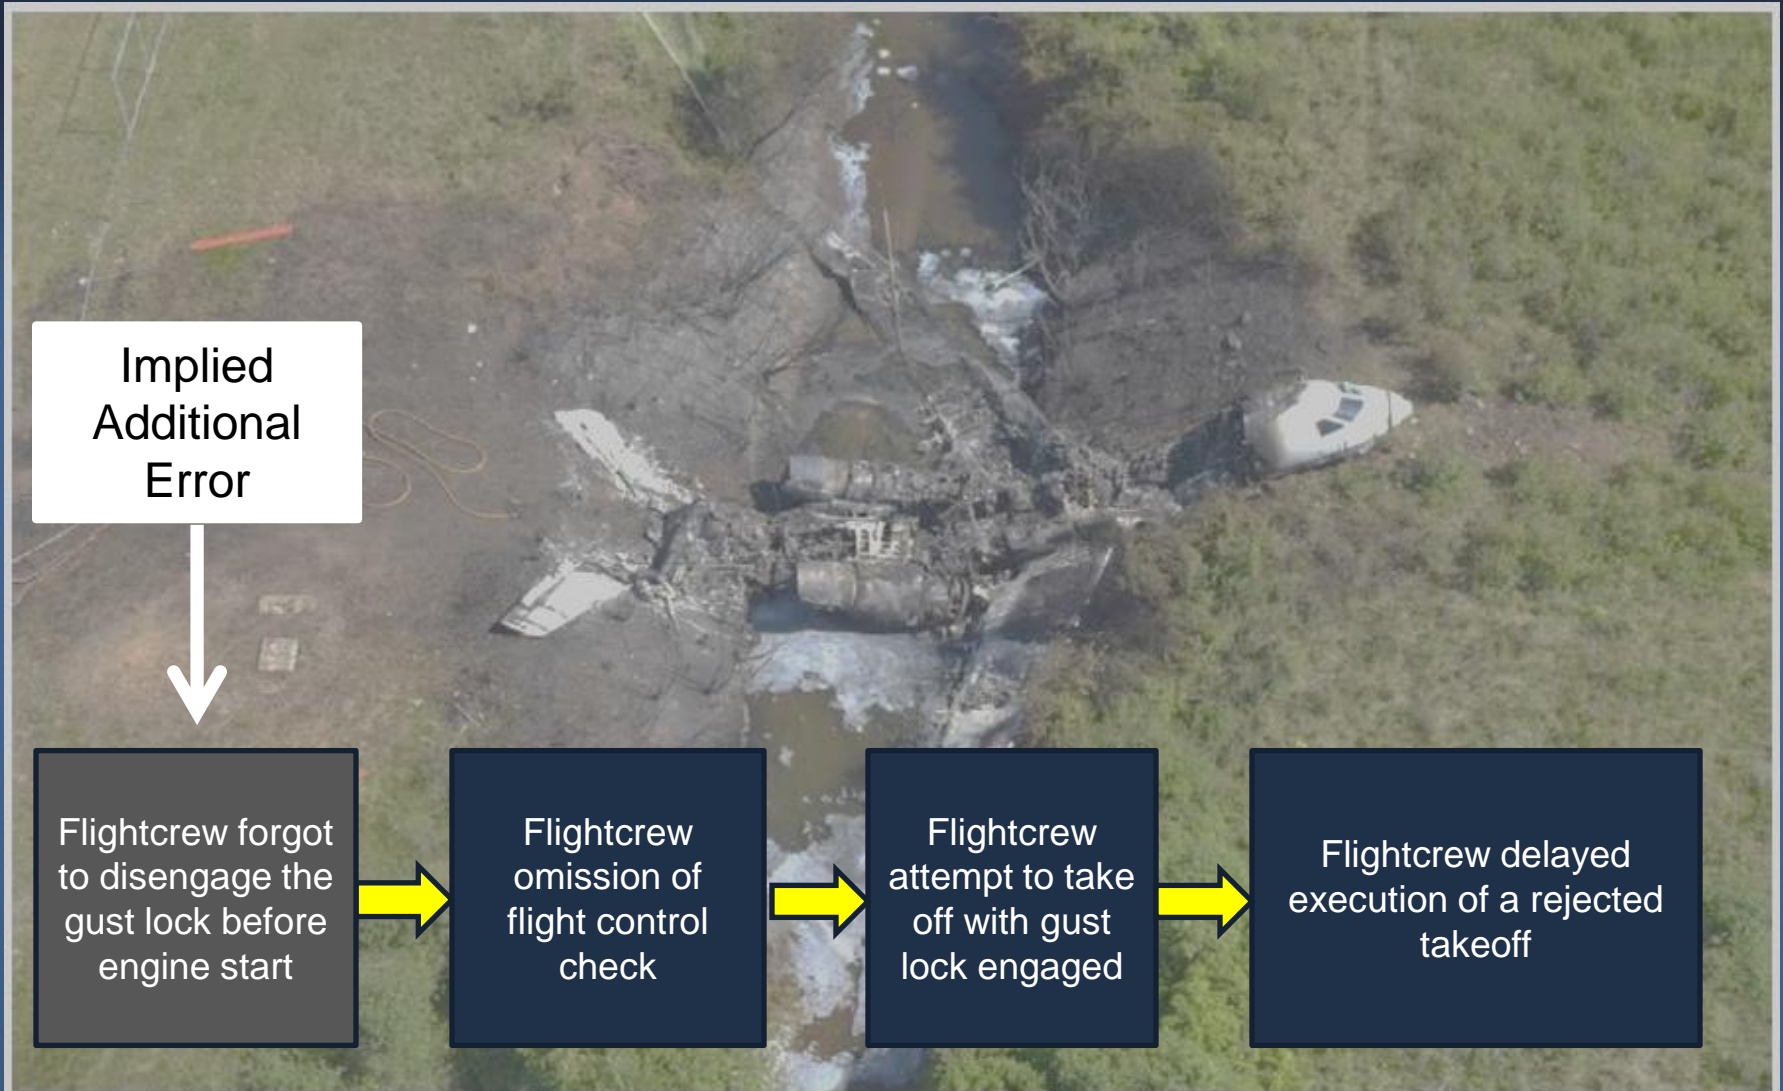
Flightcrew Errors

Source: Massachusetts State Police.

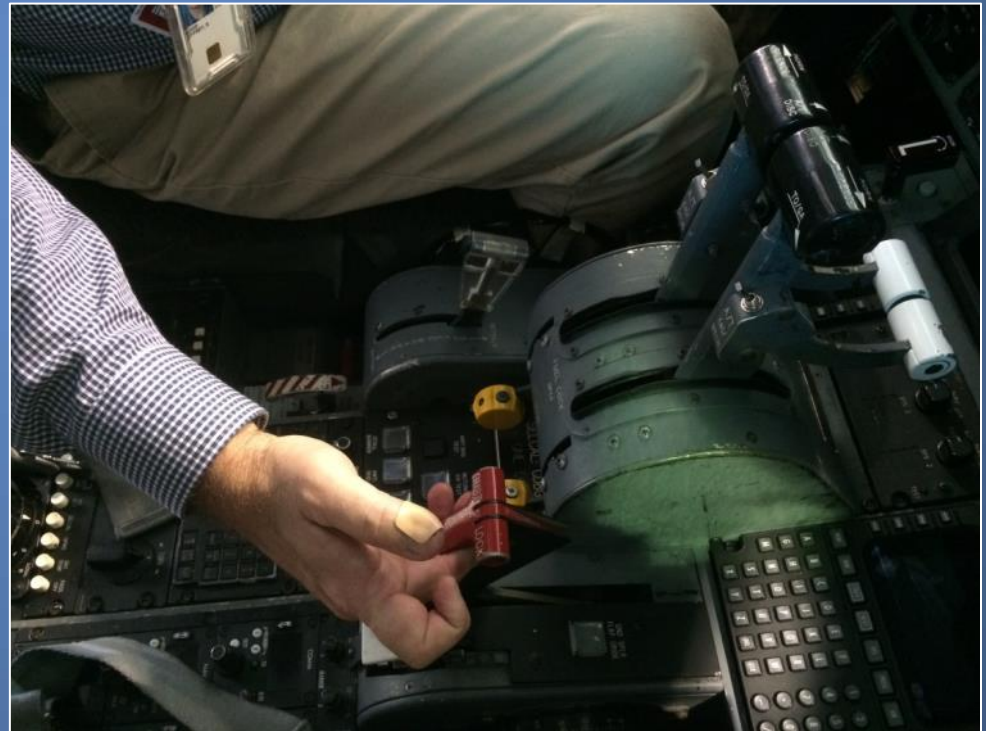
Starting Engines Checklist

GUST LOCK.....OFF

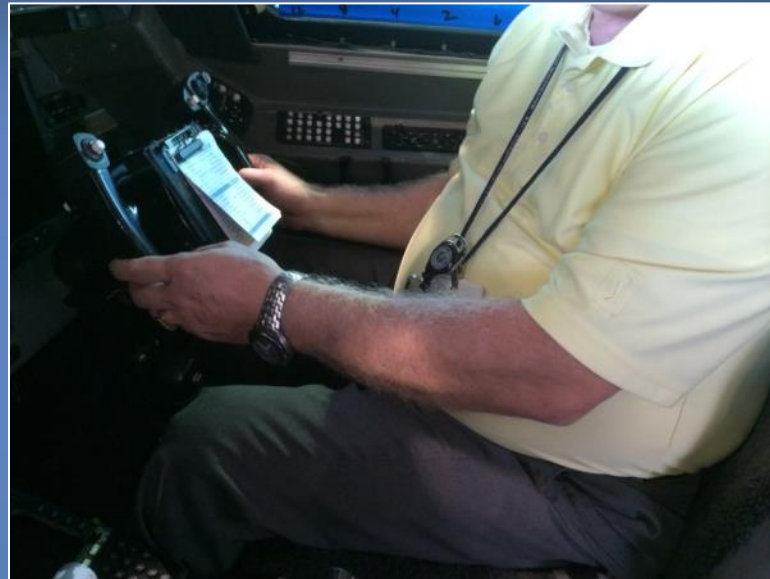
After Starting Engines Checklist

Flight Controls.....CHECK

Procedural Noncompliance

- 90% of previous 175 takeoffs lacked a preflight check of any control surface
- 98% lacked a full control check
- Procedural drift
- Normalization of deviance

- Amend audit standards to include verifying that operators require pilots to follow best practices for use of checklists

- Work with business aviation flight operational quality assurance groups to assess the rate of noncompliance with required flight control checks

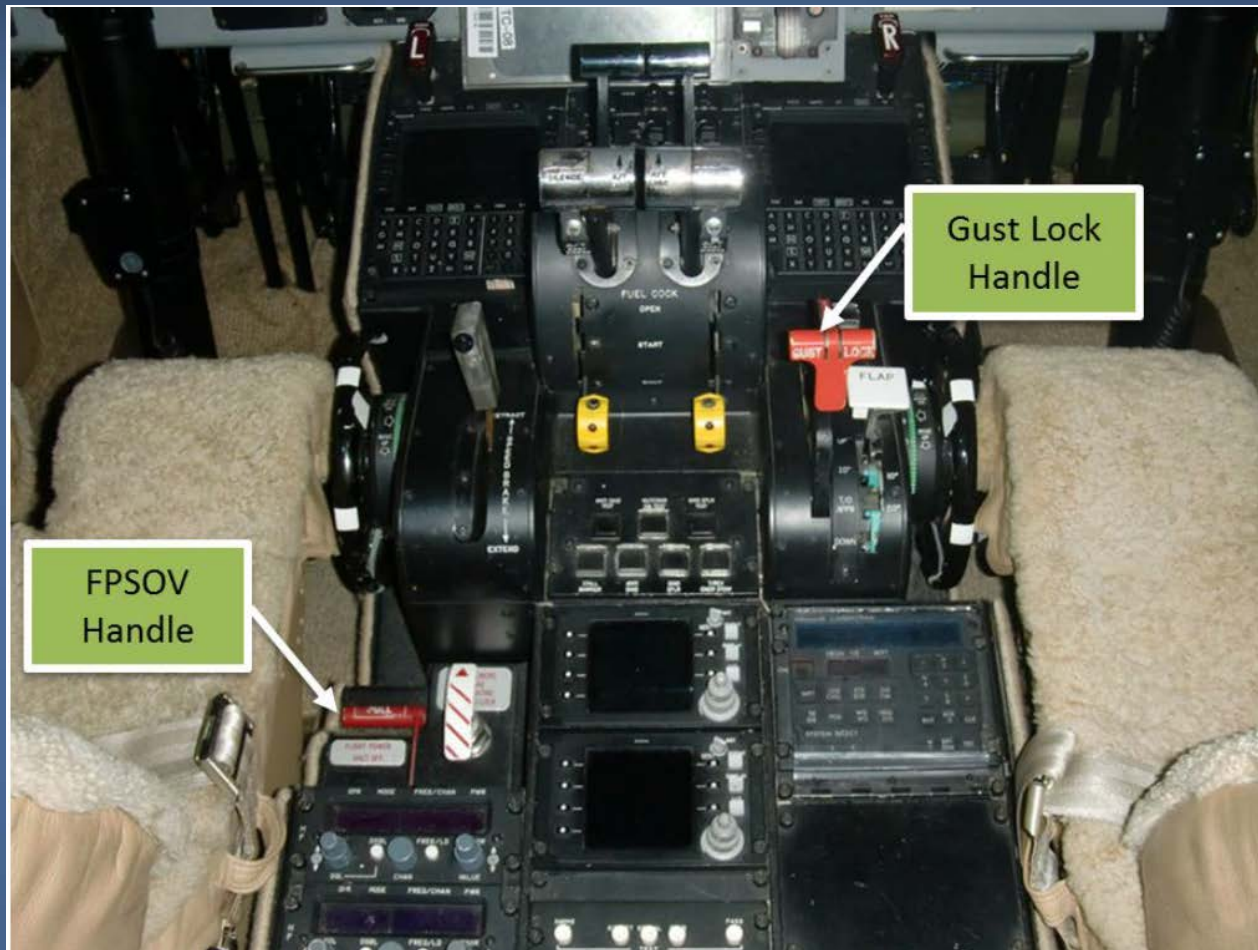
Delay in Rejected Takeoff

- 2139:59 PIC (steer) lock is on.
- 2140:02 PIC (steer) lock is on.
- 2140:03 PIC (steer) lock is on.
- 2140:04 PIC (steer) lock is on.
- 2140:06 PIC (steer) lock is on.
- 2140:07 PIC (steer) lock is on.

Engine Pressure Ratio

AUTOTHROTTLE

FPSOV PULLED

BRAKES ON

REVERSERS
