Celebrating TAWS ‘Saves’: But lessons still to be learnt.

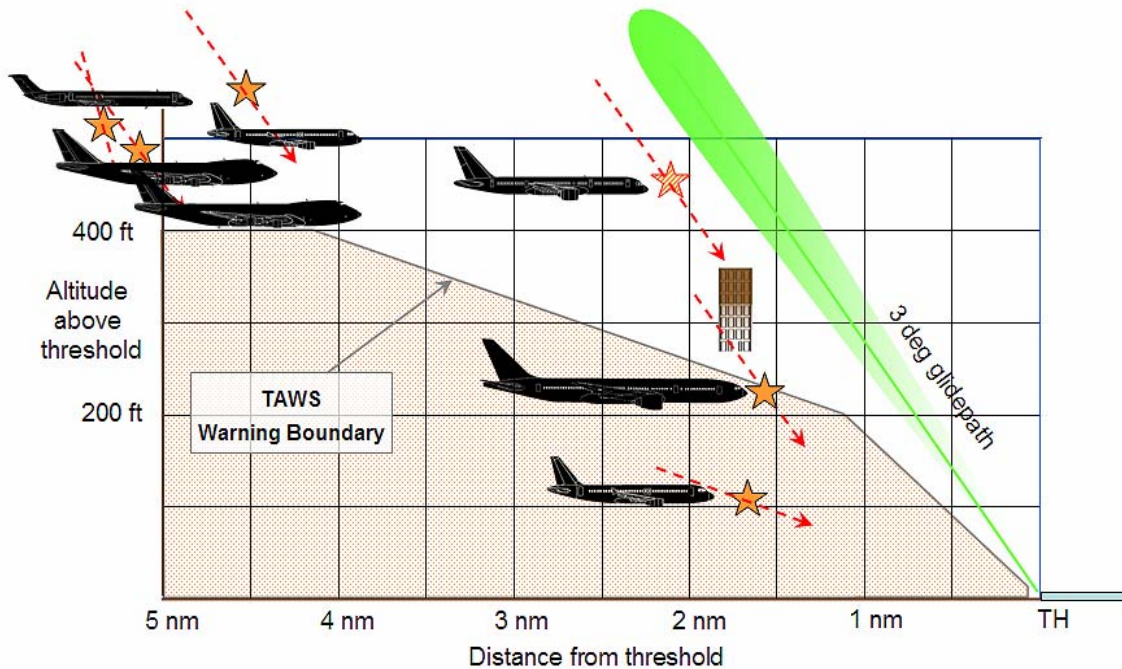
Figure 2. Warnings (saves) below 500 ft

The premature descents fell into two broad groups, those beyond 5nm from the runway threshold with warnings given above 500ft above ground level (a.g.l.) and those within 5nm of the threshold with warnings occurring below 500ft a.g.l. The latter group of incidents are the focus of this report. The relationship between altitude and distance to the runway for several incidents is shown in Figure 2.

The TAWS warning boundary shown approximates to the EGPWS 'Terrain Clearance Floor' over flat terrain. In reality the boundary is proportional to the terrain for all heights above the runway, thus the warning anticipates high ground on the approach. Alternatively if the aircraft were to be in a valley below a hill-top runway a false terrain datum is provided to generate timely warnings. The altitude at which the warnings were given (figure 2), indicate the actual terrain warning boundary at the incident airport. The incidents are plotted relative to the threshold to enable comparison and analysis. All of the aircraft received warnings in a correct and timely manner.
