Islamic Republic Of Iran
Civil Aviation Organization
Aircraft Accident Investigation Board

Final Report

Aircraft Model: Bombardier CL604 Challenger

Registration: TC-TRB

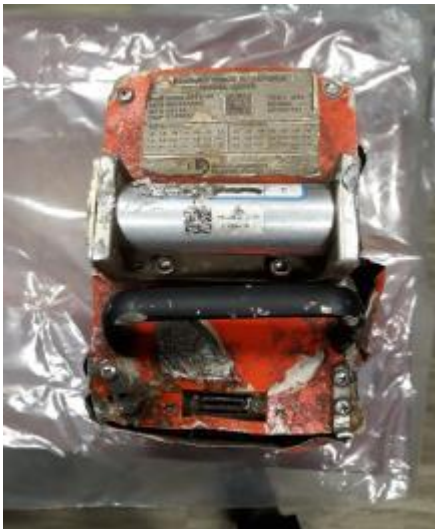
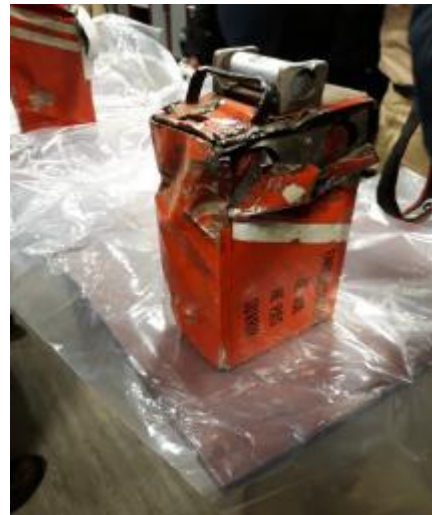
The CVR opening operations took place in BEA facilities. A visual Assessment of the CVR was performed. The recorder was damaged. The ULB was still attached to the chassis.

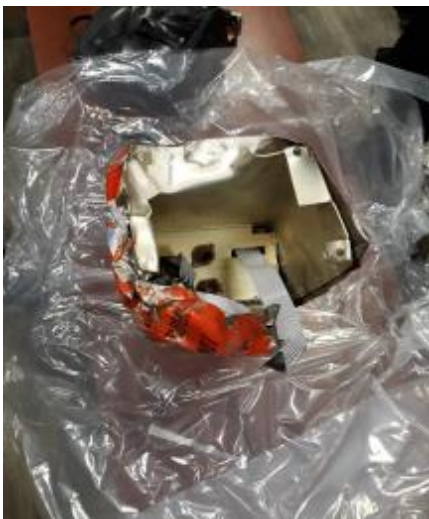
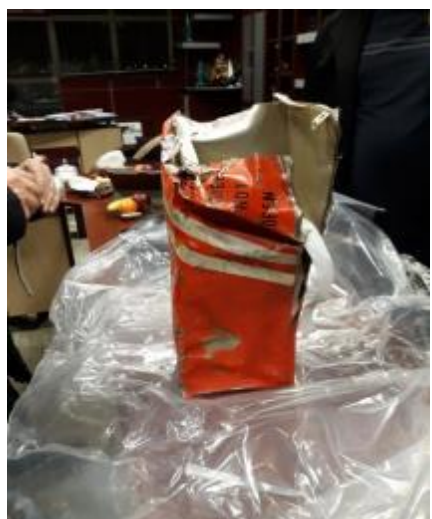
The FDR FCSSU was visually checked. The connector of the memory board was damaged.

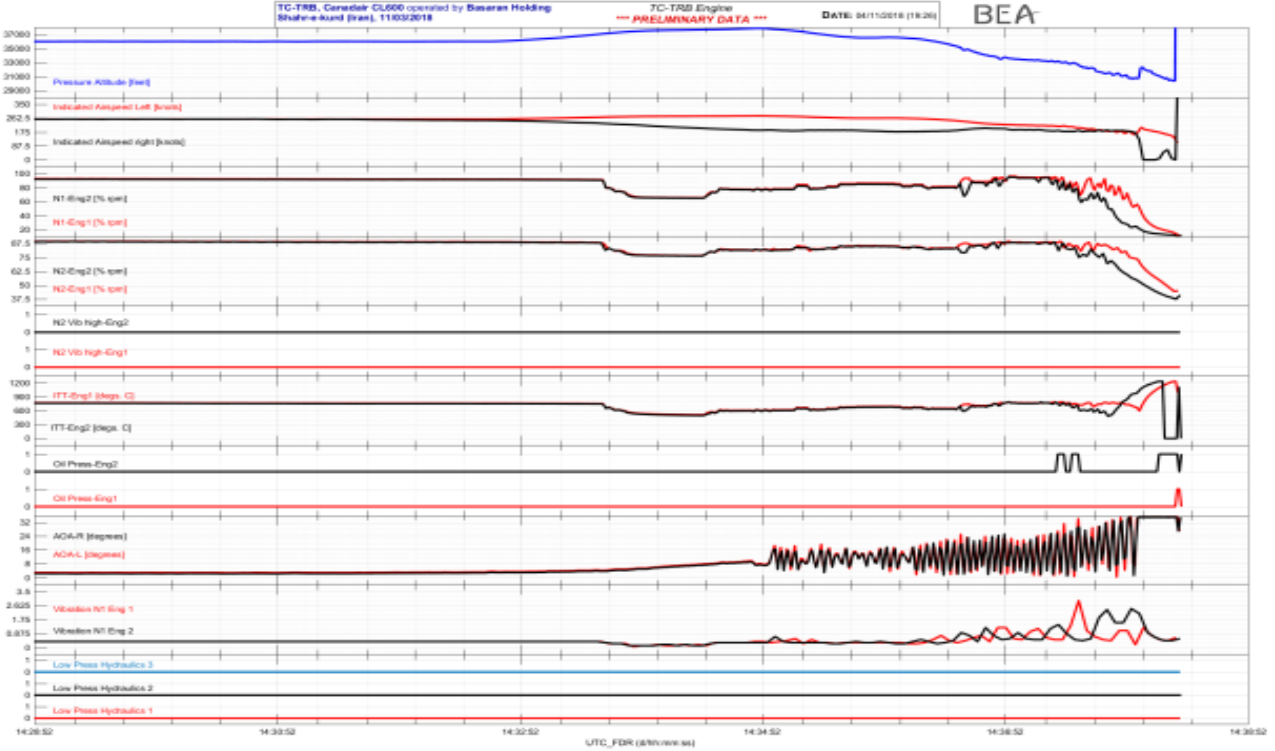
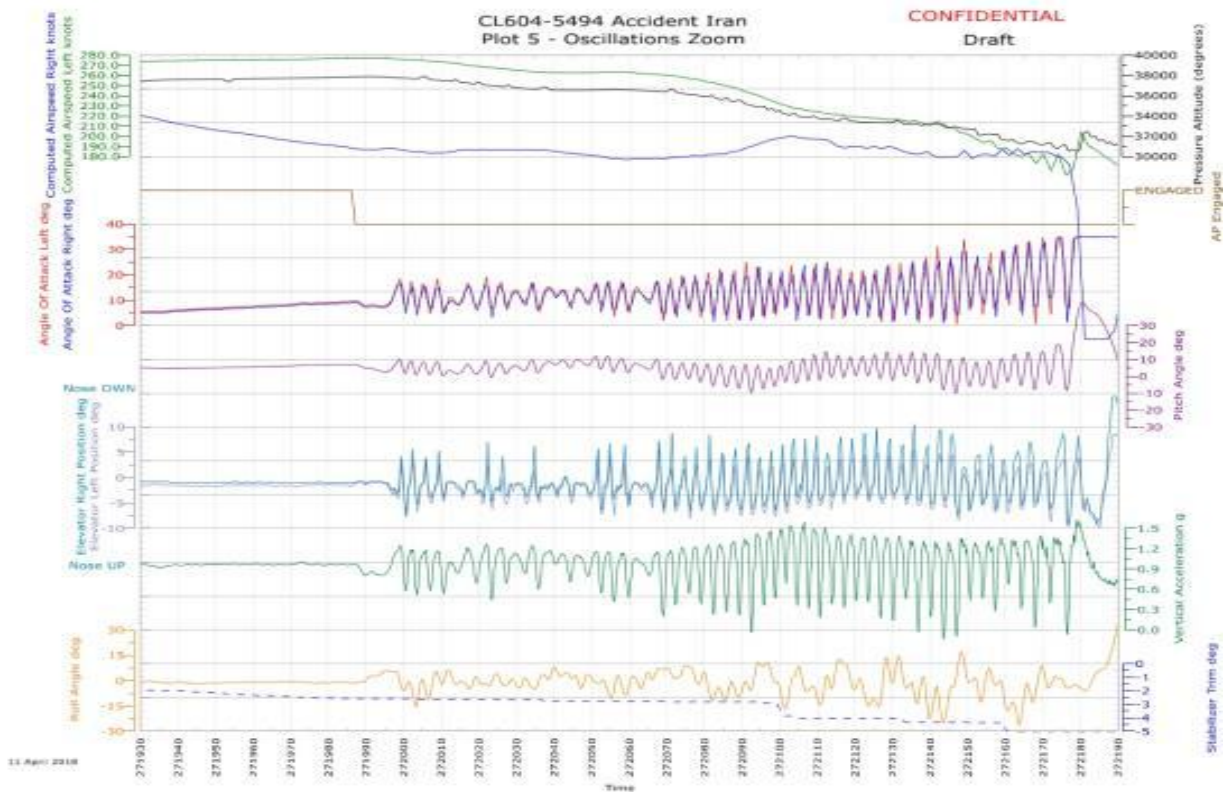
While aircraft was descending through FL370, the engine power and actual aircraft speed had reduced to stall speed but overspeed clacker was activated due to failure on indication system. The pilot never followed stall recovery procedures because she had a mind of overspeed by clacker warning [MMO over speed] on the cockpit. The stick pusher acted to pitch down aircraft to prevent stall condition but the captain's reaction on the control column just was in the opposite direction. During this time, the aircraft entered a series of pitch and roll oscillations.

The autopilot was disengaged by the crew before stall warning, which ended in oscillation of control surfaces based on FDR information. Engine power began to decrease on both sides until both engines flamed out in stall condition and FDR data recording was lost at this point. Data from the FDR shows that the aircraft experienced close to about 50 rapid pitch cycles following the activation of the stall protection systems, the result of the crew actively fighting against the pusher system.
