Aircraft Accident Investigation Board

Preliminary Report

Aircraft Model: Bombardier CL604 Challenger

Registration: TC-TRB

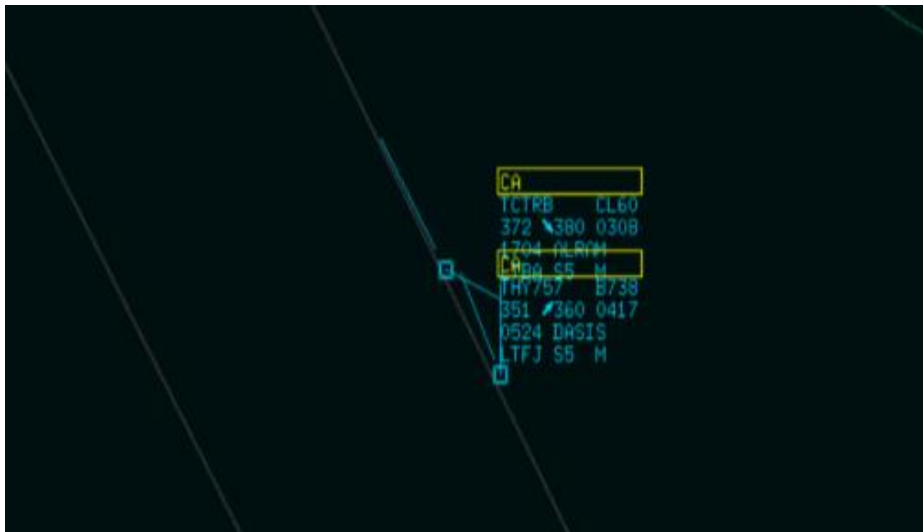
At 14:34:37 UTC, while reaching to FL 379, the pilot declared descending to FL 370 due to malfunction and started its descend to the wrong flight level without waiting for ATC approval. It was just after descending that the controller approved FL 370. Based on the information displayed on radar screen, the aircraft's speed was reduced from 390 kt at FL 360 to 316 kt at FL 379.

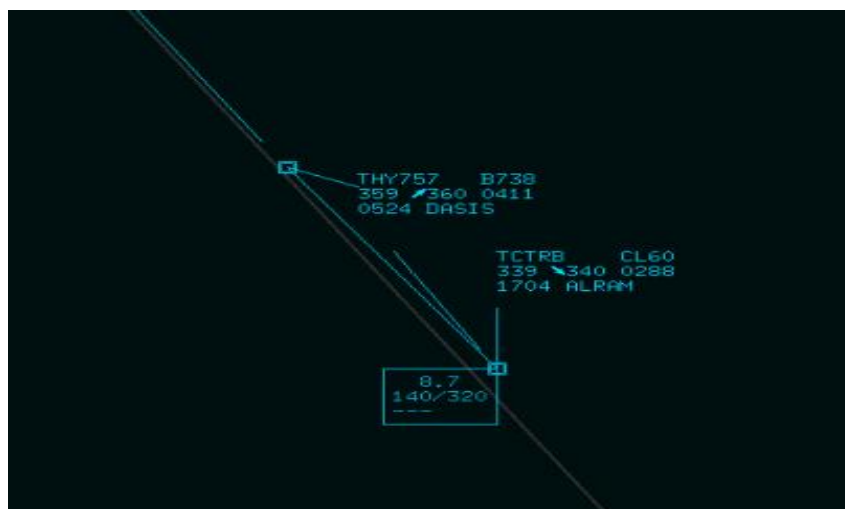
At 14:35:36, while aircraft's speed displayed on the radar further reduced to 288 kt, the pilot declared that they are continuing descend to FL340.

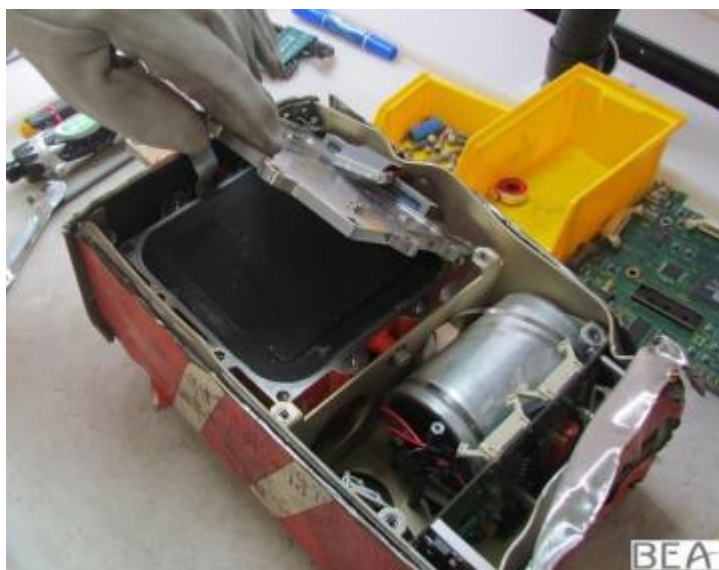
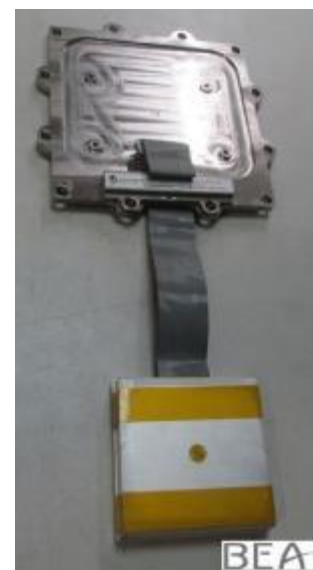
The FCSSU was opened and the metallic casing was extracted from the recorder.

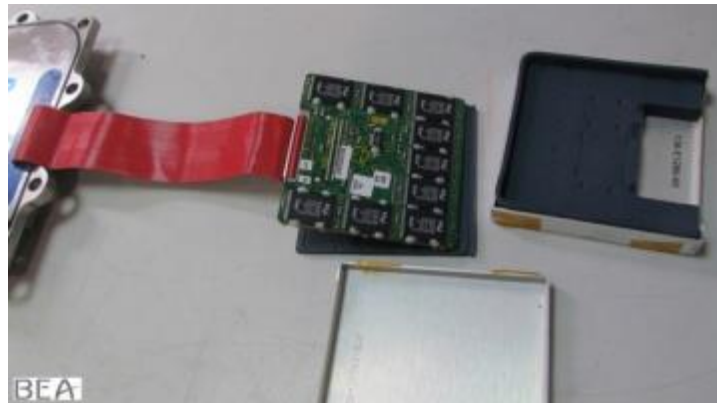
The memory board was extracted from its metallic casing.

After visual inspection of the board and electrical checks, the memory board was connected to the BEA AIK modified chassis (P/N S200-0012-00 modified with AIK 147E1609-00).

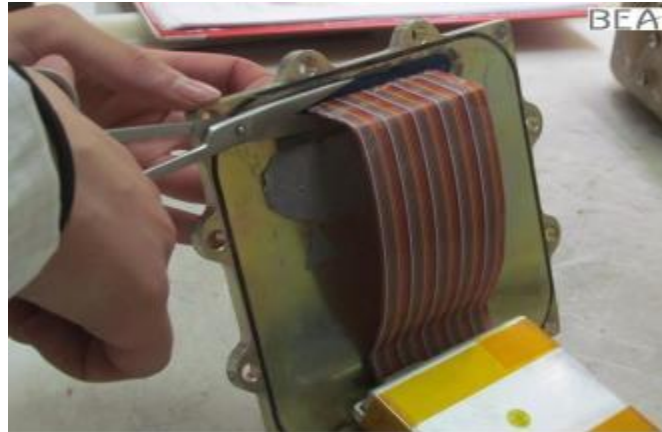
The FCSSU was opened, the metallic casing of the memory board was extracted and the ribbon cable was cut close to the cover of the FCSSU.

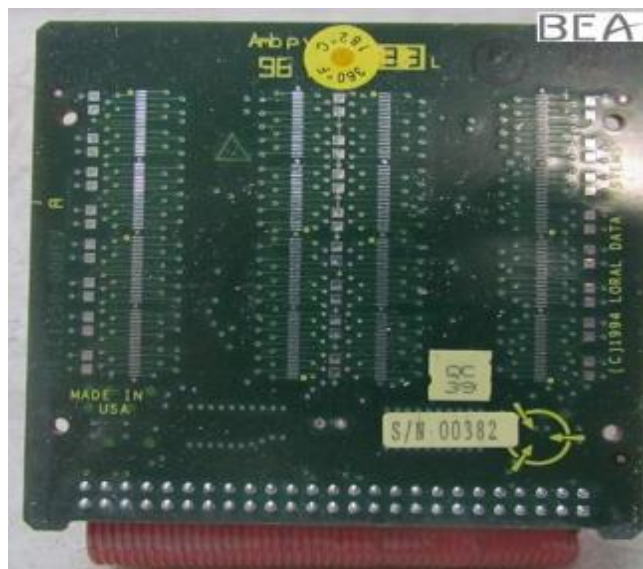
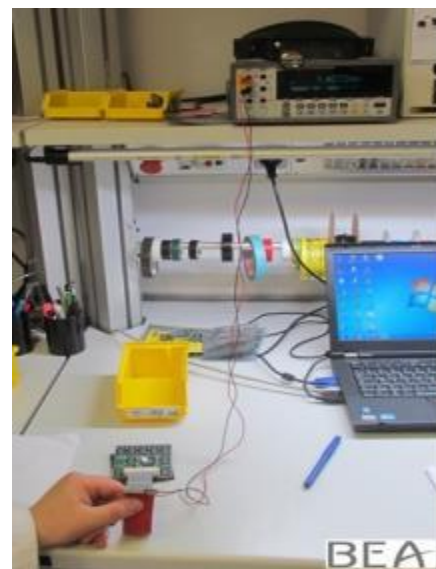
The metallic casing was removed, the memory board was visually inspected, a new 50 pins connector was installed on the ribbon cable and electrical checks were performed on the new connector.

The values of electrical checks were coherent with the BEA database values. It was then decided to connect the memory board to the BEA F1000 modified AIK chassis (P/N S800-3000-00).

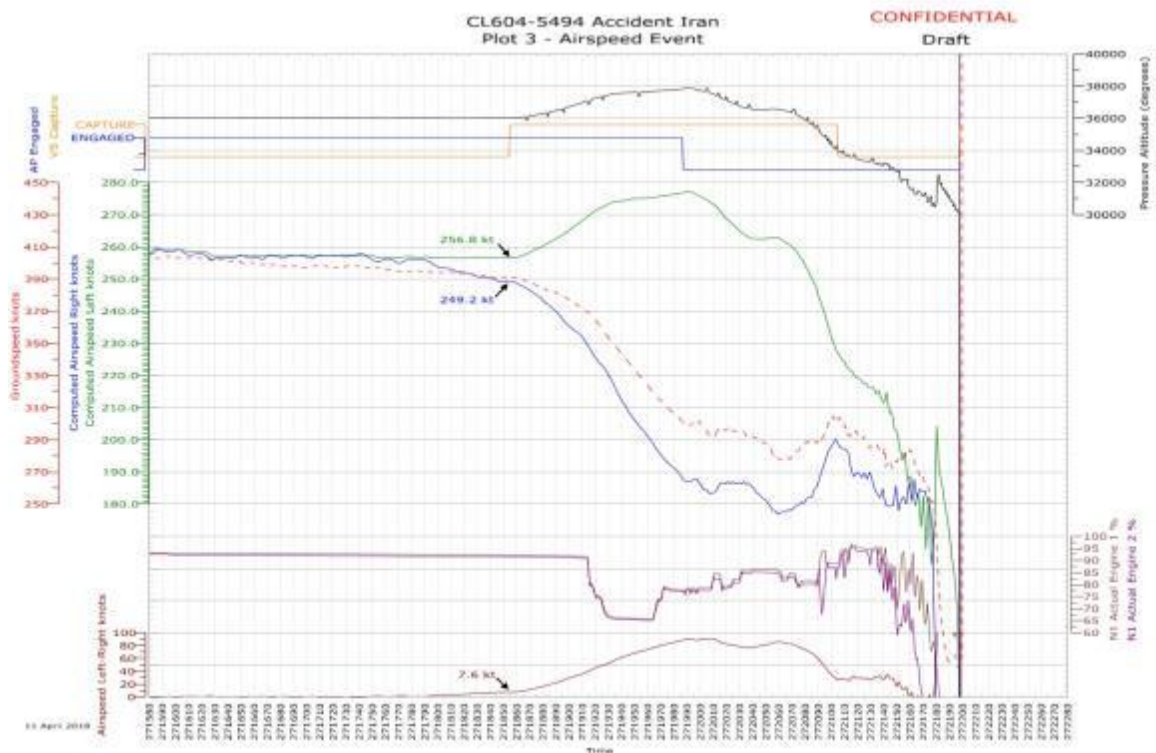
At 14:32:00 on FL360 the speeds of both side indicators began to diverge about more than 5 kt.

At 14:32:17 UTC, crew requested changing level from FL360 to FL380. The pilot selected vertical speed mode to climb and during climb acknowledged difference (10 kt) by related warning in IAS indicators.

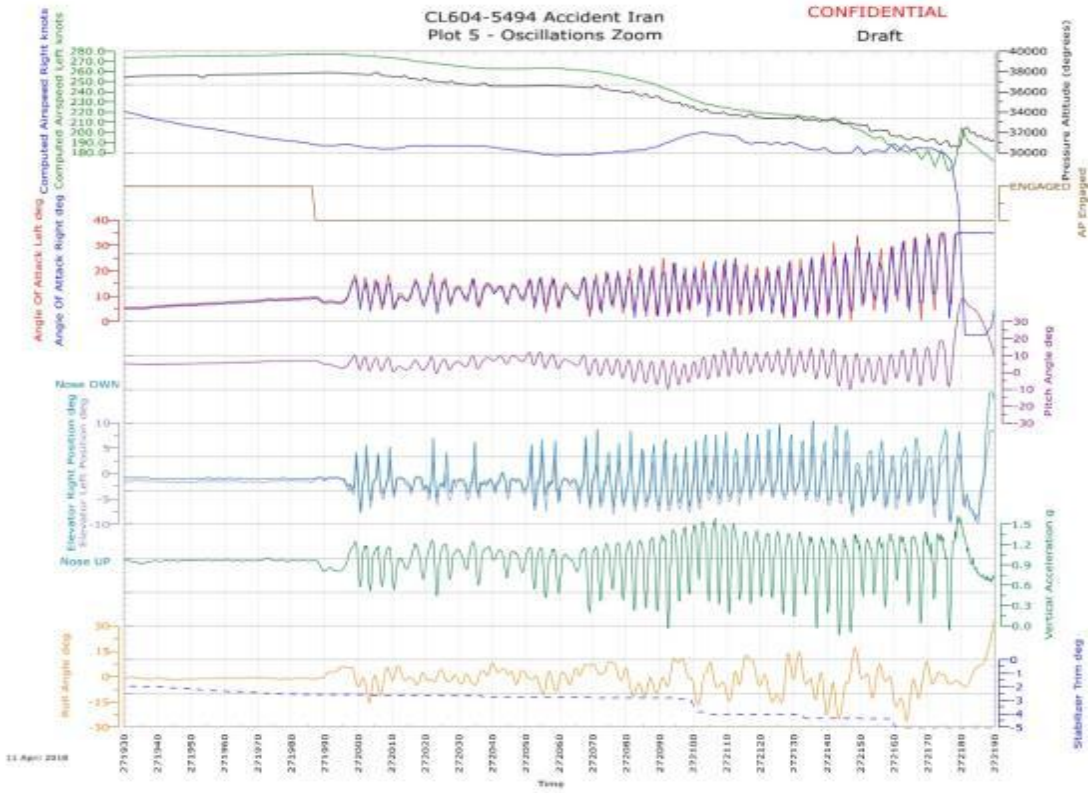
While aircraft descending through FL370, the engine power and actual aircraft speed had reduced to stall speed but over speed clacker activated due to failure on indication system. The pilot never followed stall recovery procedures because she had a mind of over speed by clacker warning [MMO over speed] on the cockpit. The stick pusher acted to pitch down aircraft to prevent stall condition but pilot reaction on the control column was in opposite action. During this time, the aircraft entered a series of pitch and roll oscillations.

The autopilot was disengaged by crew before stall warning, which ended to oscillation of control surfaces Based on FDR information. Engine power began to decrease on both sides until both engines flamed out in stall condition and FDR data was lost at this point due to powering off aircraft electric bus which did not continue to receive power from engine generators. CVR recording continued for a further approximately 1 minute and 20 seconds on emergency Electric Bus by using electric power of aircraft battery. Stall warnings, stick shaker and stick pusher activations continued until the end of the recording.
