**McDonnell-Douglas DC-8-61, C-GMXQ, accident at
King Abdulaziz International Airport, Jeddah, Saudi Arabia, on 11 July 1991.
Report released by the Presidency of Civil Aviation, Kingdom of Saudi Arabia.**

SYNOPSIS

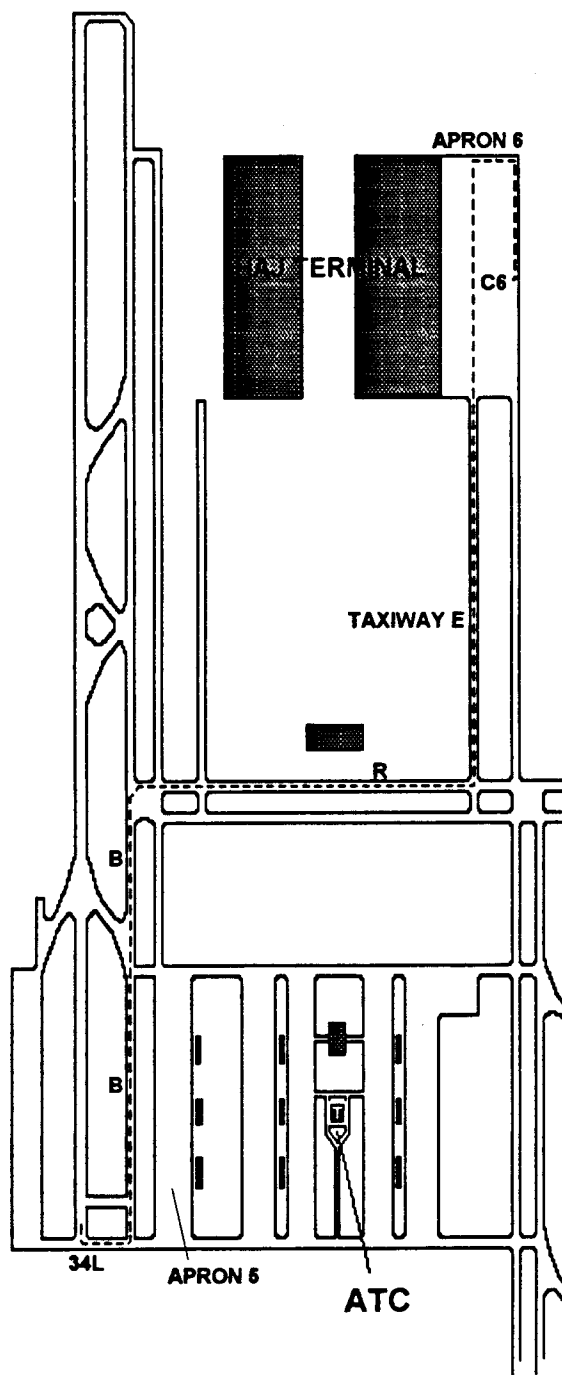
160 metres from the threshold, #1 tyre began to deposit “patchy” rubber marks on the runway. By 185 metres (from the threshold) #1 tyre was depositing dense, broad patchy rubber marks. At a distance of 290 metres from the threshold, #1 tyre had ceased depositing tread marks and the #1 wheel rim began to contact the runway surface. At the same time, #2 tyre began to deposit dense broad patchy rubber marks on the runway. To allow for the turning radius of the aircraft while lining up on the centre line, the measured distances along the runway should be reduced by 30 to 60 metres to tie in with the aircraft take-off roll.

To allow for the turning radius of the aircraft while lining up on the centre line, the measured distances along the runway should be reduced by 30 to 60 metres to tie in with the aircraft take-off roll.

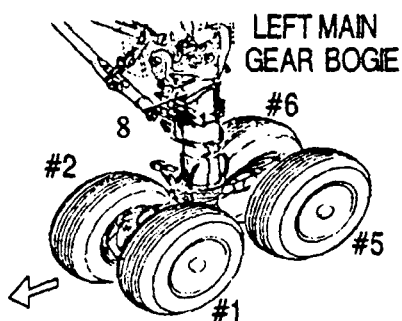
Marks on the runway showed that the #1 wheel started to break up at about this time. In addition, the left and right flanges of #2 wheel began to trace on the runway; rubber deposit from #2 tyre continued which appeared to be from a deflated tyre between the flanges.

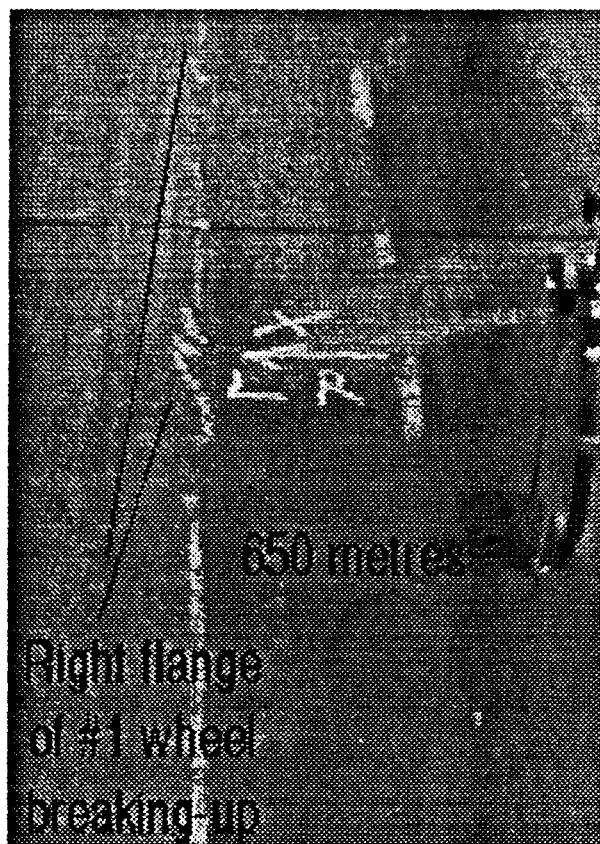
By now, marks on the runway showed continuous metal to surface contact of the left flange of wheel #1, both flanges of wheel #2 and tyre beads of tyre #2. Rubber deposits ceased.

Marks on the runway showed continuous contact by the right side of the base of the tyre-well of #1 wheel; #2 wheel had stopped rotating and both flanges and the tyre beads of #2 wheel were being ground away.

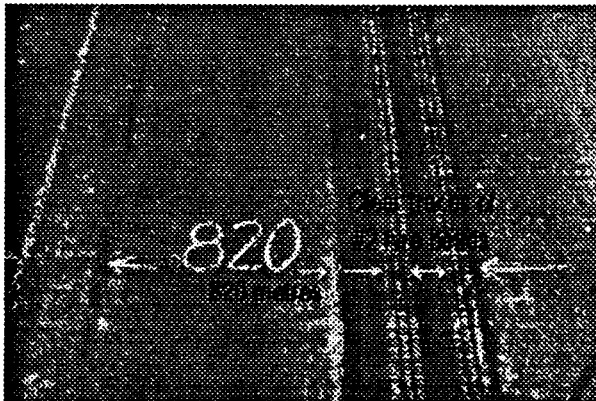
Marks on the runway showed that #2 wheel was not rotating and that the full width of the wheel assembly was being ground away and had progressed beyond a wheel tie bolt. #1 wheel continued to trace.

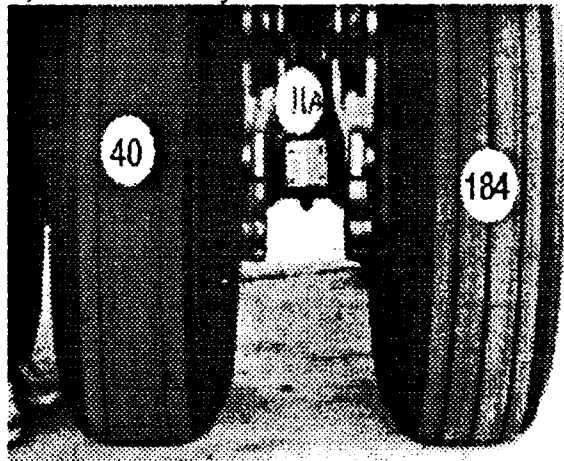
Investigators, with the co-operation of Technair, conducted a tyre deflation exercise. The #2 tyre of a DC-8 was deflated in increments of 10 psi, first from 179 to 120 psi and then in 20 psi increments down to 40 psi; the #1 tyre remained at 181-184 psi. A photographic record was made and a review of the photographs shows no discernible differences between the paired, or other tyres on the bogie, at the 150/160 psi range - which is in the 15% range when under-inflation gets critical. Even at the lowest pressure of 40 psi, except for a slightly longer tread print on the ground and a somewhat increased squareness between the tyre wall and the tread at the upper portion of the deflated tyre, there was no clear visual evidence of the under-inflation.
