One-Two-Go Airlines Flight OG269, HS-OMG September 16, 2007, Phuket, Thailand

A. INTRODUCTION:

This paper relates to the September 16, 2007, accident of One-Two-Go Airlines flight OG269, Thailand registration HS-OMG, a Boeing-McDonnell Douglas MD-82 that crashed during an attempted go-around at the Phuket International Airport (HKT), Phuket, Thailand. The flight departed the Don Muang Airport (DMG), Bangkok, Thailand on a regularly scheduled passenger flight destined for (HKT). There were 123 passengers and 7 crewmembers on the flight, of which 89 persons were fatally injured. Among the fatalities were both pilots and 3 of the 5 cabin crewmembers.

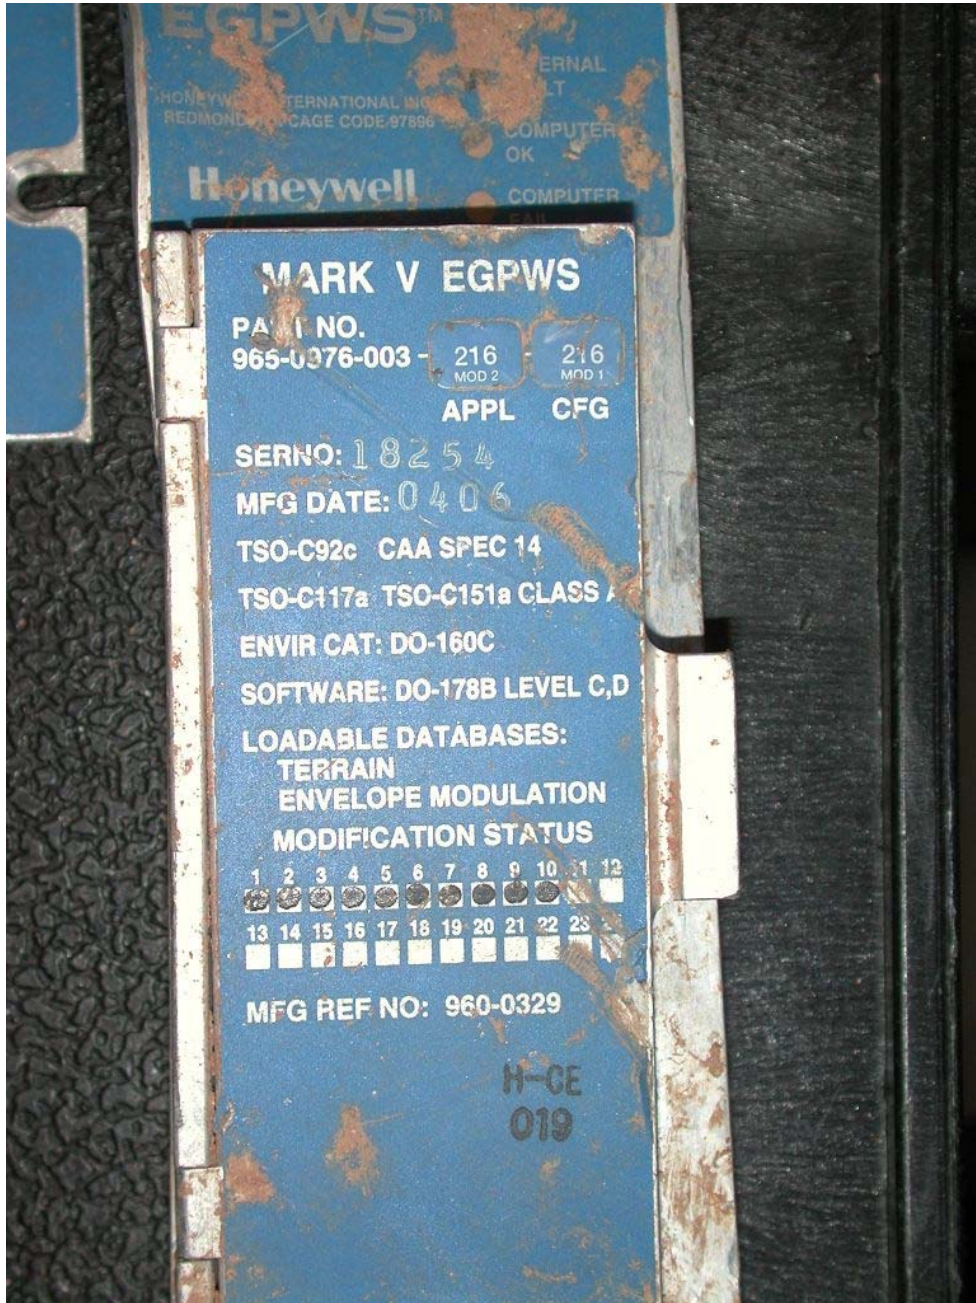
PHOTO 3

Unit removed from aircraft rack

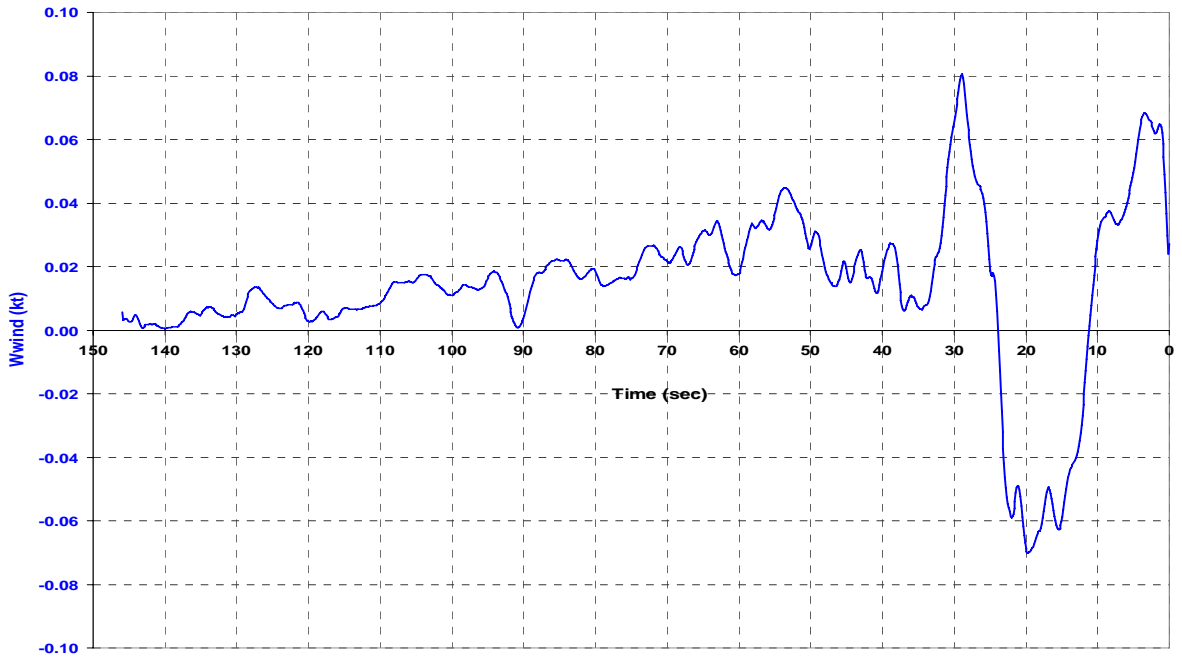
Figure 1. Vertical Wind

The wind data provided by the NTSB (Reference 3) shows that there was a relatively insignificant vertical component of wind during the landing approach (Figure 1), and it is not expected that a windshear alert should have been issued based on the vertical shear. The variable within the legacy Honeywell algorithm which is most responsive to vertical shear is the variable TVERT, and the response of this variable is shown in Figure 3.

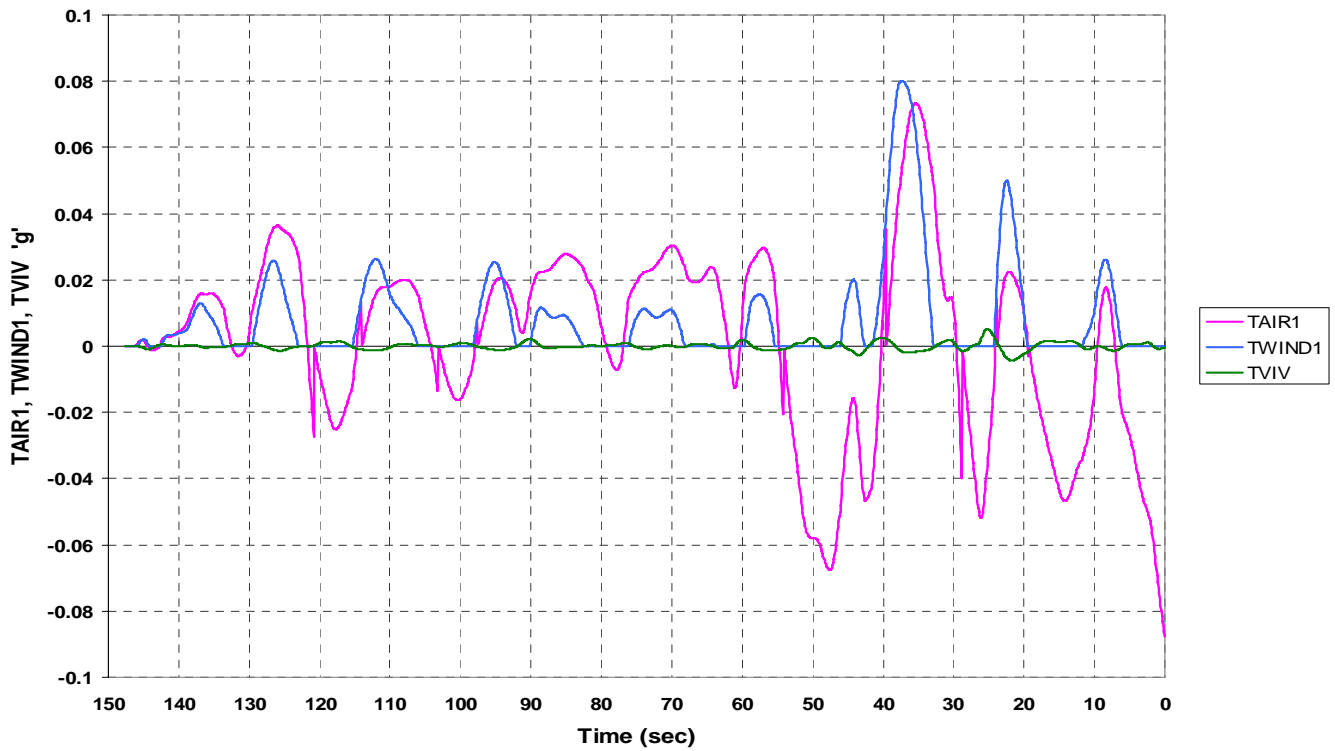
Figure 4. Simulation Time Histories of Windshear Algorithm Variables TAIR1, TWIND1 and TVIV

The variables within the legacy Honeywell algorithm which are most responsive to horizontal shear are the variables TAIR1, TWIND1 and the 'wind vector rotation' variable TVIV. Plots of these variables against time from the simulation are shown in Figure 4. It is the variable TAIR1 which finally exceeds the threshold and causes an alert, as shown in Figure 5.
