This document is an English translation of the Final Report on the fatal accident involving the Falcon 50EX aircraft registered F-GLSA that occurred on October 20, 2014 at Vnukovo Airport, Moscow.

INTERSTATE AVIATION COMMITTEE

FINAL REPORT

Type of occurrence	Fatal accident
Type of aircraft	Airplane, Falcon 50EX
Registration	F-GLSA
Owner	Unijet Airline
Operator	Unijet Airline
Place of occurrence	Russia, Moscow (Vnukovo) Airdrome , coordinates: N 55°35'29,66", E 37°15'41,12"
Date and time	20.10.2014, 19:58 UTC (23:58 local time), night time

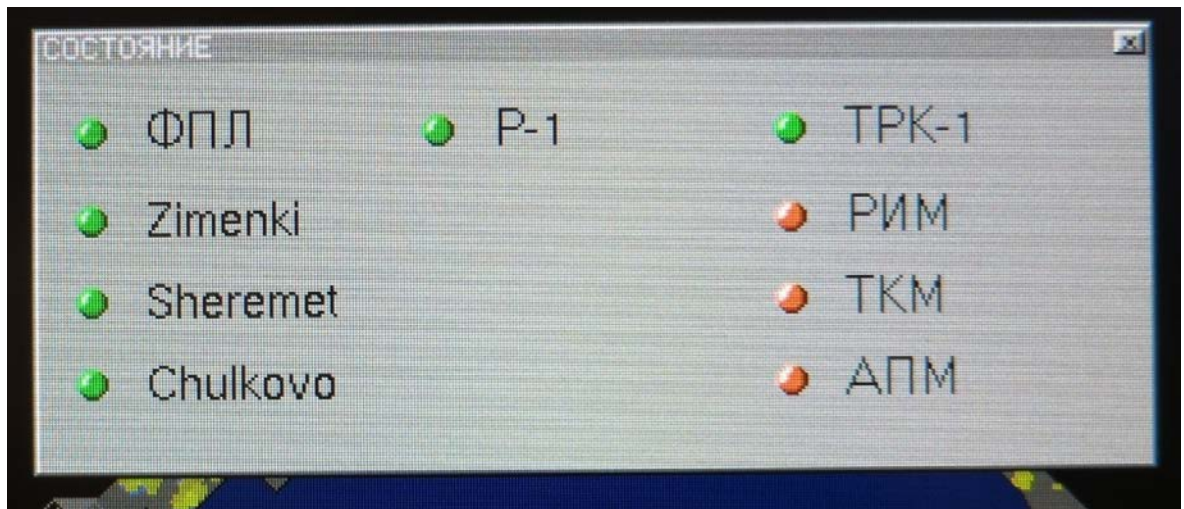
Figure 9. System Status Window at Ground Controller Working Position

1. No RIM, TCM or APM alert monitoring on (Figure 9).

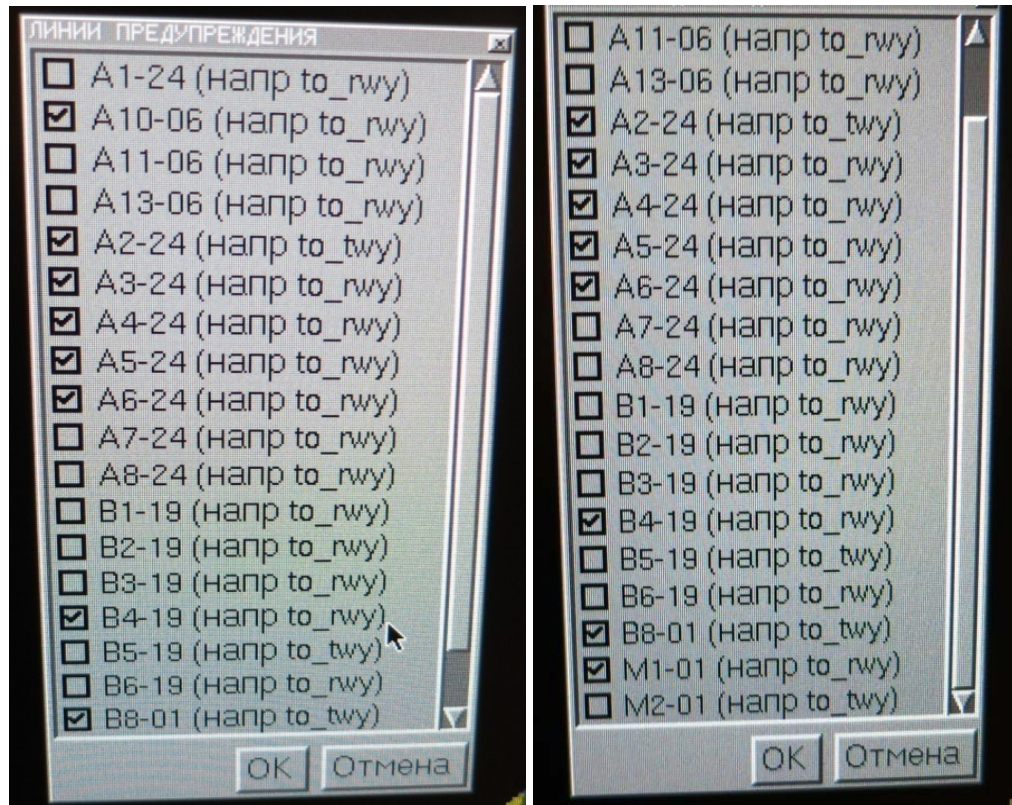
Figure 10. Reserved Lines (ticked lines are activated) at Ground Controller WP

Not activated were the following reserved lines: A1-24 (to-RWY)¹⁶, A11-06 (to-RWY), A13-06 (to-RWY), A7-24 (to-RWY), A8-24 (to-RWY), B1-19 (to-RWY), B2-19 (to-RWY), B3-19 (to-RWY), B5-19 (to-RWY), B6-19 (to-RWY) and M2-01(to-RWY).

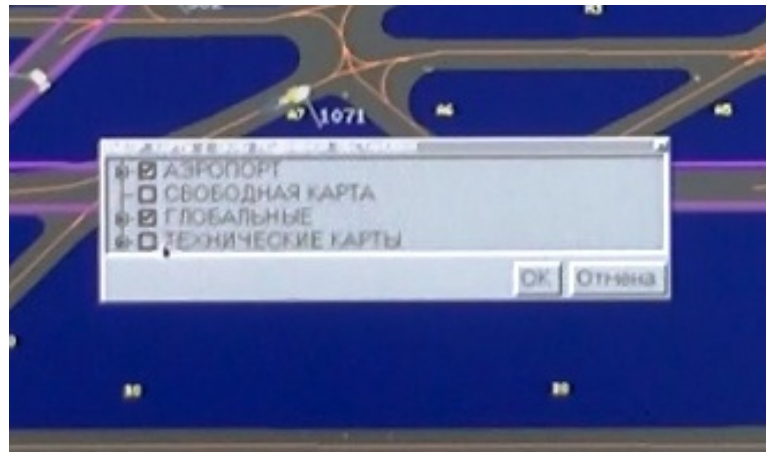
Figure 12. System technical charts status at Ground Controller Working Position. Charts are not activated (unticked)

4. The status of system technical charts is shown in Figure 12. The charts are not activated. Thus, though the Reserved Lines were on (alert messages appearing) but their indication on the screen was disengaged.

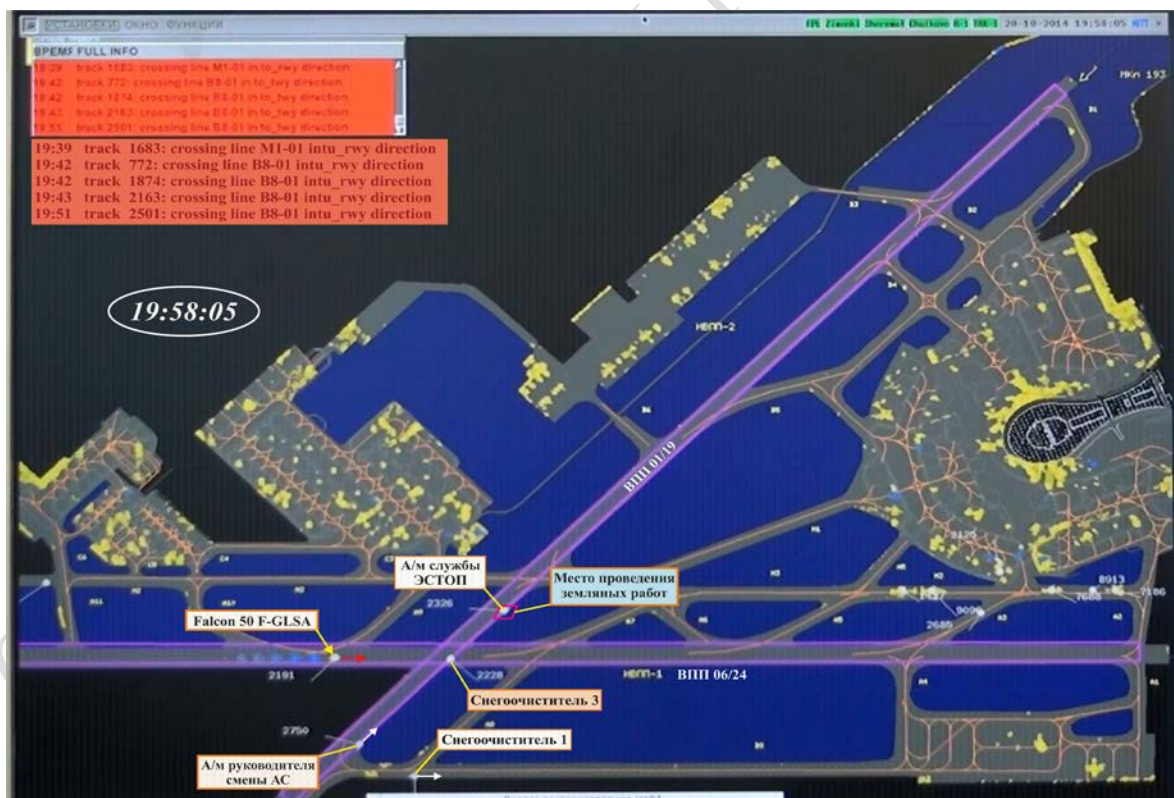
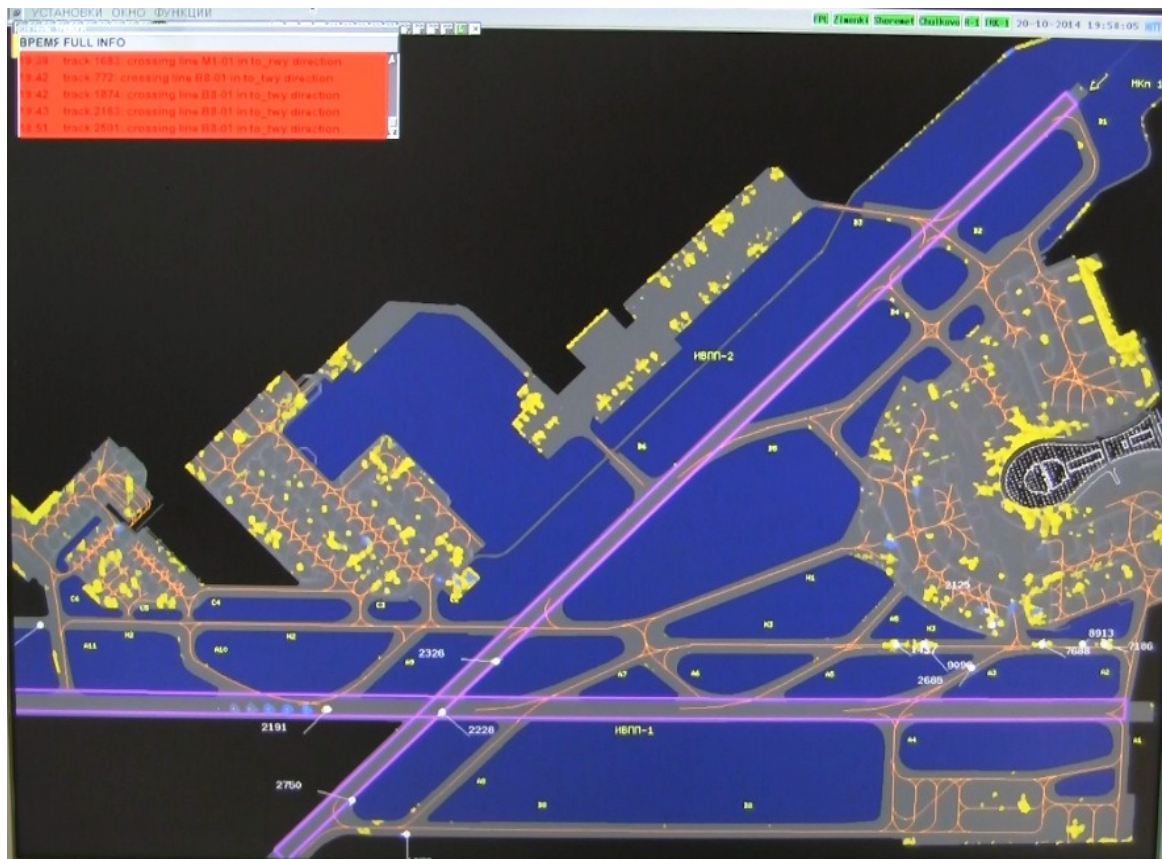
Figure 13. TRADIS indicator on ground controller's working position before the accident with additional information from the investigation team

Figure 14. TRADIS indicator on ground controller's working position before the accident

The indicator does not show the Reserved Lines as the system technical charts were deactivated.

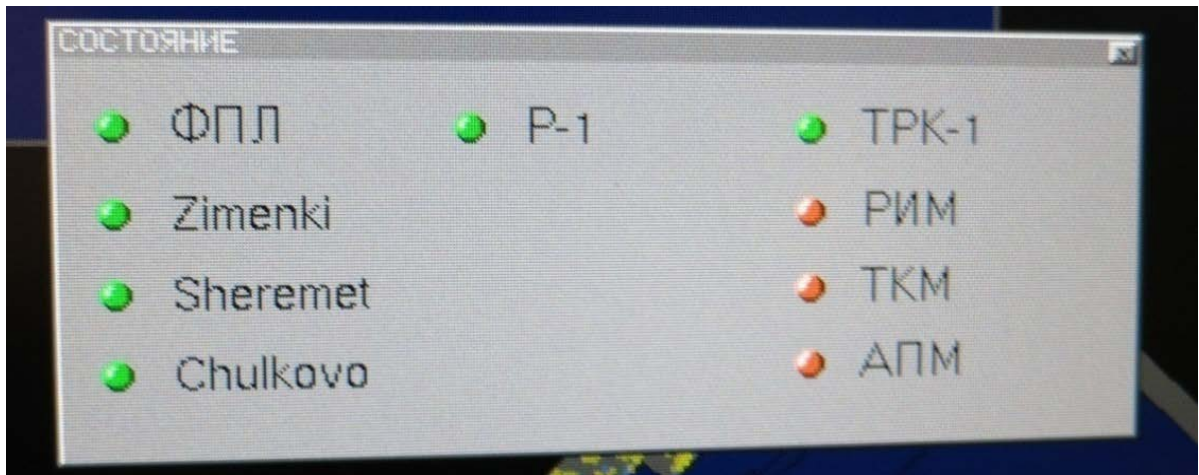
Figure 15. System Status Window at Departure ATS and Departure ATC working positions

1. RIM, TCM or APM alert monitoring off (Figure 15).

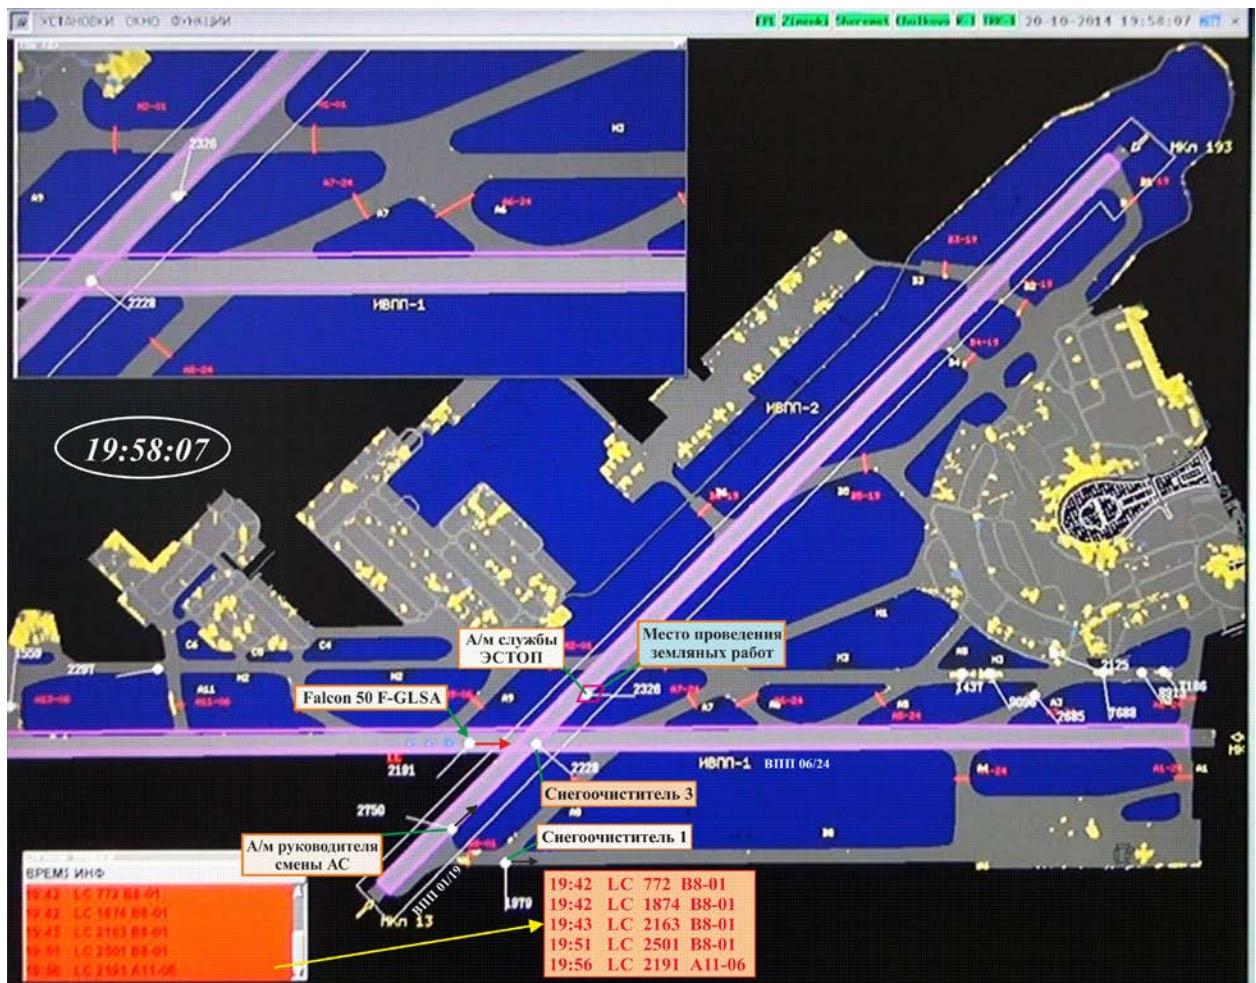
Figure 19. TRADIS indicator on departure ATC controller's working position before the accident

The indicator shows alerts of Reserved Lines crossing:

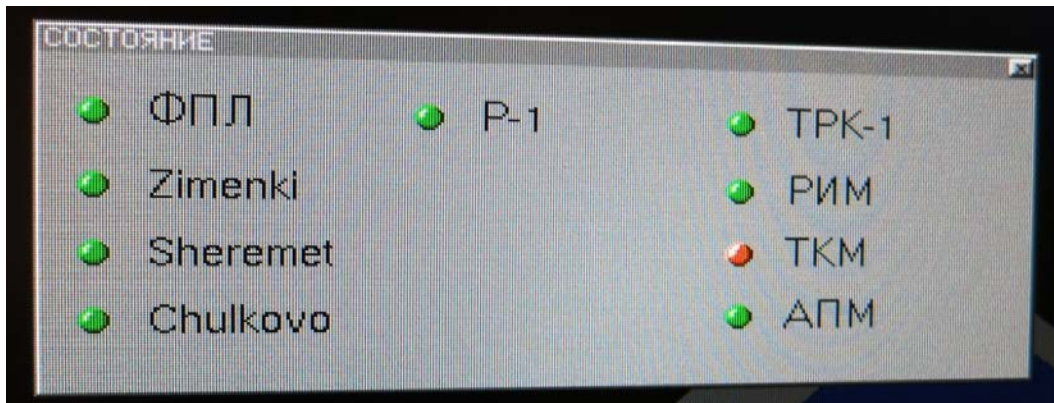
Figure 20. System Status Window at Supervisor WP

1. TCM alert monitoring off, RIM and APM alert monitoring on (Figure 20).

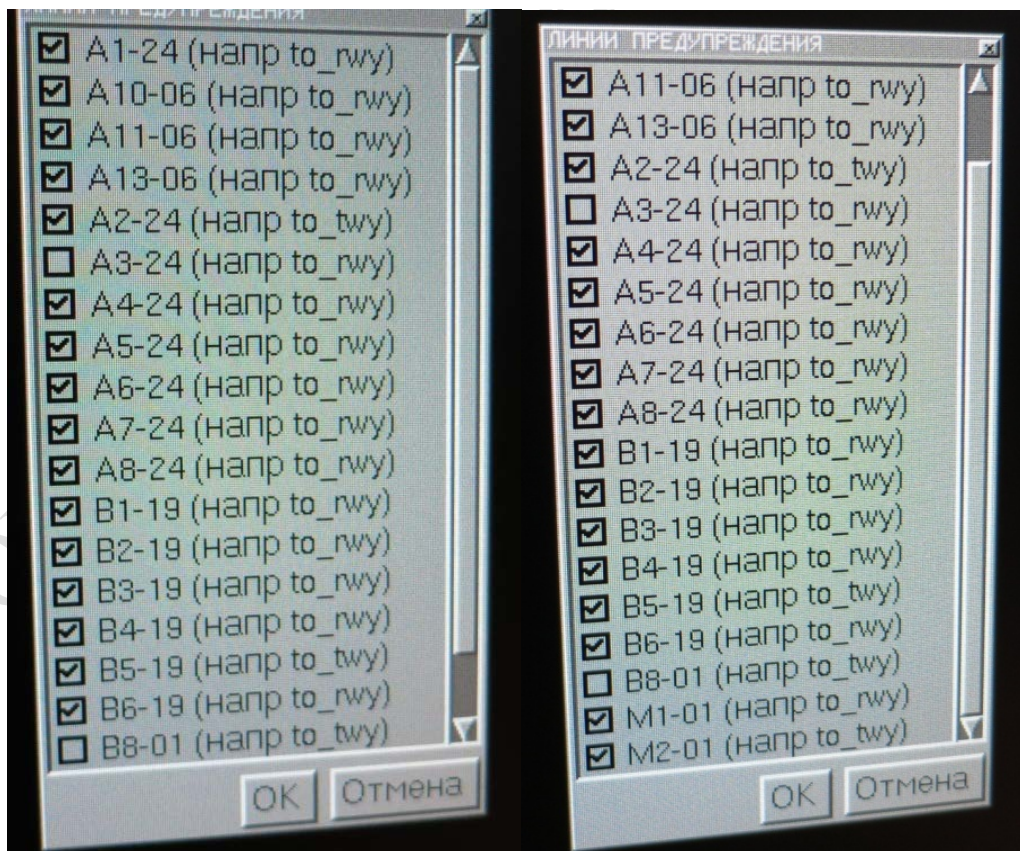
Figure 21. Reserved Lines at Supervisor WP (ticked lines are activated)

Not activated were the following reserved lines: A3-24 (To-RWY) and B8-01 (To-RWY).

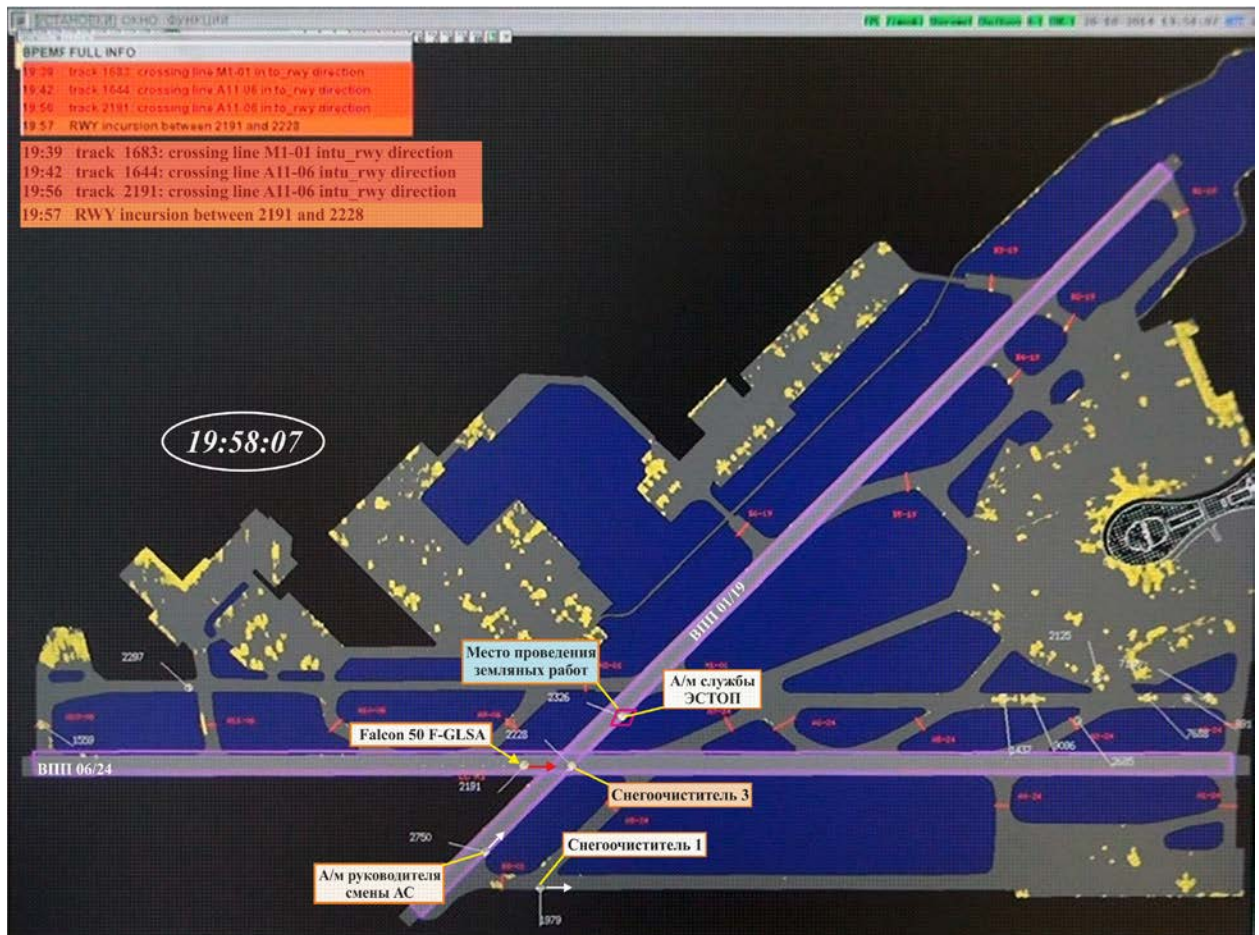
Figure 24. TRADIS indicator on supervisor's working position before the accident

The indicator shows alerts of Reserved Lines crossing:

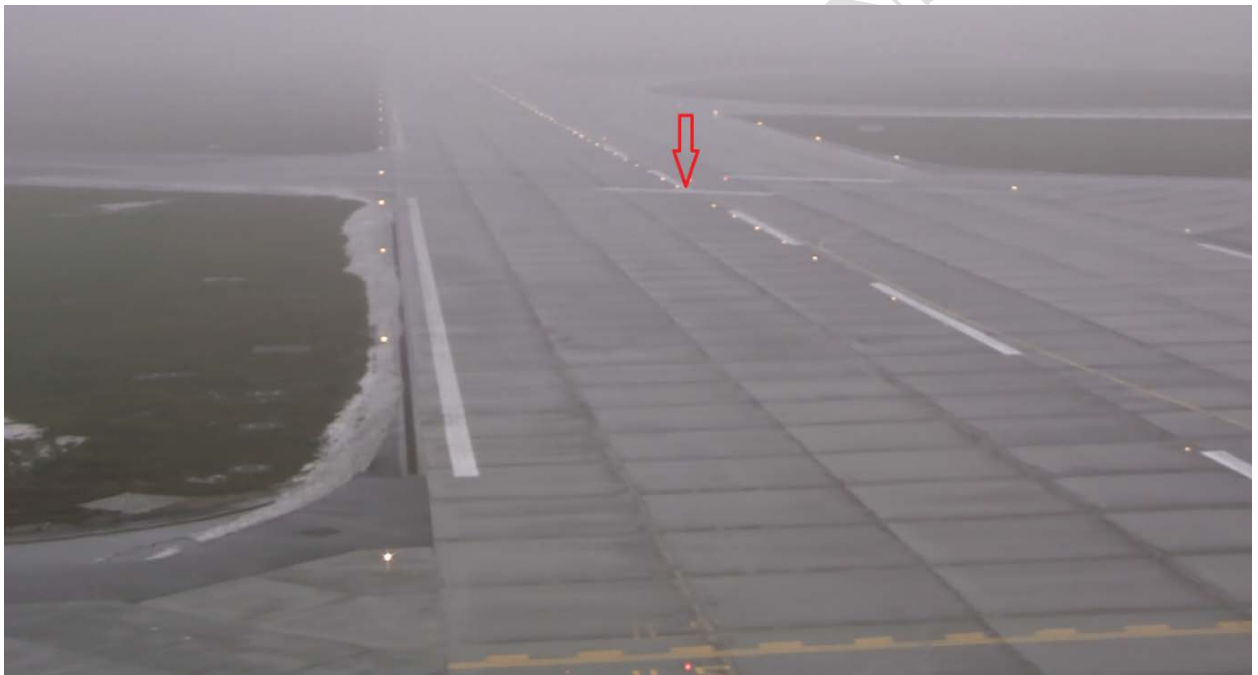
Figure 29. Crossing of RWY 1 and RWY 2 (marked by arrow) (picture taken along RWY 24)

The aircraft collided with the snowplow 3 SUPRA 5001, garage number 377 at the crossing of RWY 1 and RWY 2 at a point with the following coordinates: N 55°35'29.66", E 37°15'41.12" (Figure 29).

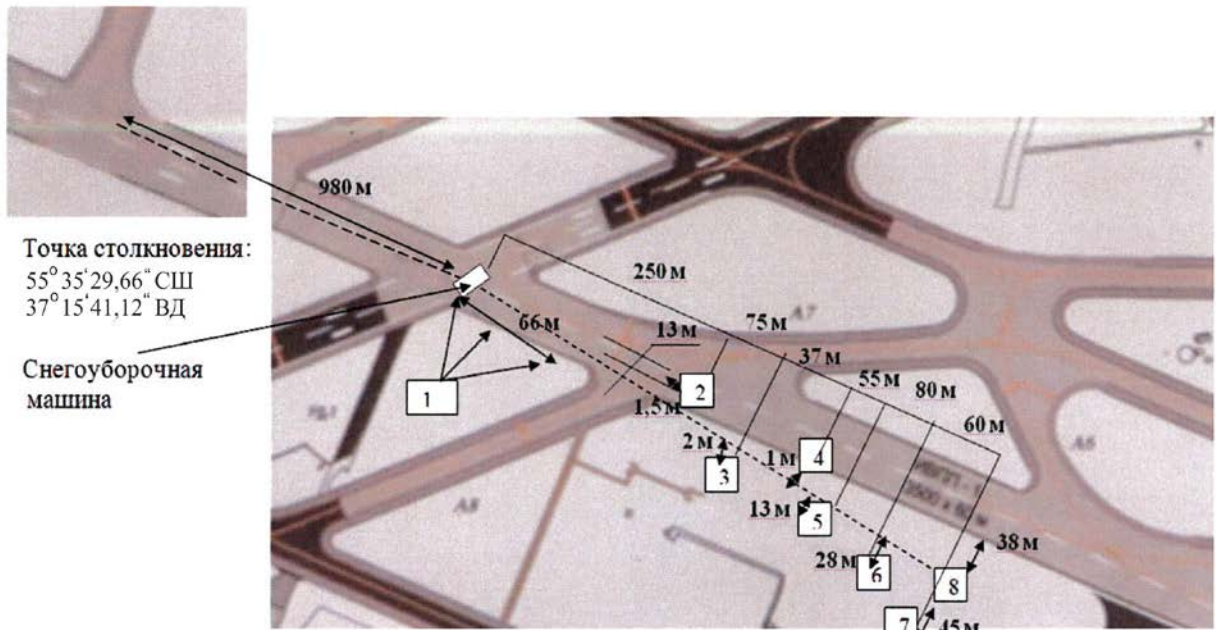
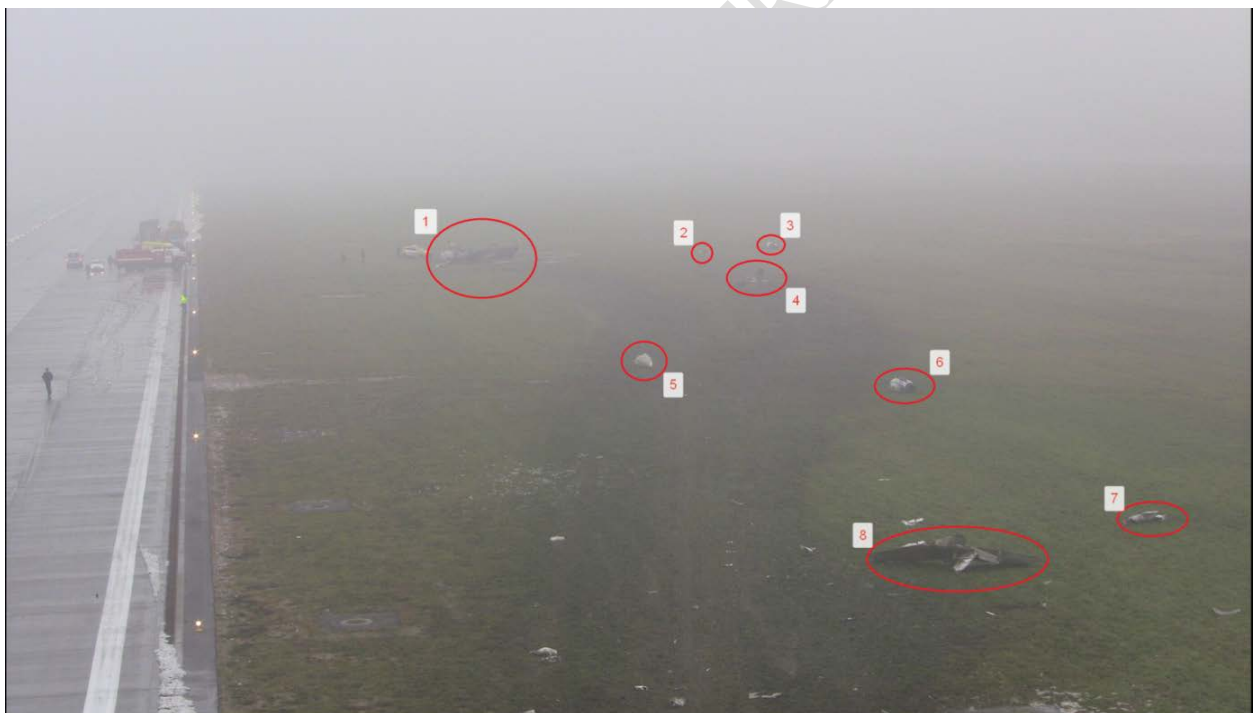
Figure 30. Wreckage plot

Figure 31. Accident Wreckage Plot

1. Main aircraft fragments location 2. Aft part of engine cowling 3. Engine No.1. 4. Left wing with main landing gear. 5. Radome. 6. Engine № 3. 7. Upper part of fin. 8. Middle part of fin.

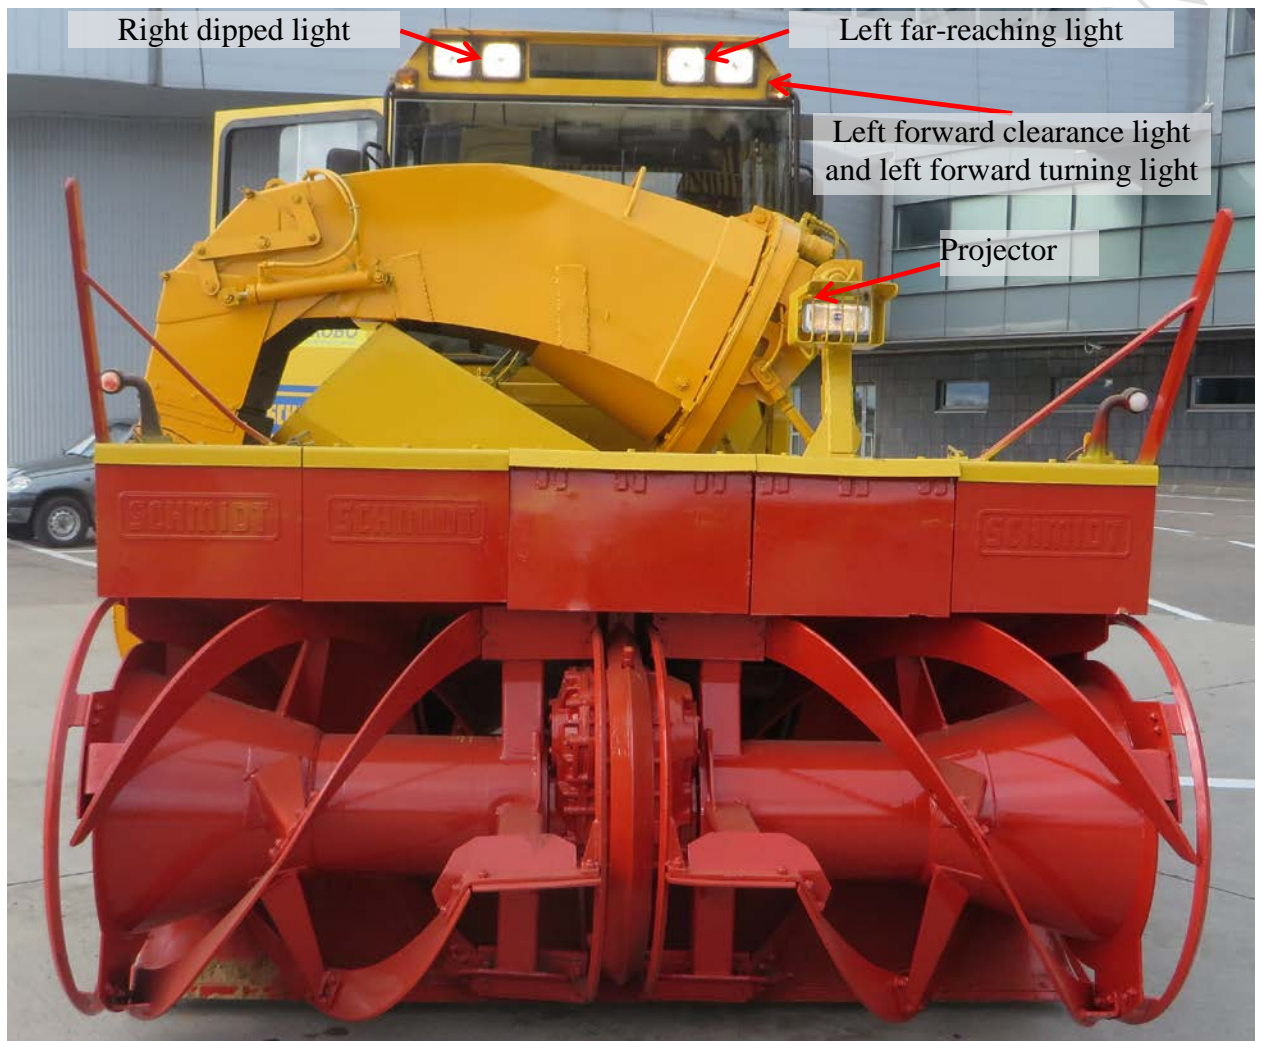
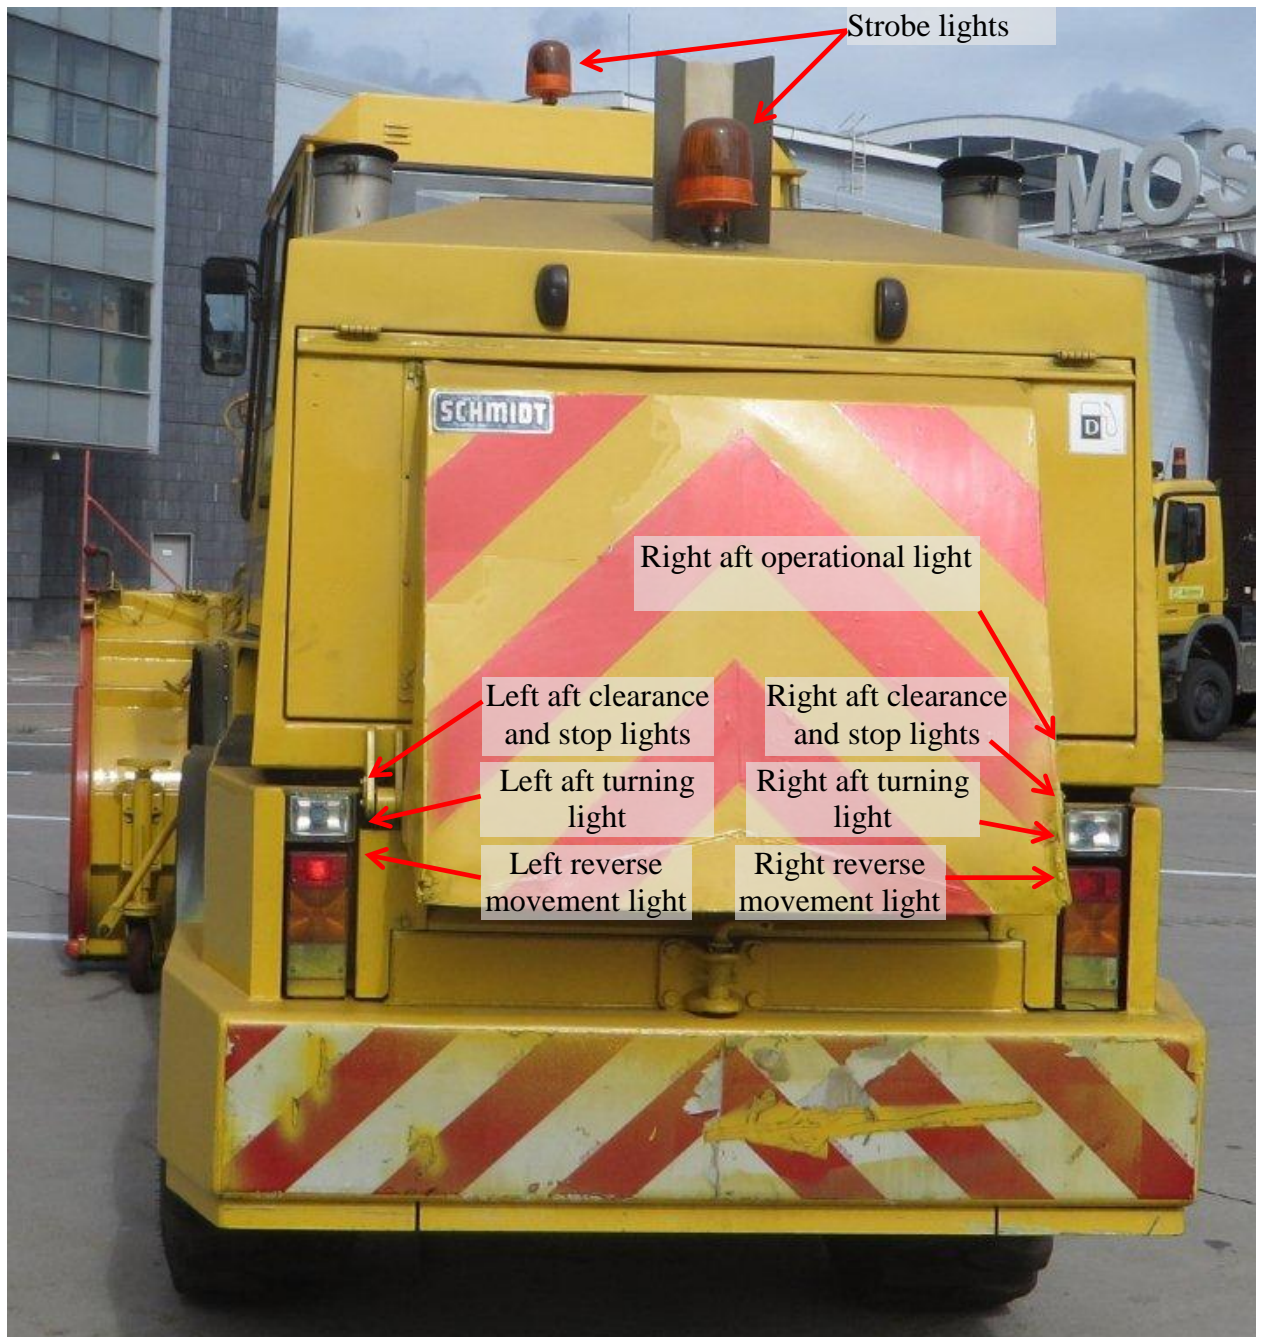
the time of its collision with the Falcon 50EX F-GLSA aircraft, the snowplow lights (Figure 46b and Figure 46c) were in the following condition:

- projector light, right and left reverse movement lights, left and right turning lights, right aft clearance and stop lights, and aft operational light bulbs did not reveal any signs of filament destruction or being under voltage.

Other lights were missing.

Figure 46b. Snowplow lights schematic (forward)

Figure 46c. Snowplow lights schematic (aft)

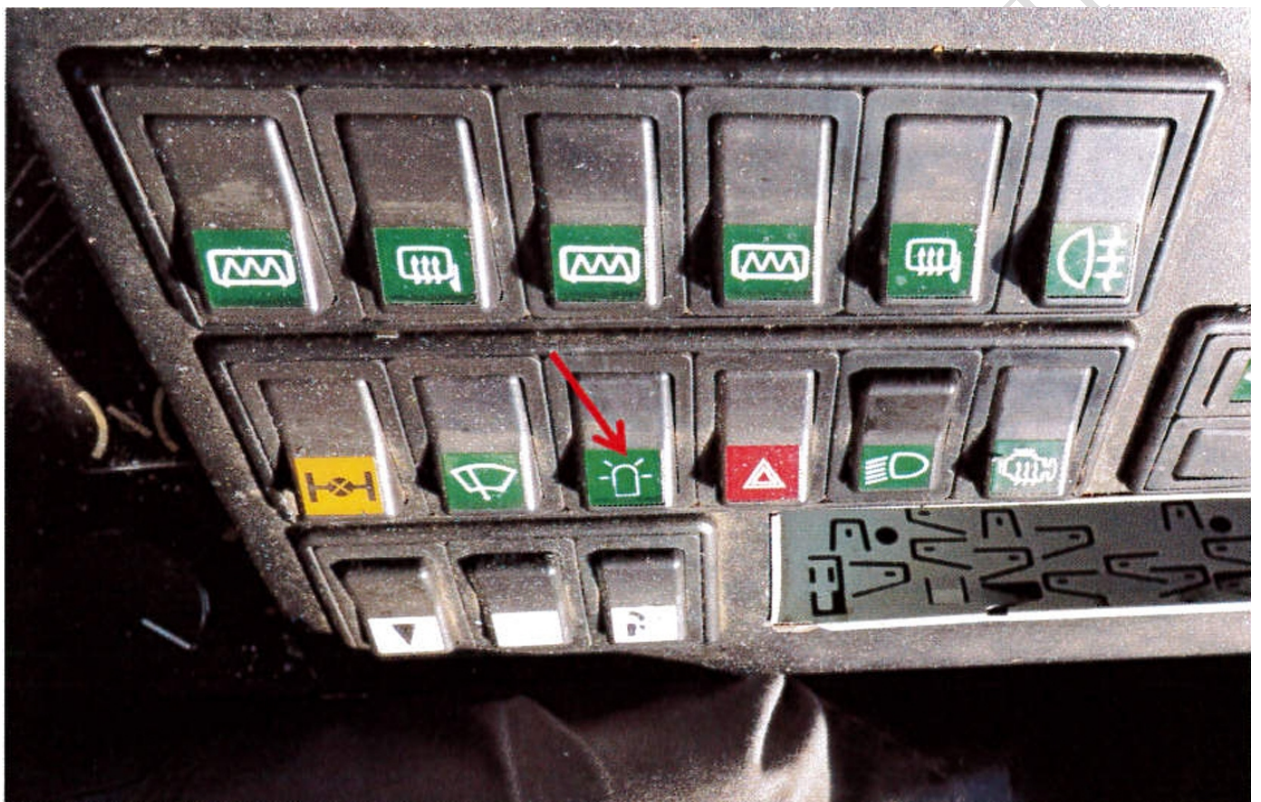
Figure 53. Strobe lights activation switch (marked with an arrow) on the cab control panel in the SCHMIDT SUPRA-5001, state number 377

Notes: amber strobe lights installed (Figure 53).

The strobes activation switch is mounted in the snowplow driver's cab.

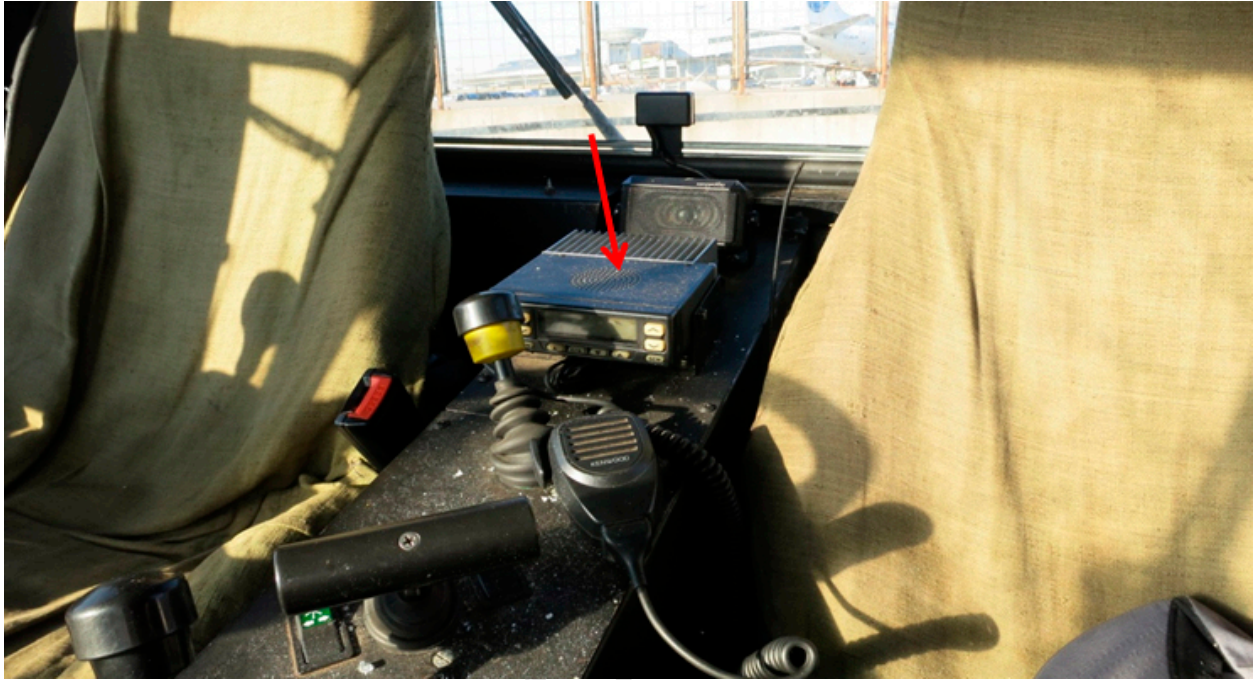
Figure 54. Kenwood radio station in the cab of SCHMIDT SUPRA-5001, state number 377 (marked by the arrow)

The radio exchange at 163.8 MHz (AERODROME) and at 163.5625 MHz (Vnukovo-3) is not recorded.

As per Para 11.3 of the Airdrome Service and Vnukovo ATC Center Interaction Procedure the drivers of airdrome vehicles shall be constantly listening to the radio exchange on the Departure Control frequency. However, airdrome vehicles including snowplow 3 were not fitted with relative equipment.

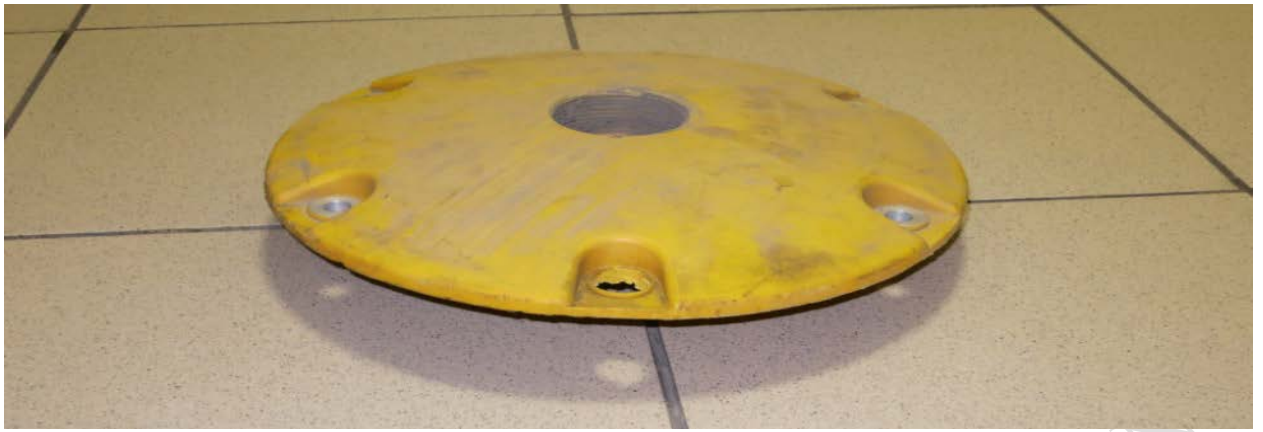
Figure 58. Fragment of runway light (basement)

While operating on the right side of RWY 2, driver of snowplow 1 detected a fragment (basement) of the runway light (Figure 58). The driver reported the runway light fragment detection via radio to the airdrome service shift supervisor. The path of vehicles movement before the runway light was detected is shown in Figure 59.

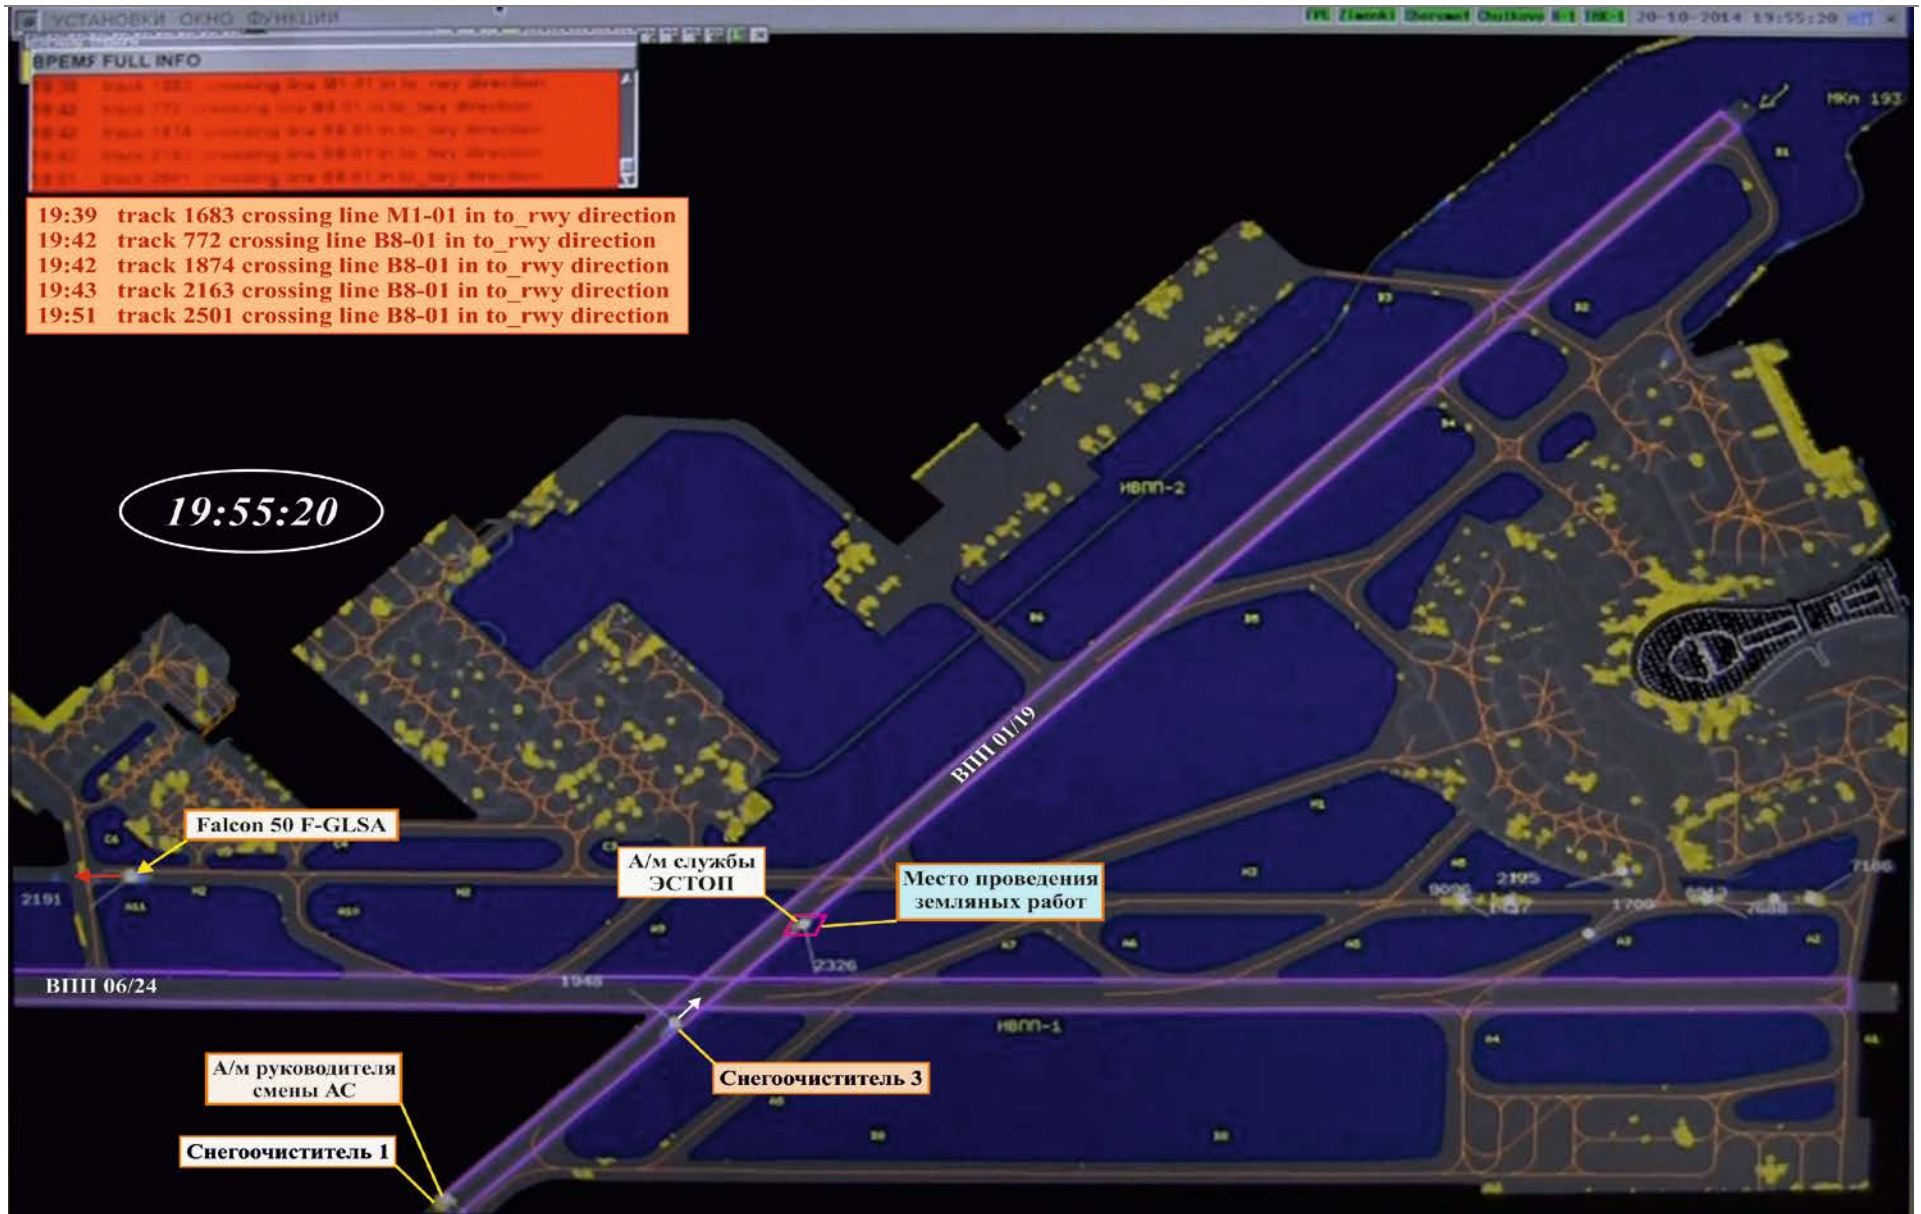
Figure 68. Location of objects at airdrome Vnukovo as viewed from the ground controller screen at 19:55:20

Snowplow 3 proceeded with its movement in the direction of RWY 1 (Figure 68), at 19:55:32 it stopped before the RWY, at 19:55:40 crossed RWY 1 without request or clearance from the departure controller and continued moving towards the small crossing.

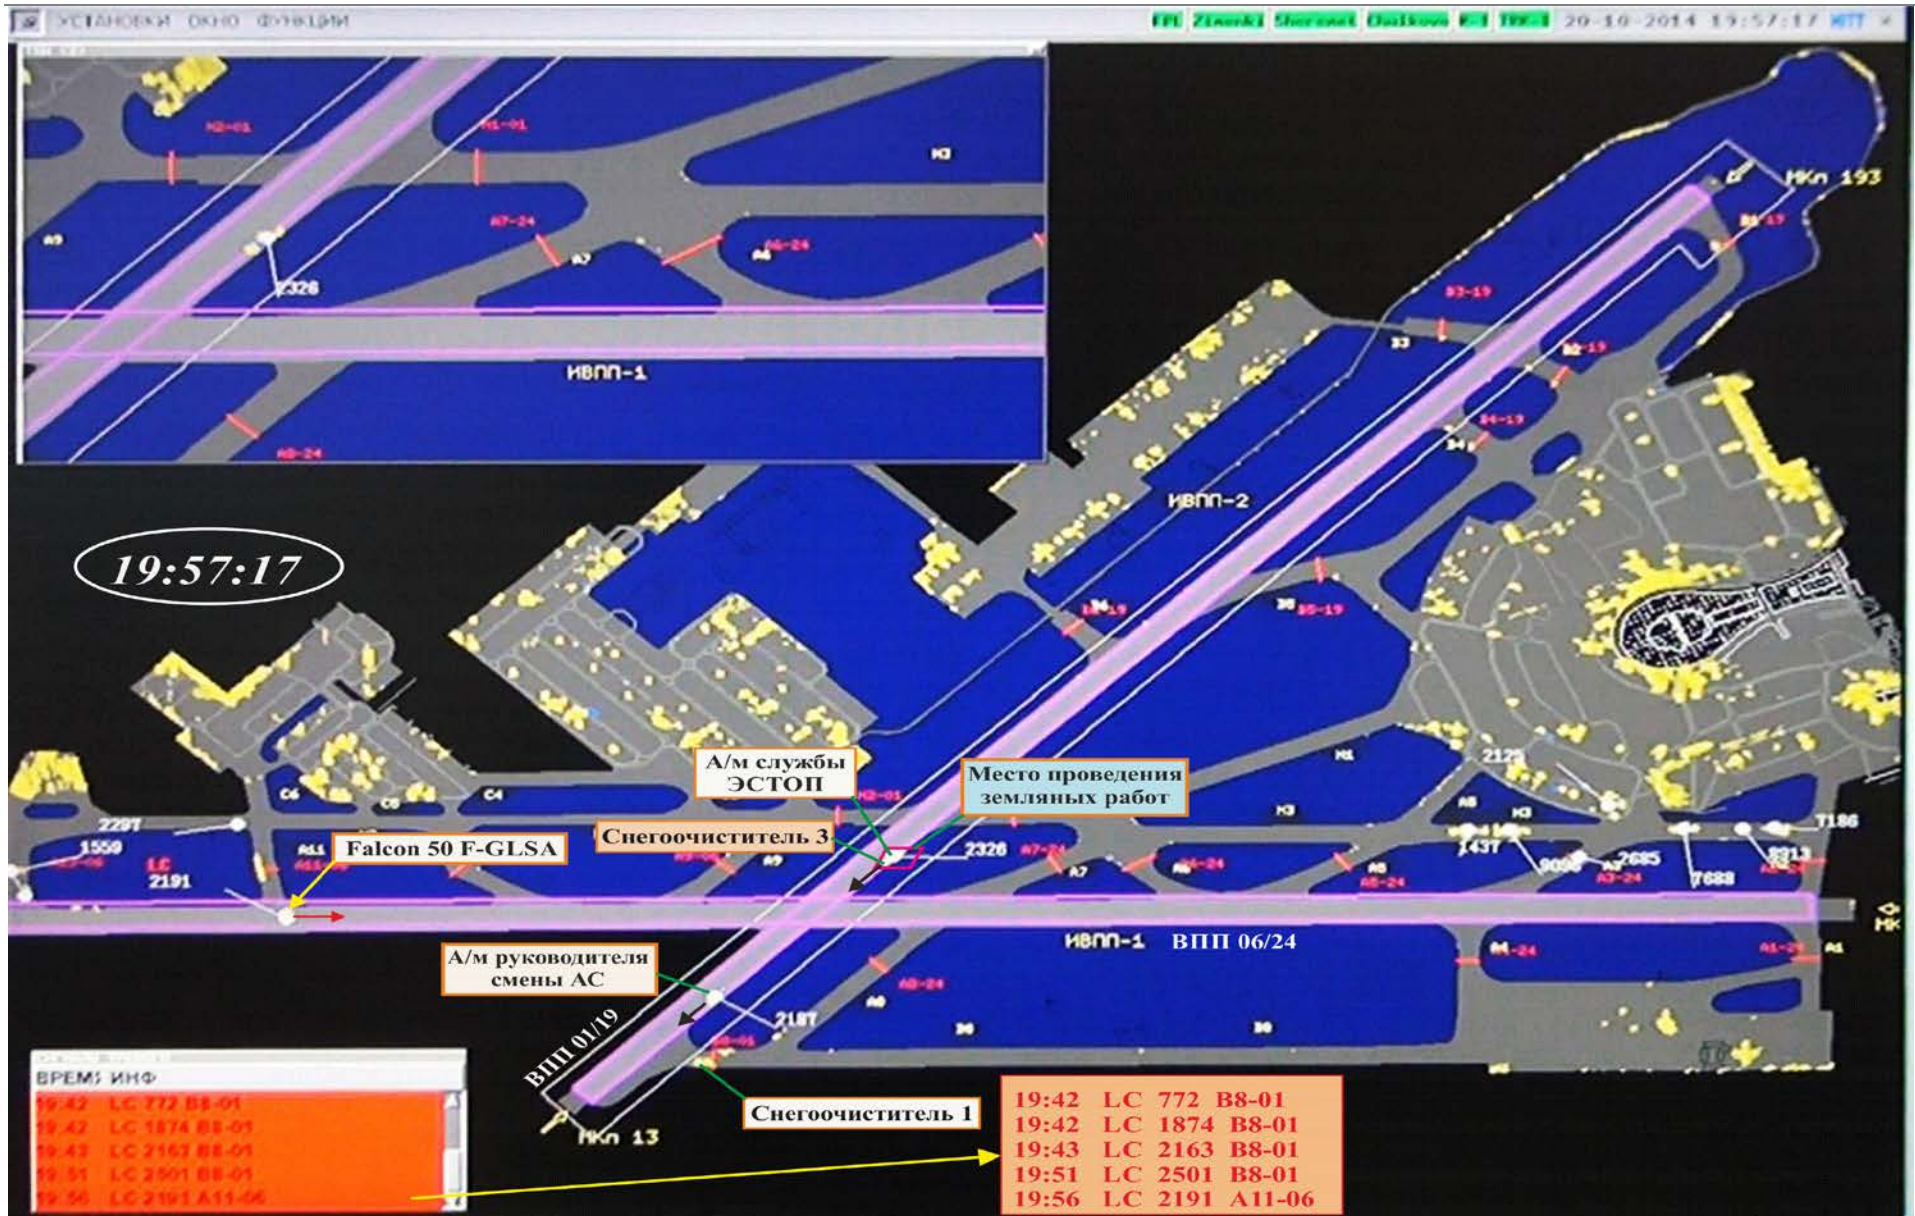
Figure 73. Location of objects at airdrome Vnukovo as viewed from the departure controller screen at 19:57:17

After completing the During Taxi checklist the crew, while still taxiing, started reading the Line-up checklist. Approximately 11 seconds after the crew had conformed the takeoff clearance (at 19:57:17) the airfield surveillance and control subsystem A3000 recorded start of the snowplow 3 movement (without track number) along the left edge of RWY 2 towards RWY 1 in use (Figure 73).
