This document is an English translation of the Final Report on the fatal accident involving the Falcon 50EX aircraft registered F-GLSA that occurred on October 20, 2014 at Vnukovo Airport, Moscow.

INTERSTATE AVIATION COMMITTEE

FINAL REPORT

Type of occurrence	Fatal accident
Type of aircraft	Airplane, Falcon 50EX
Registration	F-GLSA
Owner	Unijet Airline
Operator	Unijet Airline
Place of occurrence	Russia, Moscow (Vnukovo) Airdrome , coordinates: N 55°35'29,66", E 37°15'41,12"
Date and time	20.10.2014, 19:58 UTC (23:58 local time), night time

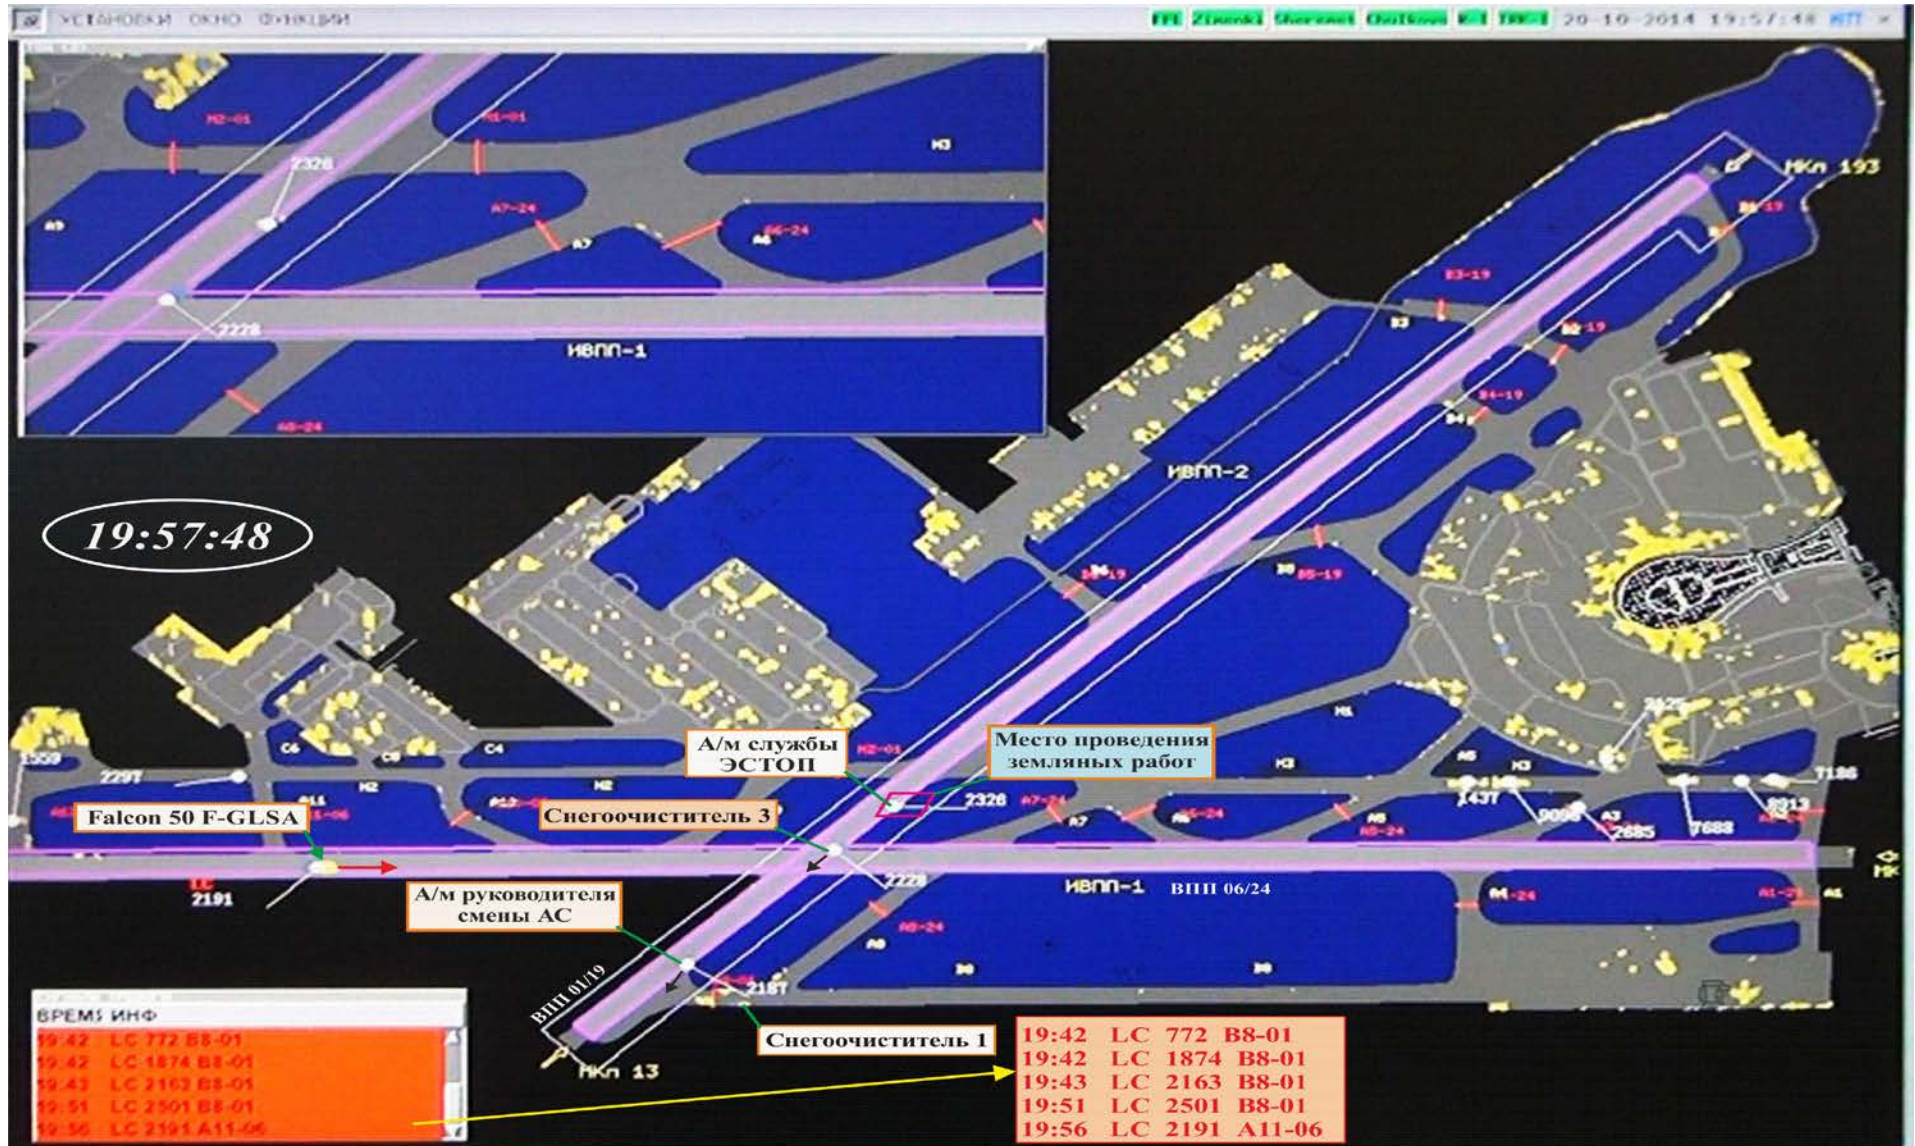
Figure 76. Location of objects at airdrome Vnukovo as viewed from the departure controller screen at 19:57:48

In the course of the takeoff roll snowplow 3, at 19:57:48, at a speed of approximately 20 km/h, without the request and without being cleared by the departure controller, started crossing RWY 1 (Figure 76). By that time the airfield surveillance and control subsystem A3000 had assigned track number 2228 to snowplow 3 and it was already identified with that number at controllers' working positions.

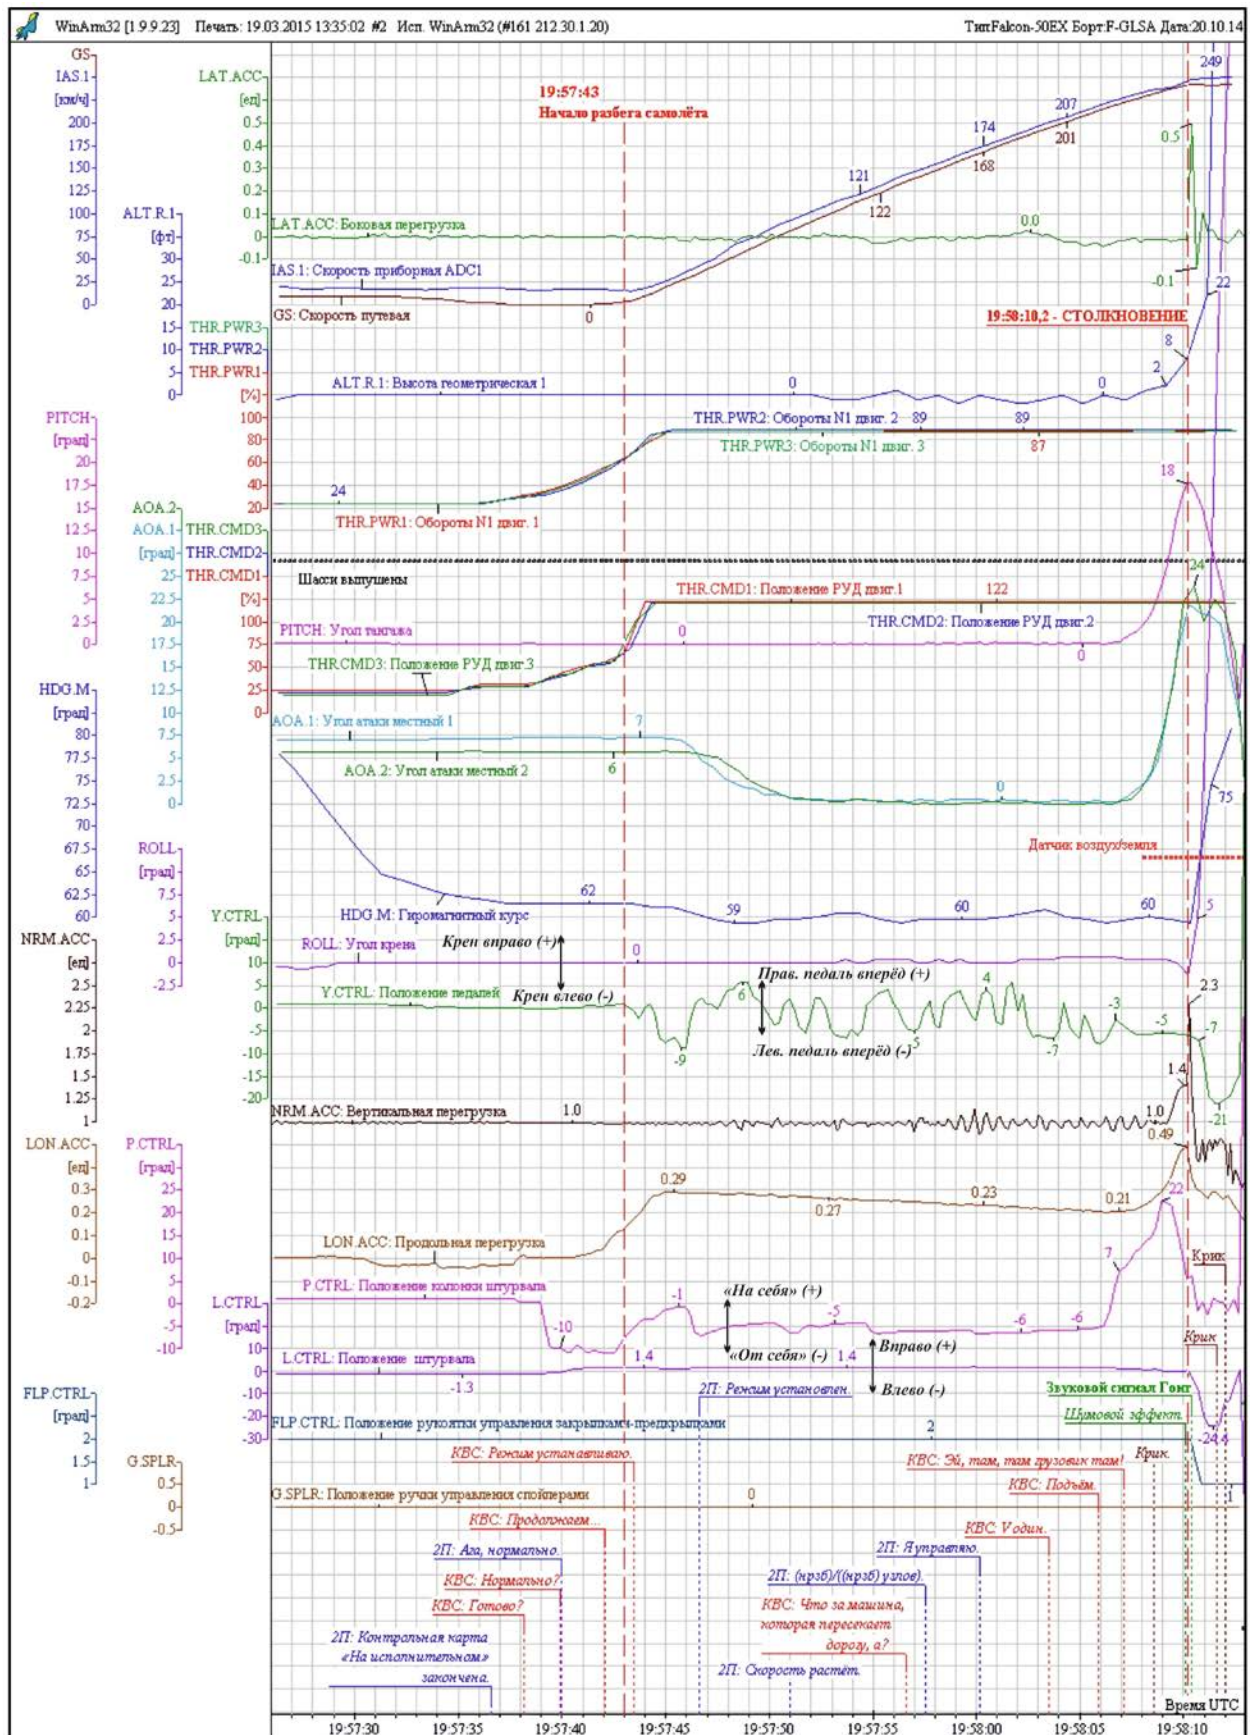
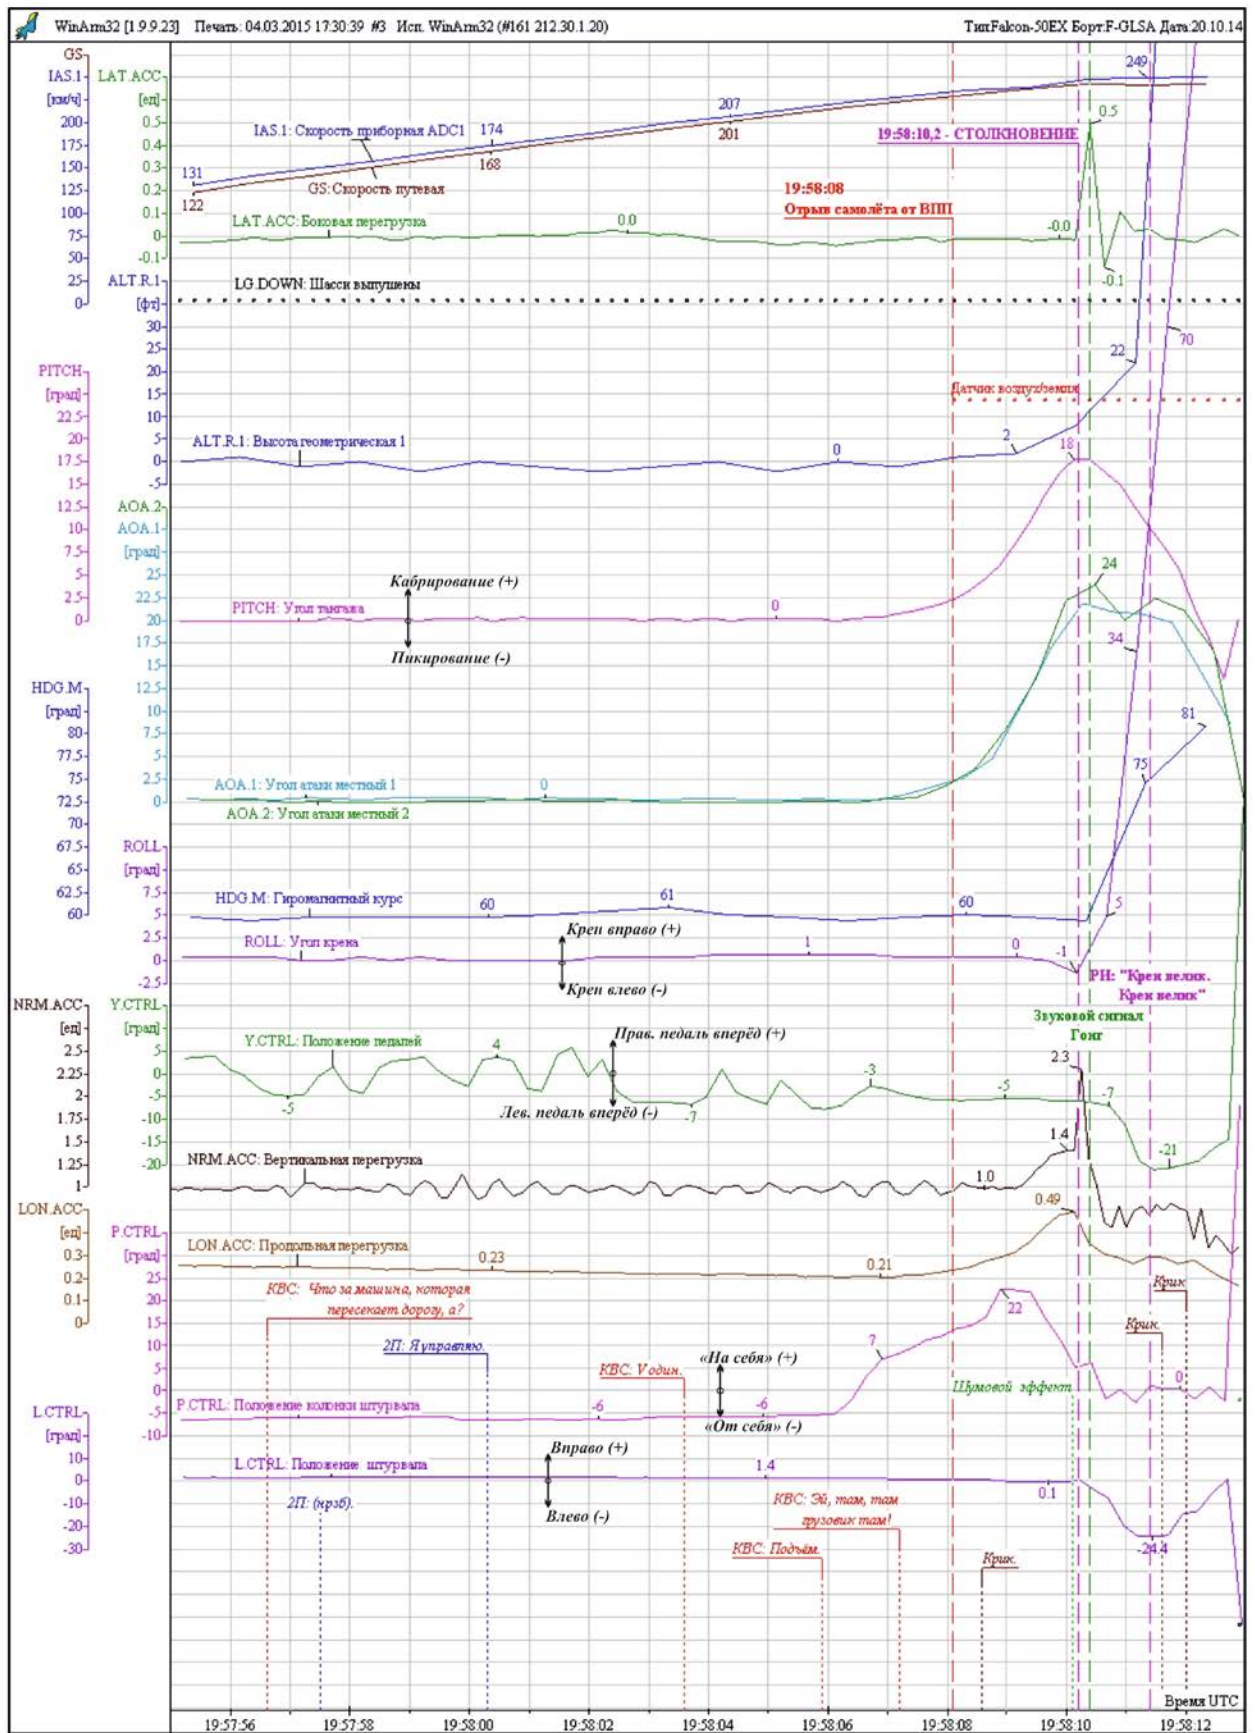
At 19:58:04 at a speed of approximately 110 kt (204 km/h) the PIC called out reaching decision speed «*V one*», and then at 118 kt (218 km/h) reported rotation speed: «*Rotate*» and then the FO started pulling up the control column (Figure 77 and Figure 78).

At 19:58:07 at 123 kt (227 km/h), approximately 210 m before snowplow 3 the PIC shouted: «*Eh beh y-a, y-a un camion là!*» ("*Hey there's, there's a truck there!*") (Figure 78 and Figure 82).

The pitch rate before the liftoff was almost the same as in the previous flight (Figure 83). After that PIC's phrase and aircraft liftoff the FDR recorded an additional abrupt nose up control column deflection. These actions is an evidence that the flying FO must have reacted to the PIC's words. As a result of such pilot actions the local aircraft AOA increased to 22-24 degrees.

Then the control column was pushed from 22 degrees to 5 degrees within about 0.75 sec. This could have been caused by the will of the pilot to avoid exceeding the critical AOA.

The collision occurred at 19:58:10 (Figure 77, Figure 78 and Figure 86) which is confirmed by the flight recorder data: noise as the aircraft structure was destroyed, as well as abrupt increase of vertical and lateral loads reaching as much as 2.3 g and 0.5 g respectively. The aircraft collided with snowplow 3, its right wing hitting the cab roof and snow evacuation nozzle while its RH landing gear hit the aft hood at a height of 1.8 m (Figure 84 and Figure 85).

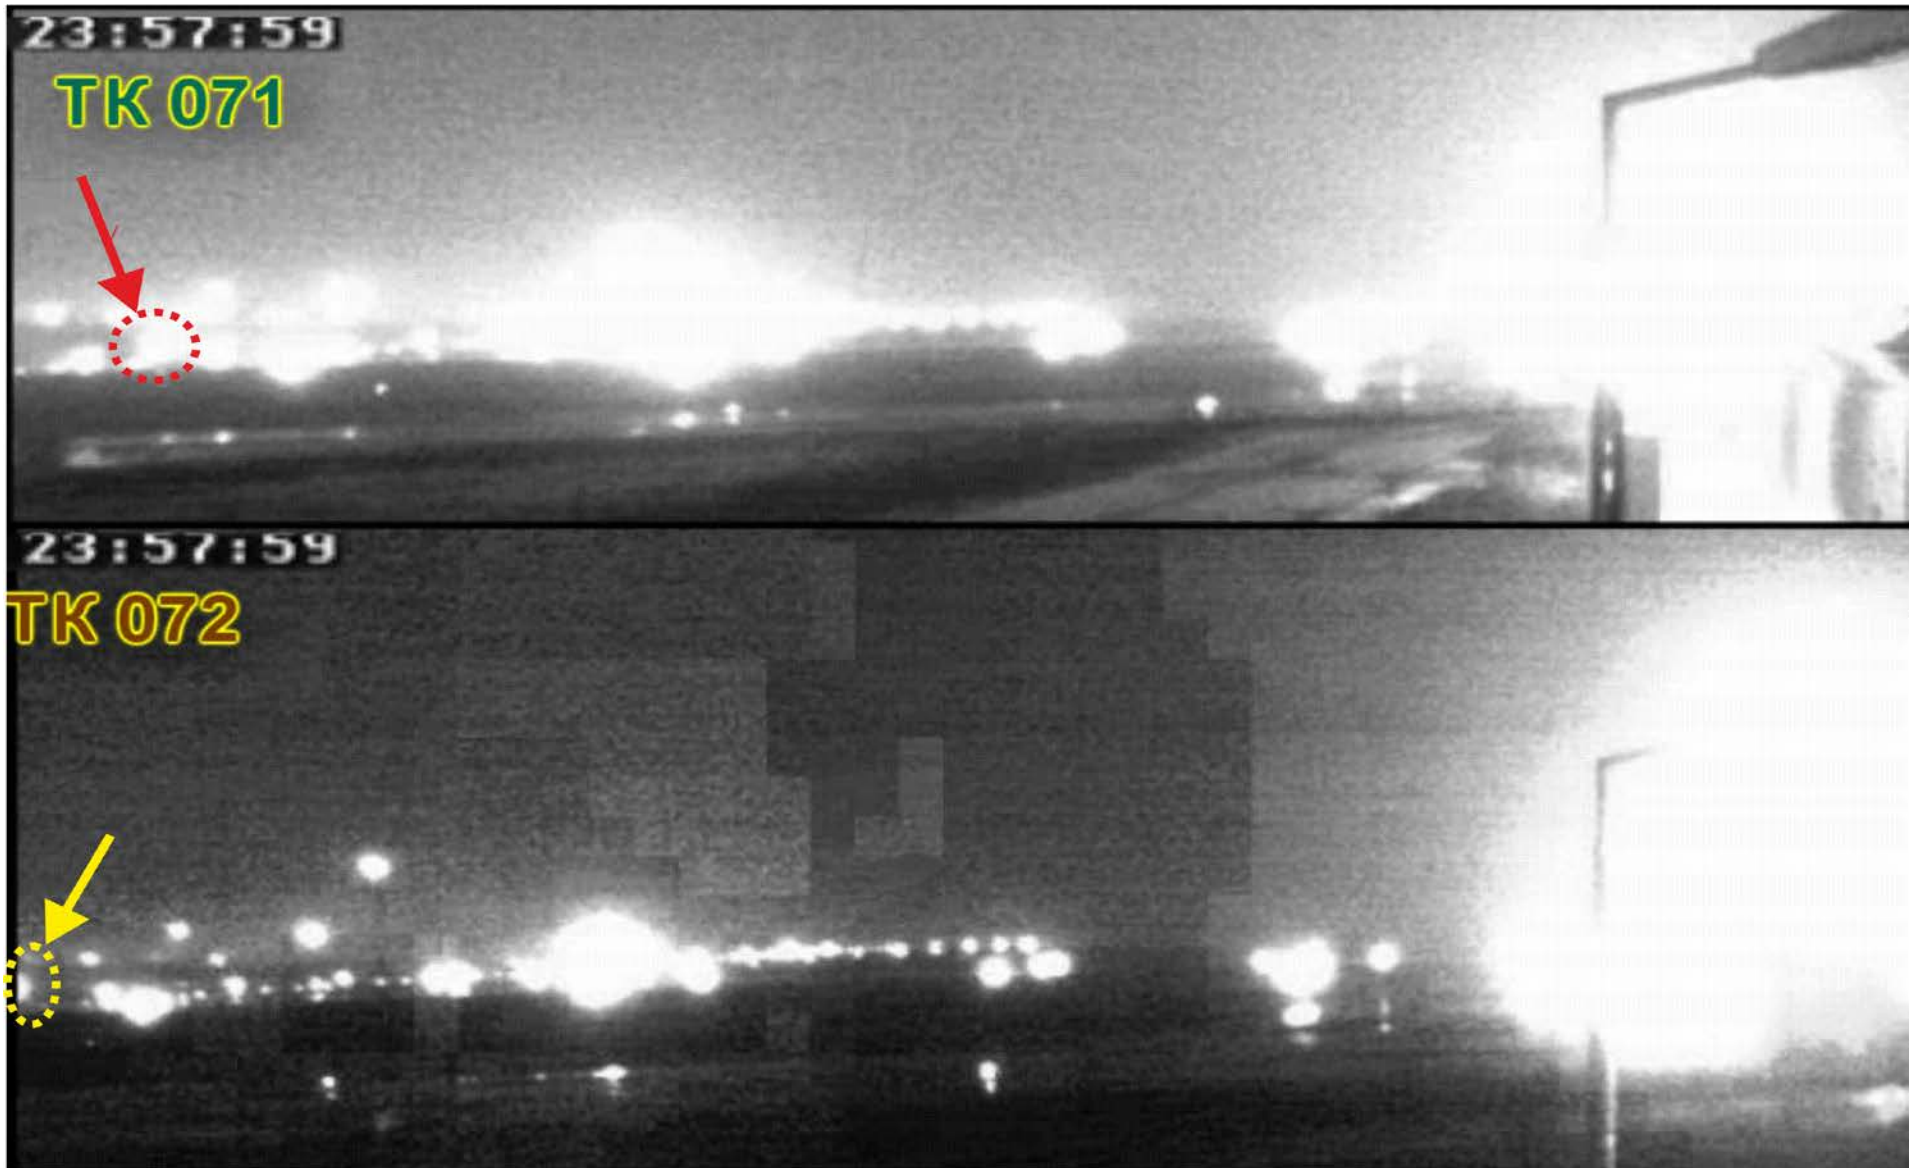
Figure 80. Location of objects at airdrome Vnukovo as viewed from the departure controller screen at 19:57:59

At 19:57:59 snowplow 3 passing a bit (5-6 meters) of RWY 1 centerline stopped near the big crossing, at about 1570 m from threshold 06 of RWY 1 (Figure 80).

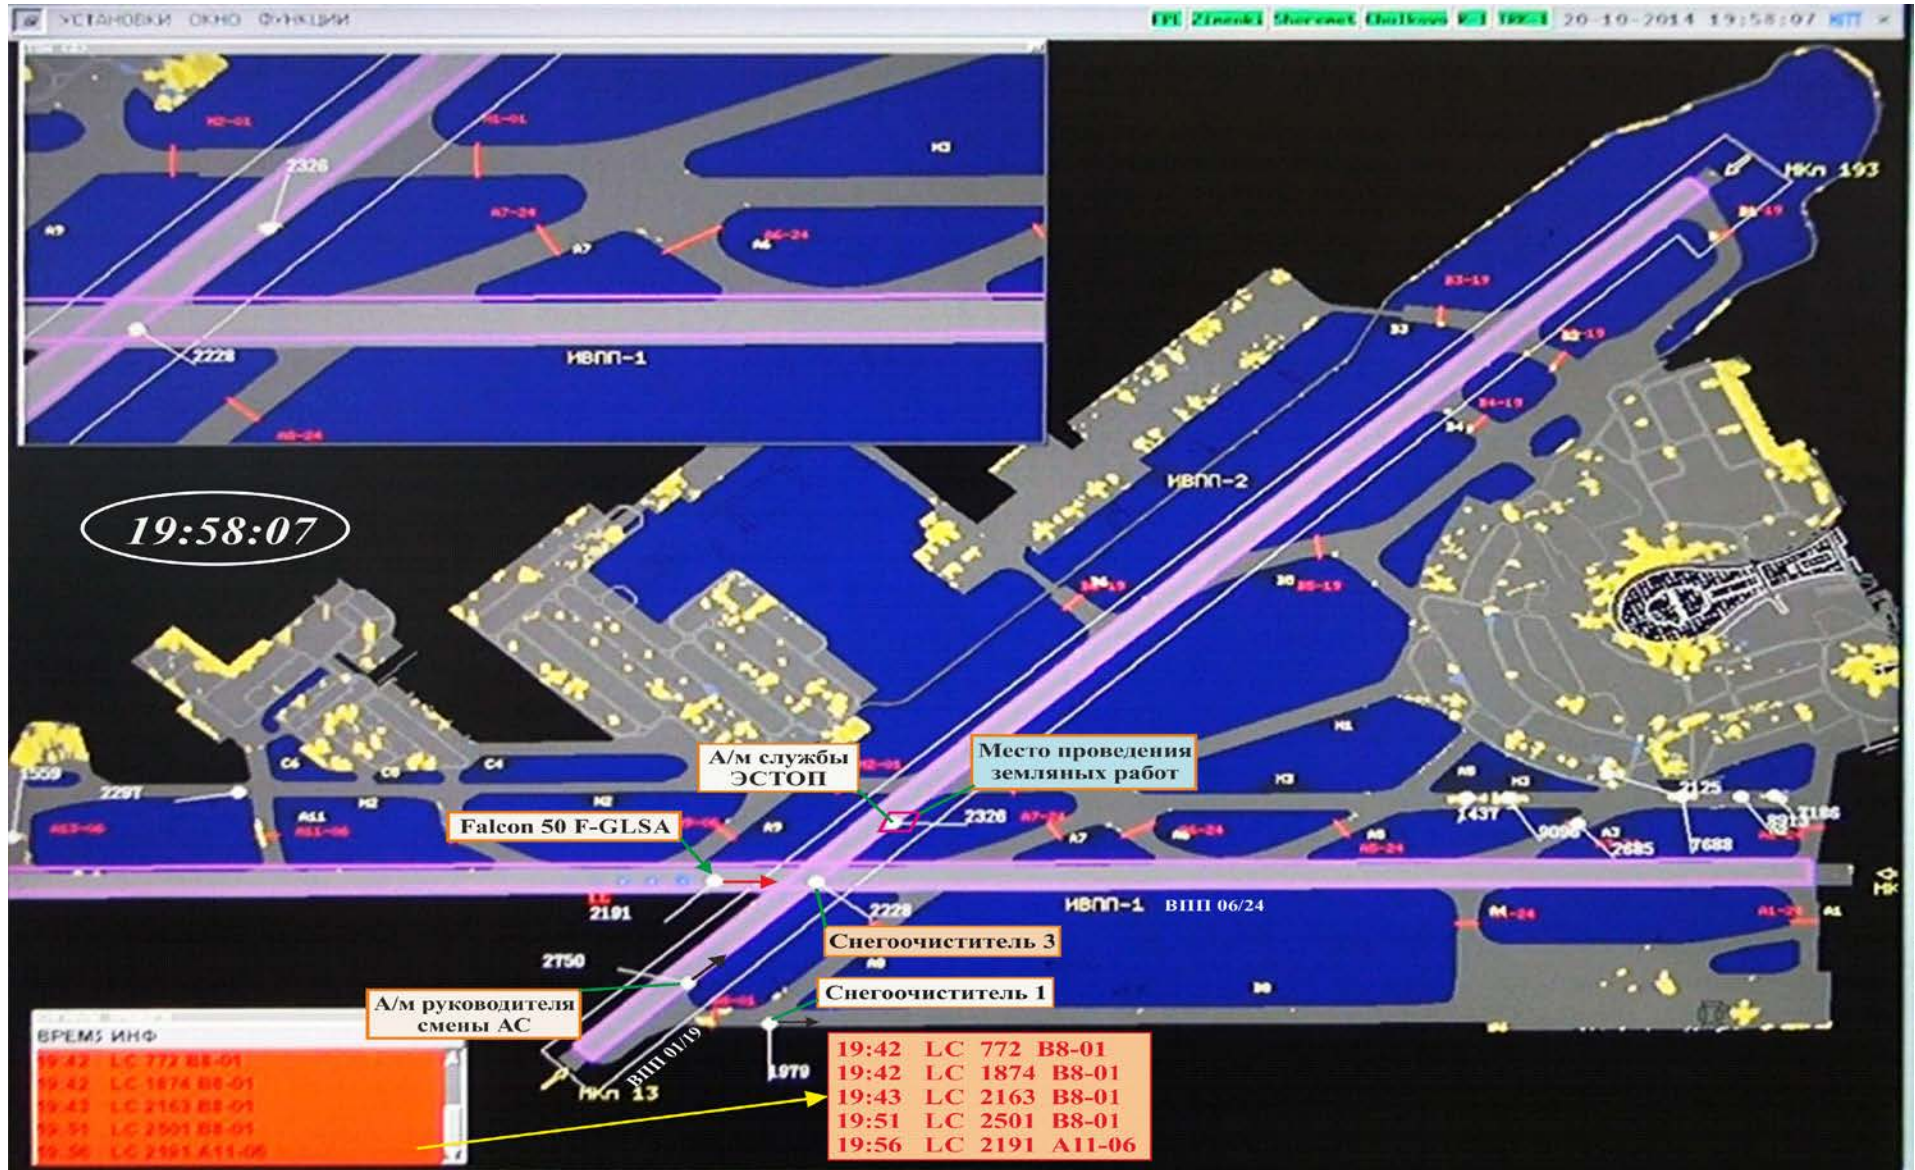
Based on the records of two surveillance cameras installed near Checkpoint 4 it was determined that strobe lights and headlights of snowplow 3 were constantly on (Figure 81).

Figure 81. Snowplow 3 stopping at 23:57:59 (19:57:59 UTC) at RWY 06 crossing

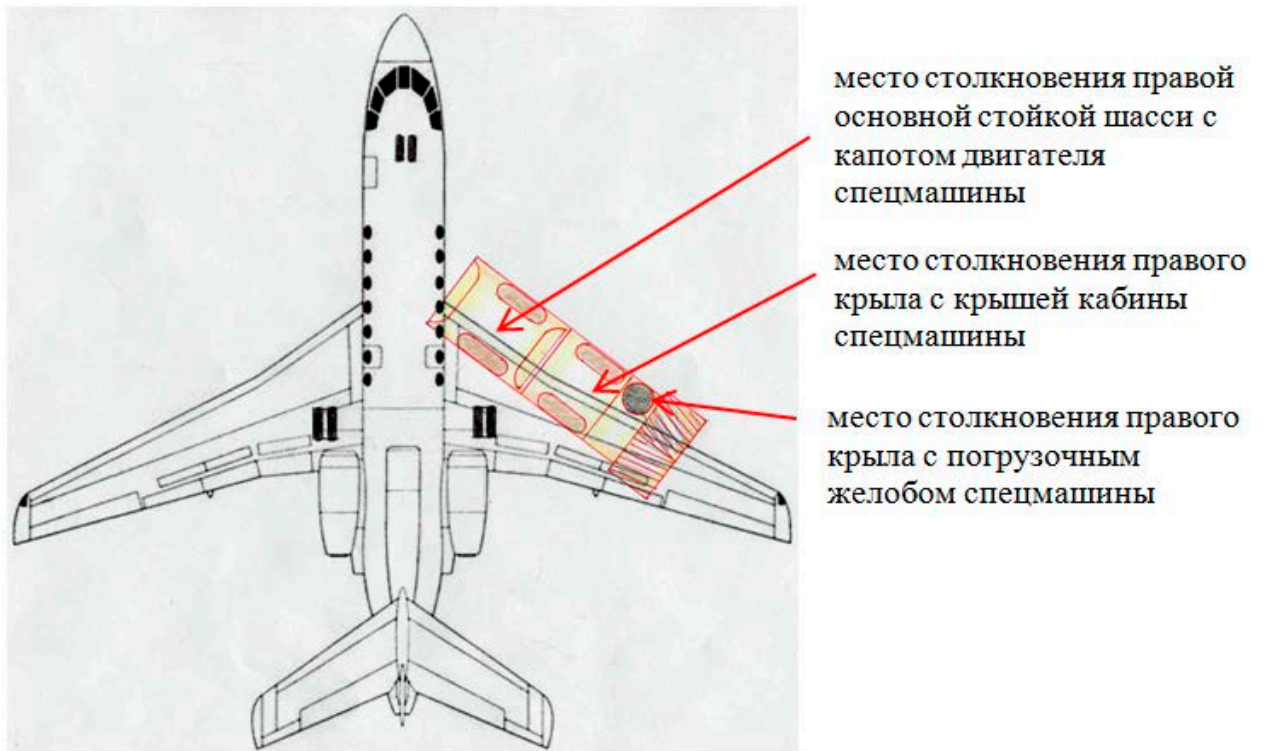
Figure 84. Collision of Falcon 50EX F-GLSA and snowplow 3

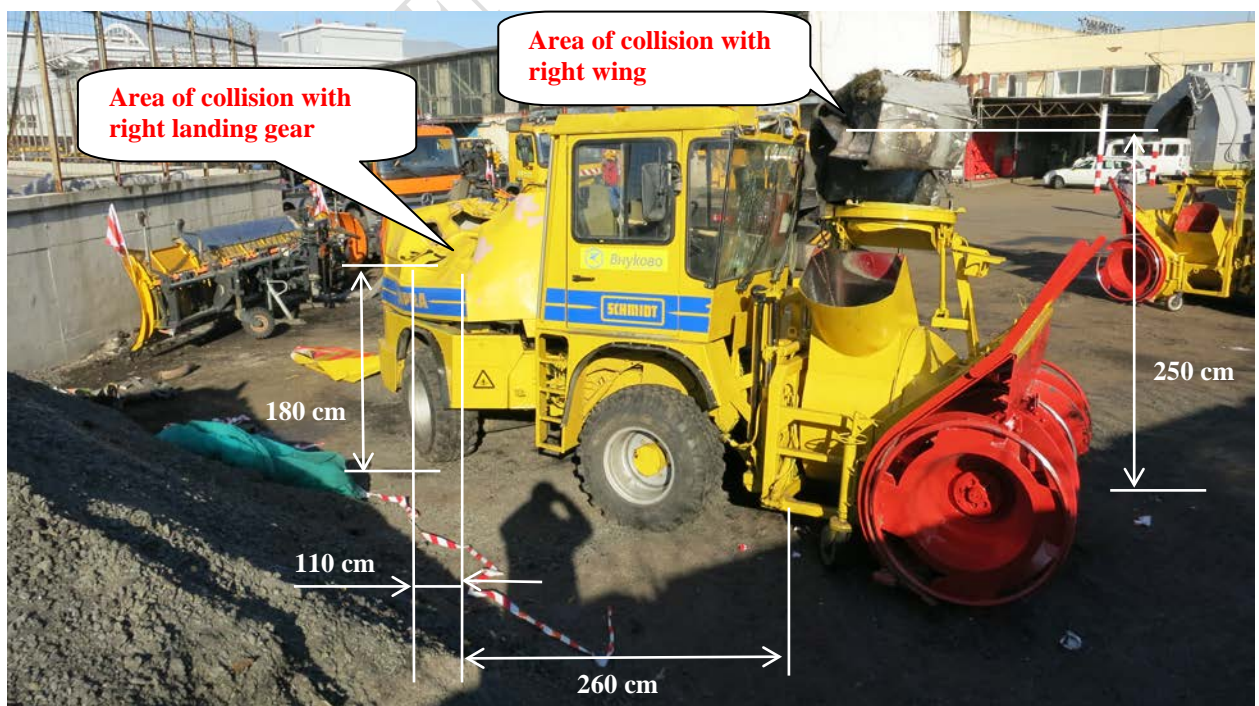
Figure 85. Location of aircraft parts hitting the snowplow

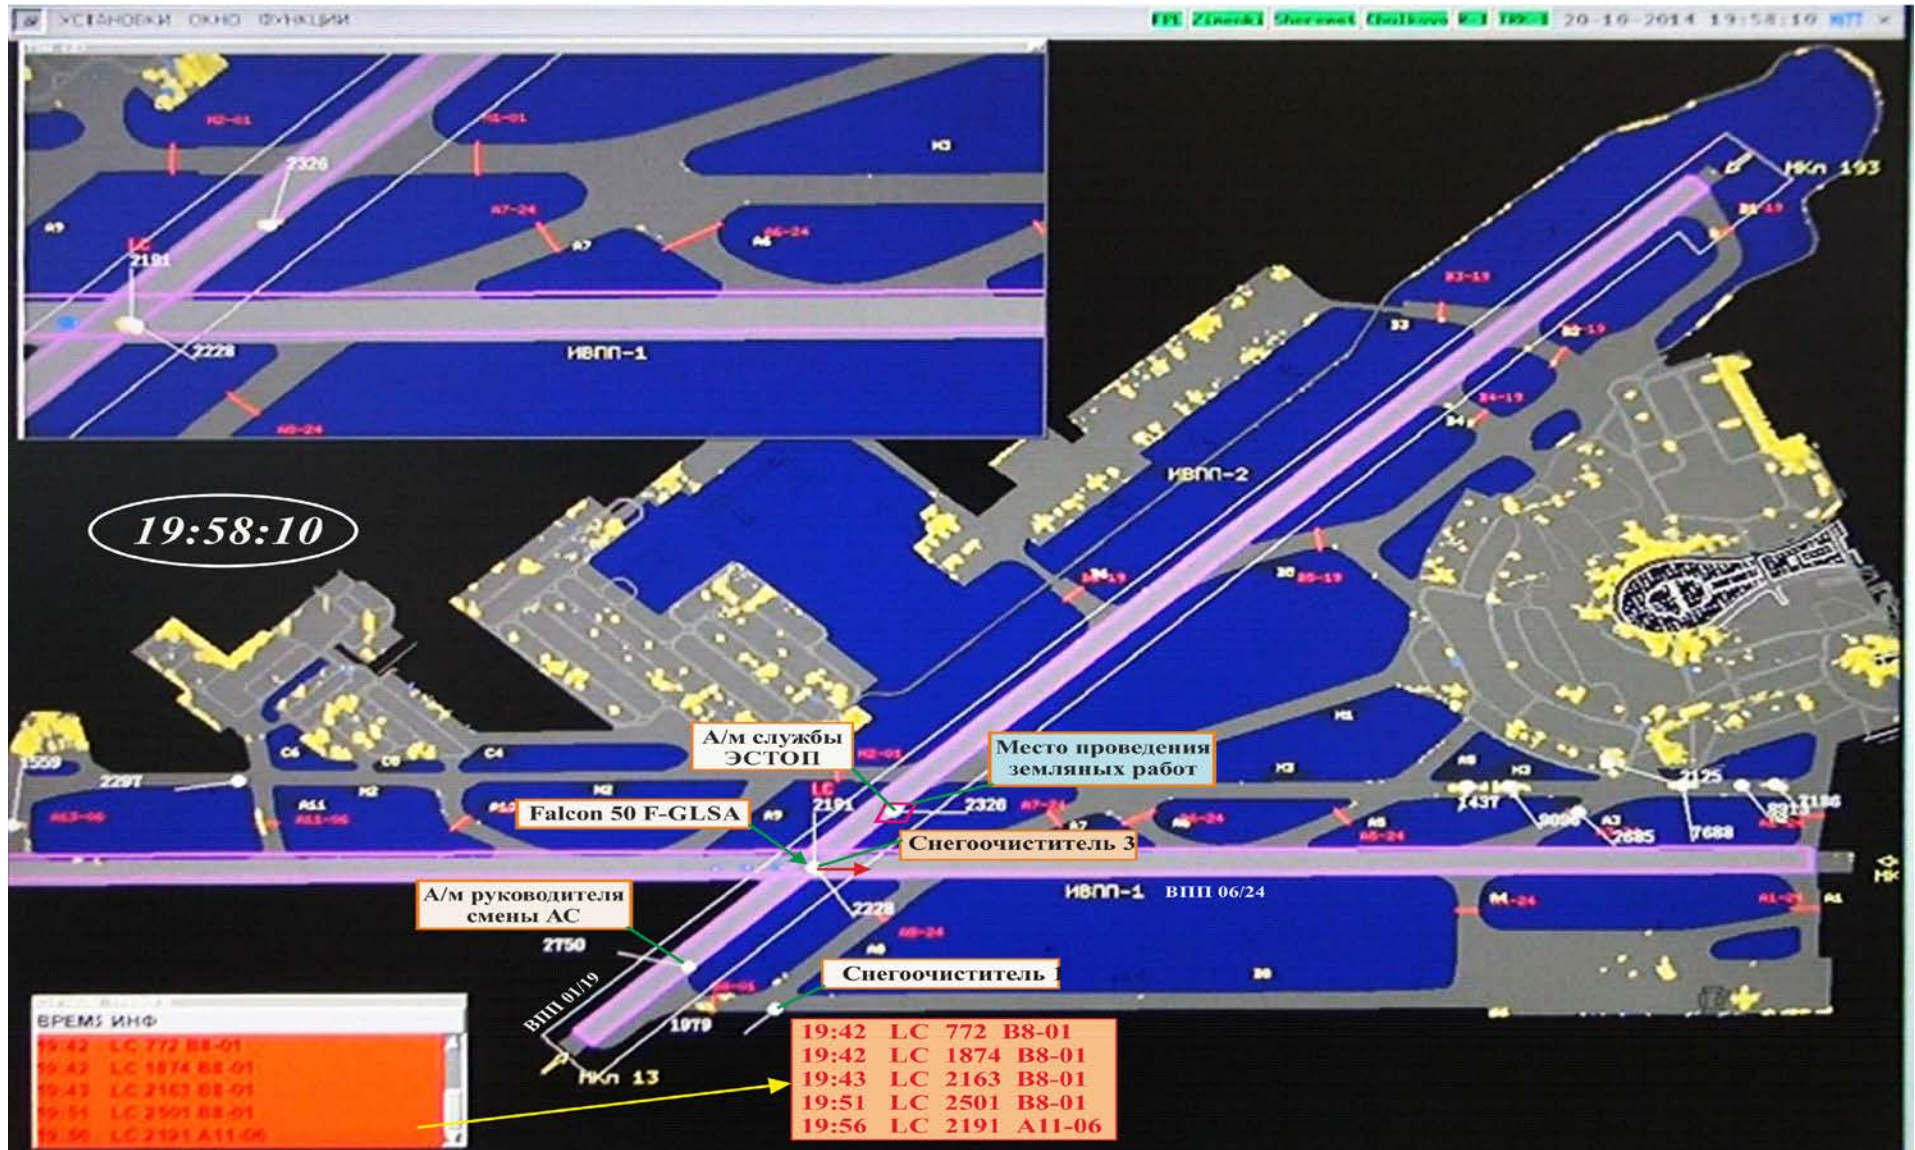
Figure 86. Location of objects at airfield Vnukovo as viewed from the departure controller screen at 19:58:10 during the Falcon-50EX F-GLSA aircraft collision with snowplow 3

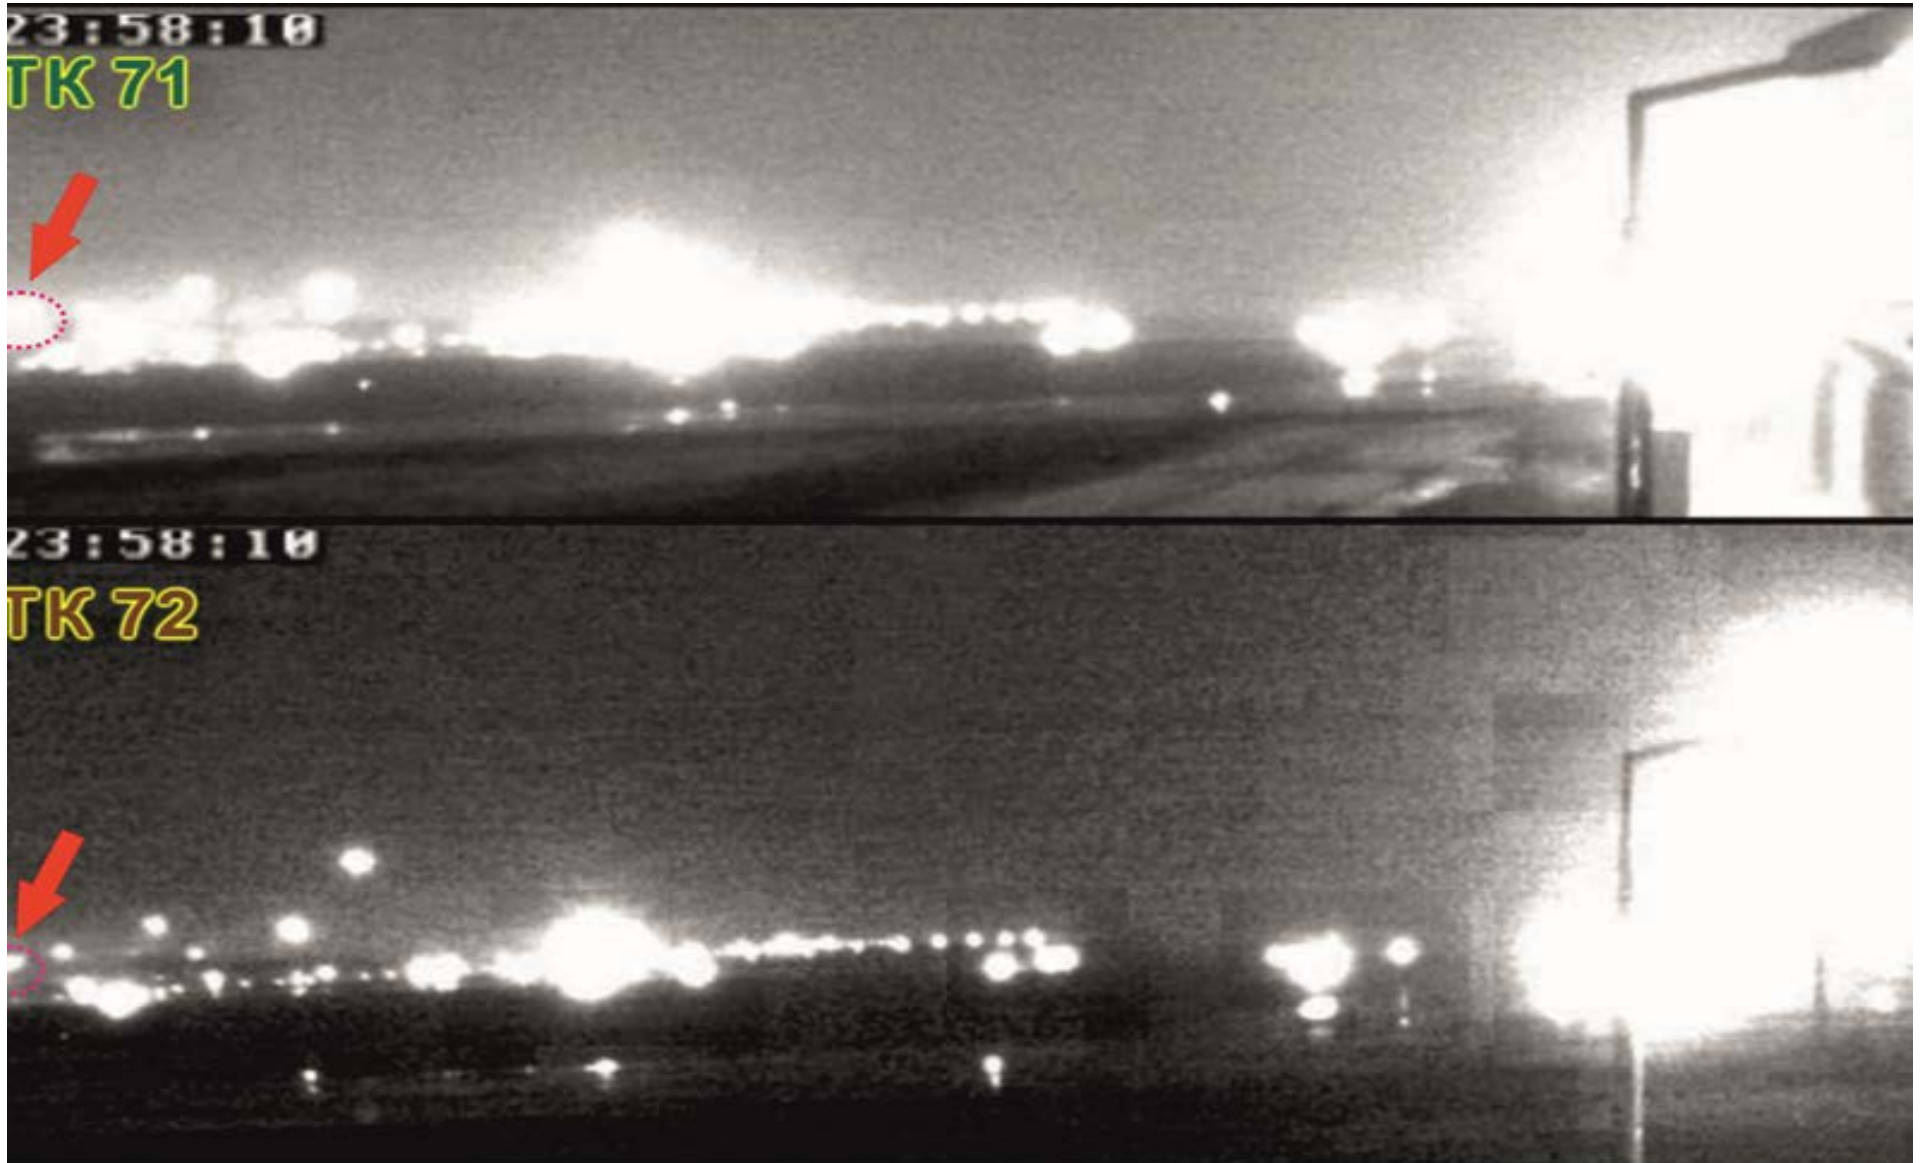
Figures 87 to 89 show the aircraft position recorded by airdrome surveillance cameras TK 071 and TK 072 at the moment of collision as well as 1 and 3 seconds afterwards.

Figure 87. Collision of Falcon 50 EX F-GLSA and snowplow 3 at 23:58:10 (19:58:10 UTC) (shown by arrows)

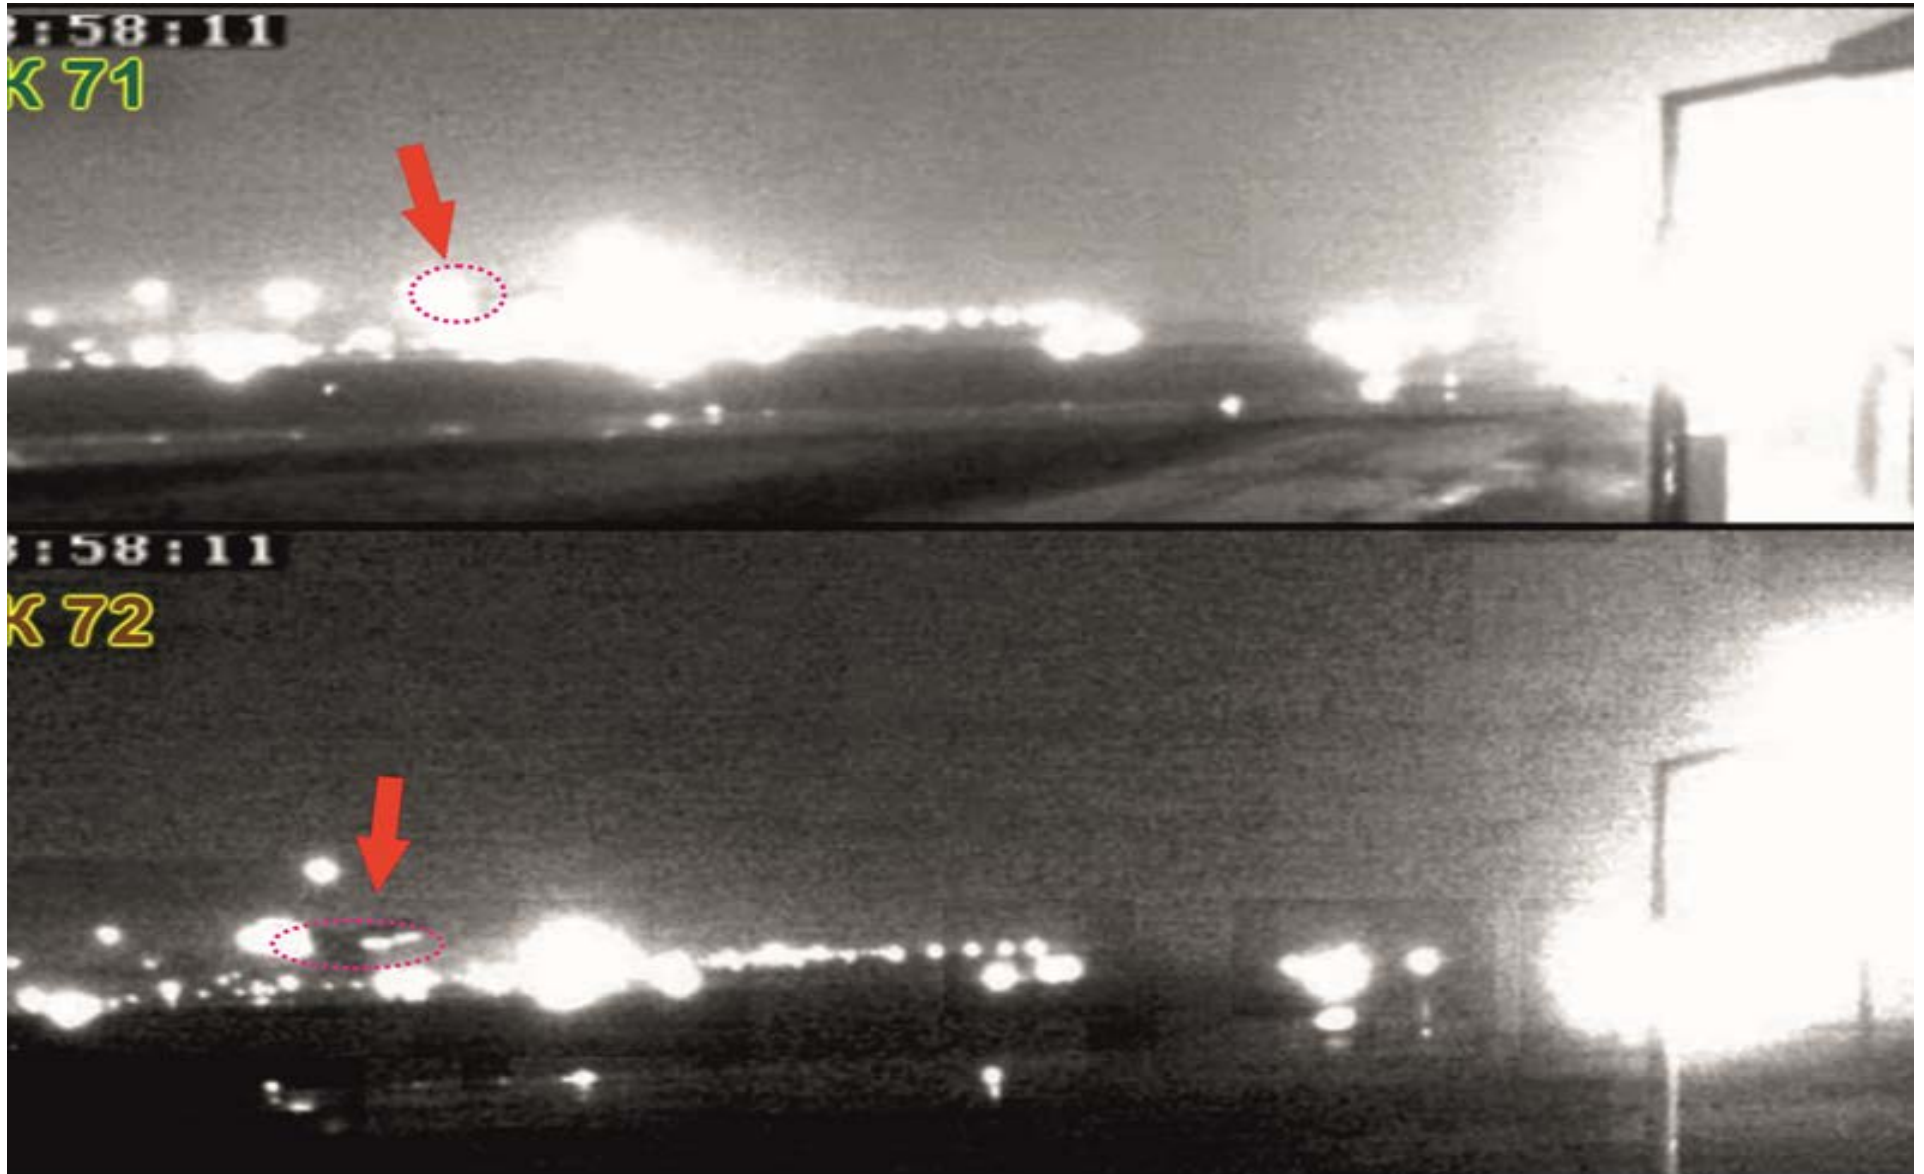
After the collision, due to the damage of the RH wing, the aircraft experienced abrupt right bank. Full left input of the control column by the crew could not counteract the right bank and after about 250 m, inverted, the aircraft hit the ground, crashed and caught fire.

Figure 88. Position of Falcon 50EX F-GLSA aircraft 1 second after the collision at 23:58:11 (19:58:11 UTC) (shown by arrows)

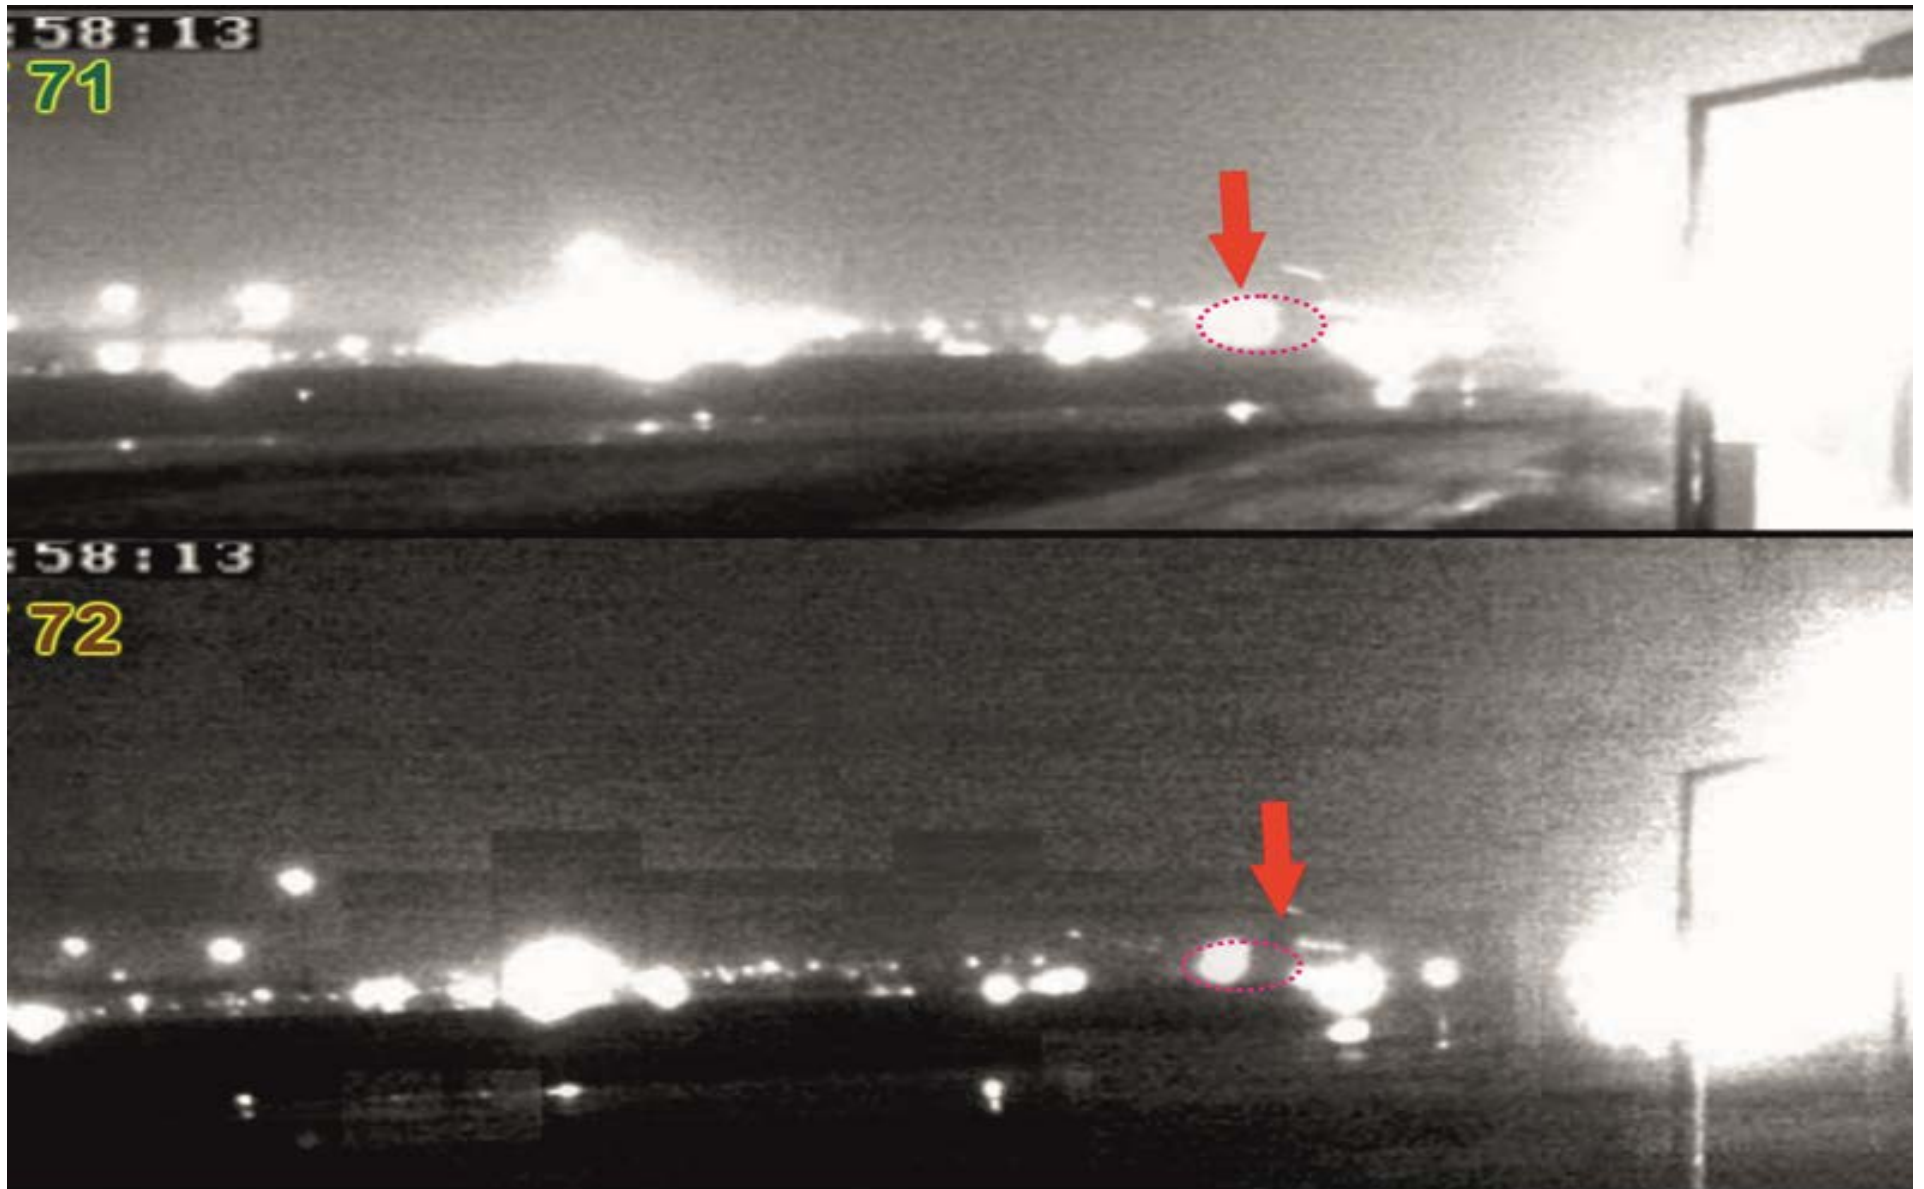
Figure 89. Position of Falcon 50EX F-GLSA aircraft 3 seconds after the collision at 23:58:13 (19:58:13 UTC)
