This document is an English translation of the Final Report on the fatal accident involving the Falcon 50EX aircraft registered F-GLSA that occurred on October 20, 2014 at Vnukovo Airport, Moscow.

INTERSTATE AVIATION COMMITTEE

FINAL REPORT

Type of occurrence	Fatal accident
Type of aircraft	Airplane, Falcon 50EX
Registration	F-GLSA
Owner	Unijet Airline
Operator	Unijet Airline
Place of occurrence	Russia, Moscow (Vnukovo) Airdrome , coordinates: N 55°35'29,66", E 37°15'41,12"
Date and time	20.10.2014, 19:58 UTC (23:58 local time), night time

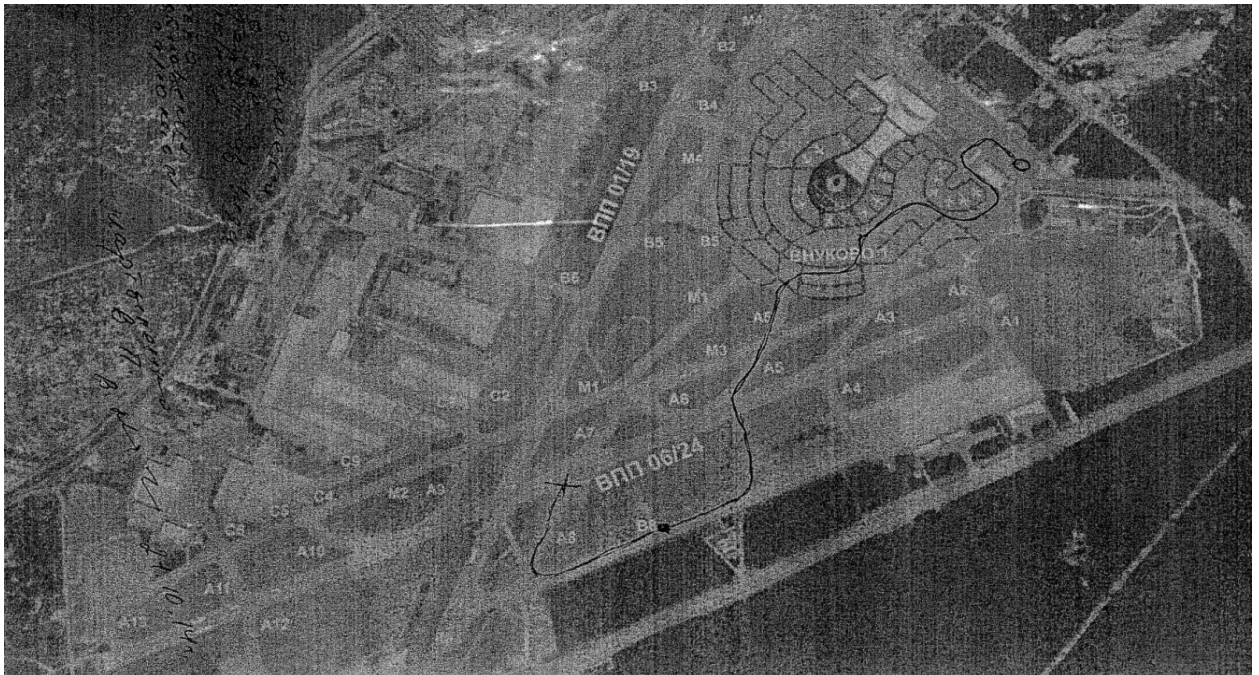
Evidence of loss of situational awareness of snowplow 3 driver is the path of his vehicle along the airfield (Figure 90) that he attached to the interrogation protocol as of 21.10.2014. The

path drawing provided by snowplow 3 driver is not consistent with his actual movements as per the data from airfield surveillance radar (Figure 91).

Figure 90. Vehicle path attached to snowplow 3 driver's interrogation protocol

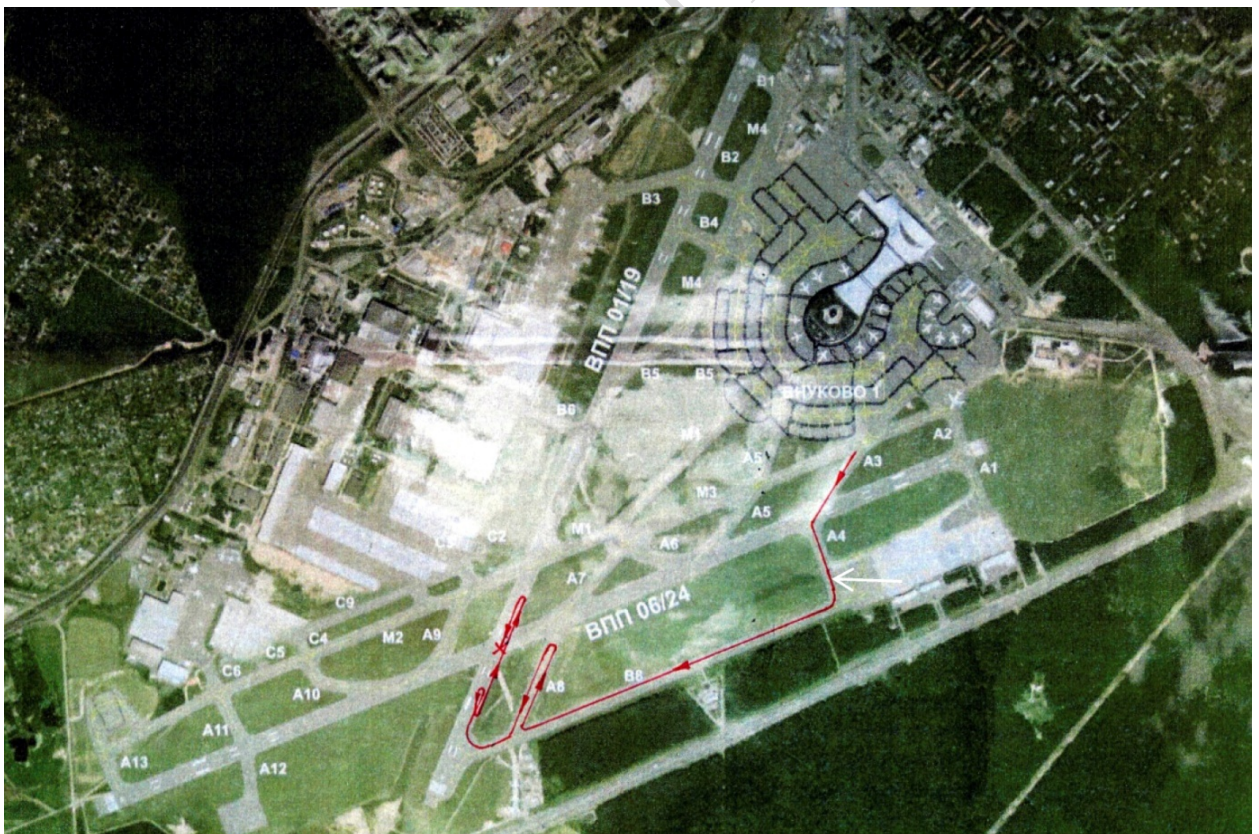
Figure 91. Snowplow 3 path as per the airfield surveillance radar data

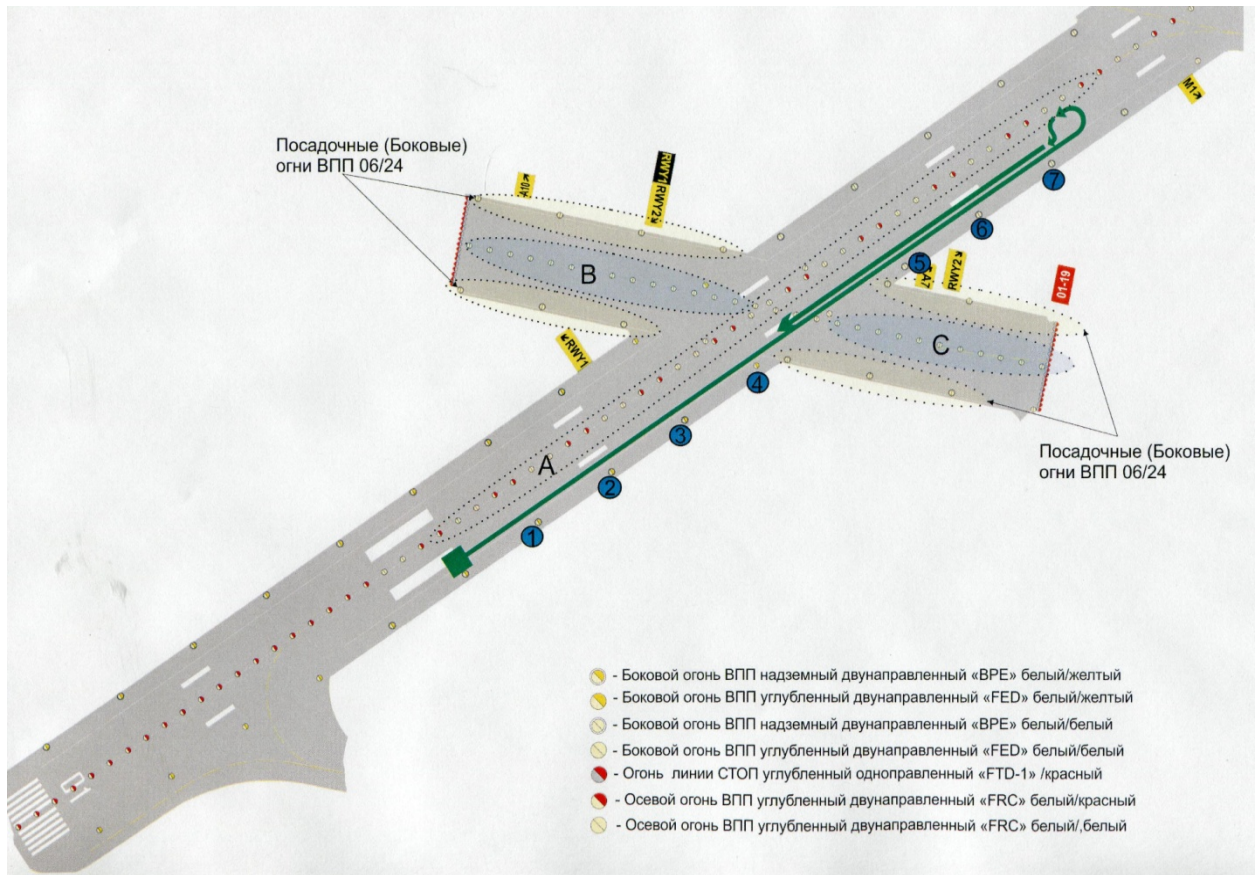
The investigation team also analyzed the actual path of snowplow 3 after the airdrome service shift supervisor lost control over it with regard to the location of runway lights and various airdrome signs (Figure 92) that could have helped the driver to regain situational awareness.

On approach to RWY 1, on the left of RWY 2 there is an airdrome sign with a black inscription RWY 1 and an arrow on the yellow background (AON-92, Para 6.2). According to the information of the electrical and lighting service of Vnukovo AP the sign was illuminated at the time of the accident. When moving from Light 4 to Light 5 there appear RWY 1 centerline lights, equipped with two-directional high-intensity recessed white lights FRC-2-090 set at an interval of 15 m and diverging to the left (B lights group) and to the right (C lights group).

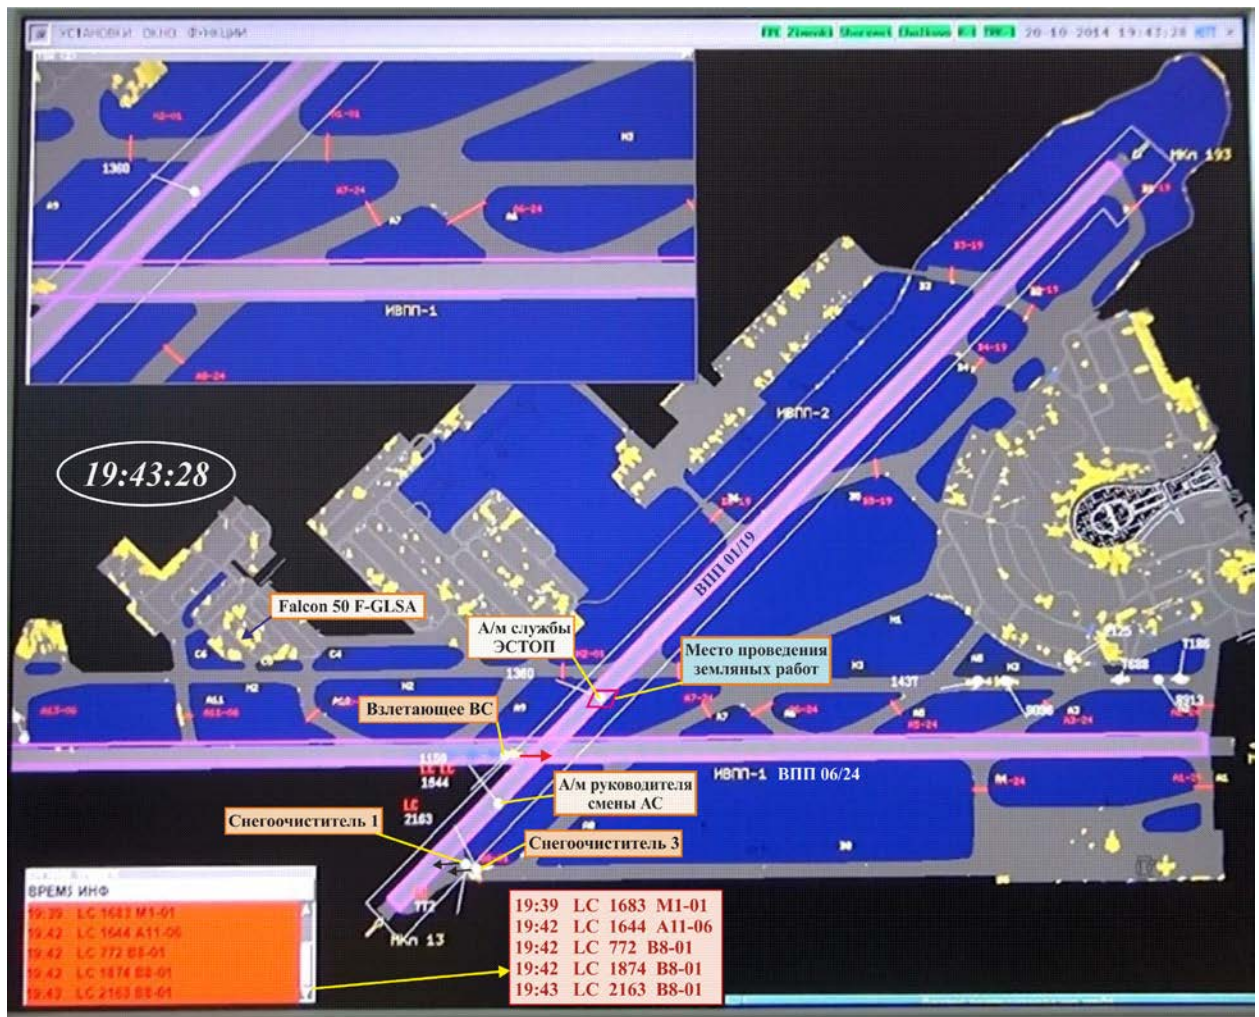
As the vehicles crossed the B8-01 Reserved Line³⁶ and during the incursion of RWY 2 (that was not in use) mentioned above, the A3000 screen of the departure controller indicated, among others, the following alerts (Figure 94):

Figure 94. TRADIS indicator on departure controller's WP at 19:43:28
(light red table shows information in the alert list)

Controllers at the departure controller's WP did not react to the appearance of these alerts. Like in case with the ground controller, the documents regulating the departure controller's duties did not determine their actions when alert signals appear on the screen. Moreover, it is not possible to manage the TRADIS system (including acknowledgement of alert messages) from the Departure ATC position. As was described in Section 1.8.2.1, acknowledging alerts was only possible from the departure ATS working position. This is also true for the screen settings (the picture shown and the setting modes at departure ATC and departure ATS are identical, but it could be managed only from the departure ATS WP) that is after the sectors had been joined proper use could only be provided from the departure ATS WP which had not been considered in the working instruction of the departure controller when the decision to join the sectors had been taken.

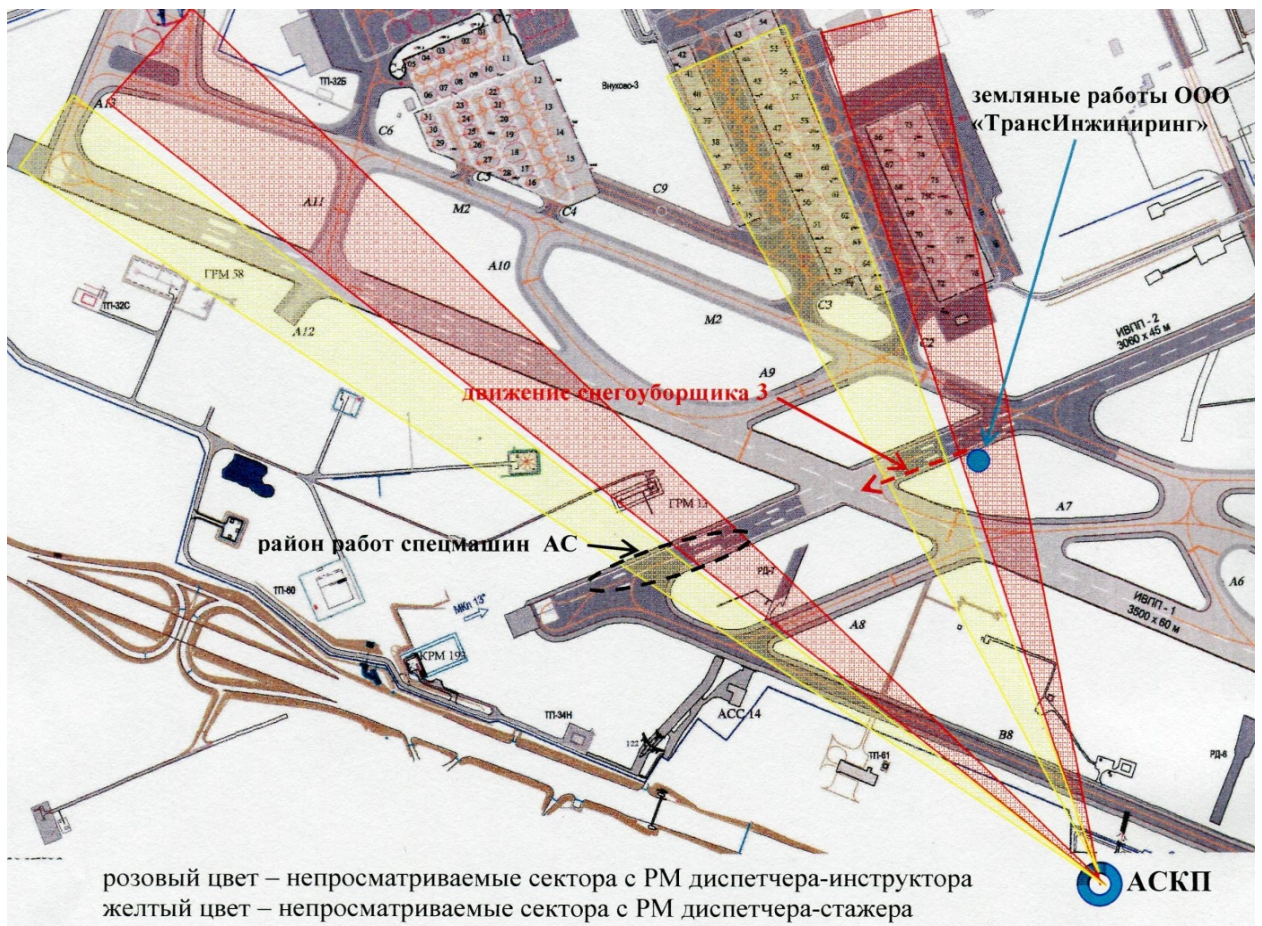
Figure 95. Sectors where visual observation is obstructed from departure ATC WP

It can be seen in the Figure that the area where the snowplow 3 was before entering the runway was in the obstructed visibility area from the departure controller's working position. As the control room is located 37 m above the ground the visibility range could have been further reduced due to complicated weather conditions at Vnukovo AP at the time of the accident (clouds with rough cloudbase: 30 m on threshold 24 and 70 m on threshold 06 of RWY 1, light drizzle and fog, night time). This situation is regulated by Para 5.2.2 of FAR-293: "A controller, visually monitoring the aircraft movement shall have complete visual range of the controller area from their working position. In case it is impossible to ensure complete visual observation of the control area from a certain working position there shall be technical means of monitoring or additional air control offices (sectors)." In the considered case the A3000 system ensured required monitoring of the complete control area of the departure controller. However, use of technical means of monitoring as addition to visual observations required additional training of controllers on the usage of the means, including attention allocation, which was not ensured in the case under consideration.

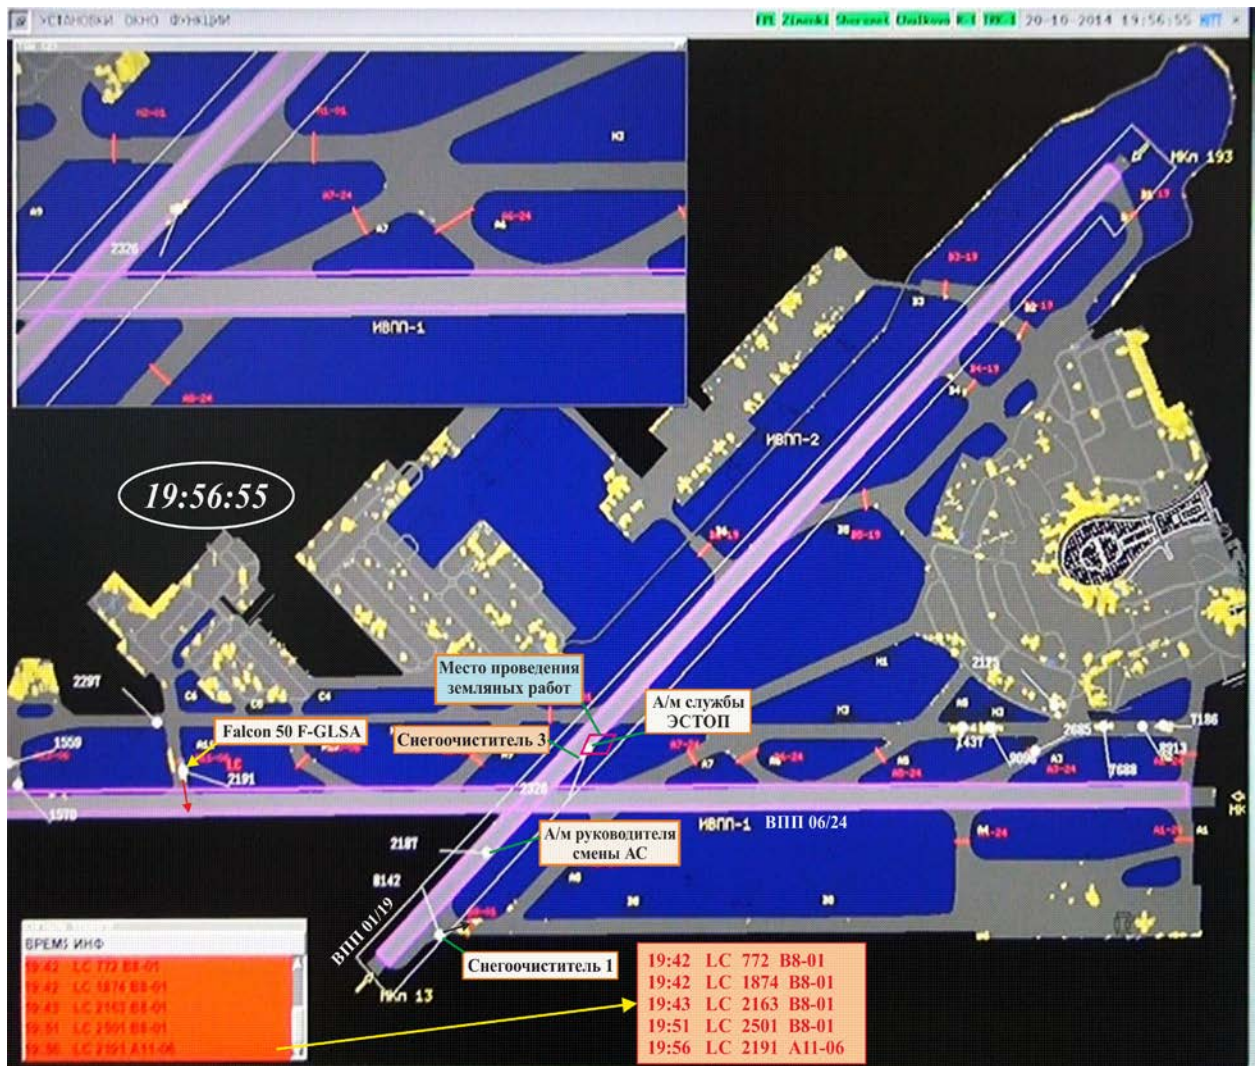
Figure 96. Location of objects at airdrome Vnukovo as viewed from the departure controller screen at 19:56:55

It is also clear from Figure 96 that after the aircraft crossed the Reserved Line between TWY A11 and the RWY, the controller's screen indicated the pertinent alert (track number 2191 belonged to Falcon 50EX F-GLSA aircraft). This alert was not acknowledged by the controller.

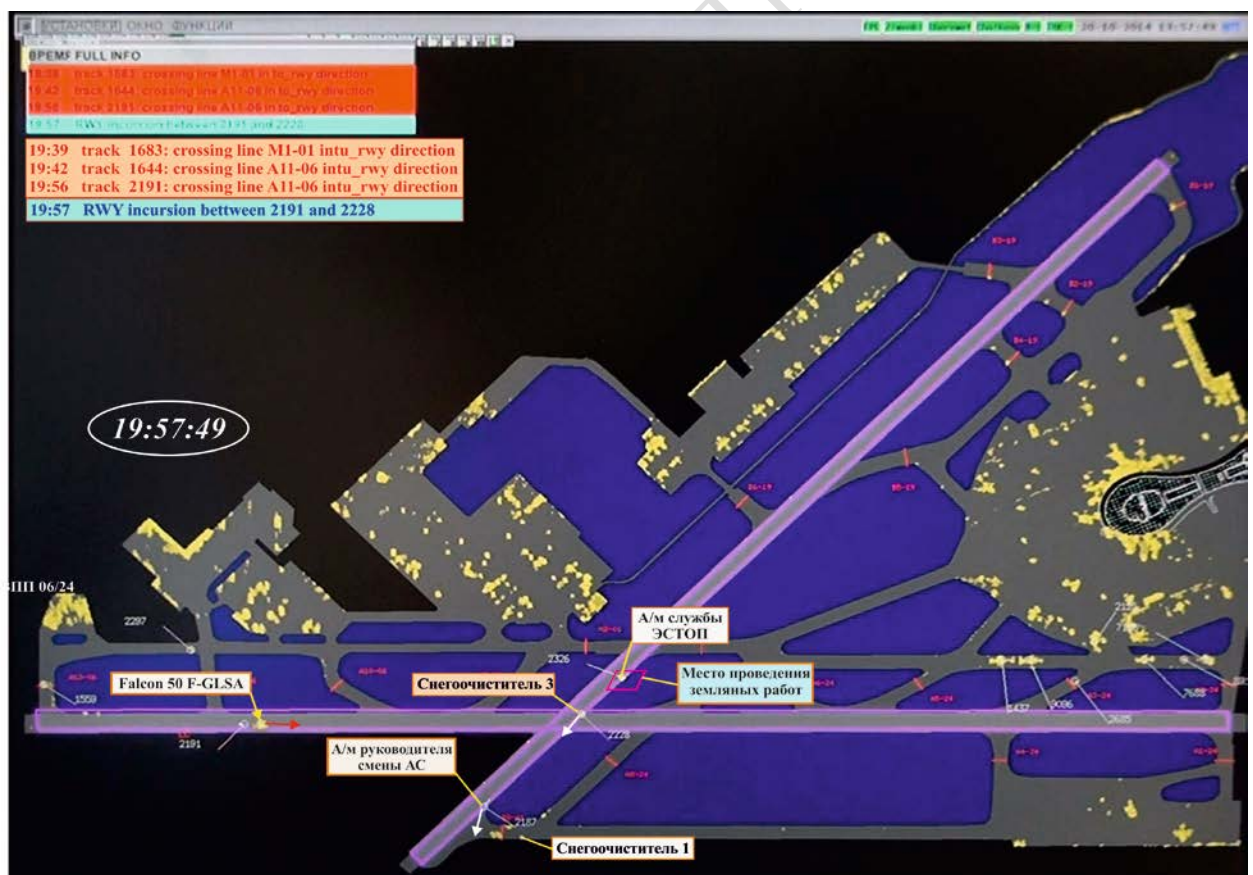
At 19:57:49, after the aircraft had started takeoff roll and the A3000 system had identified snowplow 3 as track number 2228, there was an alert message generated on the ATC shift supervisor's screen. The following indication was to appear on the screen: "19:57 runway incursion between 2191³⁸ and 2228³⁹." The message first should have appeared on the light blue background and then on the amber one (Figure 97 and Figure 98) accompanied with an aural alert.

Figure 97 Location of objects at airdrome Vnukovo as viewed from the ATC shift supervisor's screen at 19:57:49

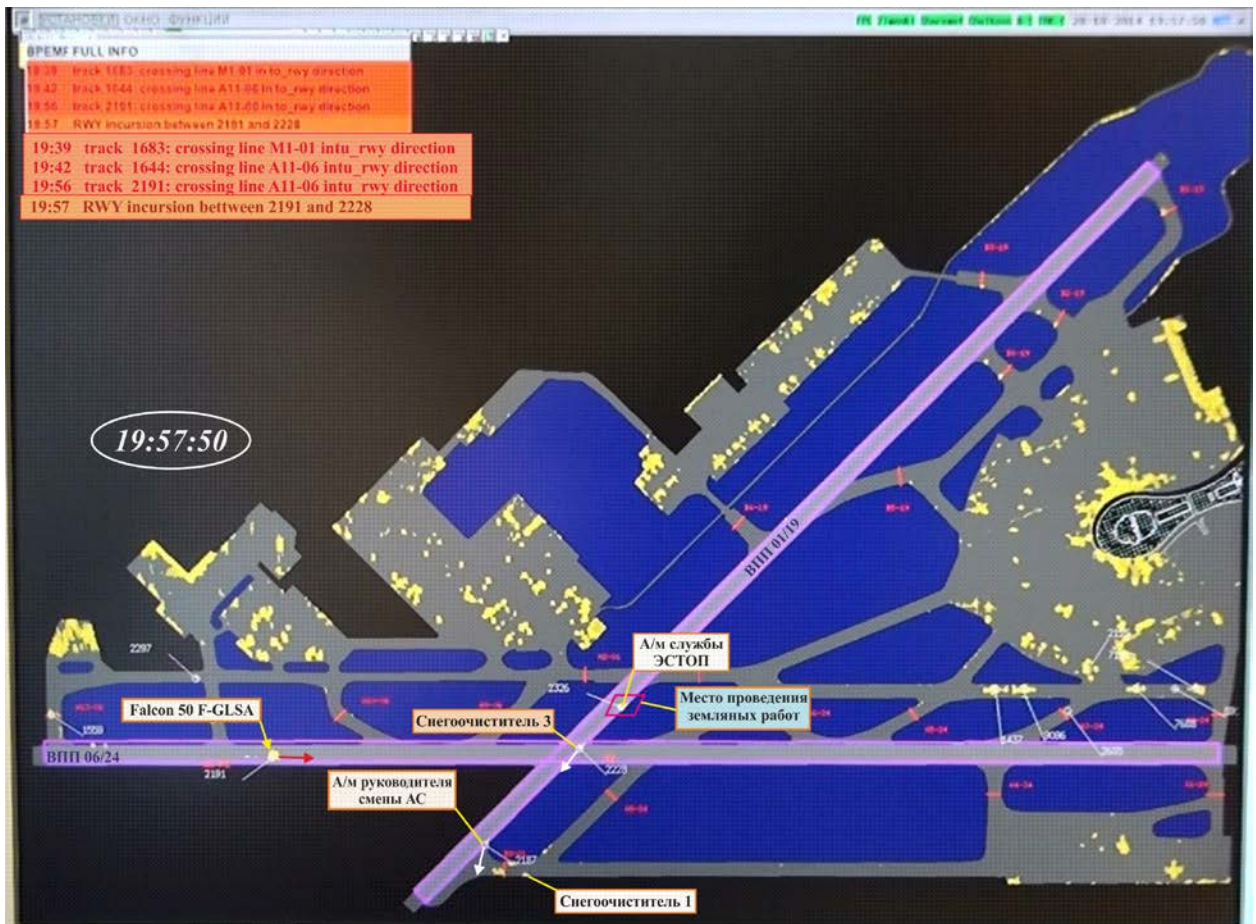
Figure 98. Location of objects at the Vnukovo airdrome as viewed from the ATC shift supervisor's screen at 19:57:50
