## PART 1.4 – ANALYSIS AND FINDINGS

1.4.5 The accident involving Hawk aircraft XX177 was a complex event. Whilst a failure in the ejection sequence led to the Pilot sustaining fatal injuries, the Panel has determined that **the accident event was the initiation of ejection**. The analysis and findings are grouped under the following headings:

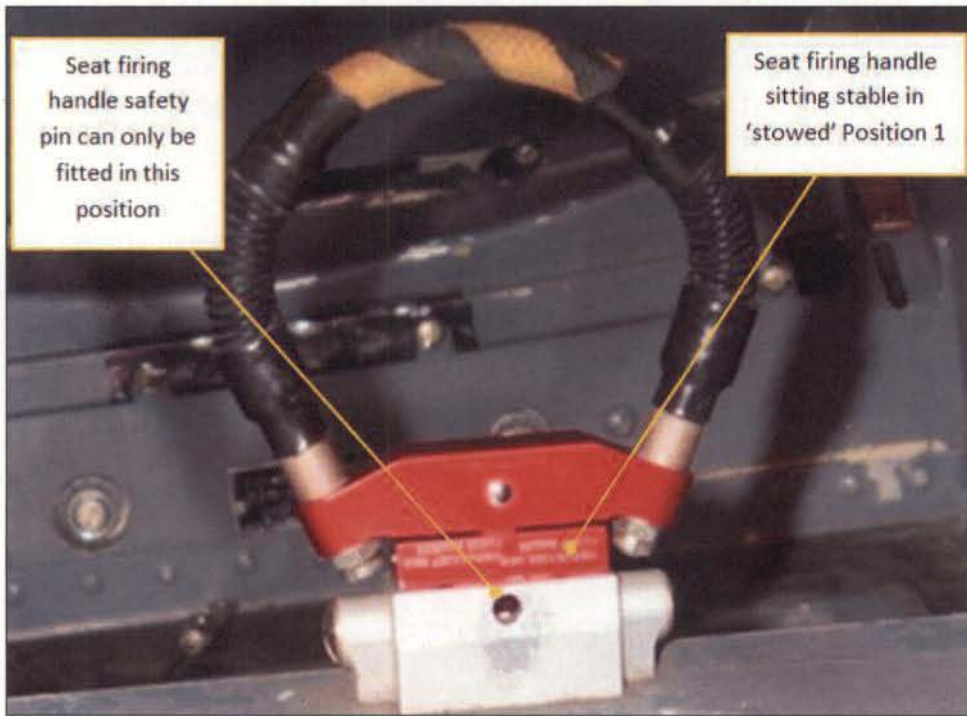
Figure 14 – Position 1.

1.4.2.7. **SFH Movement and Positions.** The scuffing marks found on the right side of the SFH body sub-assembly suggested that the SFH had been held out of the normal stowed condition (see Figure 14). Testing established that the SFH could be positioned in a number of

- a. **Position 1.** SFH stowed in the housing (see Figure 14).

Position 2 was found to be a relatively stable condition, whereby the SFH could be moved in a variety of ways and would remain in that position unless pulled vertically upwards to initiate ejection or pushed downwards to re-stow the handle. Position 3 was found to be less stable, whereby movements could displace it in one of two ways: by returning the SFH to Position 2 or overcoming seat firing unit spring pressure to withdraw the seat and initiate ejection. It was also found that in Position 3, movement of the SFH in a forward direction, away from the pilot, could initiate ejection; this was not possible from Position 2. The majority of operators and engineers would have had no reason to recognise the specific unsafe positions referenced in this report (Positions 2 and 3). However, they were aware that the only position they should expect to find the SFH in was with the handle fully housed (safety pin inserted in to the handle and housing, or removed for flight). Any other condition, if discovered, would be assessed as being unsafe. Moreover, the ability to initiate ejection by anything other than a vertical pull, was unknown. The Panel concluded that had the information regarding Position 2 and 3 been more widely known, including the possibility of initiating ejection through a forward movement, different procedures and training could have been introduced which may have made the discovery of the SFH in an unsafe condition more likely and was therefore **a contributory factor**.

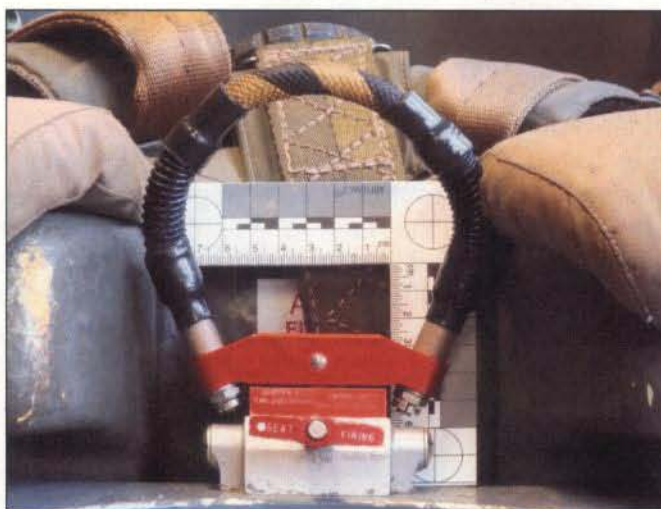
Figure 18 Front View– SFH in stowed position 1 with safety pin inserted.

1.4.2.11. **Fitment of SFH Safety Pin.** It is impossible to move the SFH from Position 1 with the safety pin inserted correctly through the housing and SFH, see Figure 18. There are two scenarios where the SFH safety pin should be moved:

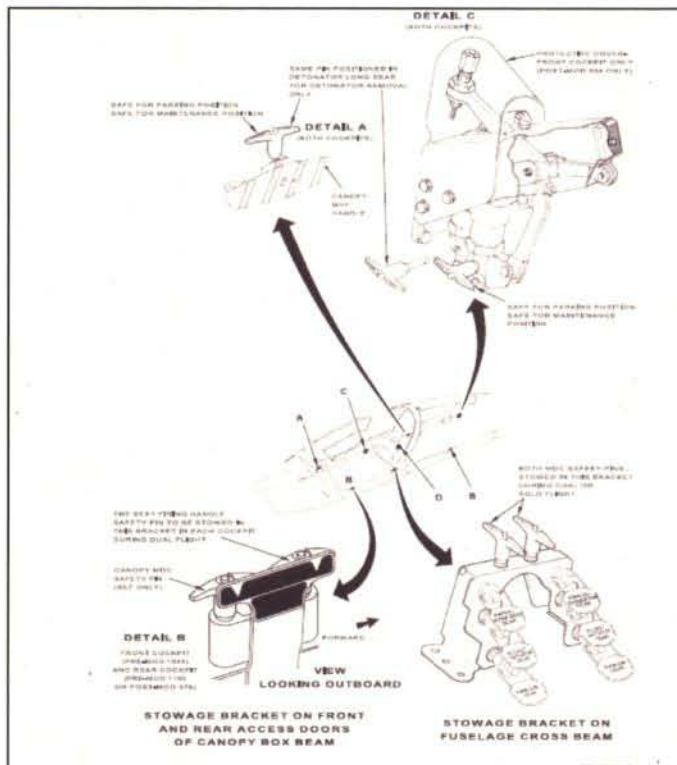
Figure 19 – Safety Pin Stowage Locations.

b. **During 'Flight'.** The SFH safety pin should be removed and stowed alongside the MDC pin in the cockpit stowage during every flight, see Figure 19. The Flight Reference Cards (FRCs)<sup>5</sup> state that this should be done after strapping-in is complete, the canopy is closed and before engine start. The pin is usually re-inserted into the SFH through the housing as part of the after landing checks.

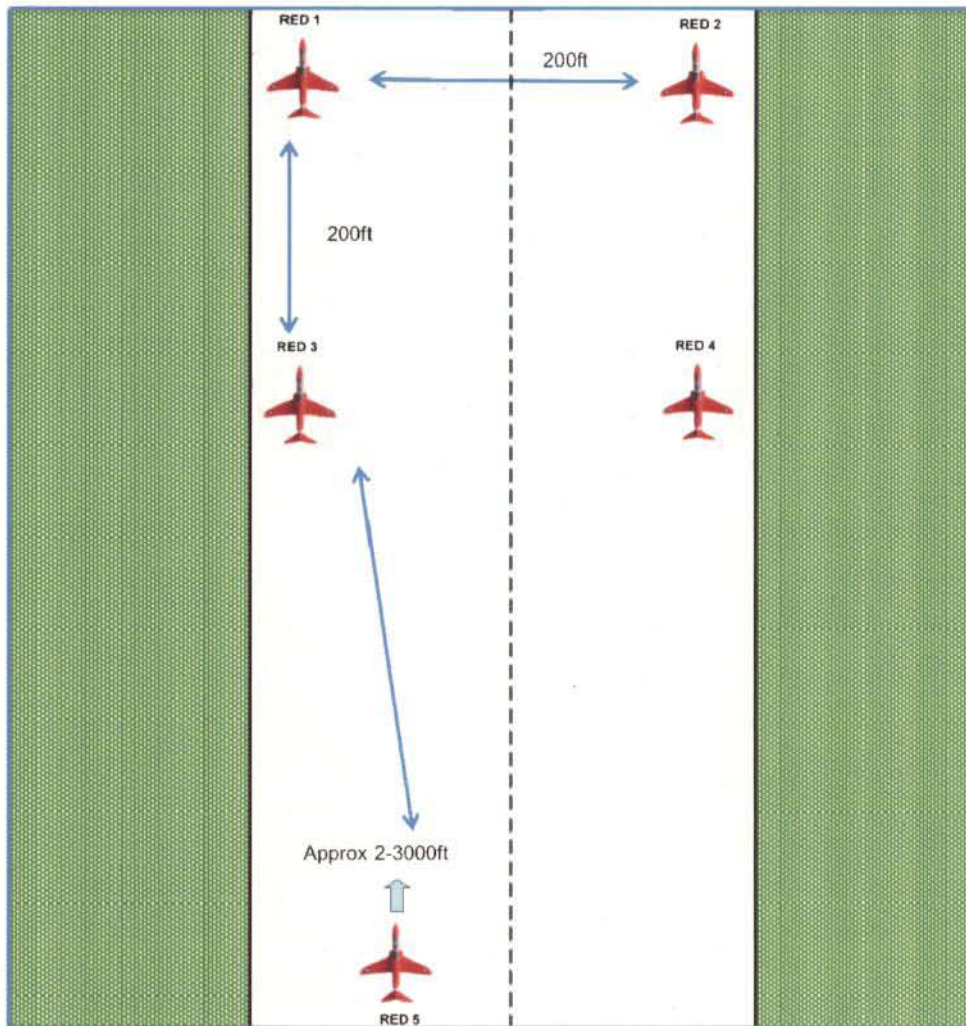
Figure 28 – RAFAT Landing Sequence.

1.4.2.22. **Safety Pin Insertion into SFH.** Witness evidence from other RAFAT pilots indicated that some pilots regularly inserted the SFH safety pin by feel without visual reference. Witness evidence indicates that once the final aircraft in the formation “knows that he is not going to be flying through or over shooting” he calls “clear cross”; this is an indication to the Formation that that they can start to taxi clear of the runway in close formation and that they can make their ejection seats safe. The last sortie prior to the accident was a five aircraft formation practice. The final landing was in number sequence with the accident Pilot, Red 5, piloting XX177 (see Figure 28). In order to make the ejection seat ‘safe’ following the final landing, the safety pin is usually inserted into the SFH and housing as part of the after landing checks. During MITL testing the ‘test’ pilot was tasked with inserting the SFH safety pin by feel alone whilst maintaining ‘eyes out’ of the cockpit to simulate a requirement for visual activity outside of the cockpit. This test was executed with the SFH in Position 2 and 3 and was carried out before the ‘test’ pilot was aware of the existence of Position 2 or 3. On each occasion the safety pin was inserted into the SFH only, leaving the ‘test’ pilot unaware that the ejection seat remained ‘live’. It is normal to move the control column forward to gain access to the SFH for safety pin insertion. The ADR trace from XX177 (4 Nov 11 final sortie) was analysed and showed a forward control column input, consistent with this movement, at 50 knots airspeed (see Figure 29). Although the time of safety pin insertion into the SFH cannot be definitively established, it is the view of the Panel that the safety pin was most likely inserted into the ‘unsafe’ SFH on roll-out from landing. Due to the speed of XX177 and subsequent rate of closure to the aircraft ahead, it is likely that the Pilot inserted the SFH safety pin by feel whilst maintaining eyes out of the cockpit. The Panel concluded that the practice of inserting the SFH safety pin without visual reference is likely to have decreased the probability of discovering the SFH in an unsafe condition or incorrect strap routing and was **a contributory factor** in the accident.
