**COMMITTEE FOR THE RE-INVESTIGATION
OF THE SMOLENSK AIR CRASH**

TECHNICAL REPORT

**Facts regarding the crash of the TU-154M No. 101,
(Fight PLF101), that took place in Smolensk, Russia on the 10th of April 2010**

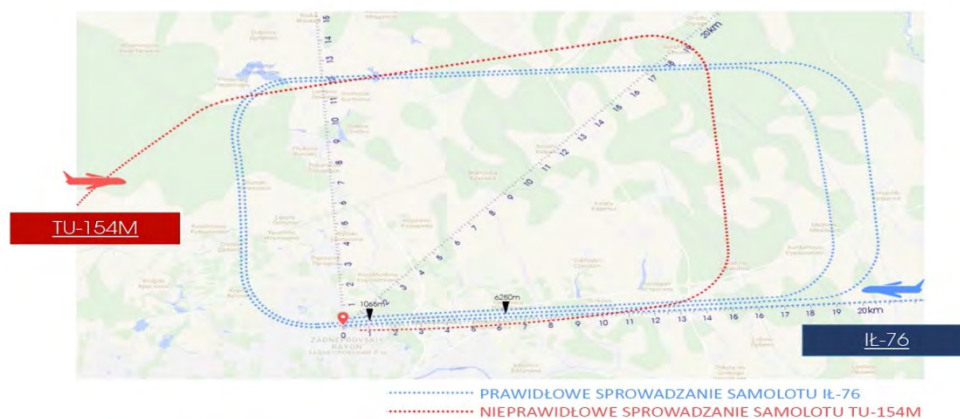
Fig. 1. Comparison of guidance of IL-76 and TU-154M on April 10th, 2010.

Yak-40 and IL-76 and TU-154M were guided with the use of a well-functioning, precision approach radiolocation station and properly functioning radio technical devices.

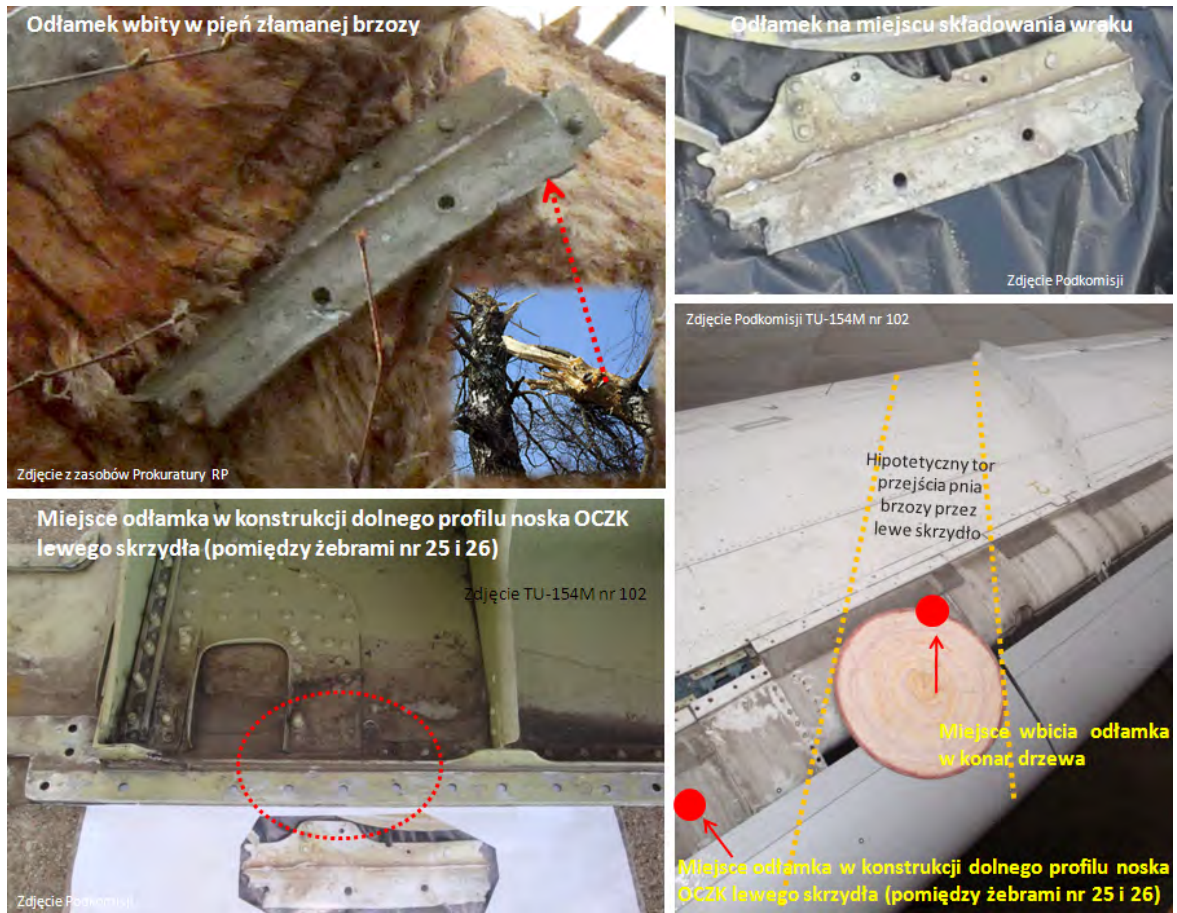
One of the elements rammed into the trunk of the so called Bodin birch does not come from the hypothetical place of contact between the wing and the birch, and was identified as an element in the construction of the plane being 70cm closer to the fuselage, than then place of contact described by the MAK and Miller reports. (Fig. 5).

Fig. 5. The place in the wing construction of the piece rammed into the so called Bodin birch tree.

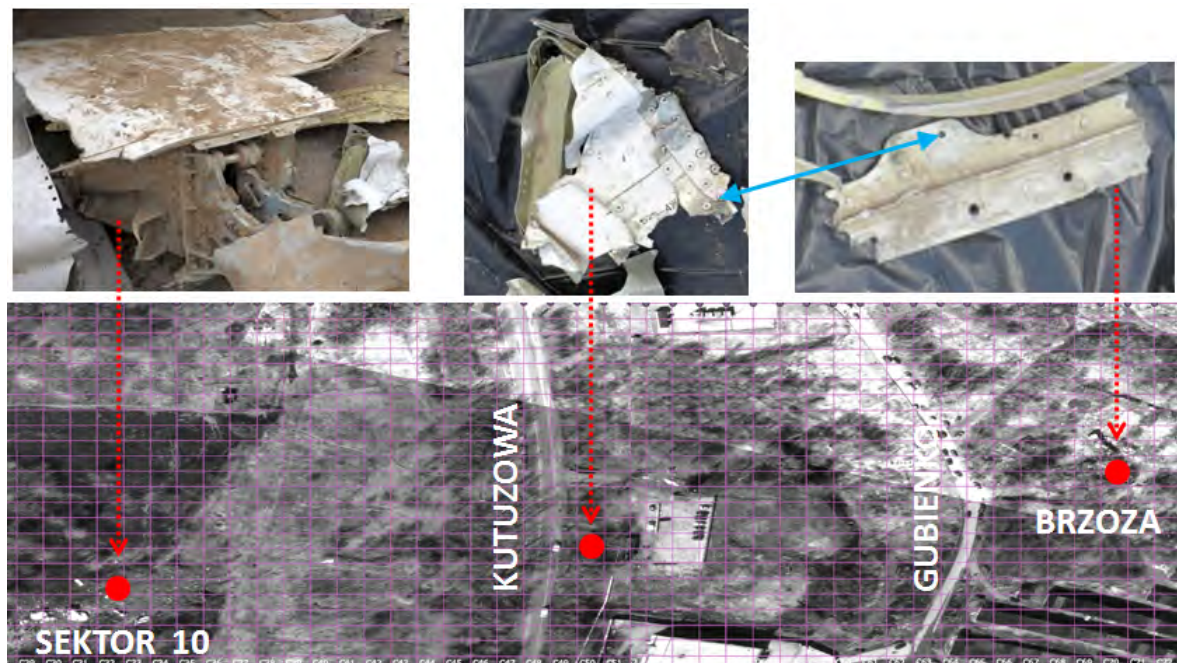
A piece of the skin of the nose, to which the piece rammed into the birch tree trunk was attached, was identified over 200m further in the direction of flight-next to the Kutuzov street. A fragment of the spar, to which this piece was attached, was identified 400m further in the direction of flight in sector 10. (Fig. 6).

Fig. 6. Position on the ground of neighboring elements in the wing construction to the debris rammed into the trunk (bb).

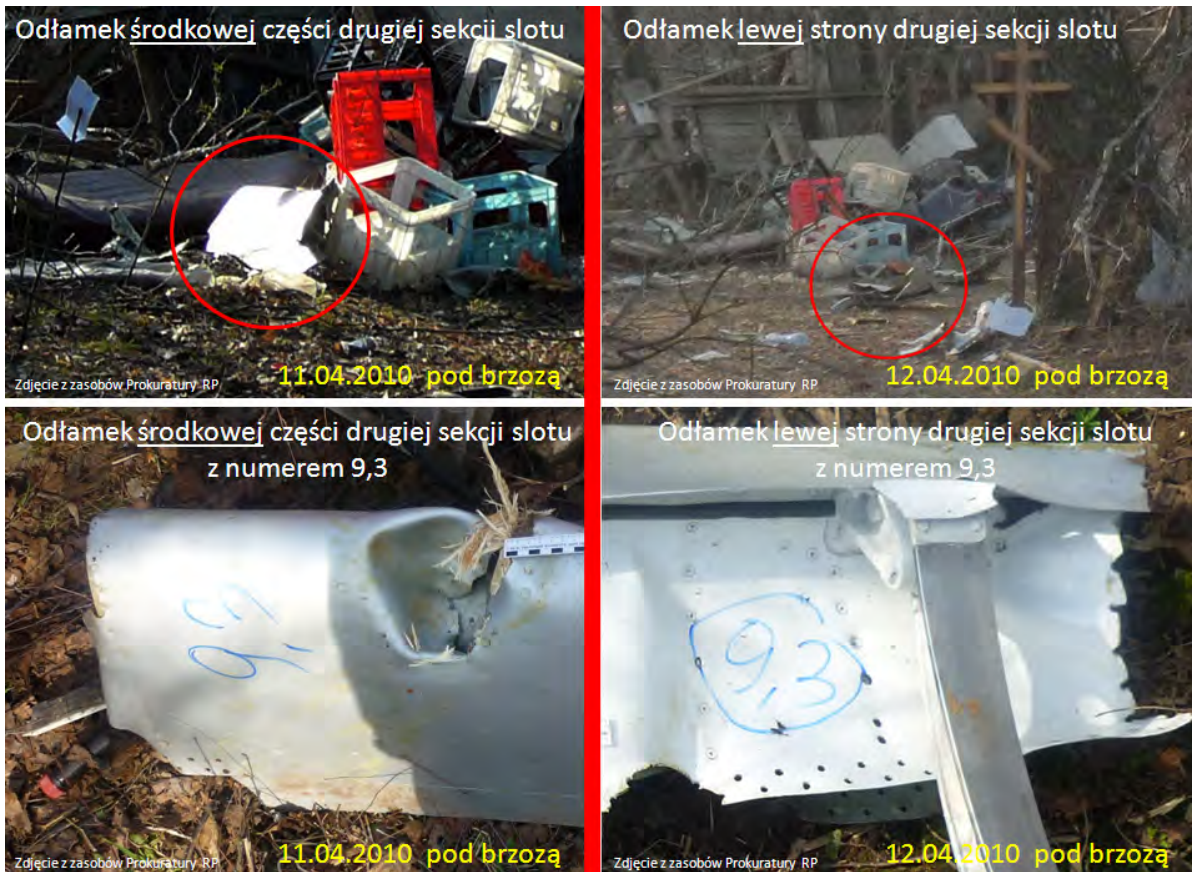
Example: One of the pieces of the 2nd section of the slot, which fell to the ditch next to the road leading from the garages to the Gubienko street approx.20m behind the birch tree, was moved on the 11.04.2010 under the bb tree. On April 12 it was swapped with another piece stemming from the line of separation (which fell to the ditch next to the street leading from the garages to the Gubienko Street, approx. 50m behind the birch). Picture 19

Fig. 19. Fragments of 2 sections of the slot moved from the original location on the ground under the tree claimed to have made contact with the wing.

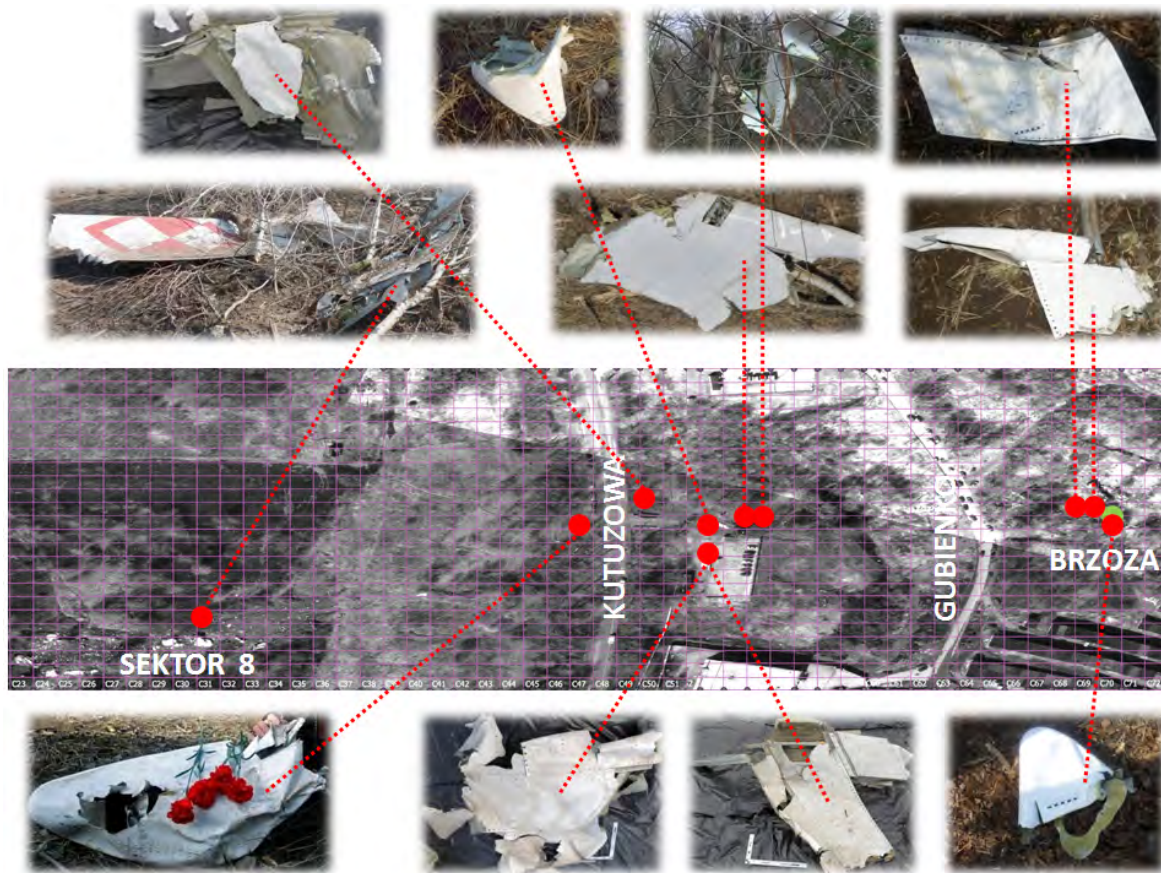
The majority of elements from the flaps of the detachable wing part were scattered from the bb tree in the direction of the main crash site on an area 15m-225m according to the flight direction of TU-154M. (Fig. 20).

Fig. 20. The locations on the ground of various parts from the left wing.

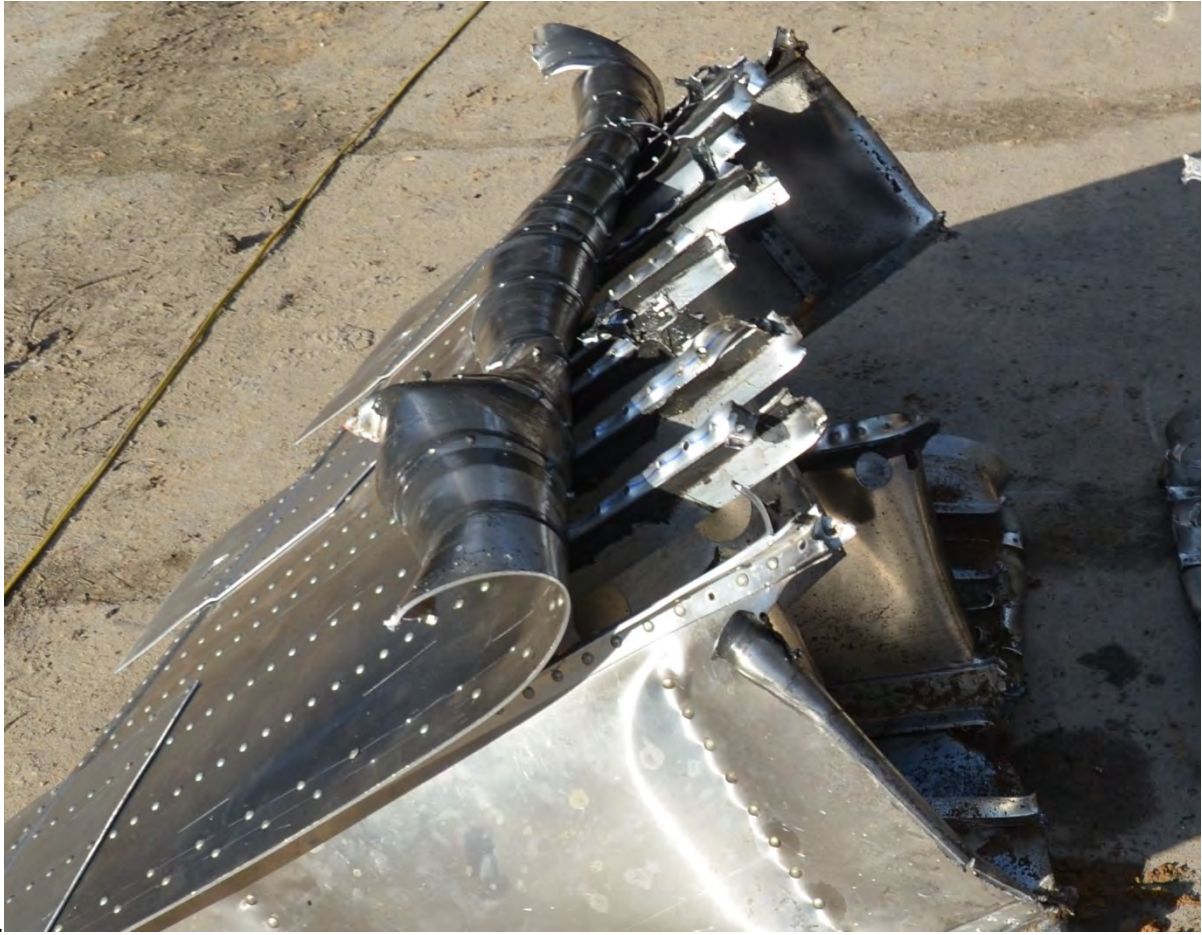
The experiments carried out by the KBWLLP Committee in March 2018 on the wing fragment model in the scale 1: 4 and 1: 1 show that the wing with fuel and fuel vapors can be destroyed by explosive charges with similar features of destruction of the structure without a major fuel explosion with many observed features similar as for the wing tip in Smolensk. (Fig. 23 and Fig. 24)

Fig. 23. Scale 1:1 Separation by explosive material of the wing box containing fuel. The experiment demonstrated the wing could be cut without a secondary major fuel explosion.

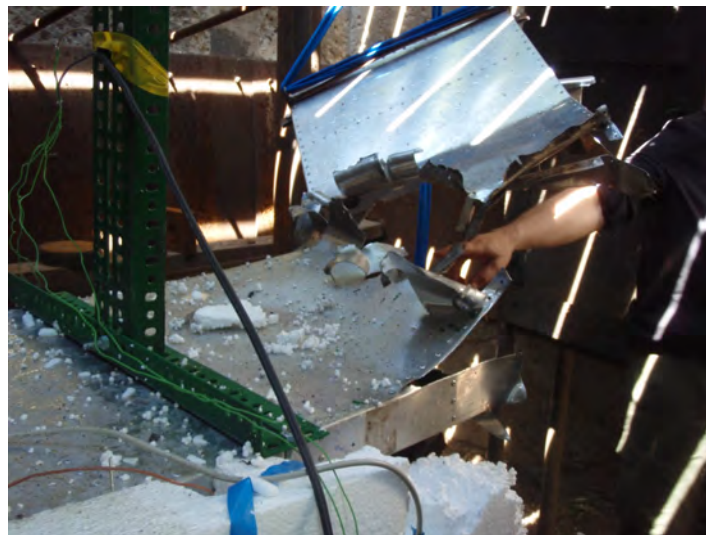
Fig.24. Experiment of cutting the wing model on a 1:4 scale with fuel, with the use of 6g/m PETN Cord Note the direction of curls away from the area of high internal pressure. The experiment demonstrated the wing could be cut without a secondary major fuel explosion.

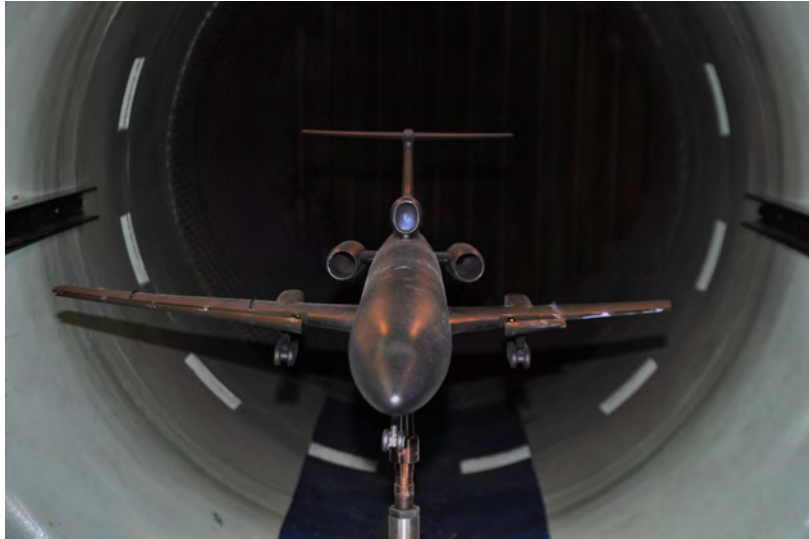
Experiments in the aerodynamic tunnel, conducted in IL, showed that the loss of lift force between 4.8% and 8.7%, due to the loss of the left wingtip, does not have to end in a left roll. Those works show that the pilots, even with an angle of attack up to 11.5degrees, can fully balance the rolling moment by introducing a 7degree sideslip (they have to change the configuration of the plane in such a way that the left wing is moved forward). Further balancing is possible with the move of the right aileron. A side slip is an element of basic aviation training and instinctive for every experience pilot, which is used during side-wind. When losing 1/3 of the left wing, the decreased wind resistance on this side will result in a right-turn of the plane to the sideslip with the left wing to the front. (Fig. 25).

Fig. 25. Airplane model in the wind tunnel of the Institute of Aviation. Here in version with a cut left wing and without slats and the outer flap.

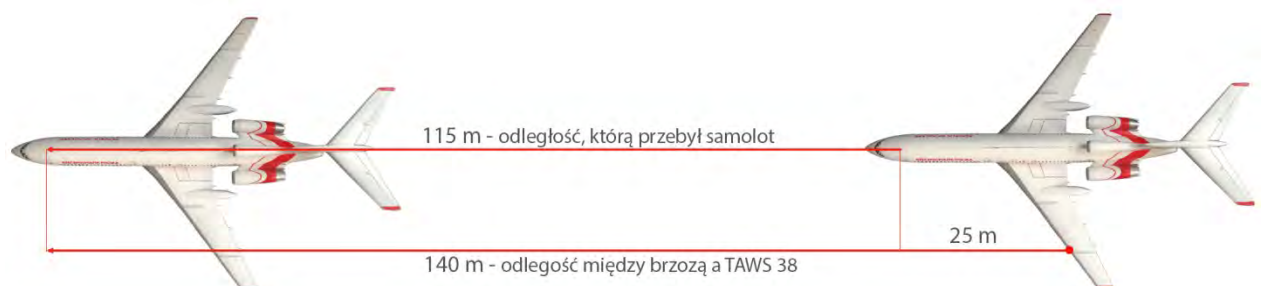
The distance between the so called bb tree and TAWS38 is approx. 140m. The distance that the plane traveled between the places of supposed contact of the wing with the bb tree, as assumed in the Miller and MAK reports, and TAWS 38 is 115m.

Fig. 26. The difference in distance from the tree claimed to have made wing contact to TAWS38 (140m) and the distance that the plane travelled (115m). The distances are different as the GPS antennas are located 25m in front of the hypothetical zone of contact.

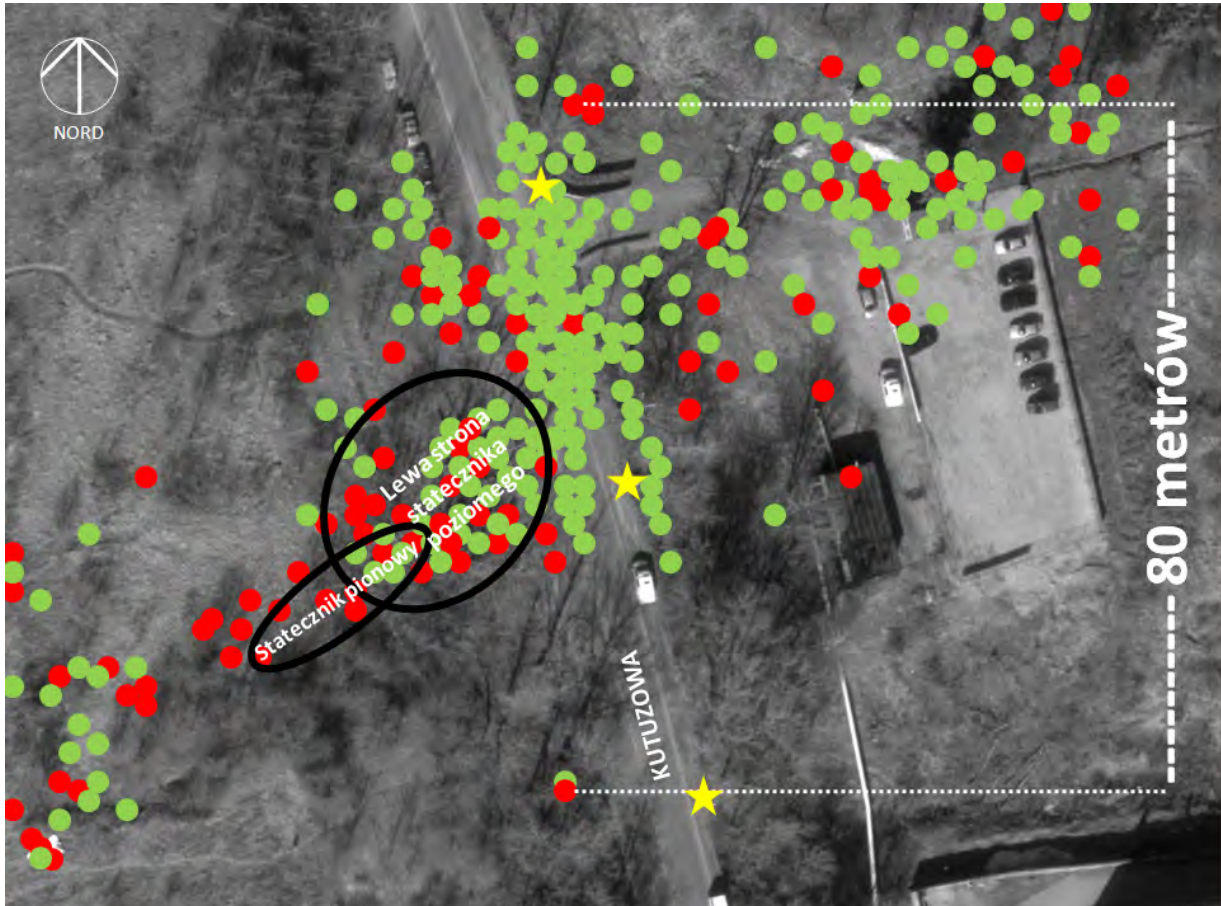
One line of elements from the left horizontal and vertical stabilizer (stemming from the area, where it was connected to the horizontal stabilizer) behind the Kutuzov street shows that the roll of the plane was large and the dispersion of parts falling off from the plane and destroyed branches points to a sudden destruction of the plane in the air (Fig. 27).

Fig. 27. Placing the left side of the horizontal stabilizer and the vertical stabilizer behind the Kutuzov highway. Flight direction is from right to left. Red dots show debris from the Tu-154M and green dots show debris from the associated tree damage.

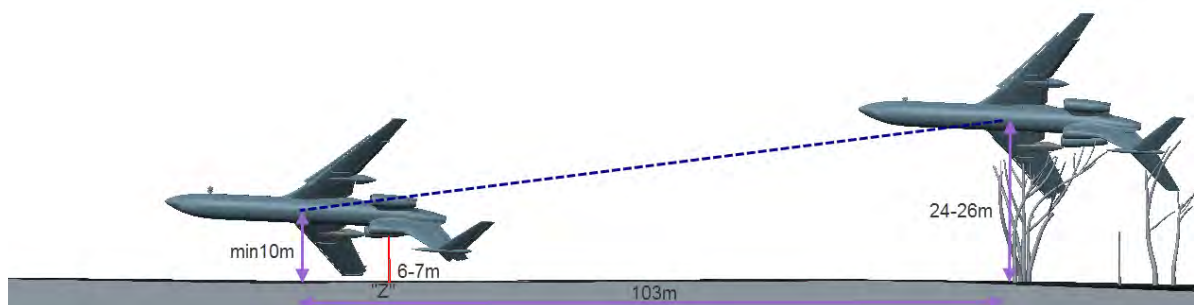
A 6-7 meter high tree marked with the letter "Z" on fig 29 to fig. 31b and directly above the trajectory of flight was not damaged by the plane which means that the altitude to the balance point in that moment, when the tail passes the "Z" tree, is at least 10m.

Fig. 29. A view to the north in the moment when the plane flies from Kutuzov street (right) to the crash site (left). The 6-7m tall tree is here marked with letter "Z".

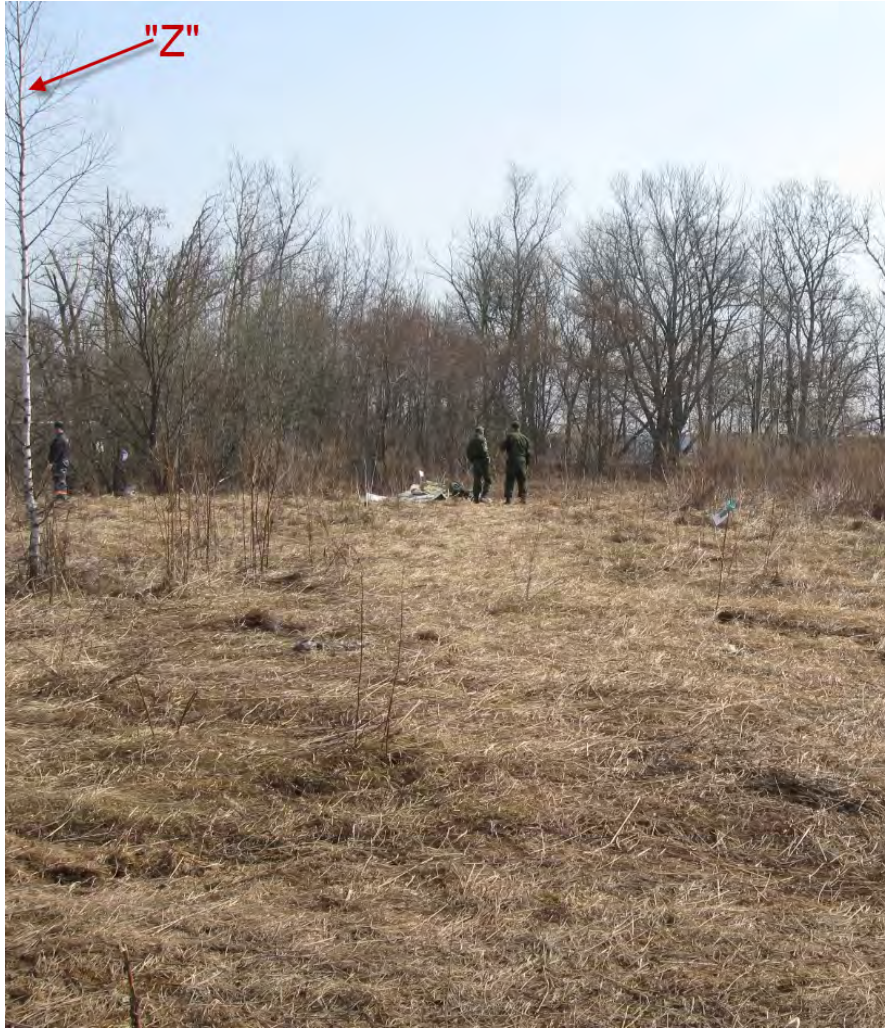
Fig. 30. The tree marked "Z" growing in the direct vicinity of the flight path, when the plane is flying from the Kutuzov Street (in the background) to the place of crash. On the right side starting at the blue marker on a stick there is a visible ground trace when hitting the ground with the left stabilizer.

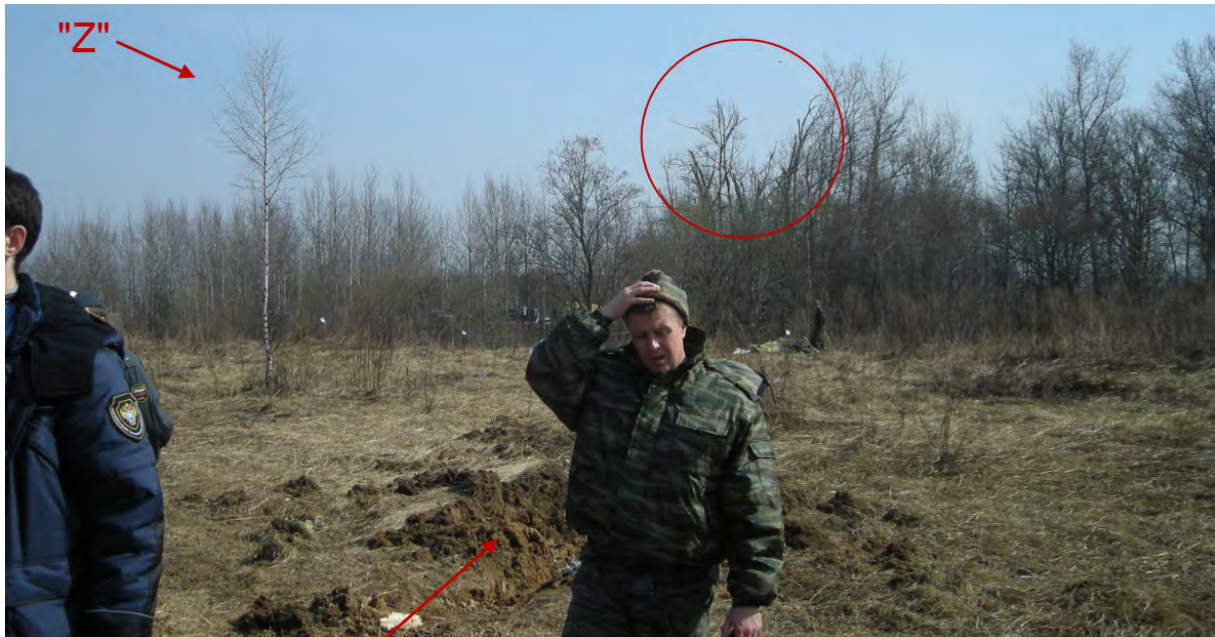
Fig. 31a. The tree marked "Z" growing in the direct vicinity of the flight path, when the plane is flying from the Kutuzov Street (red circle) to the place of crash. The ground trace from the tail is visible and marked here as "Southern Ground Trace".

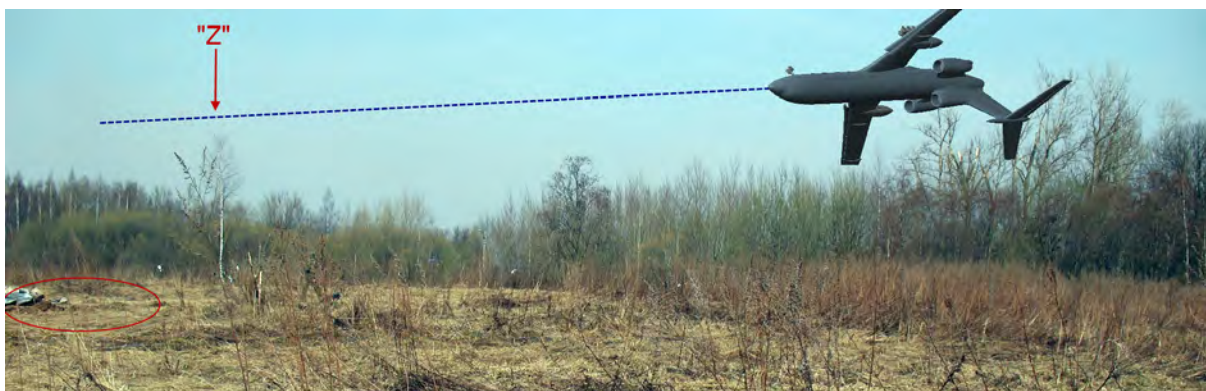
Fig. 31a. The tree marked "Z" growing in the direct vicinity of the flight path, when the plane is flying from the Kutuzov Street (right side) to the place of crash (left side). The ground trace from the tail is visible and marked here with a red ellipse. The white part inside the ellipse shows the new position of the left horizontal stabilizer after Russians had moved it 35m closer to the crash site.

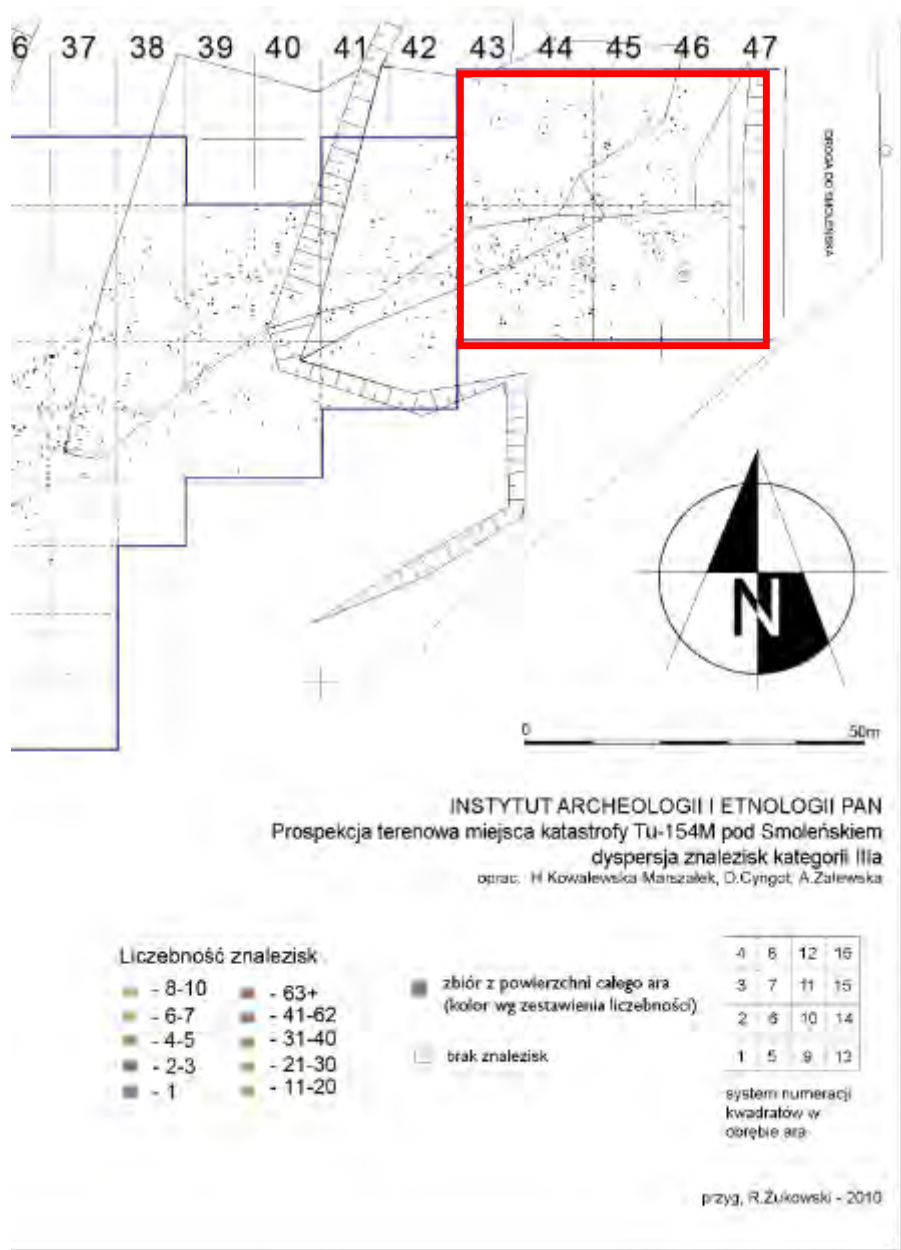
During a terrain analysis, done by Polish archeologists in Smolensk in October 2010 in sector 13 behind Kutuzov Street and before the main crash site, numerous pieces of plane were found (fig 32). Those pieces, sized from a couple to tens of square centimeters, had traces of thermal and mechanical effects (fig 33).

Fig. 32. Map from the archeologists report showing where pieces were found behind the Kutuzov street (marked "Droga do Smolensk" at the right).

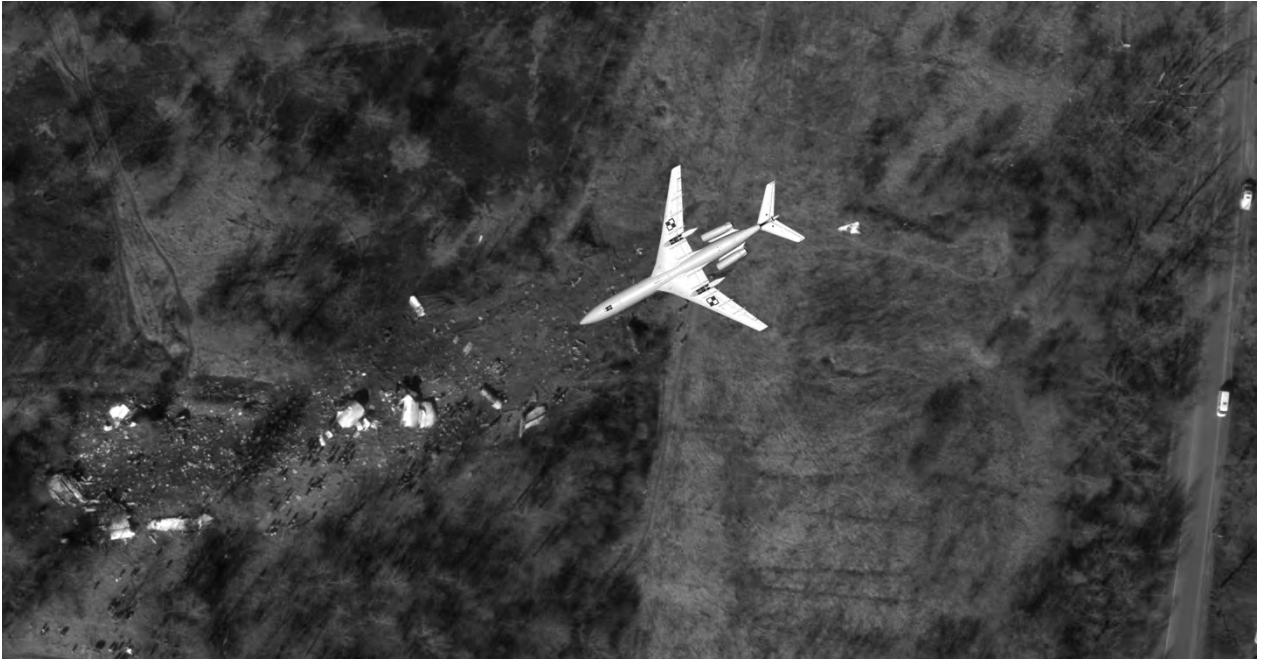
General view of the crash site compared to the shape of TU-154M in a 1:1 proportion show that the pieces of the plane fell down as a result of an explosion in the air and not the disintegration in time when sliding on the ground (no visible crater). (Fig. 35).

Fig. 35. A general view of the crash site compared to TU154M in a reverse position in correct scale.

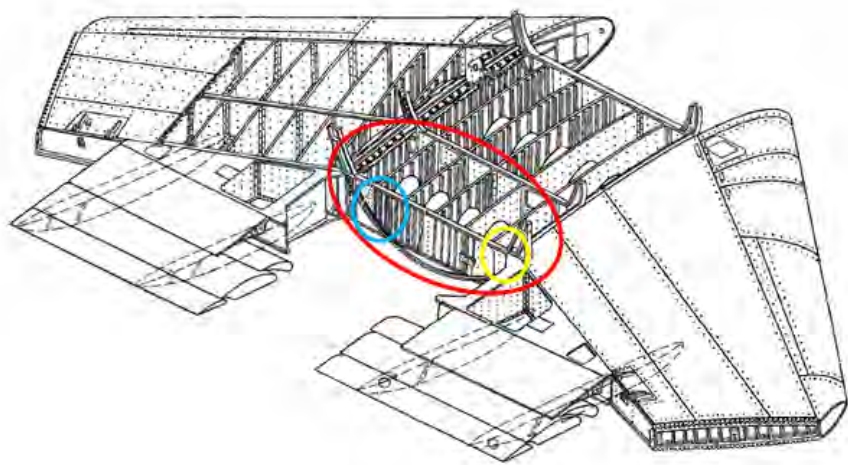
Fig. 39. Center wing box of TU-154M. Highlighted in red **fuel box no.1.**

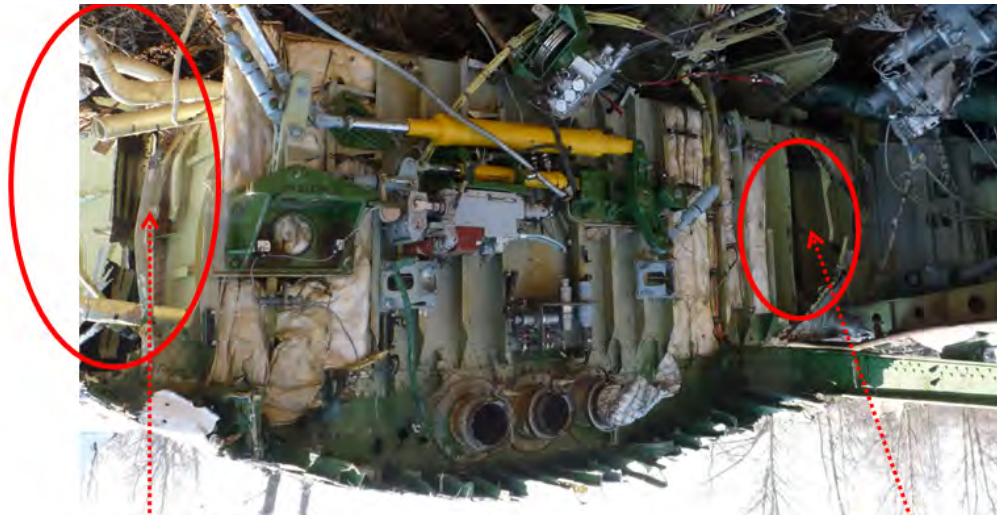
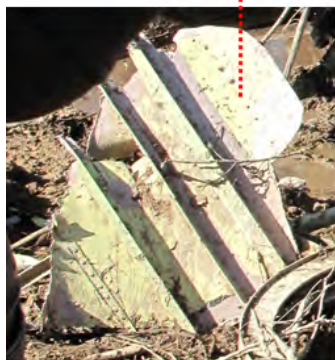
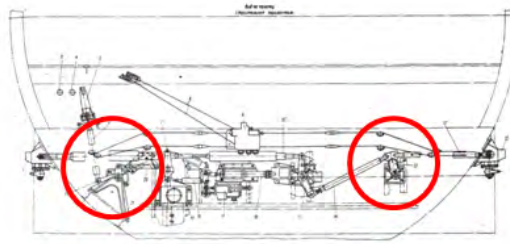
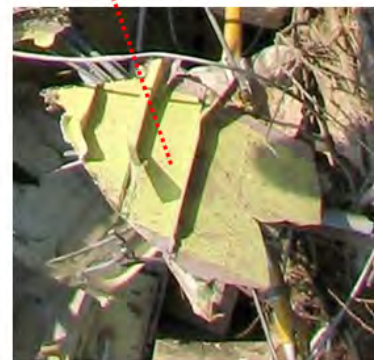
The tearing and the destruction of the fuel box could not have been a result of a hydraulic impact, caused by the impact with the ground, especially looking at the small amount of fuel and limited space. One has to consider the elements of the skin, ribs, rear spar, which were torn off likely due to high internal pressure. (Fig. 38 and fig. 40).

Odłamek lewej strony dźwigara nr 3 kesonu bakowego rozchodowego nr 1.

Odłamek prawej strony dźwigara nr 3 kesonu bakowego rozchodowego nr 1.

Fig. 40 Pieces of the left and right side of spar no.3 of fuel box no.1.

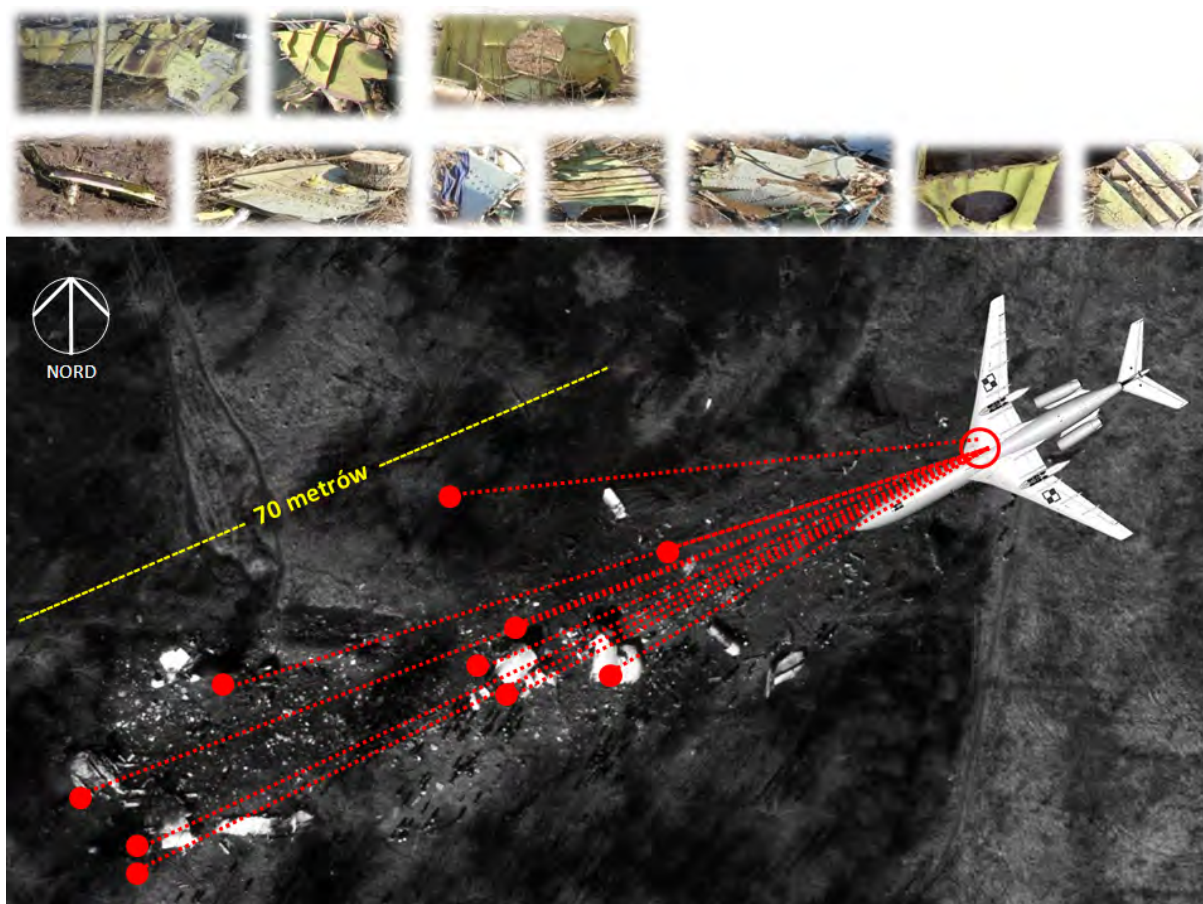
Fig. 41. General dispersion of the pieces of the centerwing on the crash site with the distance and place where the most important pieces fell.

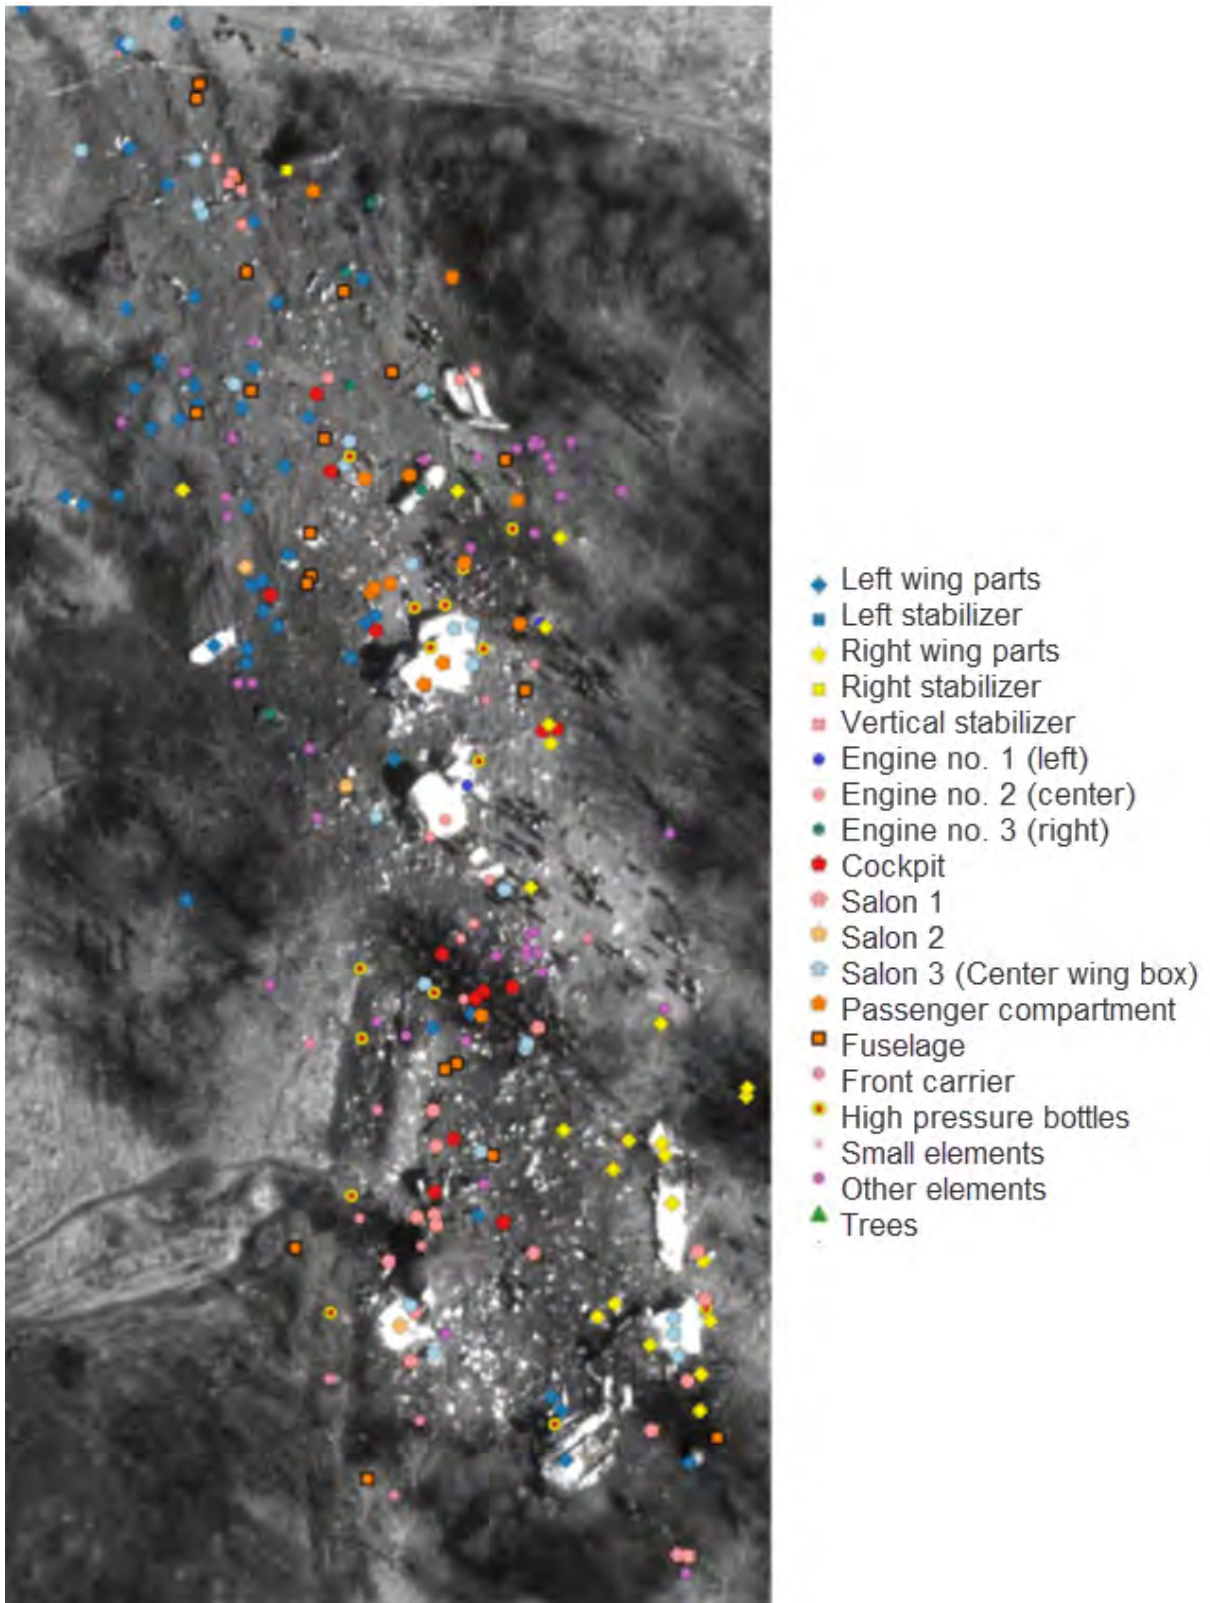
Fig. 43. Dispersion of part of the aircraft on the wreck. Study of the Committee. Direction of flight is from top left corner and down towards right bottom corner.

The TU154M aircraft disintegrated to more than 60,000 pieces. The majority of the elements were rammed into the ground, and though located, they were never extracted. 10,000 pieces were collected 6 months after the crash. Up to now the number of elements that were in the ground was not calculated and was not collected when the debris was put at the debris storage place.

The main crash site is 45m x 160m, which means that the movement of the aircraft in this area, with its total destruction, happened in a distance corresponding to 3 lengths of the plane. The ground impact of the plane happened in a reverse position of the aircraft, which is visible based on the dispersion of pieces of the left and right wing on the crash site. Indentations were observed in the ground in the place of the crash but without a deep crater. On the entire crash site there is no trace of a strong impact of the fuselage in the ground. All the seats were totally destroyed, meaning that the seating part, back lean, armrest, frame lay separately. Apart from the front part of the fuselage between the nose and the beginning of the center wing, pieces from the right side of the plane were found mainly on the left side of the crash site, and pieces from the left side of the plane were found mainly on the right side of the crash site.

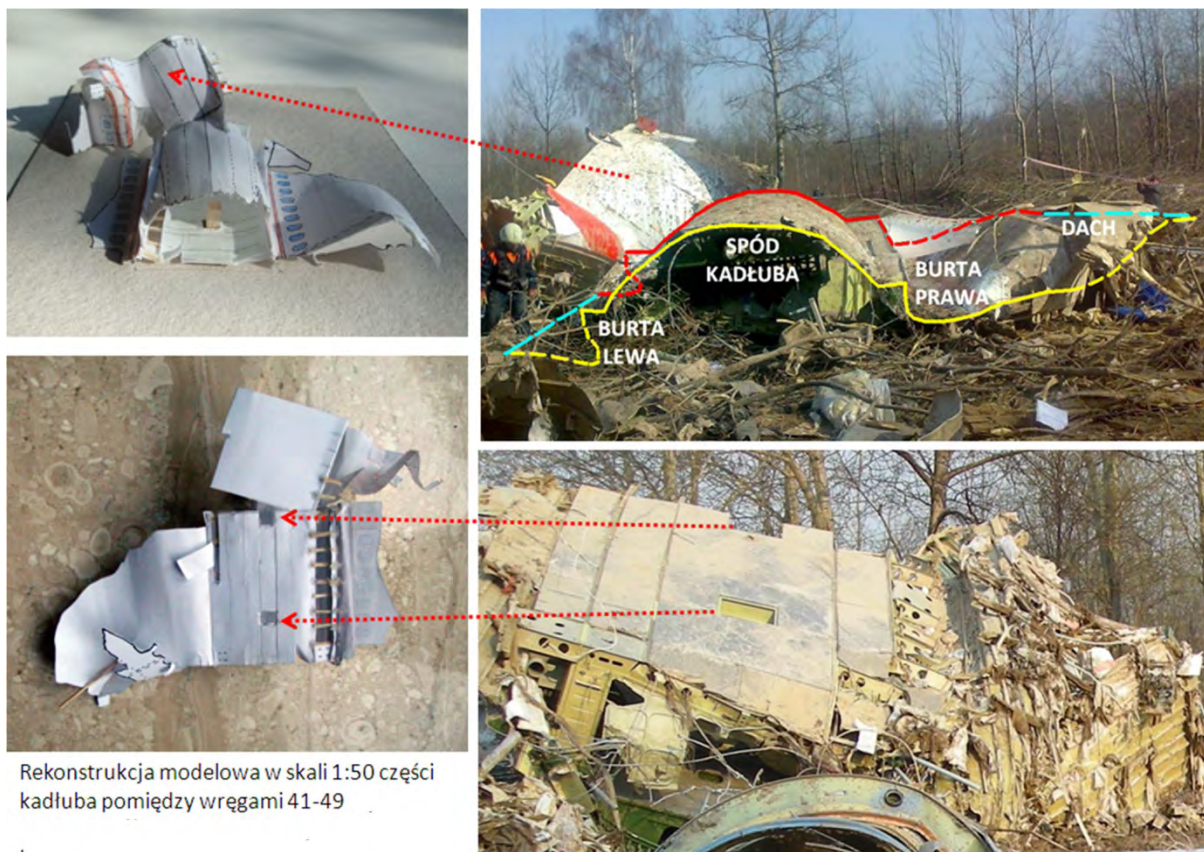
Destruction of the part of the fuselage with both sides of the plane opened and a corresponding reconstruction show the explosion in the fuselage, when the plane was in the air. Below: parts of floor panels with characteristic, explosive destructions of the panel being close to the left side of the plane and a corresponding reconstruction.

Fig. 44. Image of the fuselage destruction with both sides of the fuselage opened and thrown outwards.

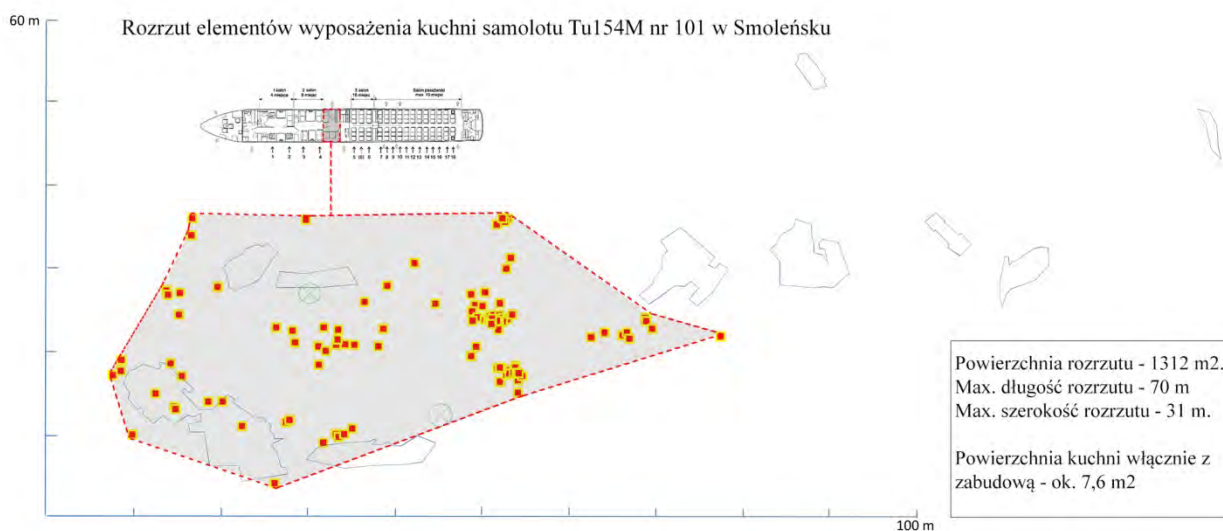
Disintegration of the galley is shown in fig. 45. The less than 8m² galley area was found scattered over more than 1300m² in small fragments.

Fig.45. Parts of the galley being before the third salon were distributed in the shown region on an area of 1312m².

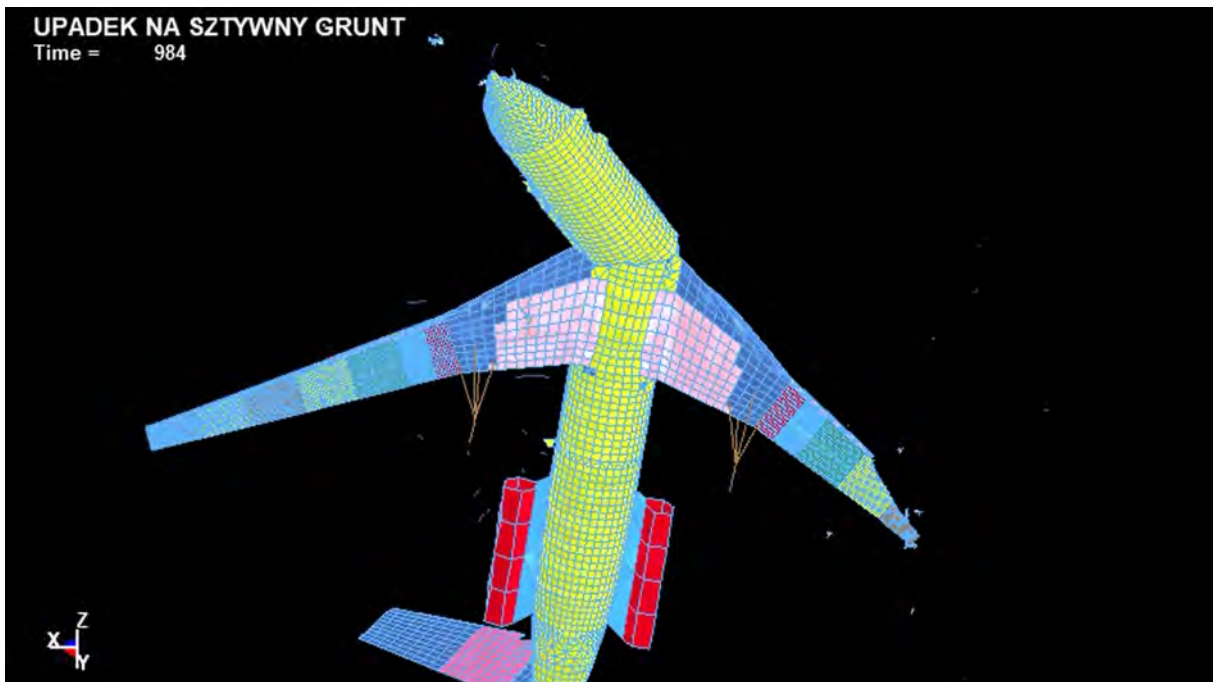
Rys. 47. Simulation of the disintegration of an airplane hitting a stiff ground (concrete). The aircraft only breaks into a few parts.

1. The simulation of the plane destruction shows a completely different destruction of the construction than the one found on the crash site.
2. The initial state of the falling plane was described in the MAK and Miller report and confirmed in supportive works [3]. It seems that this state was far from the real one, which is why the simulation presented unrealistic results.

3. The above-mentioned crash reports assume that the plane, while hitting the ground, should disintegrate into thousands of smaller and bigger pieces, according to what was found on the crash site. The results of simulation show clear destructions of the construction; however the plane is still there and not only its scattered segments.
