**COMMITTEE FOR THE RE-INVESTIGATION
OF THE SMOLENSK AIR CRASH**

TECHNICAL REPORT

**Facts regarding the crash of the TU-154M No. 101,
(Fight PLF101), that took place in Smolensk, Russia on the 10th of April 2010**

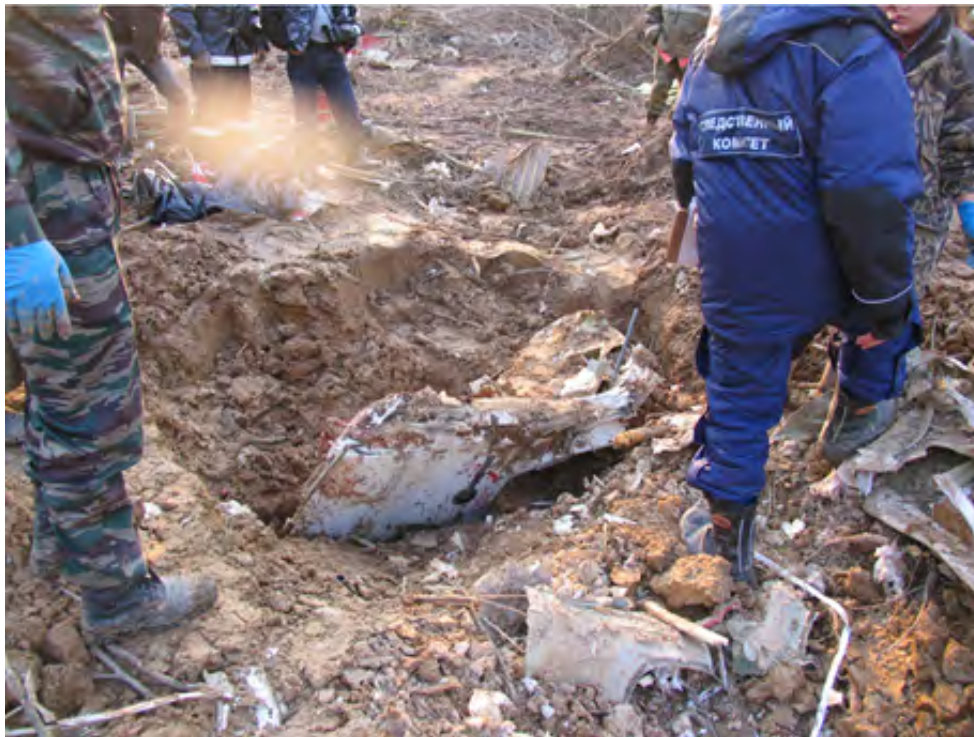
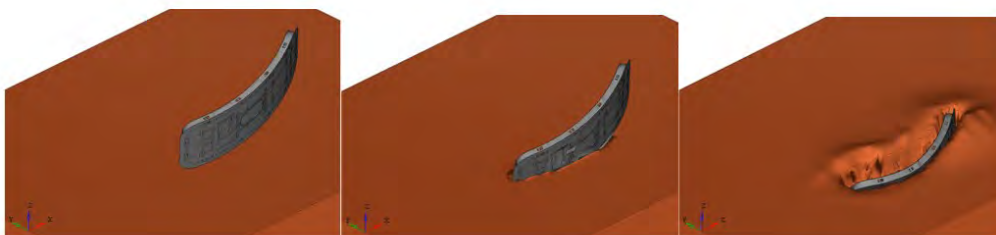
The left passenger door No. 2 (No. 823) with a mass of about 77kg located in the fuselage in the front of the left wing was found completely driven into the ground to a depth of more than 1 meter at the position 34 meters downstream (West) from the more than 6m tall tree located between the ground traces. This passenger door was found in its locked position completely detached from the massive door frame. The two bottom hinges of the left passenger door No. 2 (No 823) are each rotated 90deg compared to their orientation in the closed door position

Full penetration of door. The penetration value is low because door is crushed and has very high deformations.

Figure 48 Shows results from NIAR's simulation of the door hitting soft ground and the door 1meter in the ground as Russians were digging it out by hand.

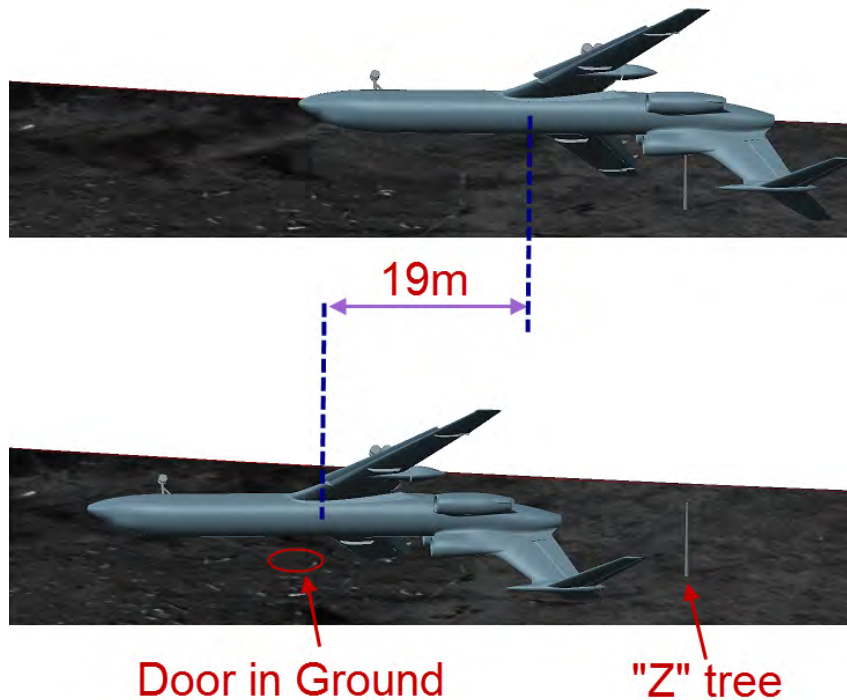
Fig. 49. The position of the plane the moment it passes the Z tree and the position of the plane above the rammed door.

The distance between the trees west of the street and the tree marked "Z" is about 103m and the time it takes to travel this distance can be found as $\Delta t = 103\text{m}/75\text{m/s} = 1.37\text{s}$

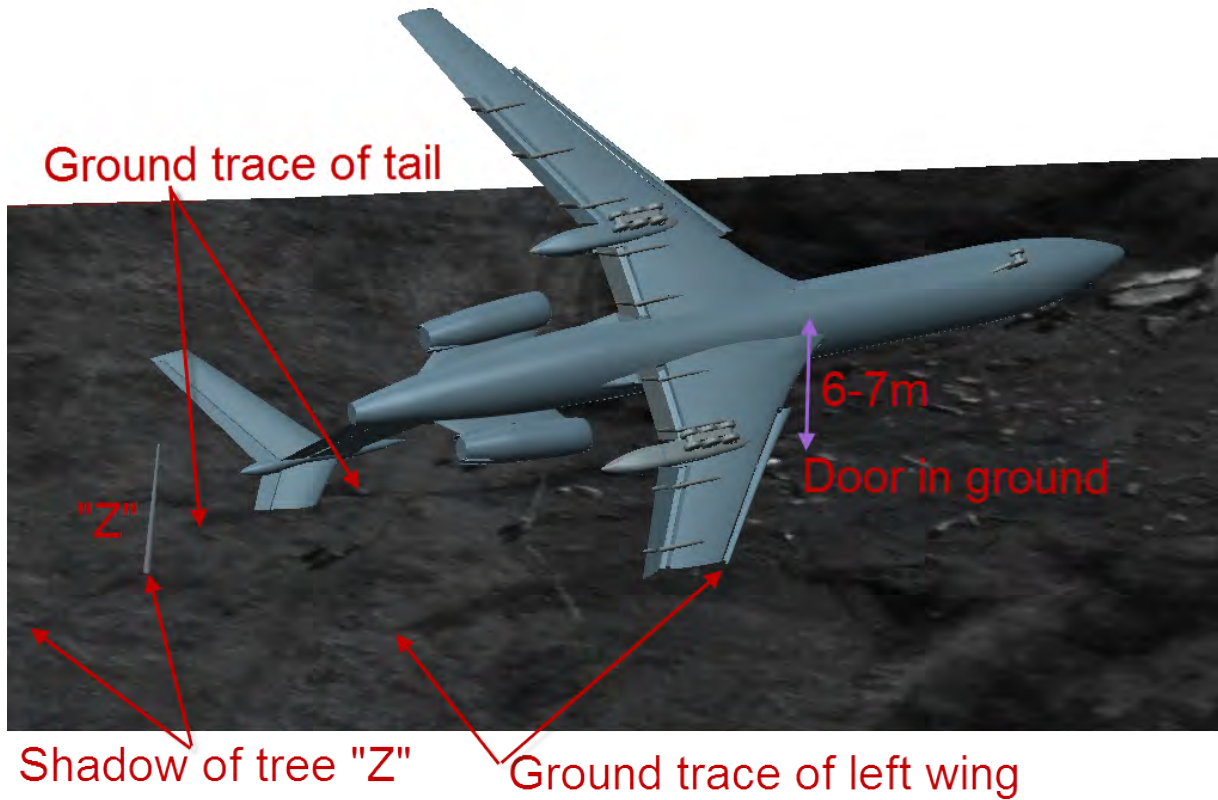
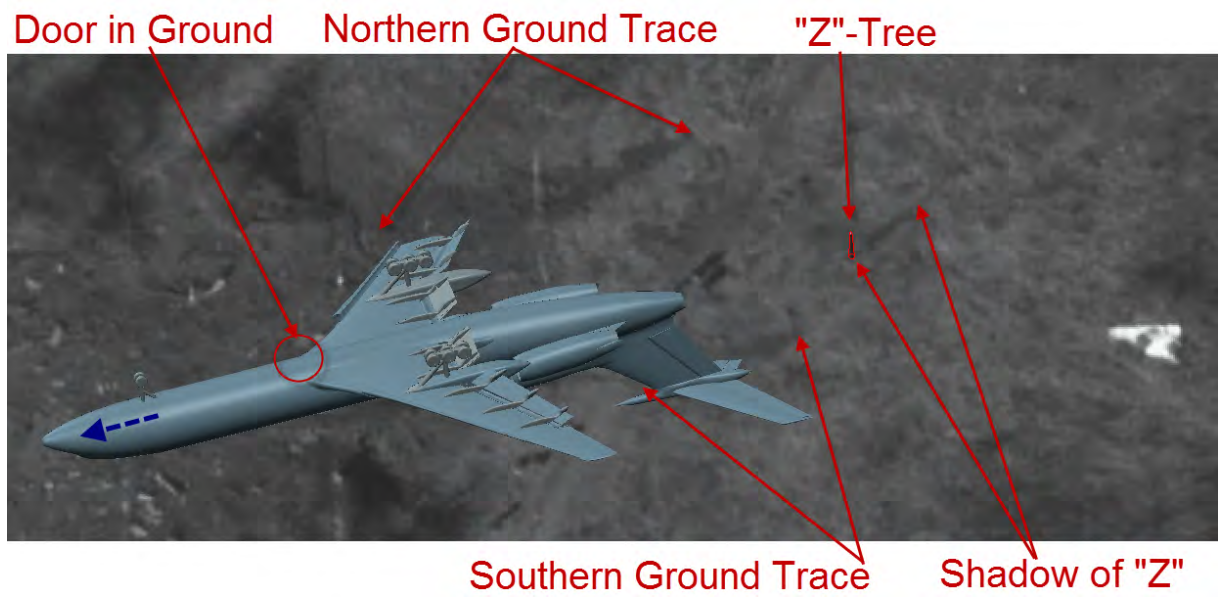
Pic.50. The moment the plane hits the ground

The 6-7m tall tree marked "Z" on following figures and under the direct line of flight was undamaged by the aircraft.

Analysis of the ground traces predicts the left roll of the aircraft to be about 130° when the remains of the left wing touched the ground at the beginning of the main crash site. They predict the height above the ground of about 6-7m when the fuselage is positioned with the left passenger door above the location it was in the ground.

The ground traces of wing come to a stop at the moment the fuselage is above the position of the door in the ground, and from this point the aircraft is found scattered in thousands of pieces without the creation of a crater.

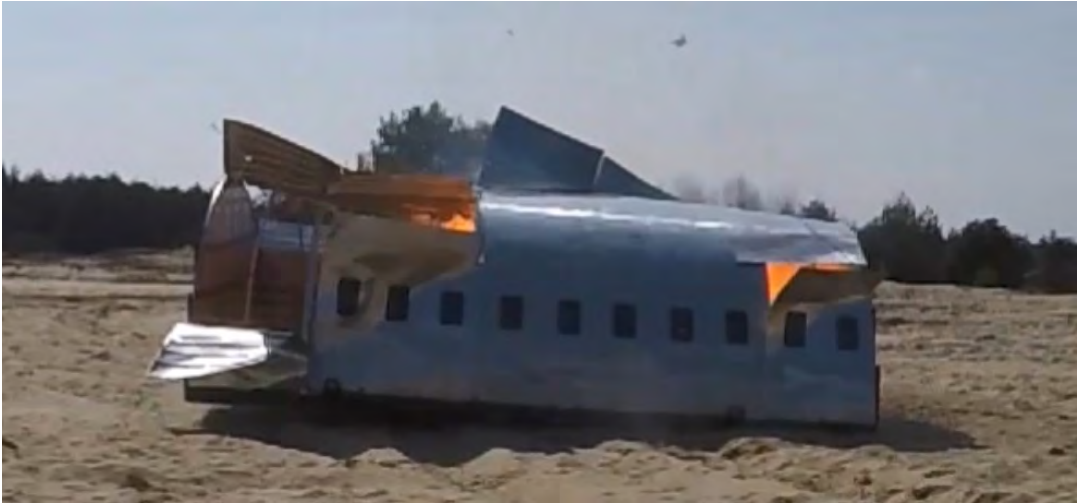
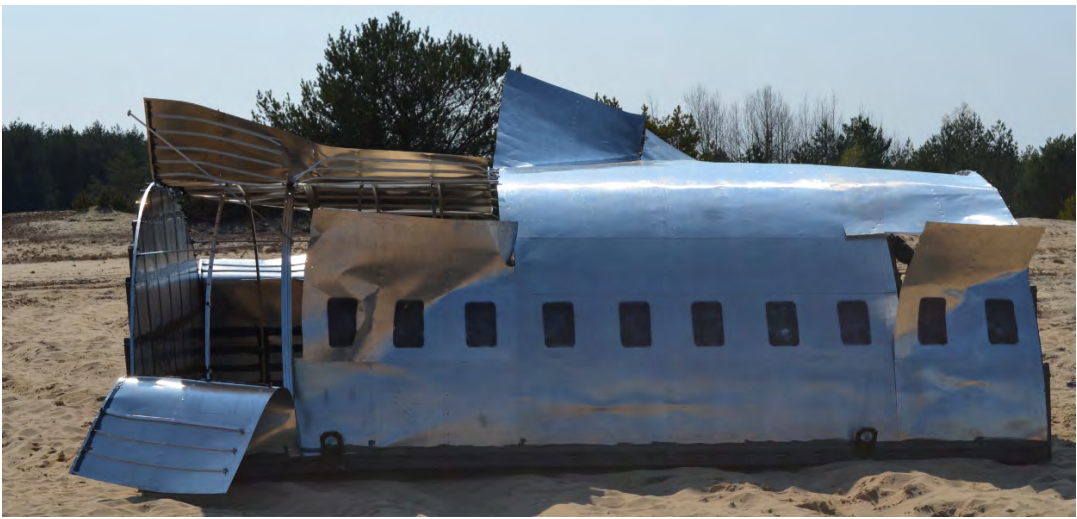
Experiments carried out by the Committee on a model of the occupants part of TU154M on a 1:1 scale show that the destruction of the plane observed in Smolensk could not be the result of a fuel explosion. (Fig. 51).

Fig.51. Explosion of jet-fuel in the occupant's part of the fuselage resulting in a large opening but no destruction in small pieces.

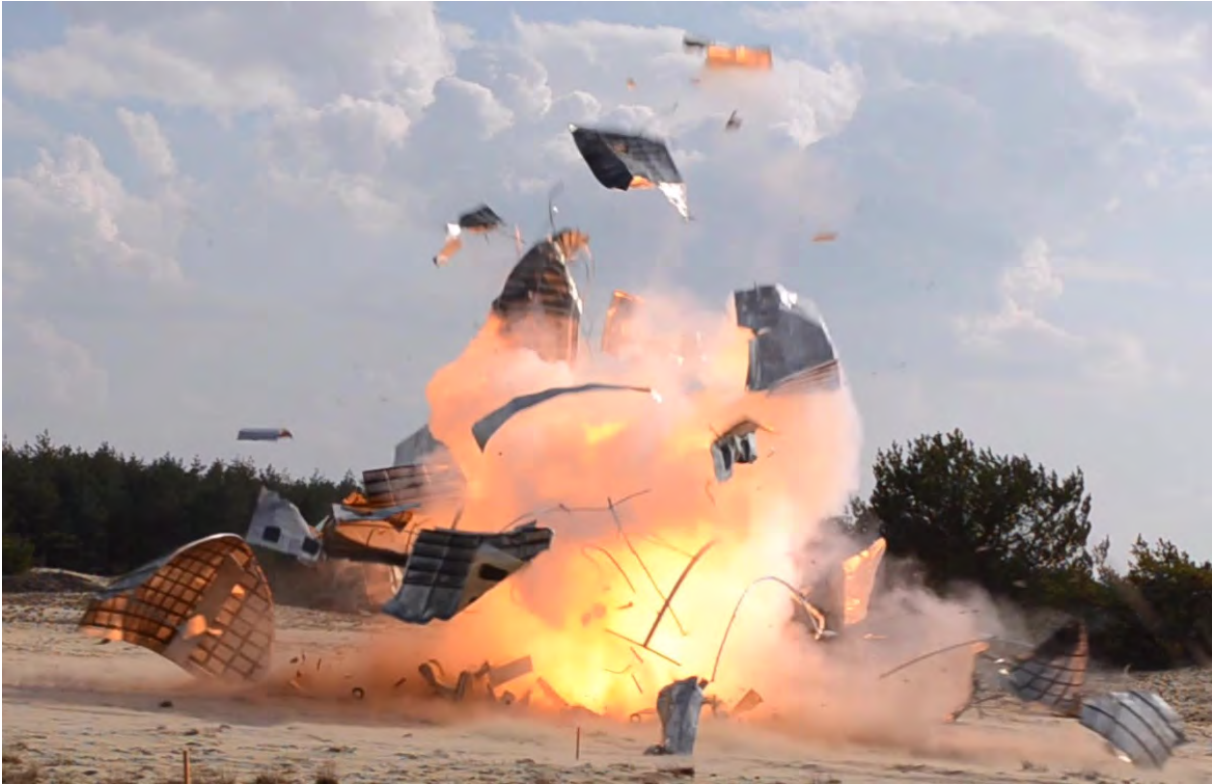
Experiments conducted by the Committee on a model 1:1 of the occupant's part show that such disintegration, as observed in Smolensk, can be the effect of one or many detonations of air-fuel charges, with special consideration of a thermo-baric charge with a longer tension impulse propagated inside the fuselage before hitting the ground. (Fig. 52).

Fig. 52. Explosion of a thermo-baric charge in the occupant's part of the fuselage resulting in the complete destruction of the fuselage and the formation of much small debris.

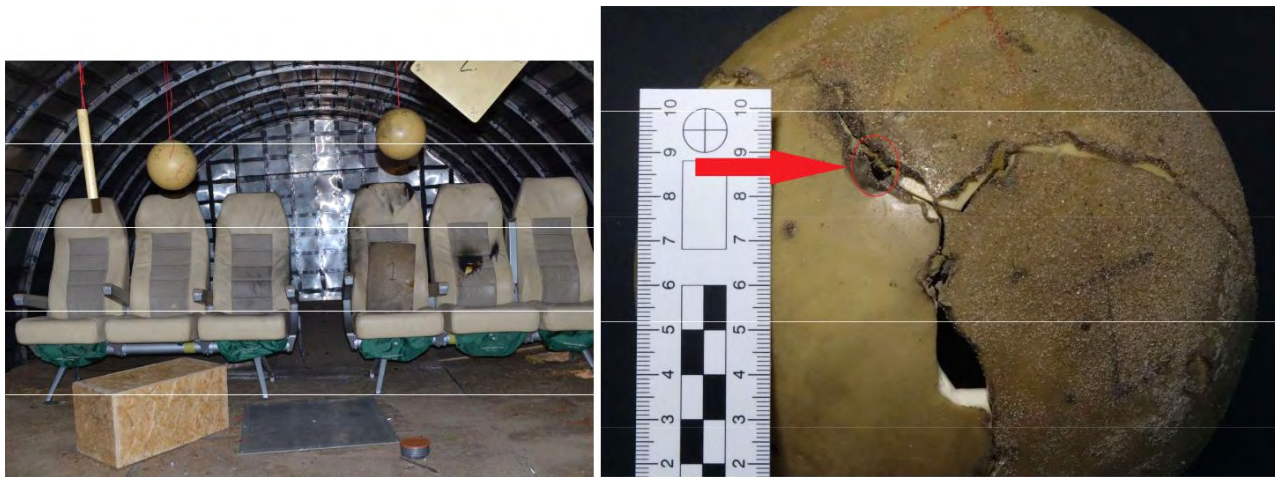
A spatial explosion (thermo-baric, as well as air-fuel) has to create a number of pieces and micro pieces from the container, where the charge is placed, or from objects being in its vicinity.

Those pieces might or might not have a metallic character. In the latter case they will not be visible on any X-Ray pictures and also not on CT. Those pieces cause characteristic damage of the bone structure (with beveling) but- what is especially important- practically impossible to notice during a routine postmortem examination, even with a CT. In order to make those damages visible (less spectacular compared to other in such circumstances), it is necessary to prepare the bone fragments (sometimes by cutting a particular fragment) and to analyze them after gluing together in an anatomical position. Without this gluing the chances to find such changes are close to zero. The postmortem examination, which have been conducted up till now (Russian, as well as Polish ones after the exhumations) ignored those issues and gave no chance to find traces of this type of explosion.

Fig. 53 Medical phantoms inside the model of the occupants part of the plane
