Aviation Investigation Report

In-Flight Fire Leading to Collision with Water

Swissair Transport Limited
McDonnell Douglas MD-11 HB-IWF
Peggy's Cove, Nova Scotia 5 nm SW
2 September 1998

Report Number A98H0003

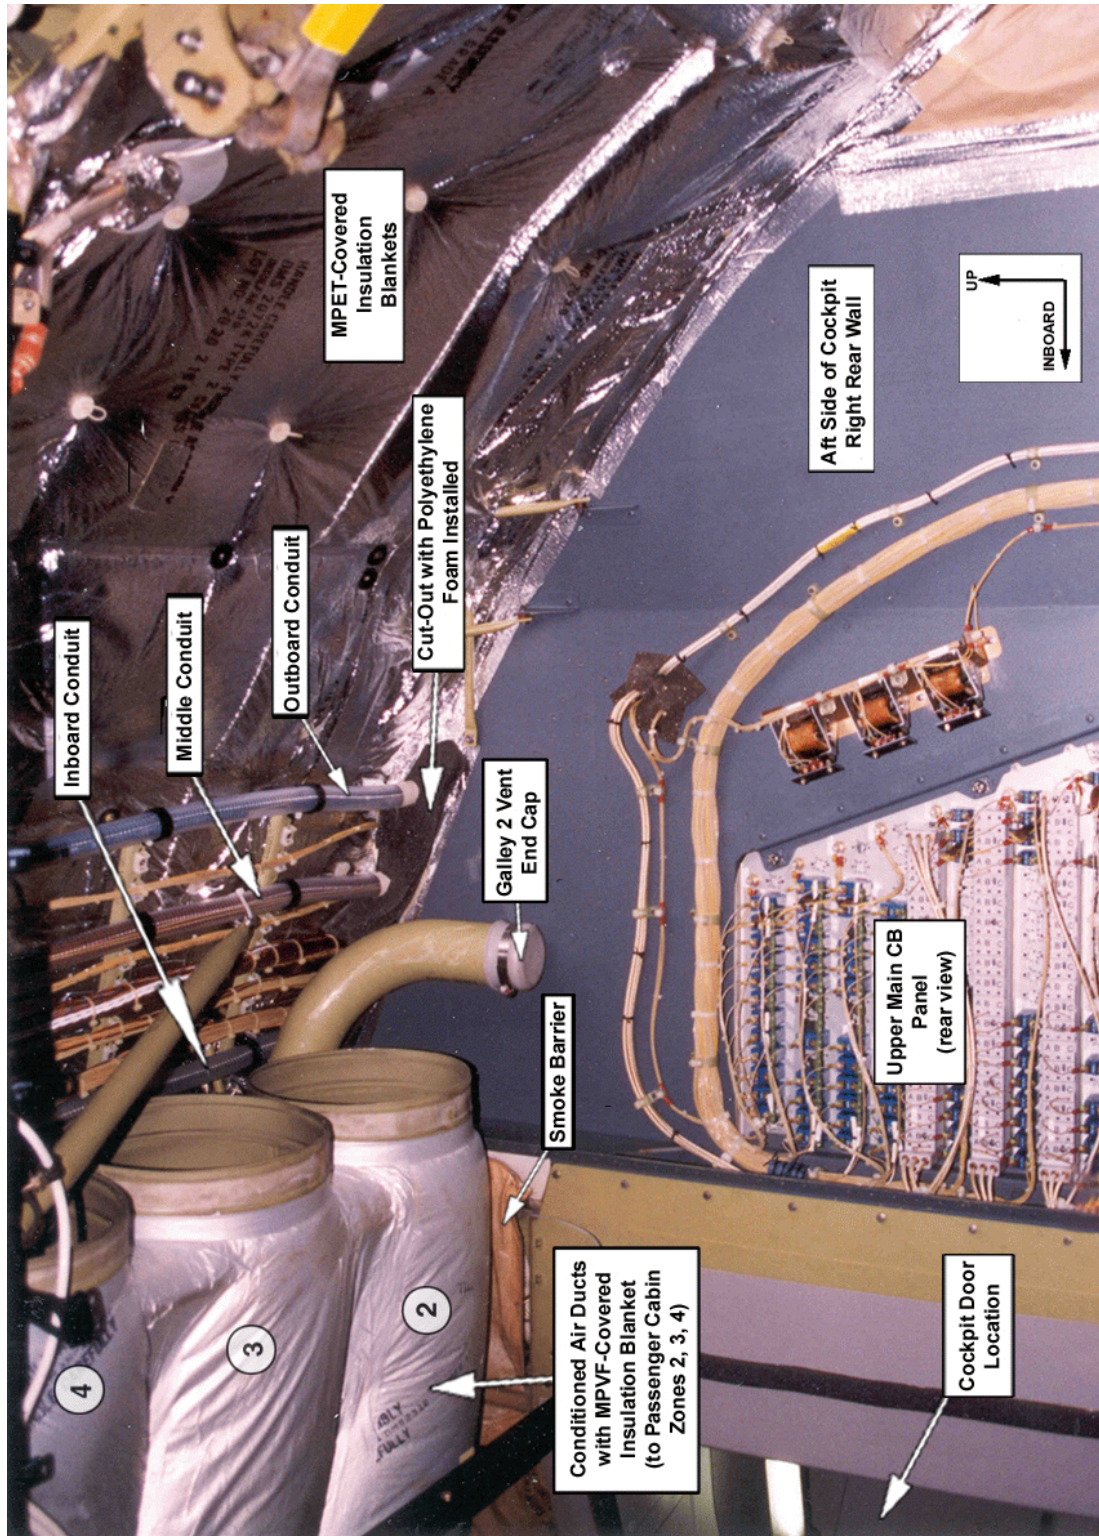
Figure 4: Area behind cockpit rear wall (Galley 2 and riser duct assembly removed)

Examination of other Swissair MD-11 aircraft in the Swissair fleet disclosed that openings existed in the smoke barriers, and in areas adjacent to the barrier. Some of these openings were located at conduit and wire run locations that pass through or above the cockpit rear wall. The top edge of the rear, right cockpit wall near STA 383 has a cut-out in it to permit the passage of wire bundles and conduits. (See Figures 4 and 5.)

In the Swissair MD-11s, the forward end of the muff assembly comes into close proximity to the lower right edge of the smoke barrier, and to the vent duct assembly for Galley 2. The galley vent duct, which is designed to exhaust odours and hot air from the galley when in operation, was not connected to the top of Galley 2, as Galley 2 was not electrically powered and not in service. A silicone elastomeric end cap was placed over the vent duct to close it off. The cap was located between the aft side of the cockpit rear wall and the forward side of one of the three riser ducts (see Figures 4 and 6).

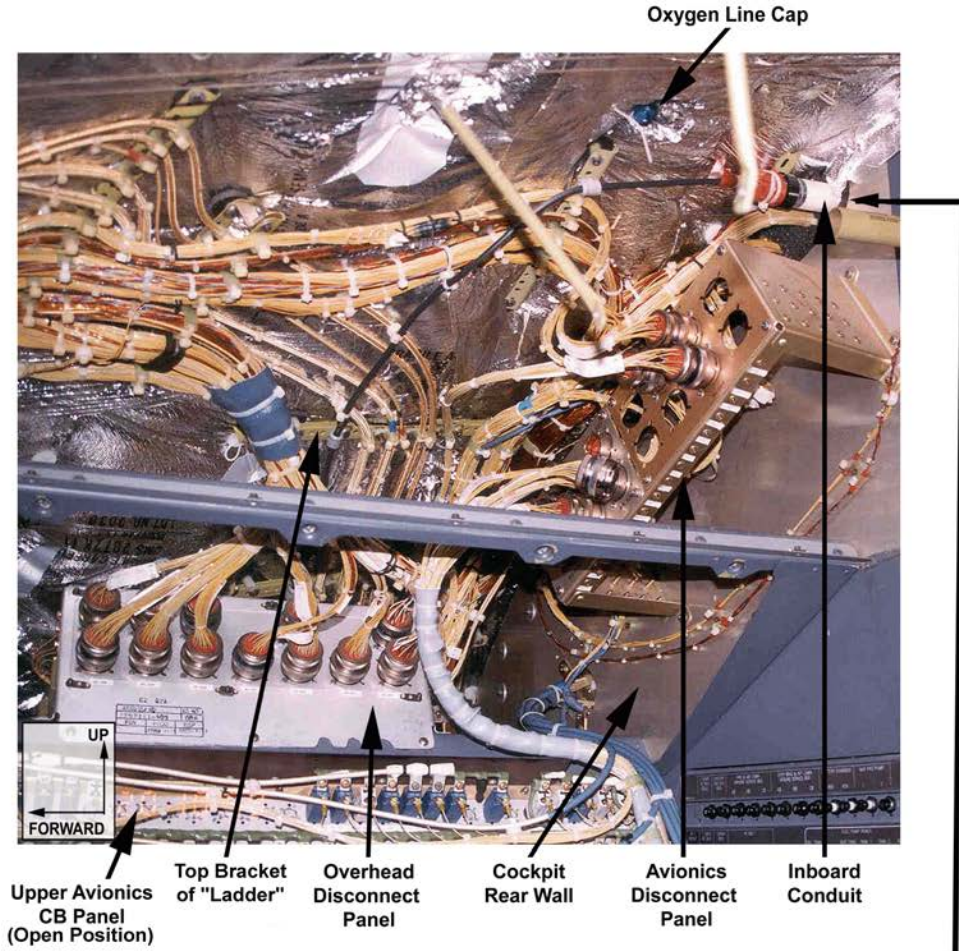
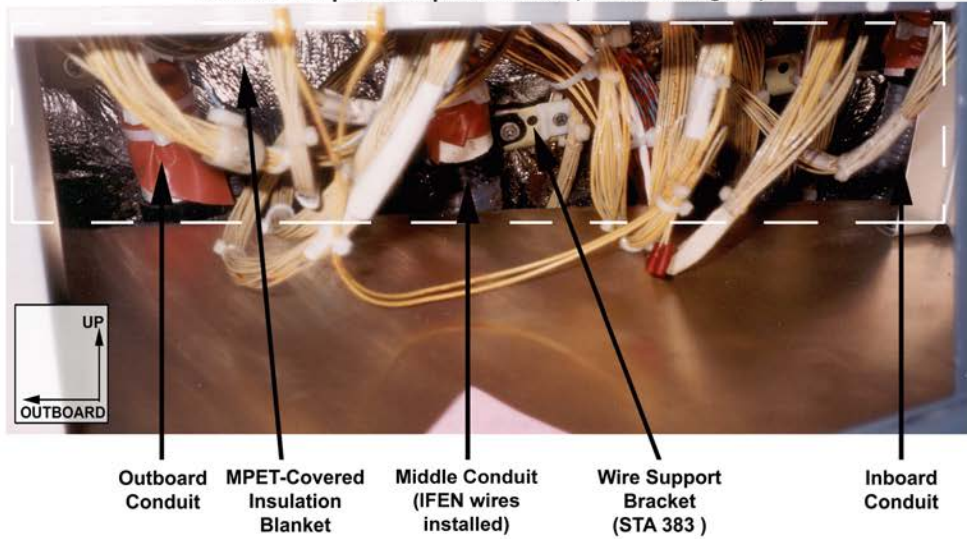
Figure 5: Cockpit attic area and cut-out above cockpit rear wall

Three 102-centimetre (cm) (40-inch) long conduits¹⁴ and five wire bundles pass over the cockpit rear wall at this point, and continue aft over the top of Galley 2 between STA 383 and STA 420. (See Figures 3, 4, 5, and 7.) The ends of the conduits were not required to be sealed and were found unsealed in other MD-11 aircraft that were examined. These conduits and wire bundles are attached by straps to a series of wire support brackets located at STA 383, 392, 401, 410, and 420. The wire bracket positioned at STA 383 is at a slight angle relative to the cockpit wall, which is directly below it. The top edge of this bracket, and attached wire bundles, are in contact with the metallized polyethylene terephthalate (MPET)-covered insulation blanket. Each of the conduits protrude forward of the cockpit wall by varying amounts because of the angle of the wall to the bracket.

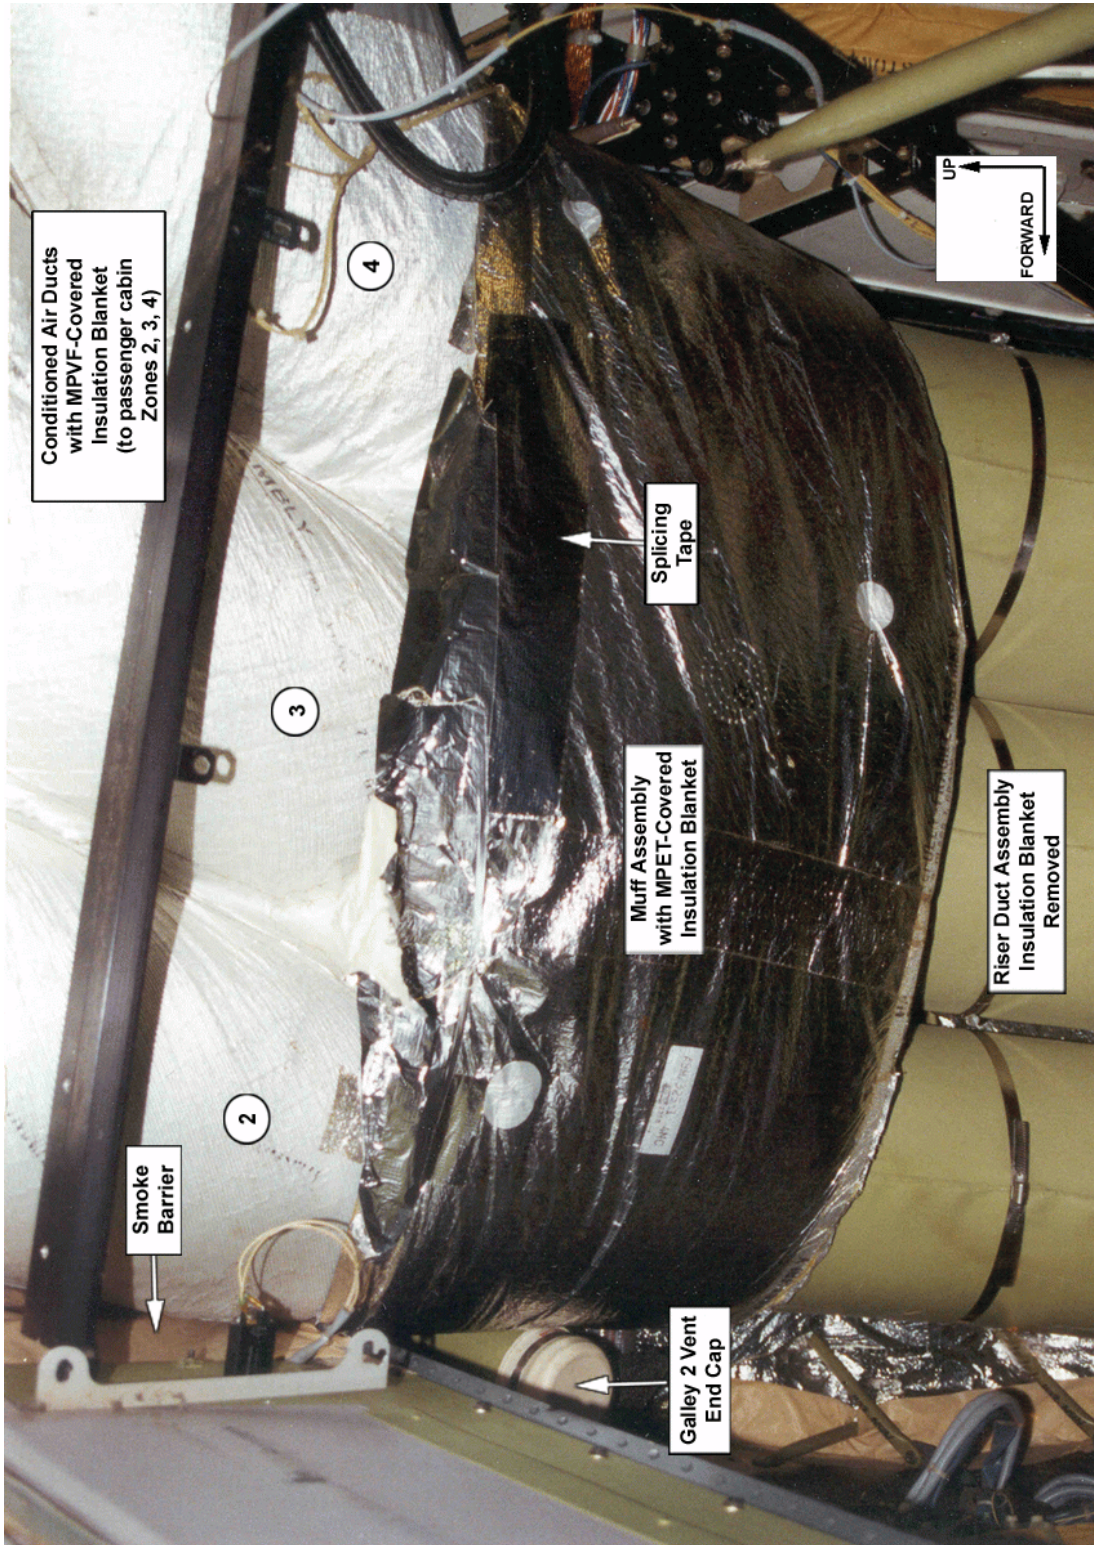
Figure 6: Muff assembly with MPET-covered insulation blanket

Just aft of the right side of the cockpit rear wall, above Galley 2, a sound-suppression muff assembly (muff assembly) was installed around a splice junction of the conditioned air riser duct assembly (see Figure 6). The muff assembly uses an MPET-covered insulation blanket secured at both ends by hook-and-loop fasteners.

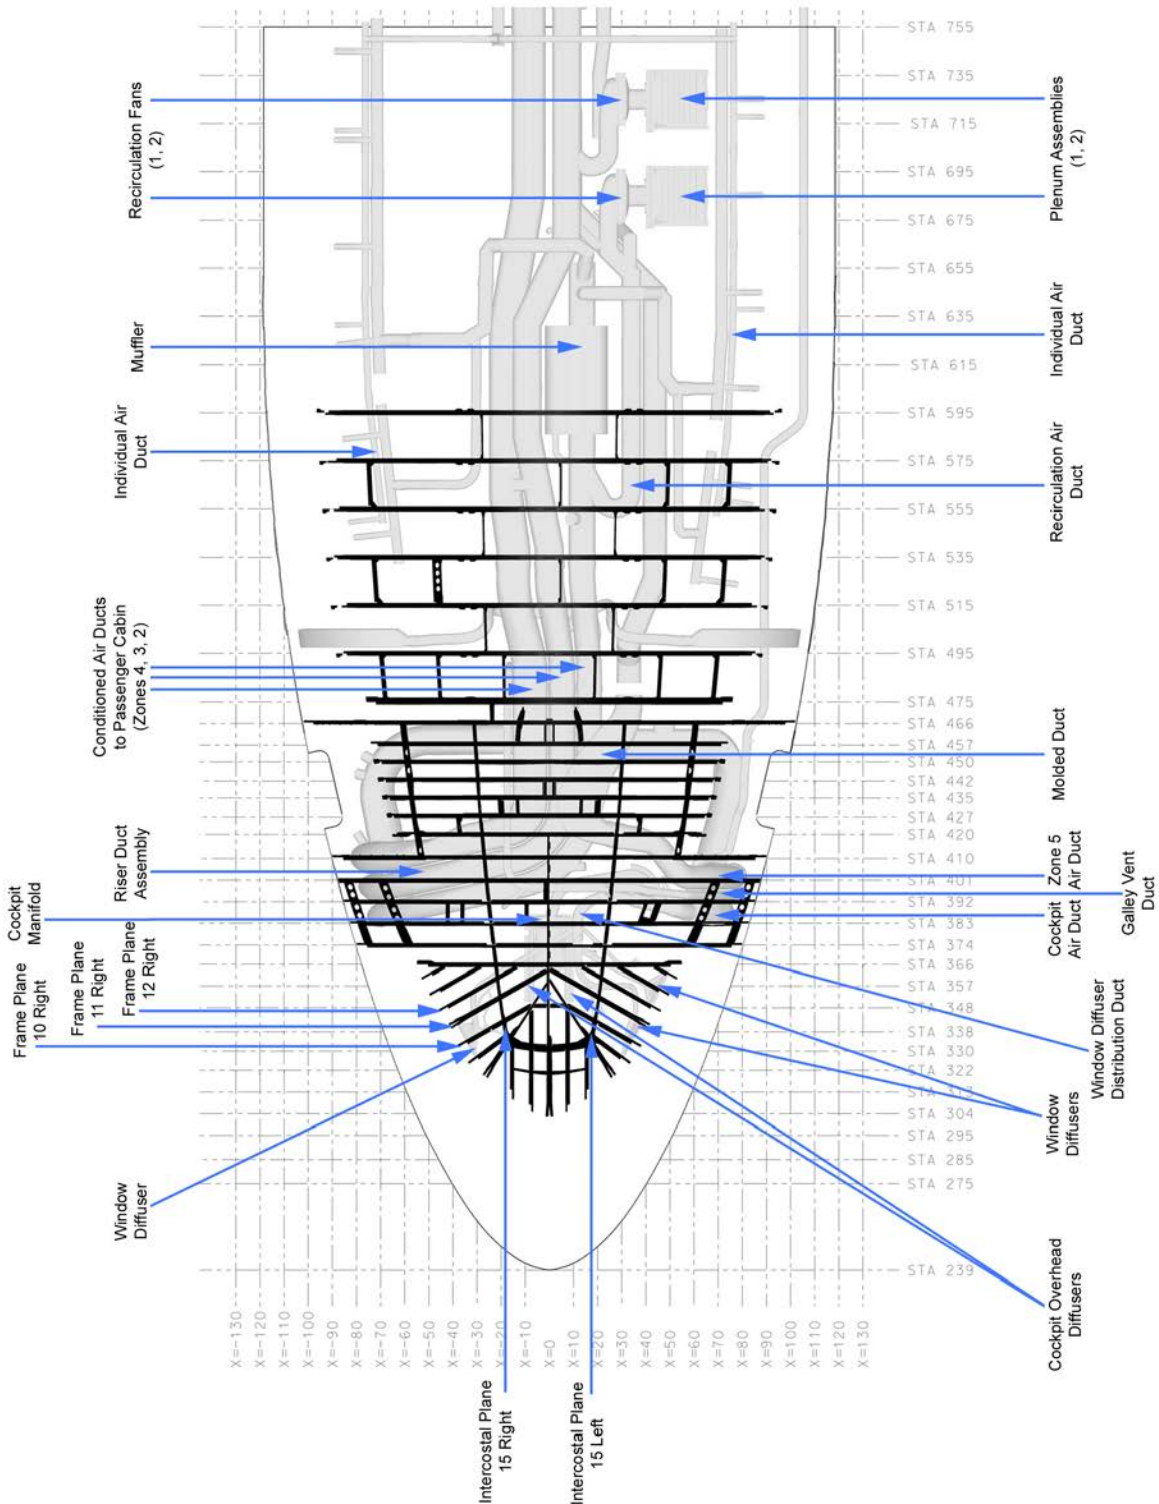
Figure 24: Airframe structure and air distribution system

There was bare-metal heat damage on the ducts behind the cockpit air diffusers from STA 350 aft to STA 402, primarily between the plane 15 left and right intercostals. The exception was the window diffuser distribution duct, which had bare-metal heat damage along STA 392 to $X = 32$. The heat damage to the recovered portions of the diffusers varied, with higher heat on the upper surfaces and lower heat on the lower surfaces adjacent to the cockpit ceiling liner.

Damage to the riser duct assembly ranged from no heat damage to bare-metal heat damage. The vertical portion of this assembly had no heat damage. The first area of bare-metal damage to the riser duct assembly started at intercostal plane 15 right, where the lower surface had a region of bare-metal heat damage from $X = -30$ inboard to the joint at $X = -20$. This was in the vicinity of the Galley 2 vent end cap. There was bare-metal damage from approximately STA 395 to STA 442 between $X = 25$ and $X = -10$. A section of molded duct was installed in that area from STA 420 to STA 442 between $X = 5$ and $X = 25$. No portions of this molded duct were identified in the wreckage.

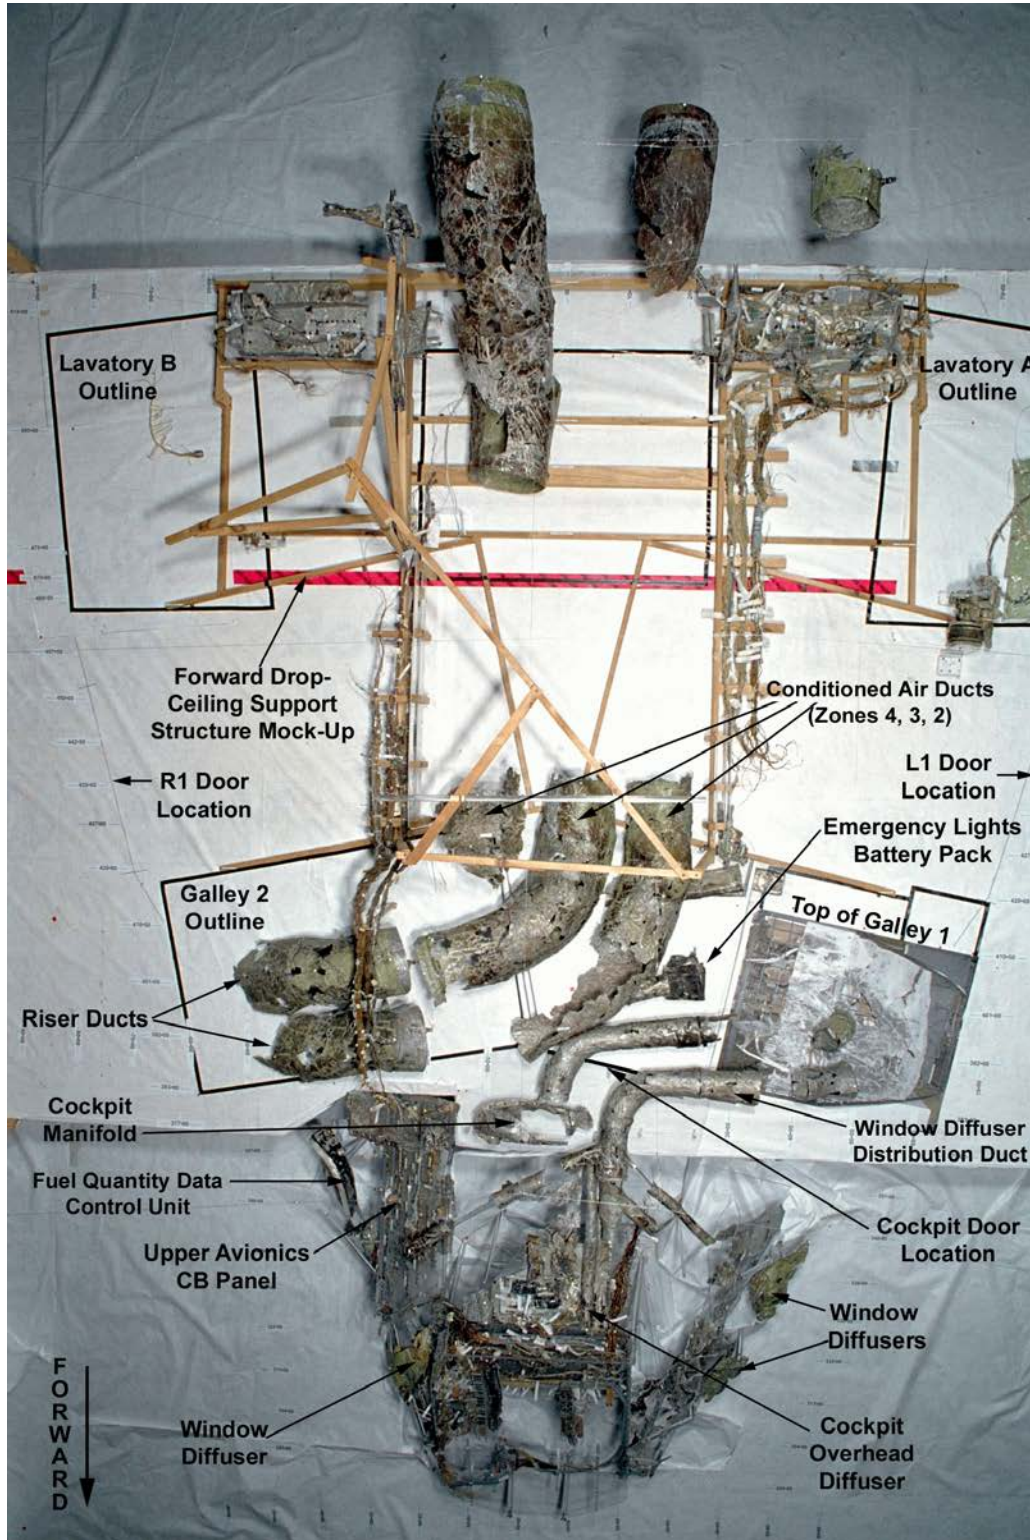
Figure 27: Cockpit attic and forward cabin drop-ceiling areas mock-up

About 75 per cent of the upper and lower CB panels were identified, reconstructed, and placed in the reconstruction mock-up (see Figures 27 and 28). The most forward sections of the upper and lower CB panels were not recovered. The upper avionics CB panel had been exposed to heat coming from both the front and back sides. The lower CB panel did not show any heat damage. The heat damage pattern on the front face of the upper CB panel was shown by the change in colour of the paint. Parts of the panel displayed damage consistent with temperature reference exemplar coupons exposed to temperatures from 430°C to 620°C (800°F to 1 150°F) for 10 minutes.⁶⁷ Discolouration and heat damage was present on the back side of this panel on some electrical components and on some bare-metal surfaces. Although there were similarities at some locations, the damage pattern on the back side was less than on the front

side, particularly on those pieces near the forward end of the panel where the front side of the panel showed considerably more heat damage than the back side. Individual CBs showed soot on the white indicator ring; soot could only have been deposited if the CB had tripped and subsequently been exposed to combustion by-products. Details concerning the CBs on the avionics CB panel and wiring in the vicinity are included in separate sections of this report.
