INTERSTATE AVIATION COMMITTEE
AIR ACCIDENT INVESTIGATION COMMISSION

FINAL REPORT

Type of occurrence	Accident
Type of aircraft	Airplane, Boeing 737-500 (53A)
Registration	VQ-BBN (Bermuda)
Registered Charterer (according to the registration certificate)	AWAS (BERMUDA) LIMITED, Clarendon House, 2 Church Street, Hamilton HM 11, Bermuda
Operator	Tatarstan Airlines, JSC, Russia
Aviation Administration	Tatar ITO, FATA
Place of occurrence	Russian Federation, Kazan International Airdrome, coordinates: N 55° 36,5291' E 49°16,6111'
Date and Time	November 17, 2013, 15:24 UTC, 19:24 local time, night time

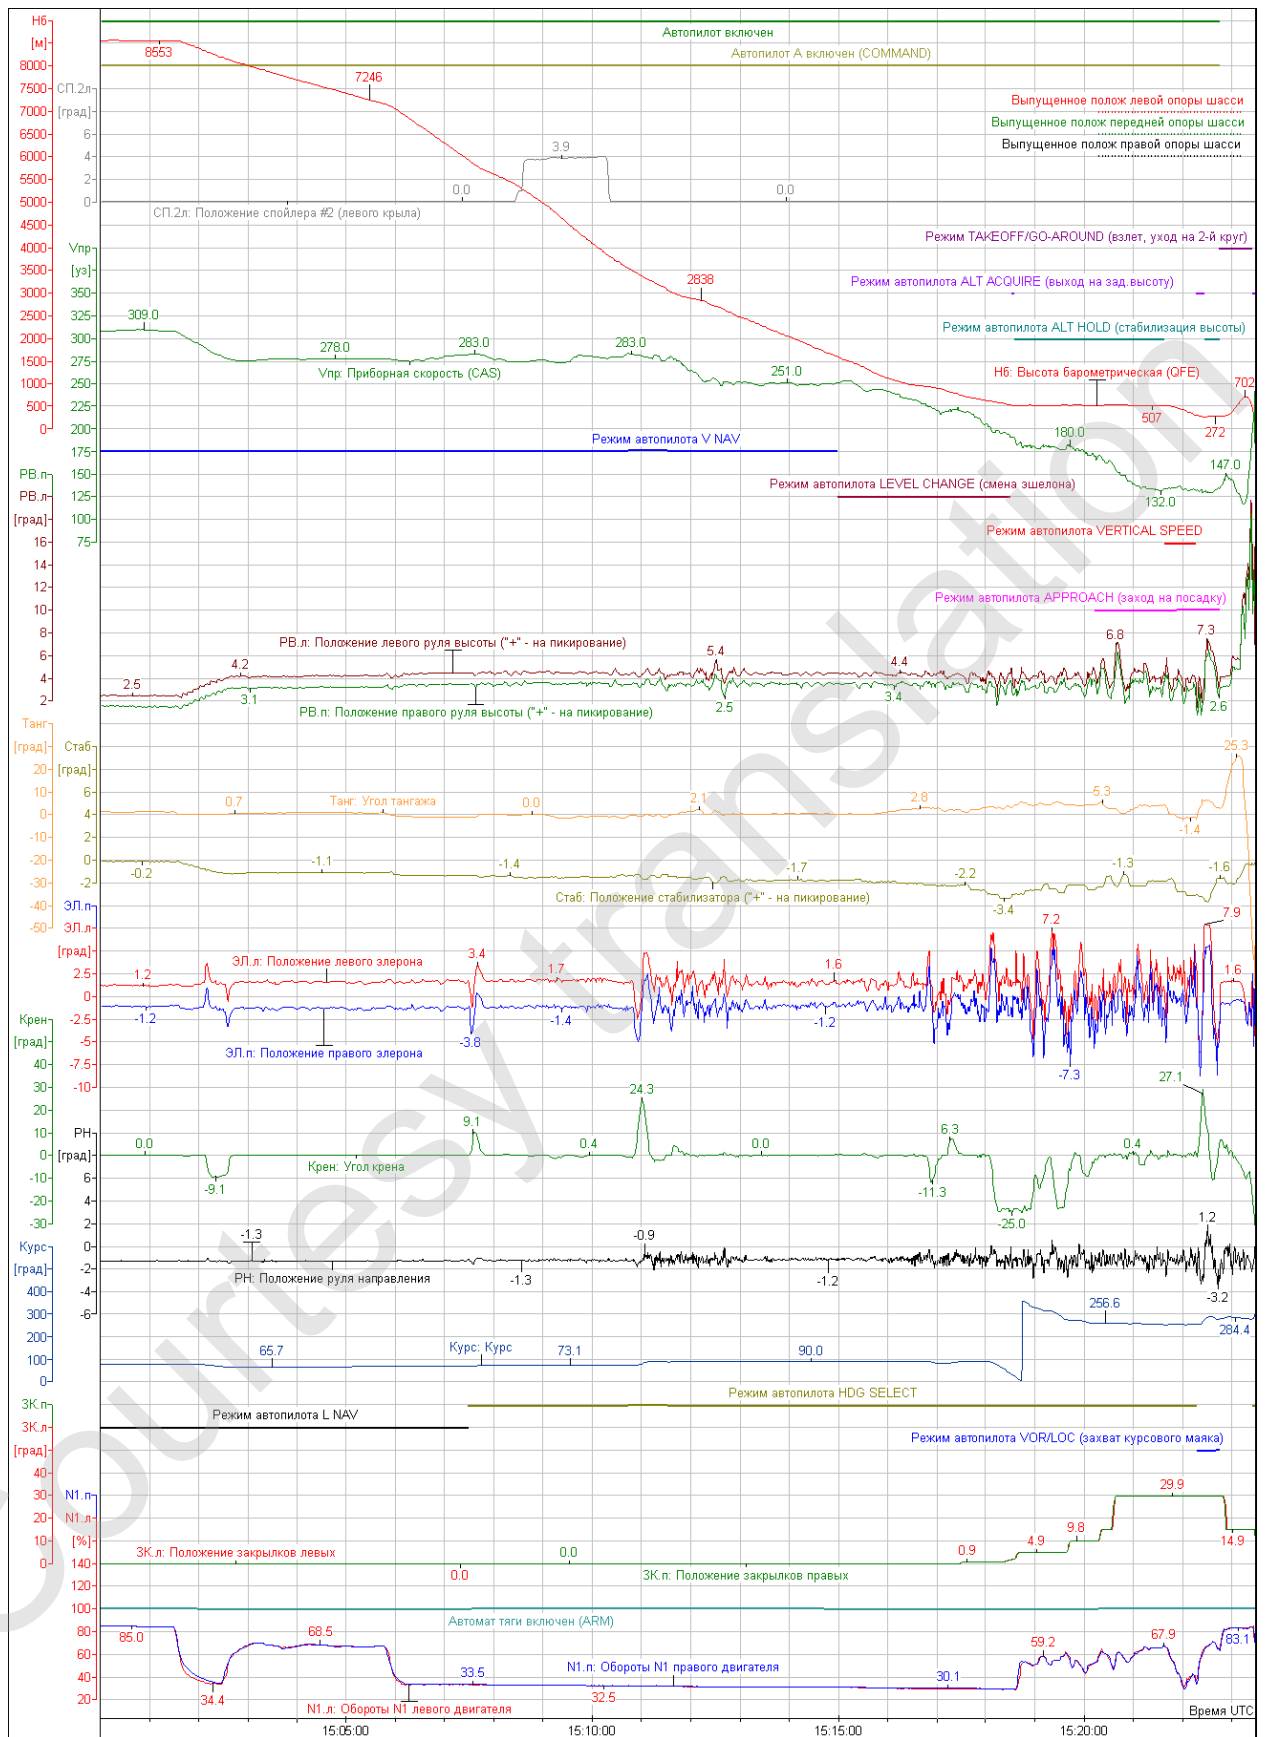
Figure 11 Boeing 737-500 VQ-BBN Flight Data for 17.11.2013 (descent)

At 15:00 the aircraft passed SHUMERLYA waypoint and was handed over to Kazan Control. At 15:01 at FL 290 the crew contacted Kazan Control to report: “*Kazan Control, Tatarstan 3-6-3, good evening, Shumerlya, flight level 2-9-0, ready for descent*”. The ATC instructed them to descend to FL 70, “*Tatarstan 3-6-3, Kazan Control, descend flight level 7-0, identified*”. The descent was initiated at 15:01:30 (Figure 11).

The crew received the ATC information and spent a long time discussing the map shift and transitioned from L-NAV to HDG SEL mode. At 15:08 the heading was changed from 68° to 73° (Figure 11). However, this heading change was not enough to capture the track axis.

As the aircraft was approaching the base turn the flaps were set at 1° (Figure 11). As the flaps were being extended to 1°, at an altitude of 2600 ft (800 m) the Altitude alert was triggered. It alerted approaching the altitude set at the MCP (1700 ft).

In the course of the turn, at 15:18:30, the aircraft reached the MCP altitude of 500 m that was maintained by the A/P in the ALTITUDE HOLD mode. During the turn the Flaps were set to 5°, and by the end of the turn they were extended to 10° (Figure 11).

As the aircraft was heading approx. 250° the crew continued to prepare for landing, they extended the flaps to 15° and then to 30°, they extended the landing gear (Figure 11), while the HSI LOC deviation pointer was at the most left position. The crew completed the Landing Checklist. After the landing configuration was achieved, the aircraft was flown with an airspeed of 130-135 kt.

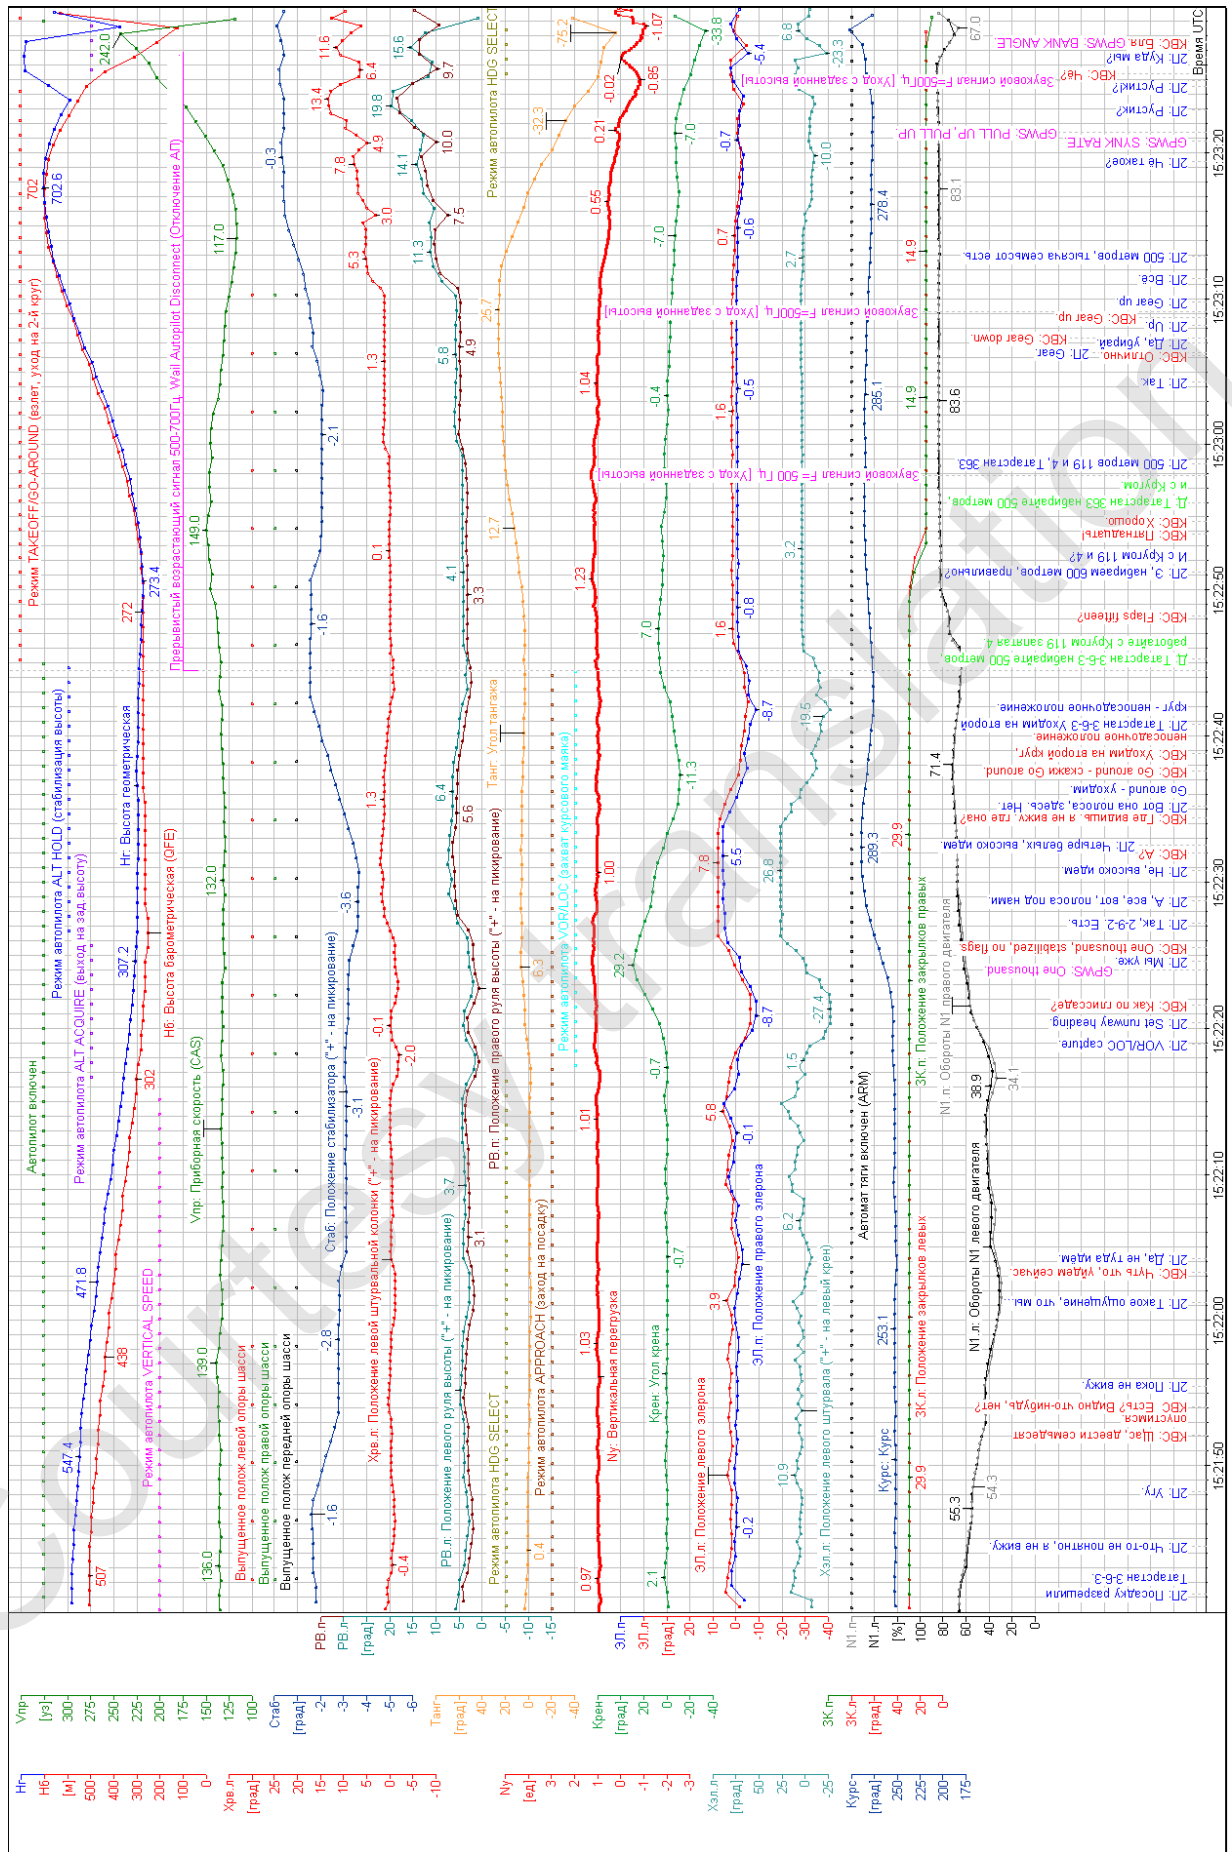
Figure 12 Boeing 737-500 VQ-BBN Flight Data for 17.11.2013 (final segment)

After they received the clearance the crew engaged the V/S mode (selected vertical speed 1200 fpm) to descend to 270 m (900 ft) height which was selected on the MCP and maintained by the A/P until the go-around (Figure 12).

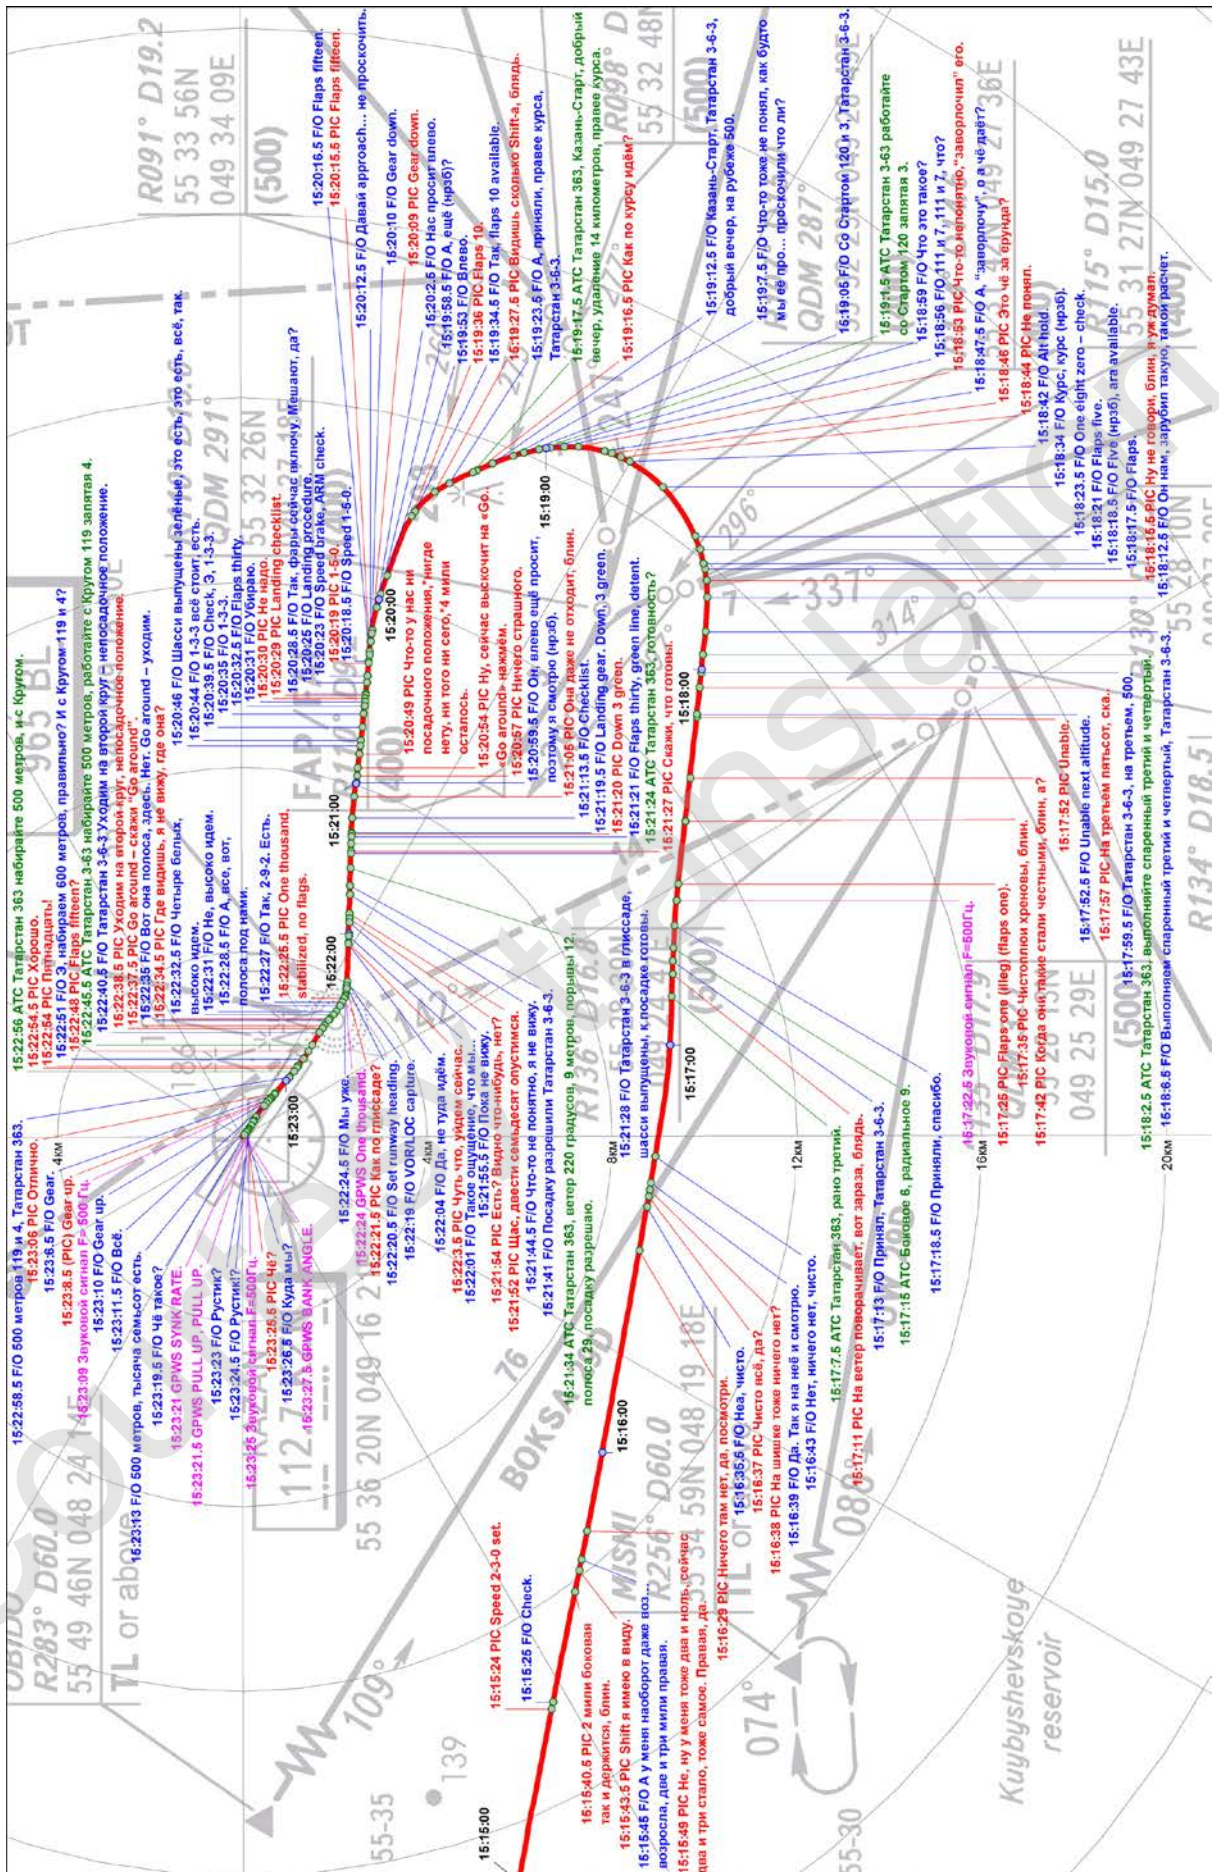
Figure 15 Boeing 737-500 VQ-BBN flight path on 17.11.2013 near Kazan Airport (there is a gap on the STAR pattern from the base turn point to MISMI waypoint, MISMI position is out of scale)

heading change was not enough either. The aircraft was approaching the base turn parallel to the standard approach pattern (Figure 15 and Figure 81).

After the crew informed the ATC on reaching the base turn point they were cleared for base and final turn. Actually the turn was initiated at 15:18 in the HDG SEL mode before the aircraft reached the altitude of 500 m with a significant deviation from the STAR pattern (Figure 15 and Figure 81), that the ATC could have seen on the radar, and the crew could have seen that using the VOR/DME.

The turn was completed with a significant “overturn” (Figure 15 and Figure 81). The cockpit communication analysis revealed that the crew was not completely aware of their position with regard to the approach pattern, which is confirmed by the following dialogue between the PIC and the FO at 15:18:46:

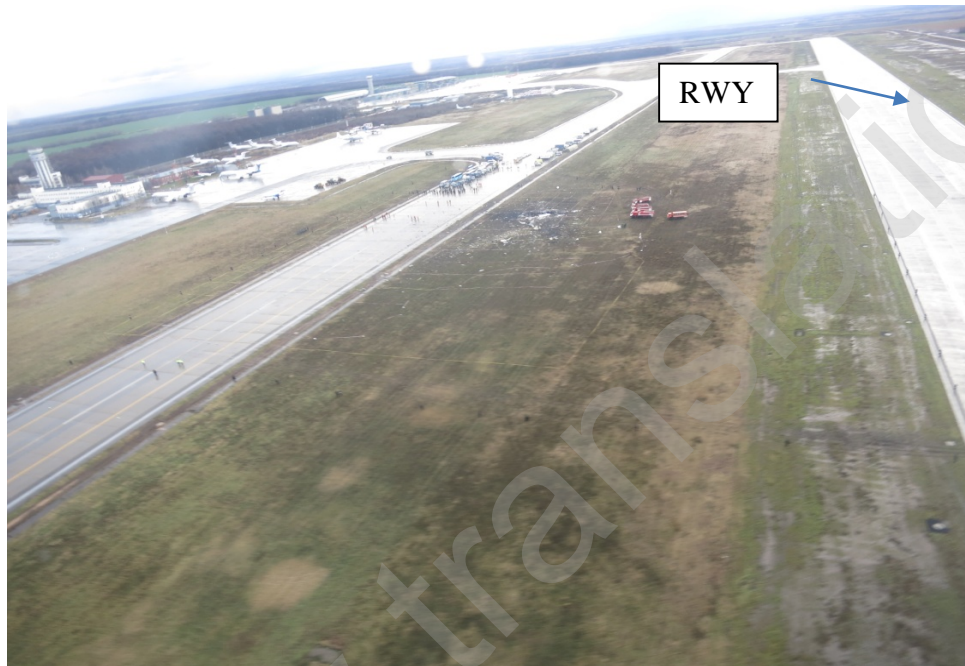
Figure 16 Accident site general view from opposite to the flight direction

The aircraft was approaching to land with magnetic heading 292 degrees. The accident occurred at the airfield of Kazan International Aerodrome between the runway, main taxiway, Taxiway C and taxiway B (Figures 16 and 17). The airport is located in the plain. The runway threshold elevation is 125 m for heading 292 degrees, and 106 m for heading 112 degrees. The elevation at the accident site is 115 m.

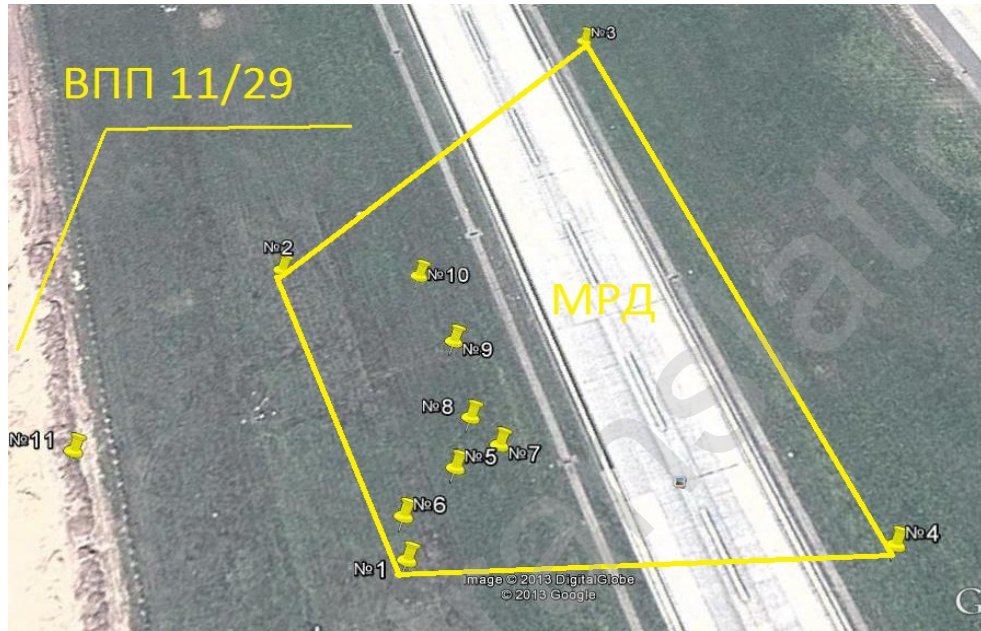
Figure 18 Wreckage plot

The aircraft impacted the ground between the runway in use (RWY 29) and the main taxiway at point 5 (Figure 18) ($N55^{\circ}36.5291'$ and $E49^{\circ}16.6111'$). The wreckage spread area was

insignificant and is marked with points 1-2-3-4 (Figure 18). The perimeter distance between the points was:

The largest structural fragments are marked with points 5 through 11.

The accident site examination revealed that the aircraft impacted the ground with a large nose down pitch angle. This is determined by the nature of the crater (Figure 18), as well as engine position being almost vertical in the ground.

After the impact the fuselage was destroyed with the tail cone detached (Figure 20), the latter being found 20 m ahead of the impact point in the direction where the aircraft was heading (point 8, Figure 18).

Forty meters ahead of the tail cone fragment in the flight direction (point 9, Figure 18) a rudder fragment was found (Figure 21).

At distance of 120 m from the first impact point and 25 m from the right edge of RWY 29 (runway in use) (point 11, Figure 18) a red fire extinguisher bottle was found (Figure 22). This fragment was the closest one to the runway.

The runway examination made immediately after the accident revealed no aircraft marks or fragments on the runway and beyond the fragment spread area (Figure 18). Thus, there were no signs of uncontained inflight damage.

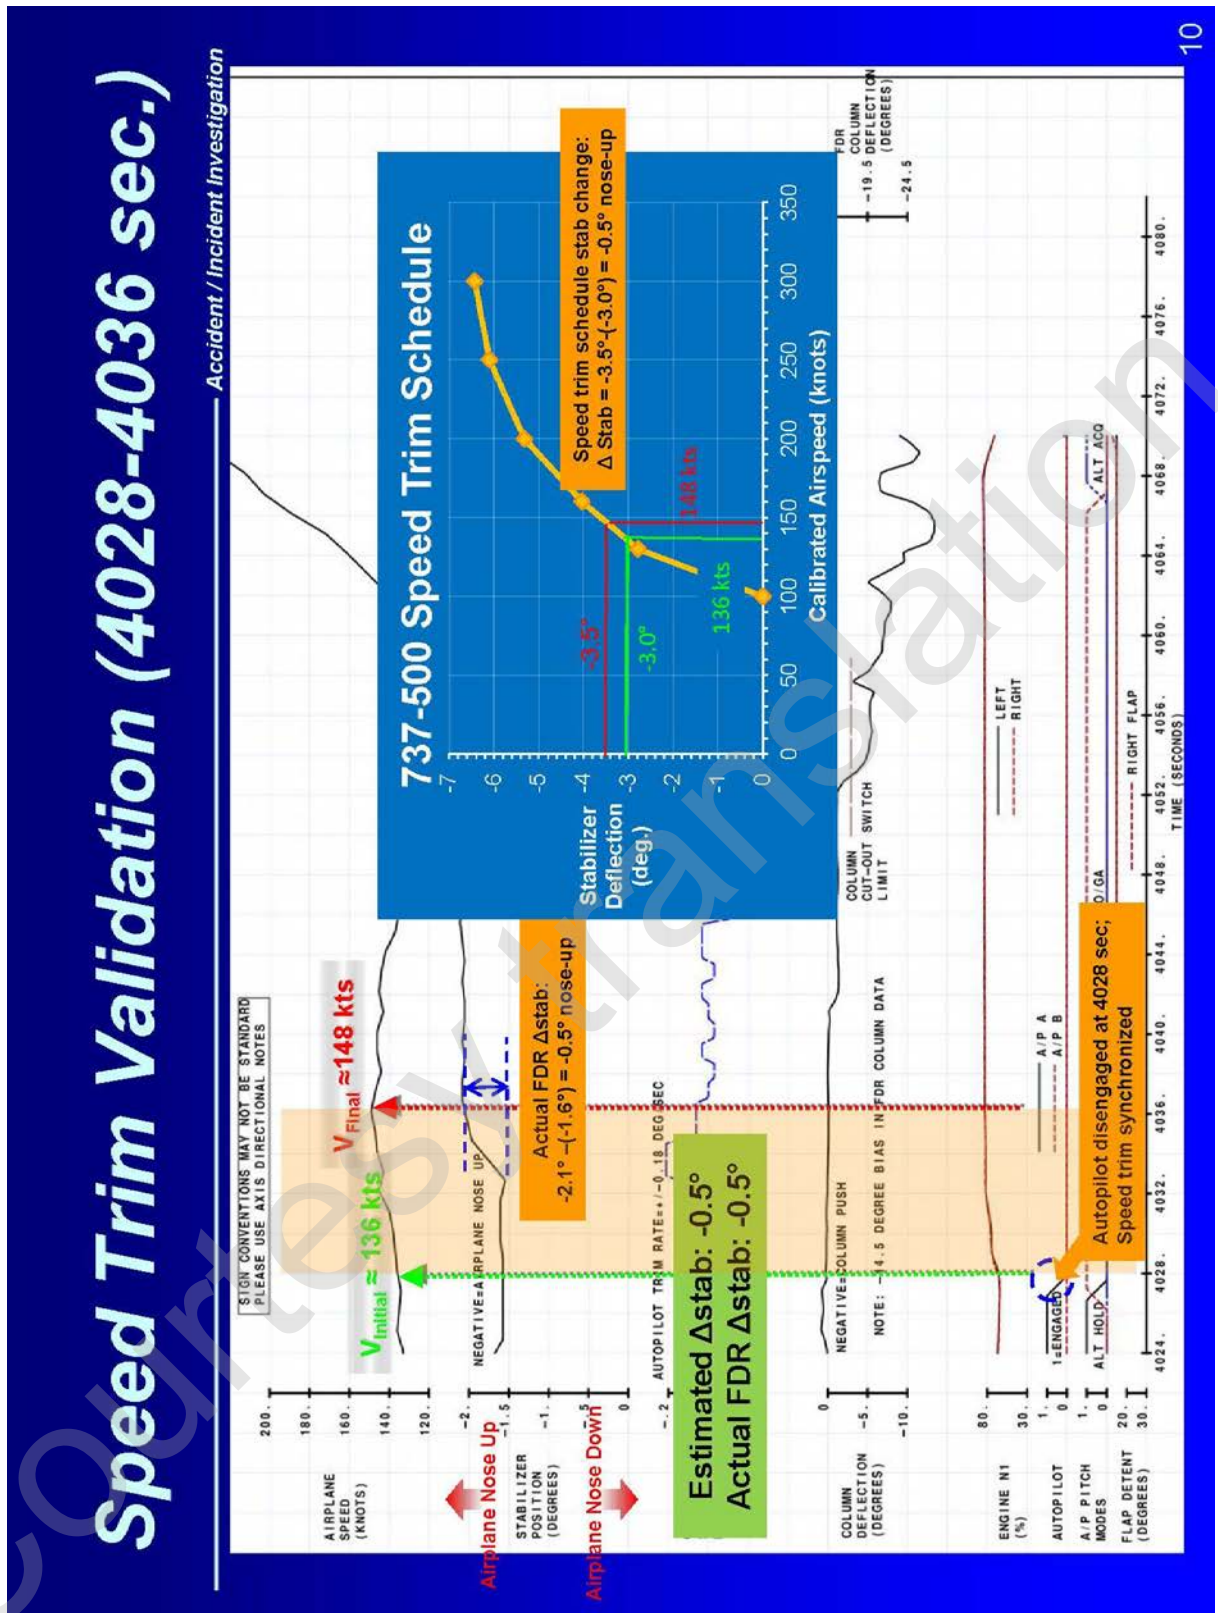
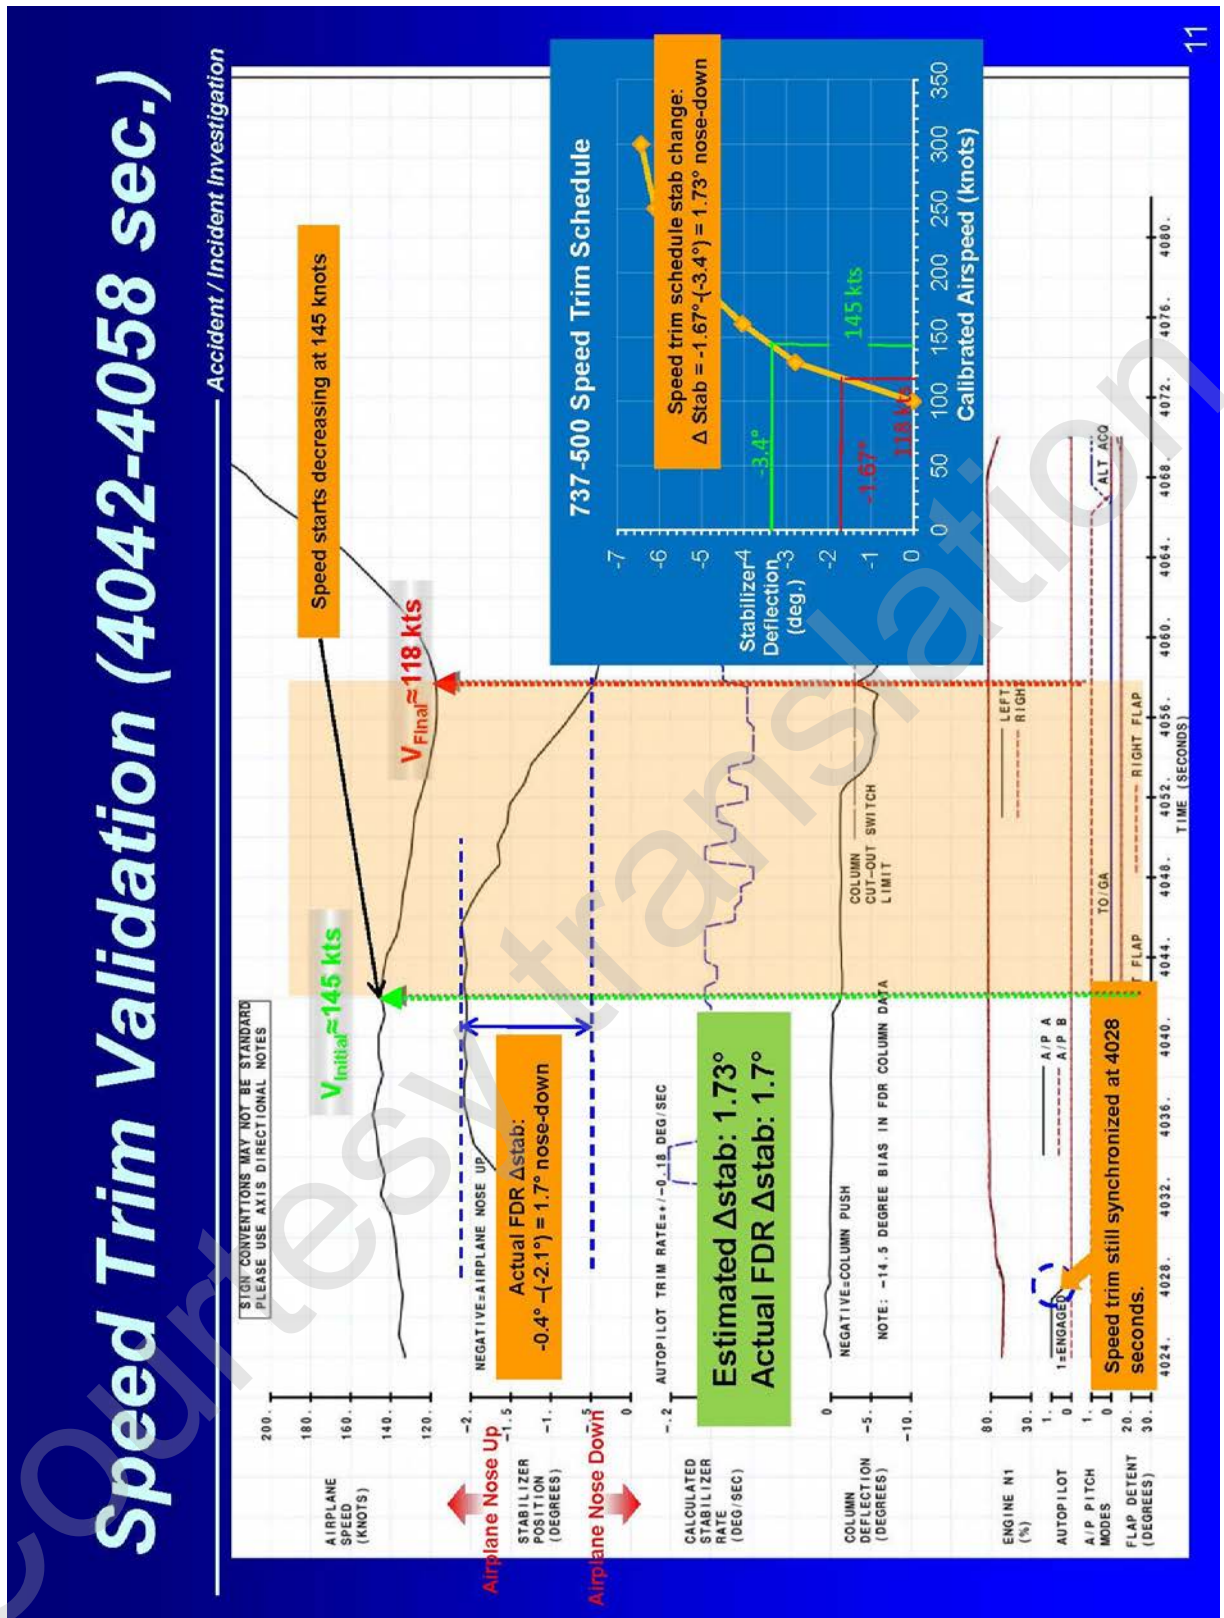
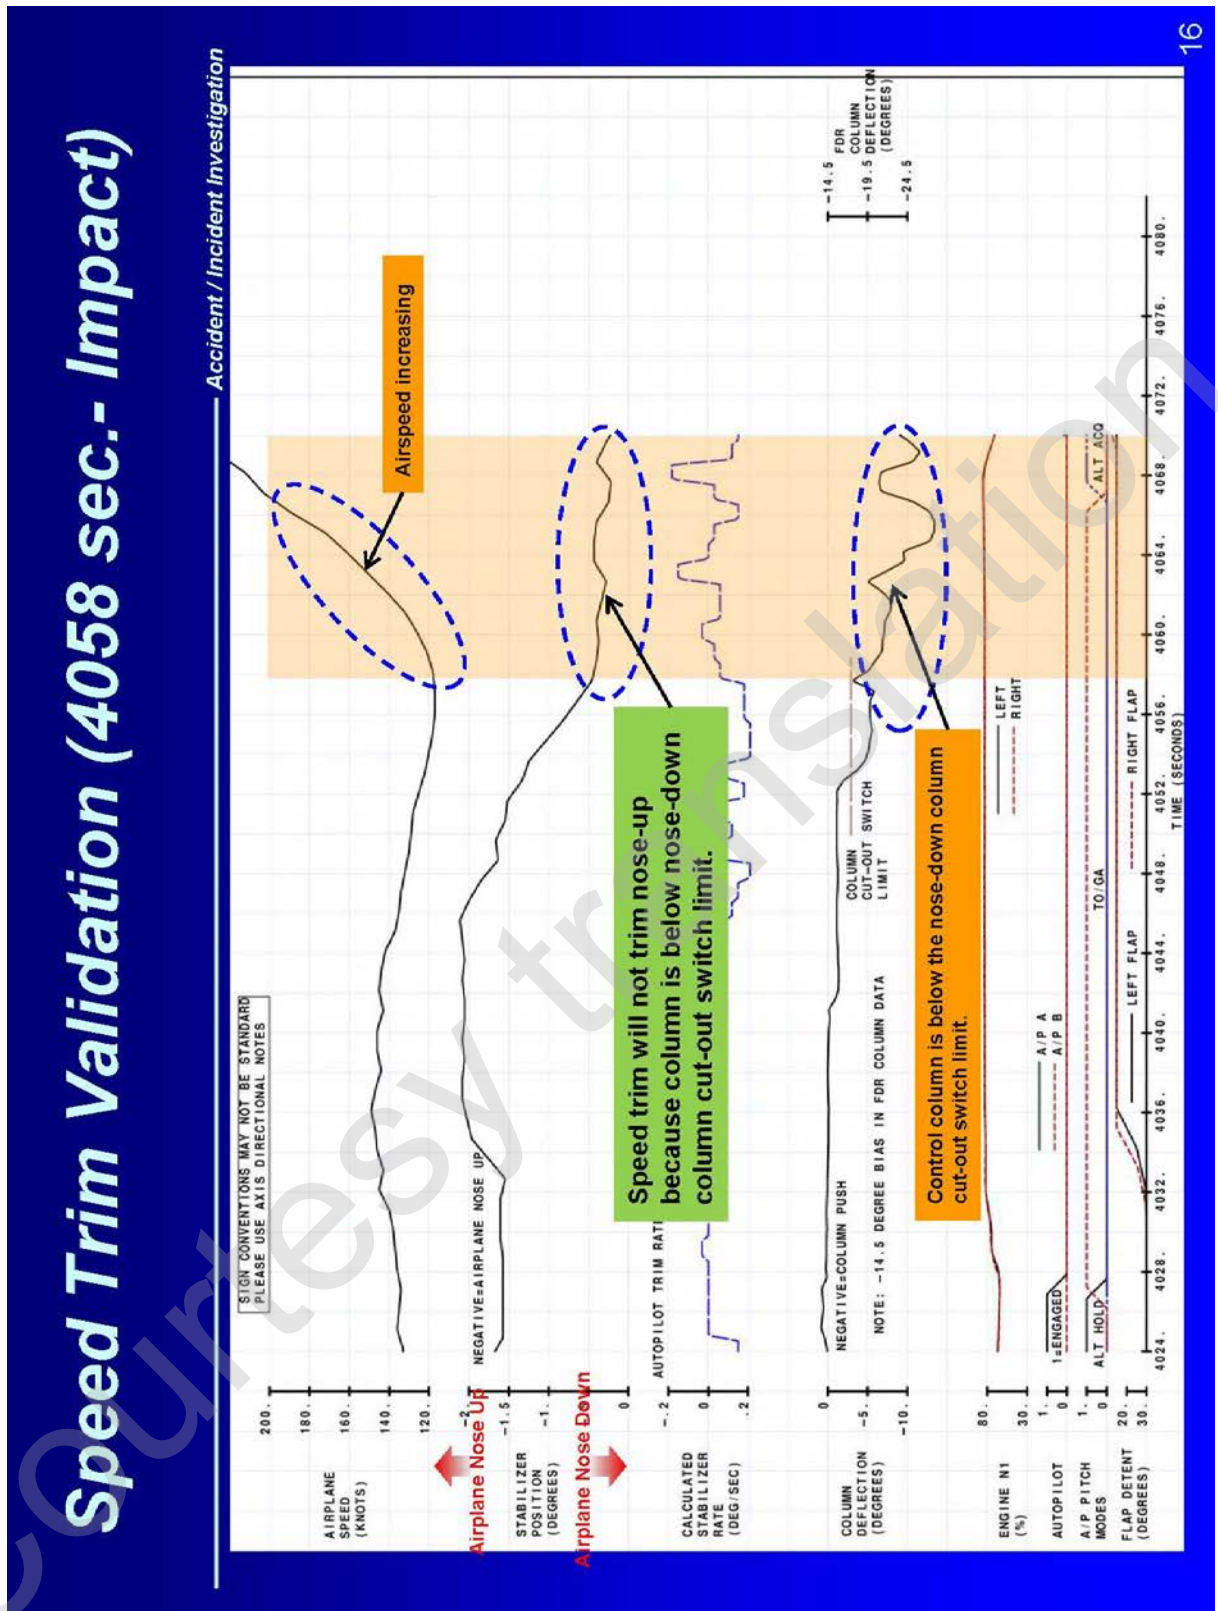
Figures 29 to 31 show the three specific segments of the final flight stage. In the first segment (Figure 29) as the airspeed increased from 136 knots to 148 knots the stabilizer made an increment 0.5° nose up deflection, which corresponds to the value determined by the chart on Figure 28. In the second segment (Figure 30) as the airspeed decreased from 145 knots to 118 knots the stabilizer made an increment 1.7° nose down deflection, which also corresponds to the value determined by the chart on Figure 28. In the third segment (Figure 31) despite the extensive airspeed increase the stabilizer did not deflect nose up as the crew deflected the column nose down to a value exceeding the threshold value, which deactivated the STS as per design.

Thus, the Speed Trim System was operating normally in the accident flight.

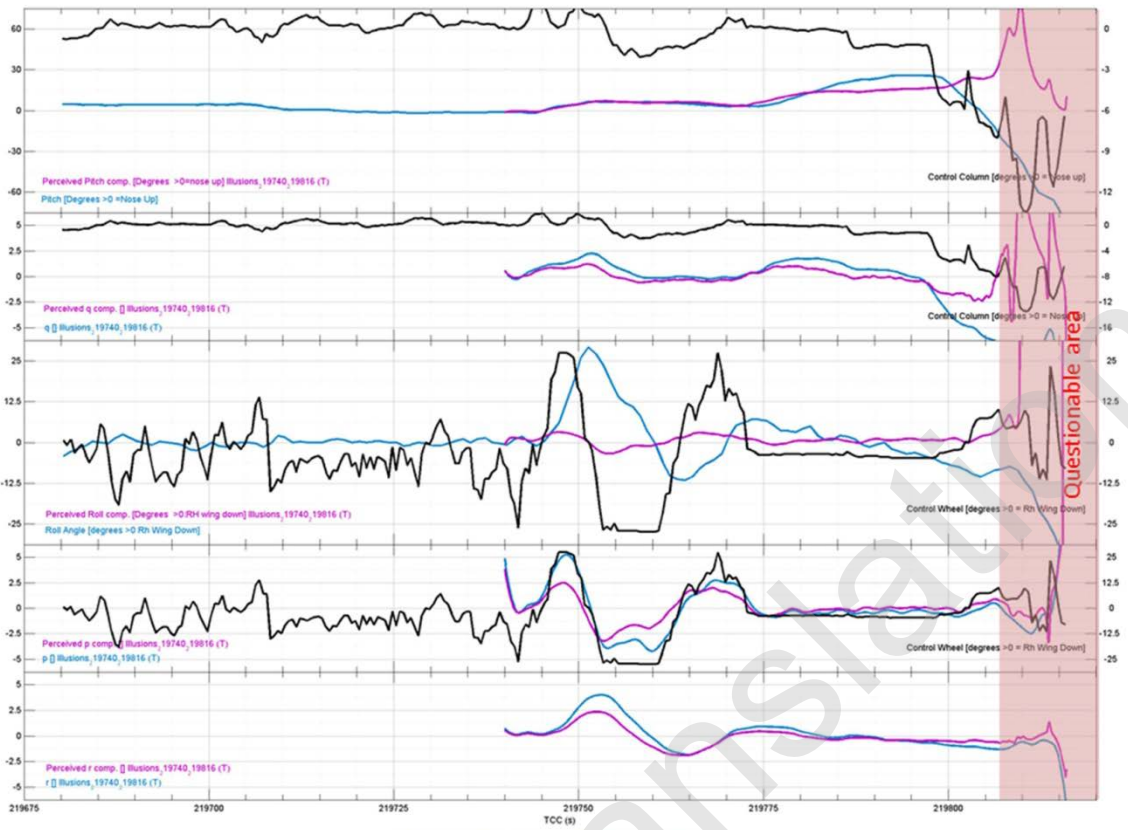
Figure 32 BEA Sensorial Modelling Results

The applied model has a number of limitations. The modelling results require verification when the actual pitch is greater than 25 degrees or lower than -15 degrees and could not be used when the normal acceleration is lower than 0 G (negative load factor). The abovementioned conditions are applicable to the 9 last seconds of the flight (Figure 32, see the red area)¹⁵.

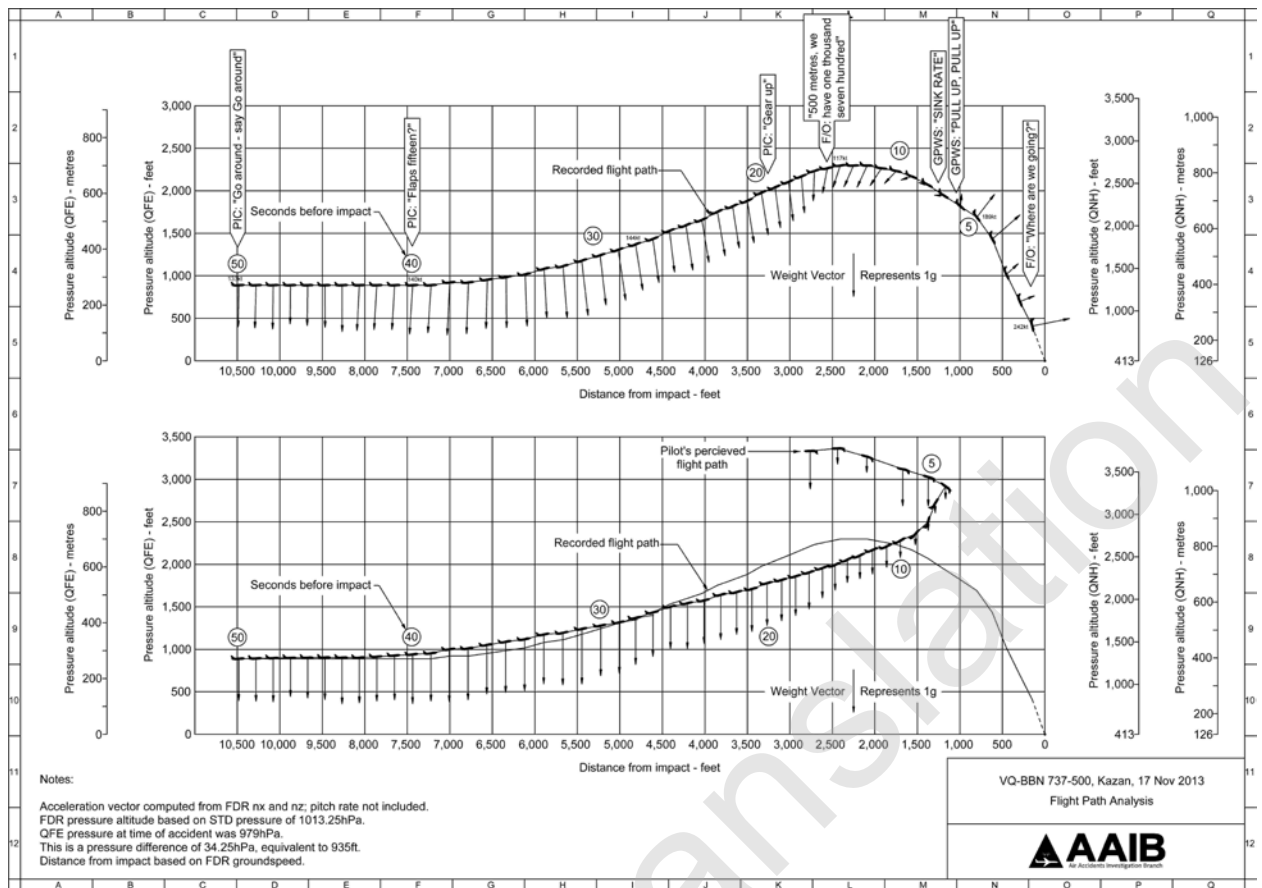
Figure 34 AAIB UK Sensorial Modelling Results

The modelling led to a conclusion that provided the pilots did not monitor the flight instruments in due manner they could have experienced the so-called “inversion” illusion during a change from climb to descent and during descent, which could have forced the PIC to apply nose down pitch control to correct the perceived pitch angle increase (sensed “looping” flight path).

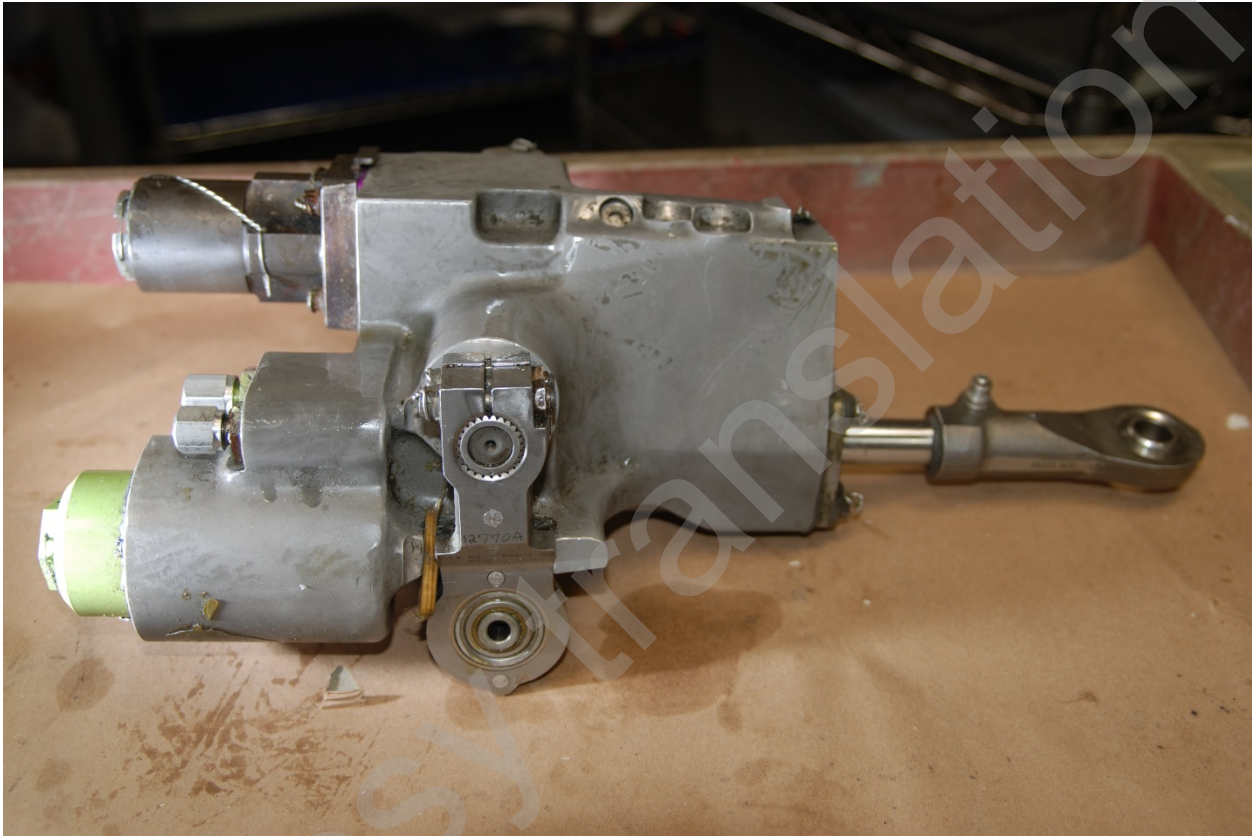
Figure 35 Left hand actuator

Taking into account the accident circumstances and FDR data readout (intense nose down pitching during the final phase of the flight and no nose up inputs) as well as earlier in-service occurrences related to PCU malfunctioning (Section 1.18.7) the investigation team decided to request an examination of the elevator power control units. Figures 35 and 36 below show the PCU as they arrived for the examination.

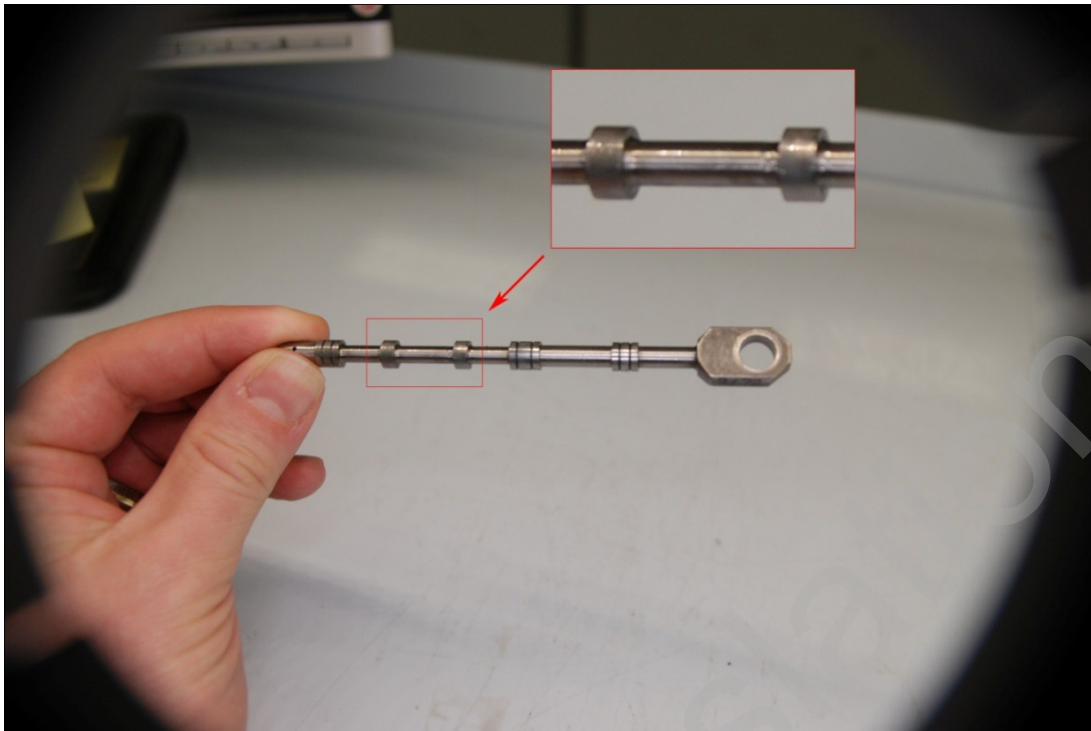
Figure 66 RH control valve primary slide

The first feature is different design of the RH and LH control valve primary slides. Two of the RH control valve primary slide lands have no balance grooves (Figure 66). While the LH control valve primary slide has those balance grooves (Figure 67).

Similar differences were revealed on the bypass valve slides. The absence of balance grooves may lead to increased friction forces and more extensive wear. According to the designer's explanation both types of slide design are acceptable. This is explained by the fact that balance grooves were added to slide design over time and are now considered the industry standard, though

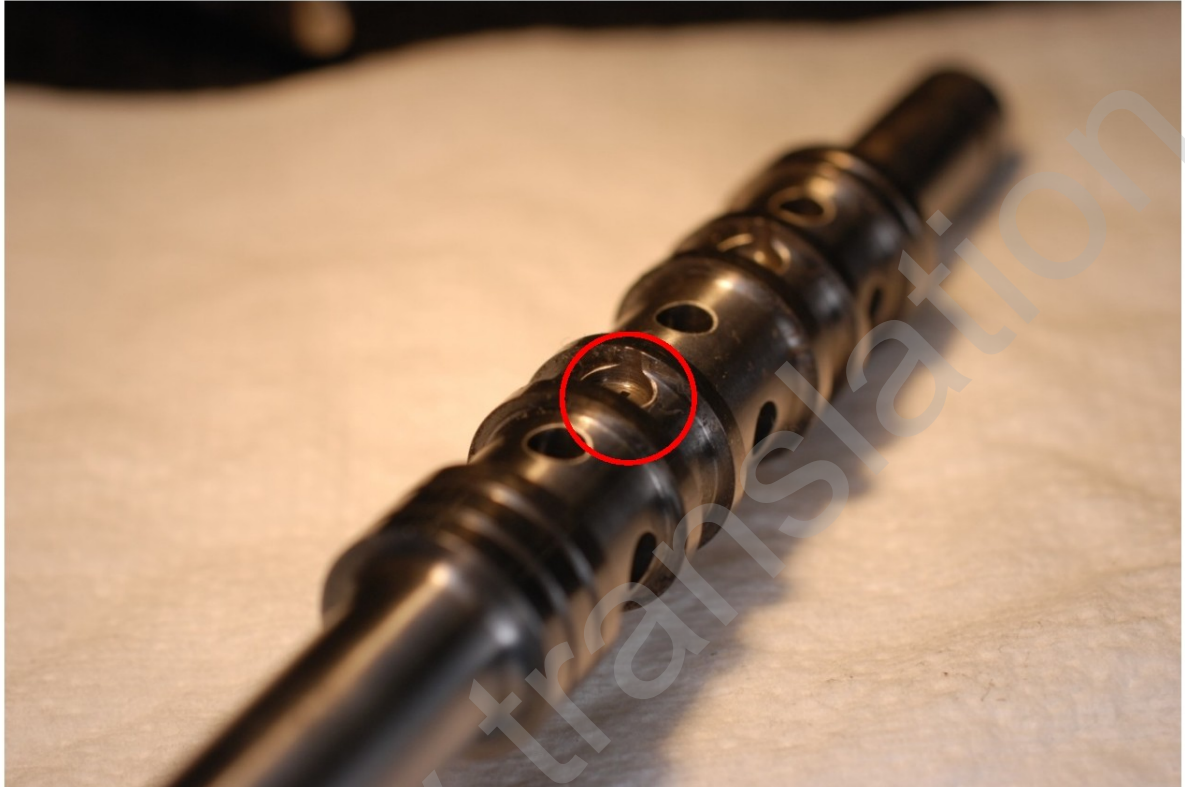
Figure 68 RH control valve secondary slide land edge deformation

The second feature is the edges deformation on lands of the RH control valve secondary slide (Figures 68 and 69).

Such feature is a result of the manufacture of the recessed hole in the secondary slide. The features were measured and were determined to be within the tolerance requirements of the applicable drawing. It was also noted that the side of the land edge that was deformed is non-critical non-metering edge side.

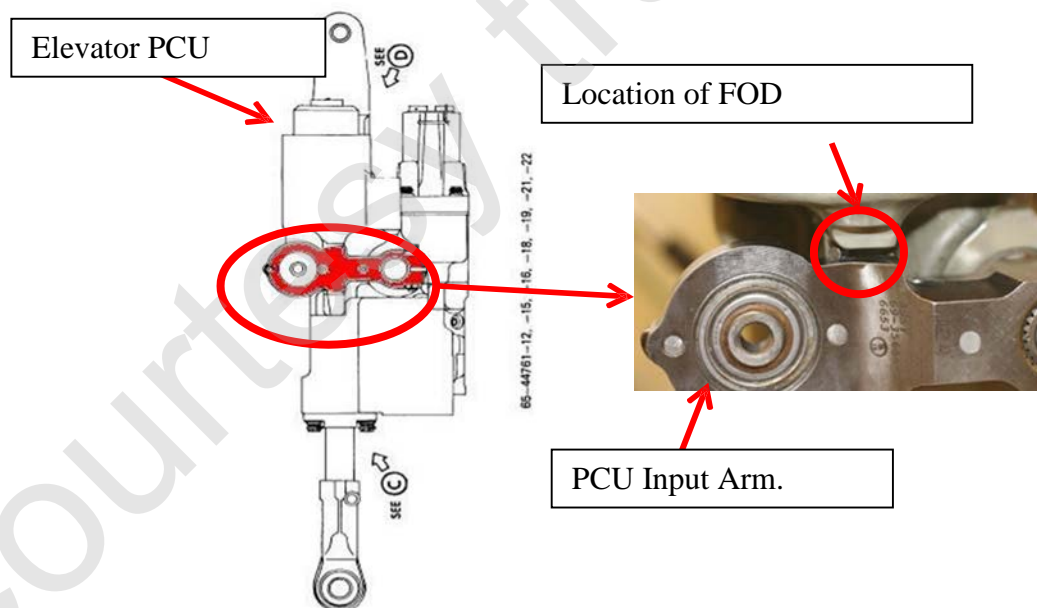
Figure 70 Location of FOD

The incident investigation was conducted by the NTSB. The NTSB's investigation found that the incident was caused by an uncommanded elevator deflection as a result of a left elevator power control unit (PCU) input arm assembly jam due to foreign object debris (FOD). The FOD was a metal roller element (about 0.2 inches long and 0.14 inches in diameter) from an elevator bearing. As a result, the PCU would be commanded to move the elevator to a position that would pitch the aircraft nose up.
