INTERSTATE AVIATION COMMITTEE
AIR ACCIDENT INVESTIGATION COMMISSION

FINAL REPORT

Type of occurrence	Accident
Type of aircraft	Airplane, Boeing 737-500 (53A)
Registration	VQ-BBN (Bermuda)
Registered Charterer (according to the registration certificate)	AWAS (BERMUDA) LIMITED, Clarendon House, 2 Church Street, Hamilton HM 11, Bermuda
Operator	Tatarstan Airlines, JSC, Russia
Aviation Administration	Tatar ITO, FATA
Place of occurrence	Russian Federation, Kazan International Airdrome, coordinates: N 55° 36,5291' E 49°16,6111'
Date and Time	November 17, 2013, 15:24 UTC, 19:24 local time, night time

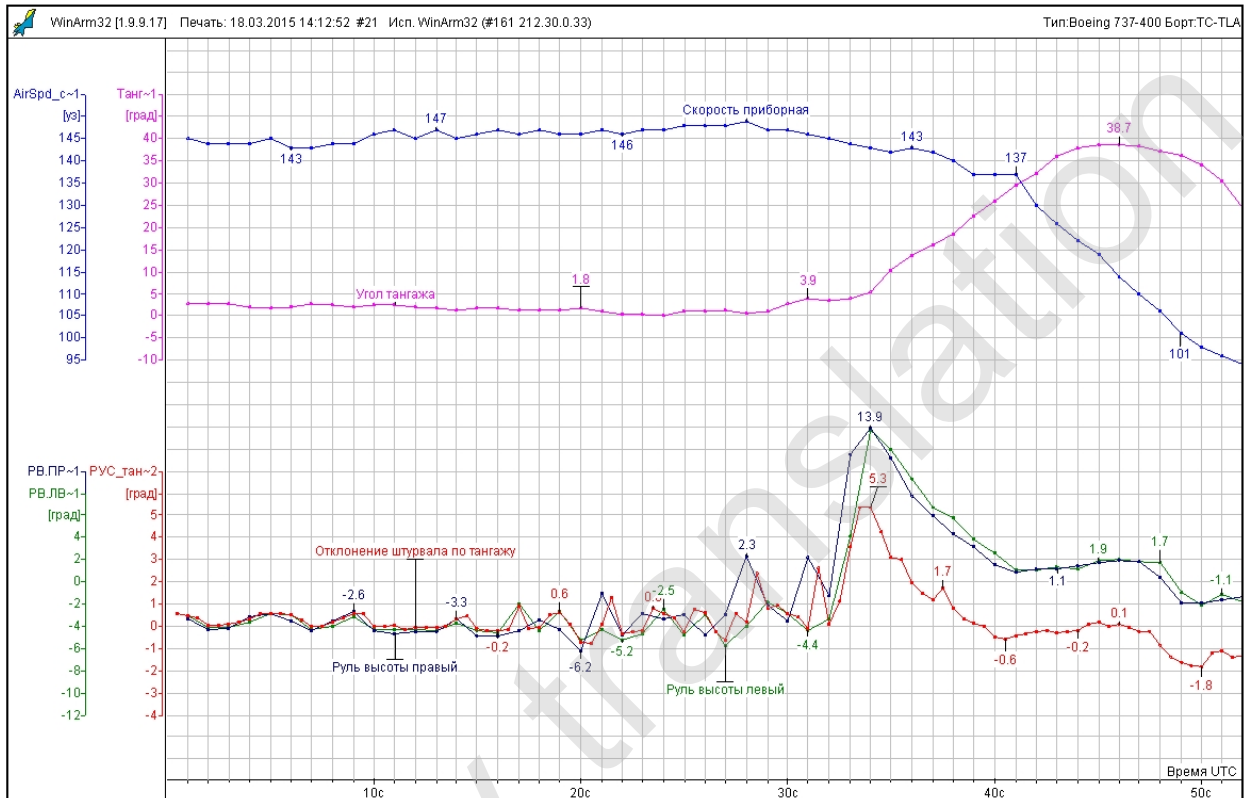
Figure 71 Boeing 737-400 TC-TLA Flight Parameters

The FDR record analysis (Figure 71) revealed that the significant column input forces applied by the crew led to control linkage extension. This is revealed by comparing the column and elevator positions before and after the jam. The same column position corresponds to different elevator deflection angles.

Figure 71 contains the FDR record for the Turkish event. Apparently the significant column input forces while the control linkage was jammed led to cable (control linkage) extension. This is revealed by comparing the column and elevator positions before and after the jam. The same column position refers to different elevator deflection angles.

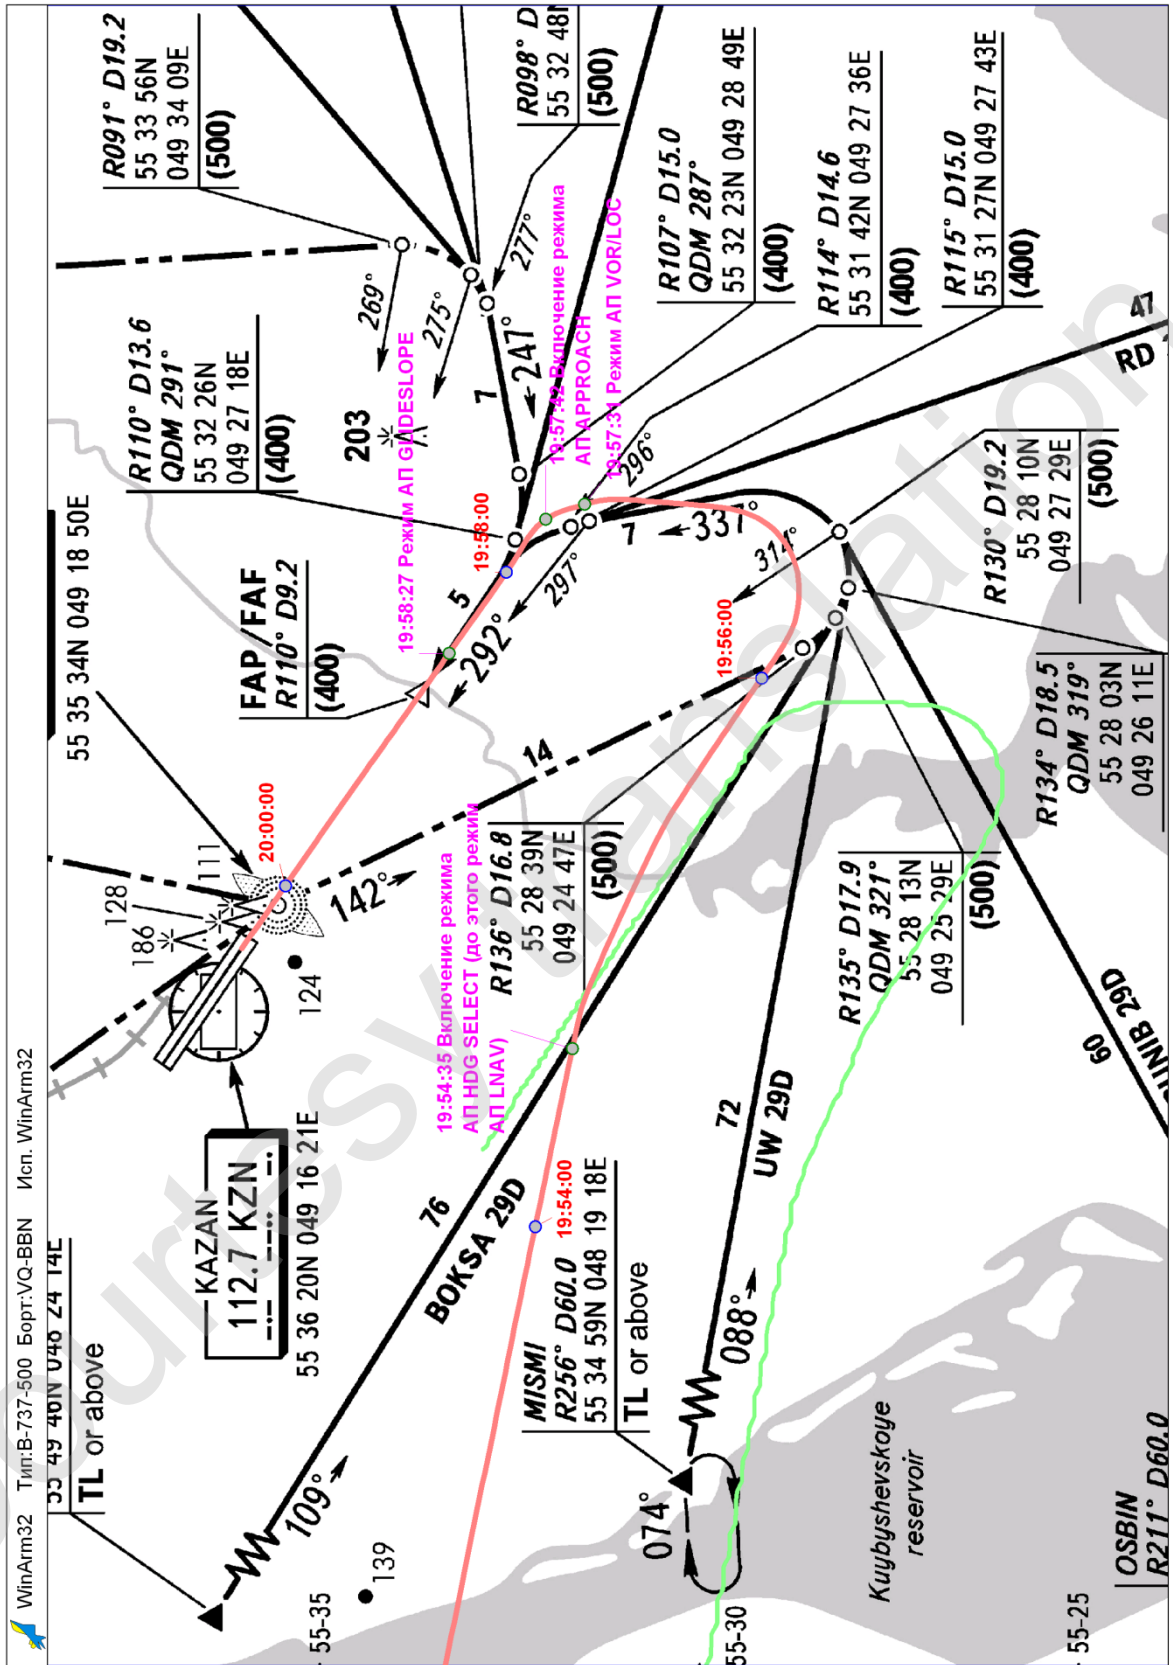
Figure 76 Boeing 737-500 VQ-BBN Flight Parameters, October 17, 2013

- during all approaches the crew engaged the VOR/LOC in due time, which ensured the aircraft intercepted the localizer in automatic mode;
- the flight path in Figure 76 is similar to the accident flight path from the MISMI waypoint to the disengagement of the L-NAV mode. After the L-NAV mode was disengaged and the HDG SEL mode activated the crew made a corrective turn right to intercept the base turn entry point with acceptable accuracy.

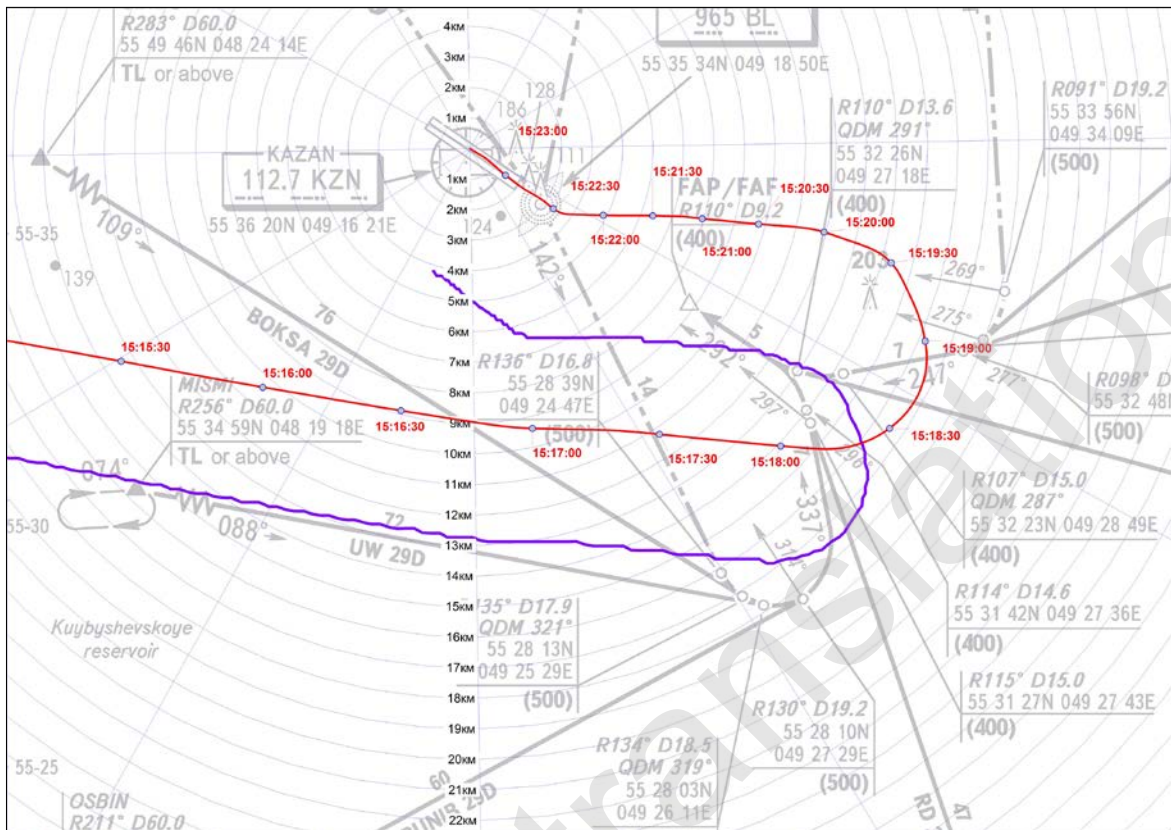
Figure 81 Actual flight path (red) and FDR (IRS) flight path (blue). There is a gap between the base turn and MISMI waypoint, the location of MISMI WP is out of scale

heading change was not enough either. The aircraft was approaching the base turn parallel to the standard approach pattern (Figure 15 and Figure 81).

After the crew informed the ATC on reaching the base turn point they were cleared for base and final turn. Actually the turn was initiated at 15:18 in the HDG SEL mode before the aircraft reached the altitude of 500 m with a significant deviation from the STAR pattern (Figure 15 and Figure 81), that the ATC could have seen on the radar, and the crew could have seen that using the VOR/DME.

The turn was completed with a significant “overturn” (Figure 15 and Figure 81). The cockpit communication analysis revealed that the crew was not completely aware of their position with regard to the approach pattern, which is confirmed by the following dialogue between the PIC and the FO at 15:18:46:

By the time the aircraft reached the approach pattern the map shift on the left IRS was approx. 4 km (Figure 81) southwards (i.e. the actual flight path was to the north of that recorded by the FDR)⁴⁰.

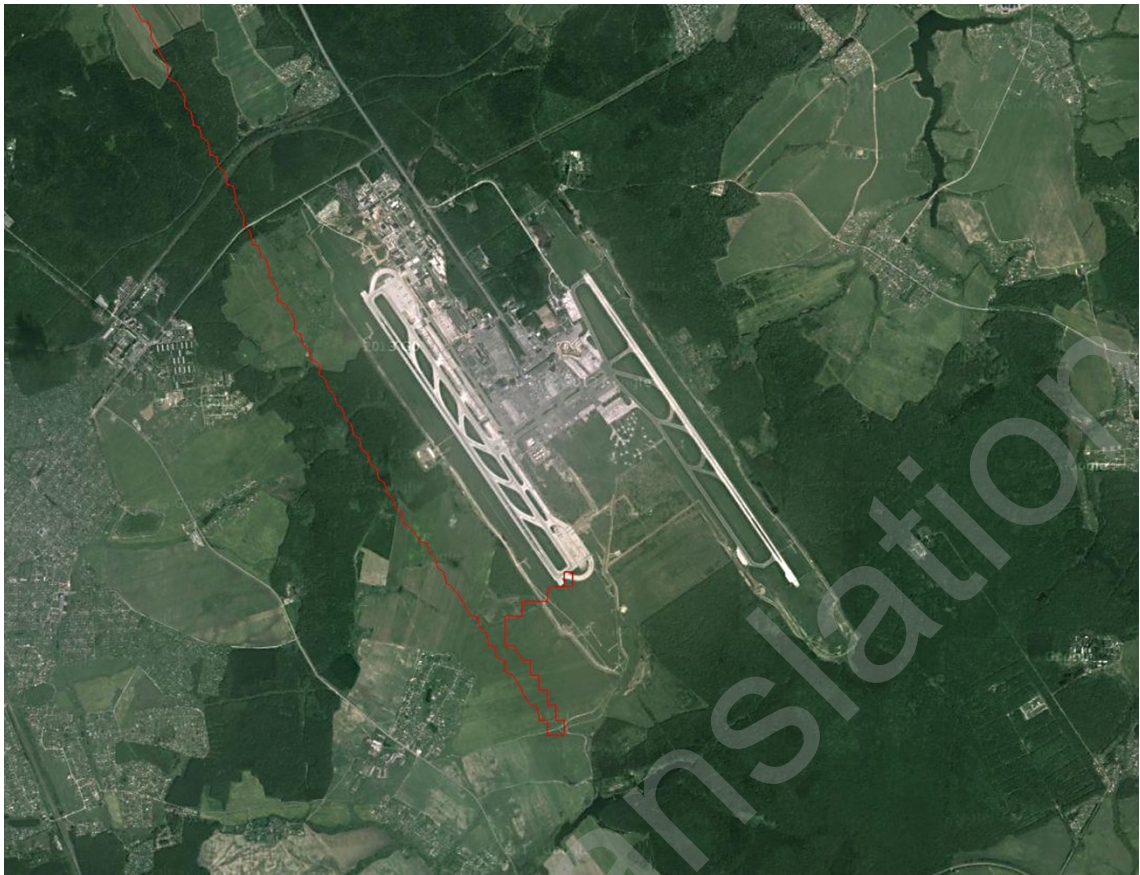
Figure 82 Map-shift during the takeoff at Domodedovo Airport

Comparison of the recorded aircraft position during taxiing and takeoff with the actual path can lead to a conclusion that during the takeoff a map shift of approx. 2 km southwards was also present (Figure 82). Thus, most probably when the crew aligned the IRS's before the flight they entered the current coordinates with some error (probably they entered the last position that remained in the FMS memory when it was switched off after the previous flight). The analysis showed (Section 1.18.10) that the same was true for the vast majority of other flights made by the airline crews.

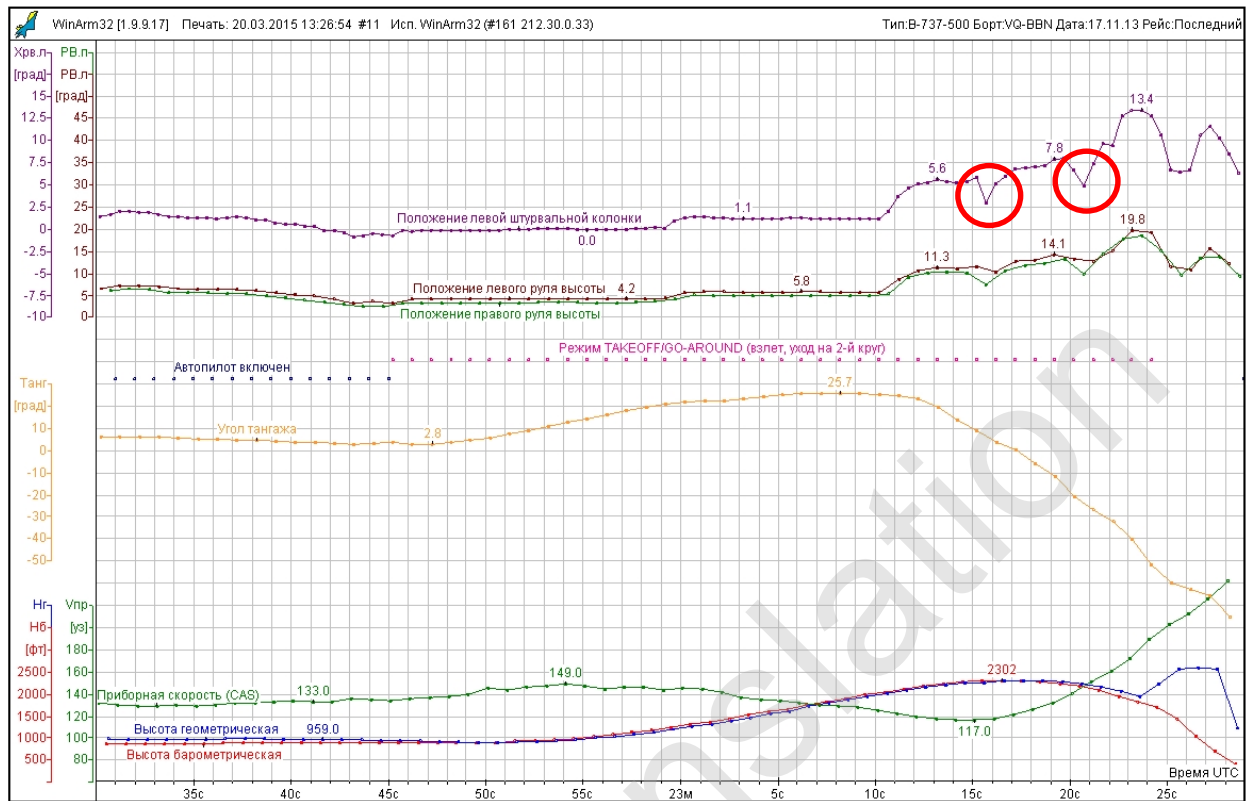
Figure 83 Longitudinal parameters during the final segment of the accident flight

When analyzing the accident circumstances and recorded flight data (intensive nose up pitching during the final flight segment and no nose up control inputs) some of Rosaviatsyia experts that were involved in the investigation had an opinion that there could have been no nose up control inputs because the elevator control linkage has been jammed partly and could not be moved nose up. As an argument they pointed to some remarkable peaks on the column and elevator deflection records (Figure 83, circled).

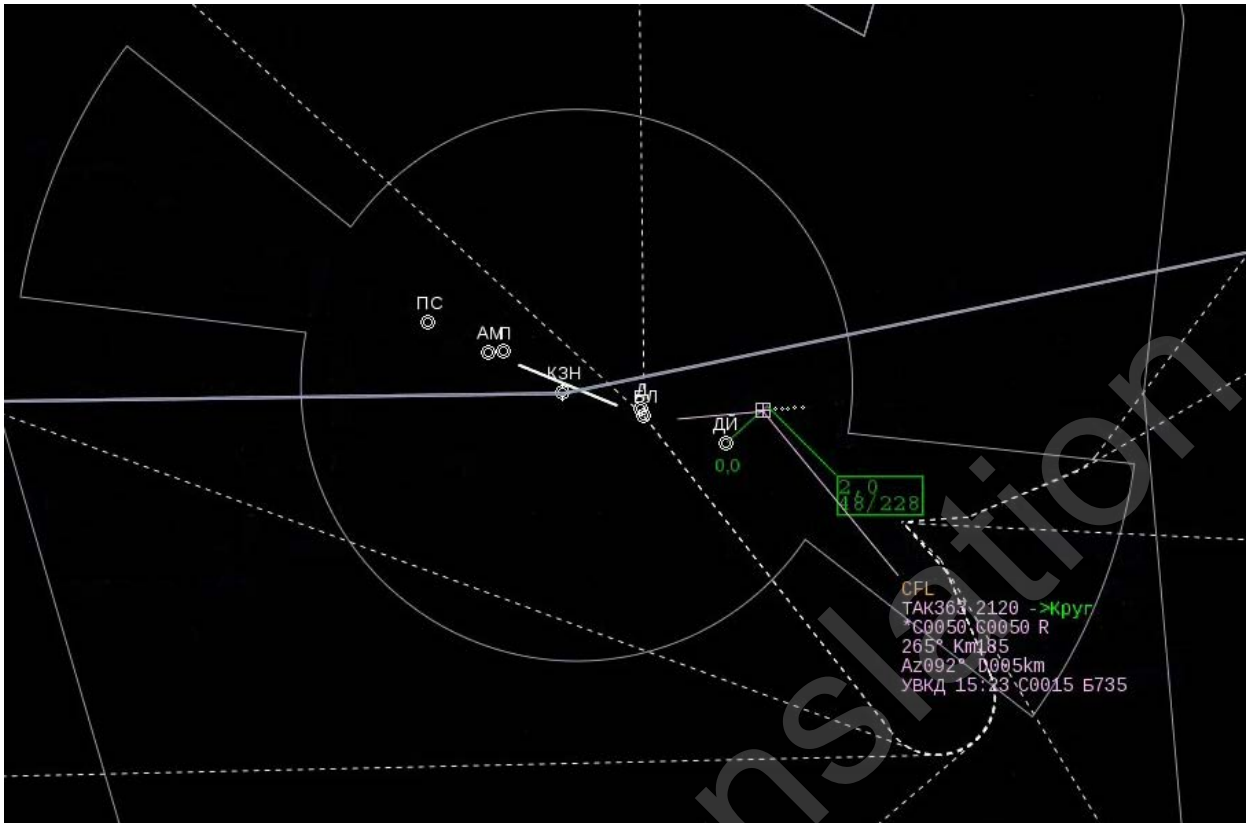
Figure 84 Radar printscreen at the time of the landing clearance providing

The ATC officer cleared them for landing, although he could see it on the radar that the aircraft was not stabilized (Figure 84): the distance from the localizer was about 5 km, according to Galaktika ATM automation complex, the altitude was 500 m according to the aircraft information tag without any tendency to descend (the descent symbol was not present in the tag) and the aircraft was offset to the right of the landing track. It would have been a more appropriate decision for the ATC officer to inform the crew on their actual position at least and recommend to go around.
