# **Aviation Occurrence Report**

**TransAsia Airways Flight GE235**

**ATR72-212A**

**Loss of Control and Crashed into Keelung River**

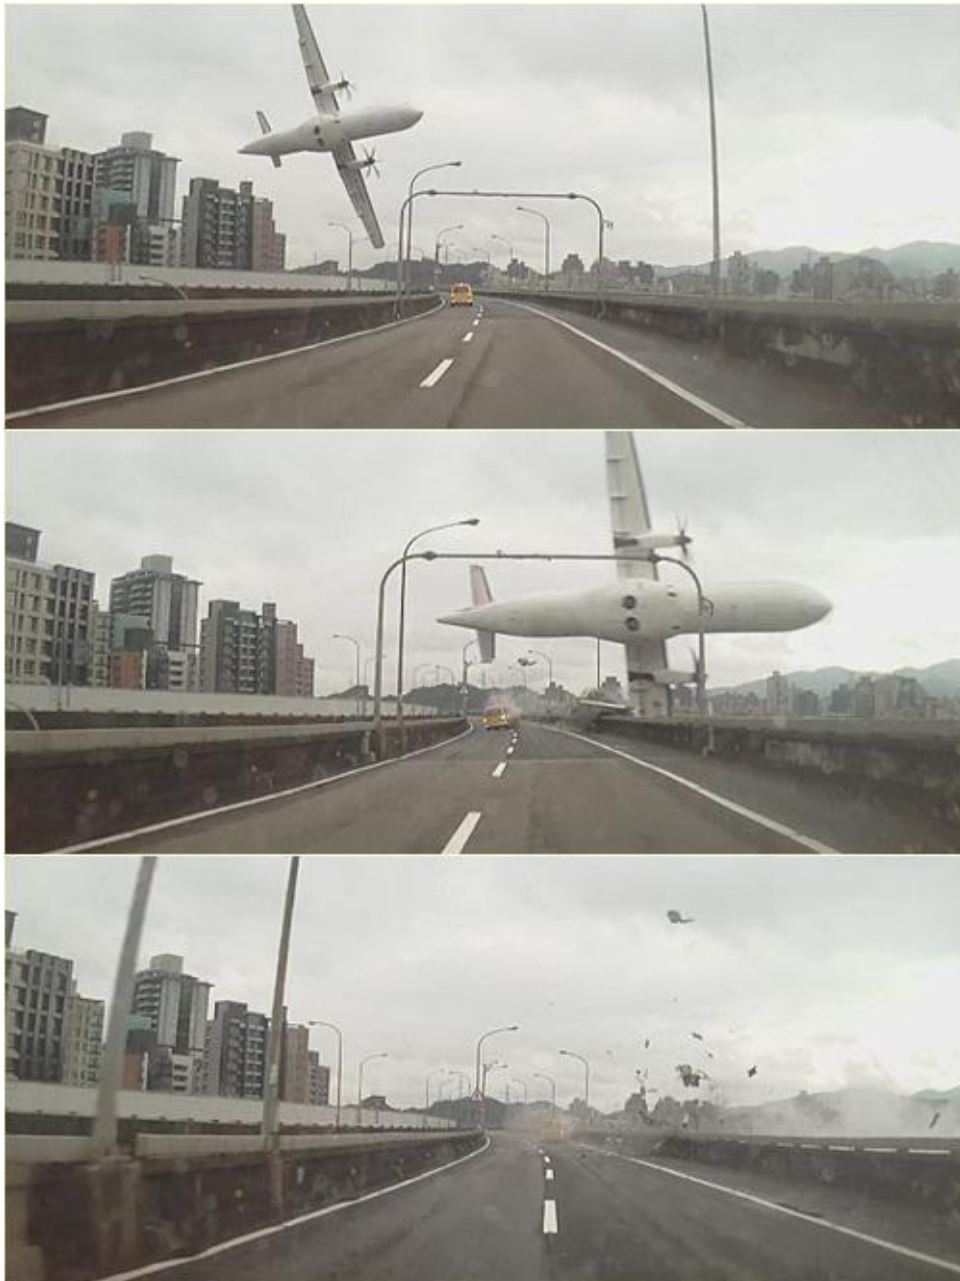
Figure 1.1-2 GE235 loss of control and initial impact sequence.

At 1054:34, the enhanced ground proximity warning system (EGPWS) “pull-up” warning was annunciated in the cockpit. At 1054:35 the aircraft's left bank angle increased from 10 to 80 degrees. The aircraft's left wing then collided with a taxi driving on the overpass. The wing then impacted the fence and a light pole at the edge of the overpass located southwest of the Keelung river occurrence site (see Figure 1.1-2). The aircraft continued to bank to the left after those collisions and then entered the river inverted.

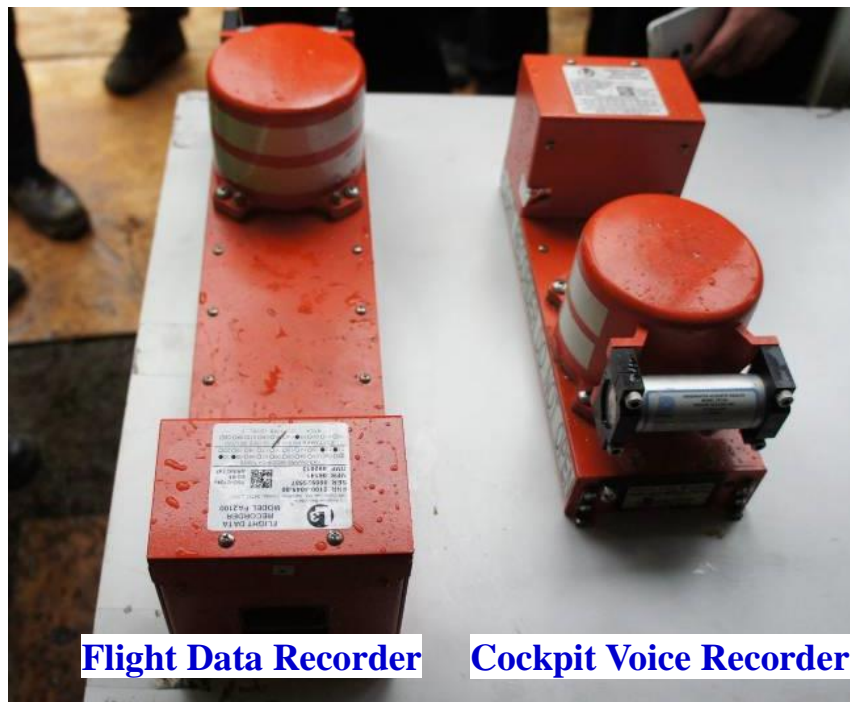
Figure 1.11-1 External view of the FDR and CVR

The flight data recorder (FDR) and the cockpit voice recorder (CVR) were recovered by the ASC investigators at 1605 on the occurrence day. Both recorders were immersed in water but exhibited no external damage. The recovered CVR and FDR are shown in Figure 1.11-1.

Both recorders were transported to the ASC Investigation Laboratory for disassembling and readout on 4 February. The crash survival memory units (CSMU) of both the CVR and FDR were in good condition. After cleaning and drying the CSMUs, data from both recorders were successfully downloaded.

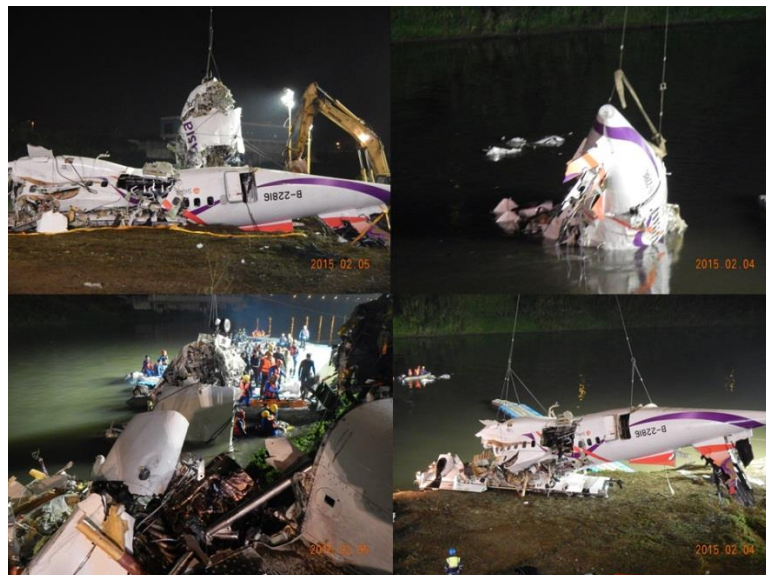
Figure 1.12-1 Wreckage recovery operations

The primary aircraft wreckage consisted of two major separated sections of the airframe: the cockpit section; and the middle/aft section of the fuselage. The nose of the aircraft was embedded in the mud of the riverbed. A floating bridge and three heavy lift vehicles were deployed by the Army Engineering Corps to facilitate the recovery of the deceased passengers and salvage of the aircraft wreckage. The salvage of the aircraft wreckage commenced after the search and rescue operation had recovered all surviving passengers and crew. Figure 1.12-1 depicts the initial salvage of the two major portions of the aircraft wreckage. The major portions of aircraft wreckage, including the remnants of the engines and propellers, were successfully recovered by the late afternoon of the second day of the salvage operation.

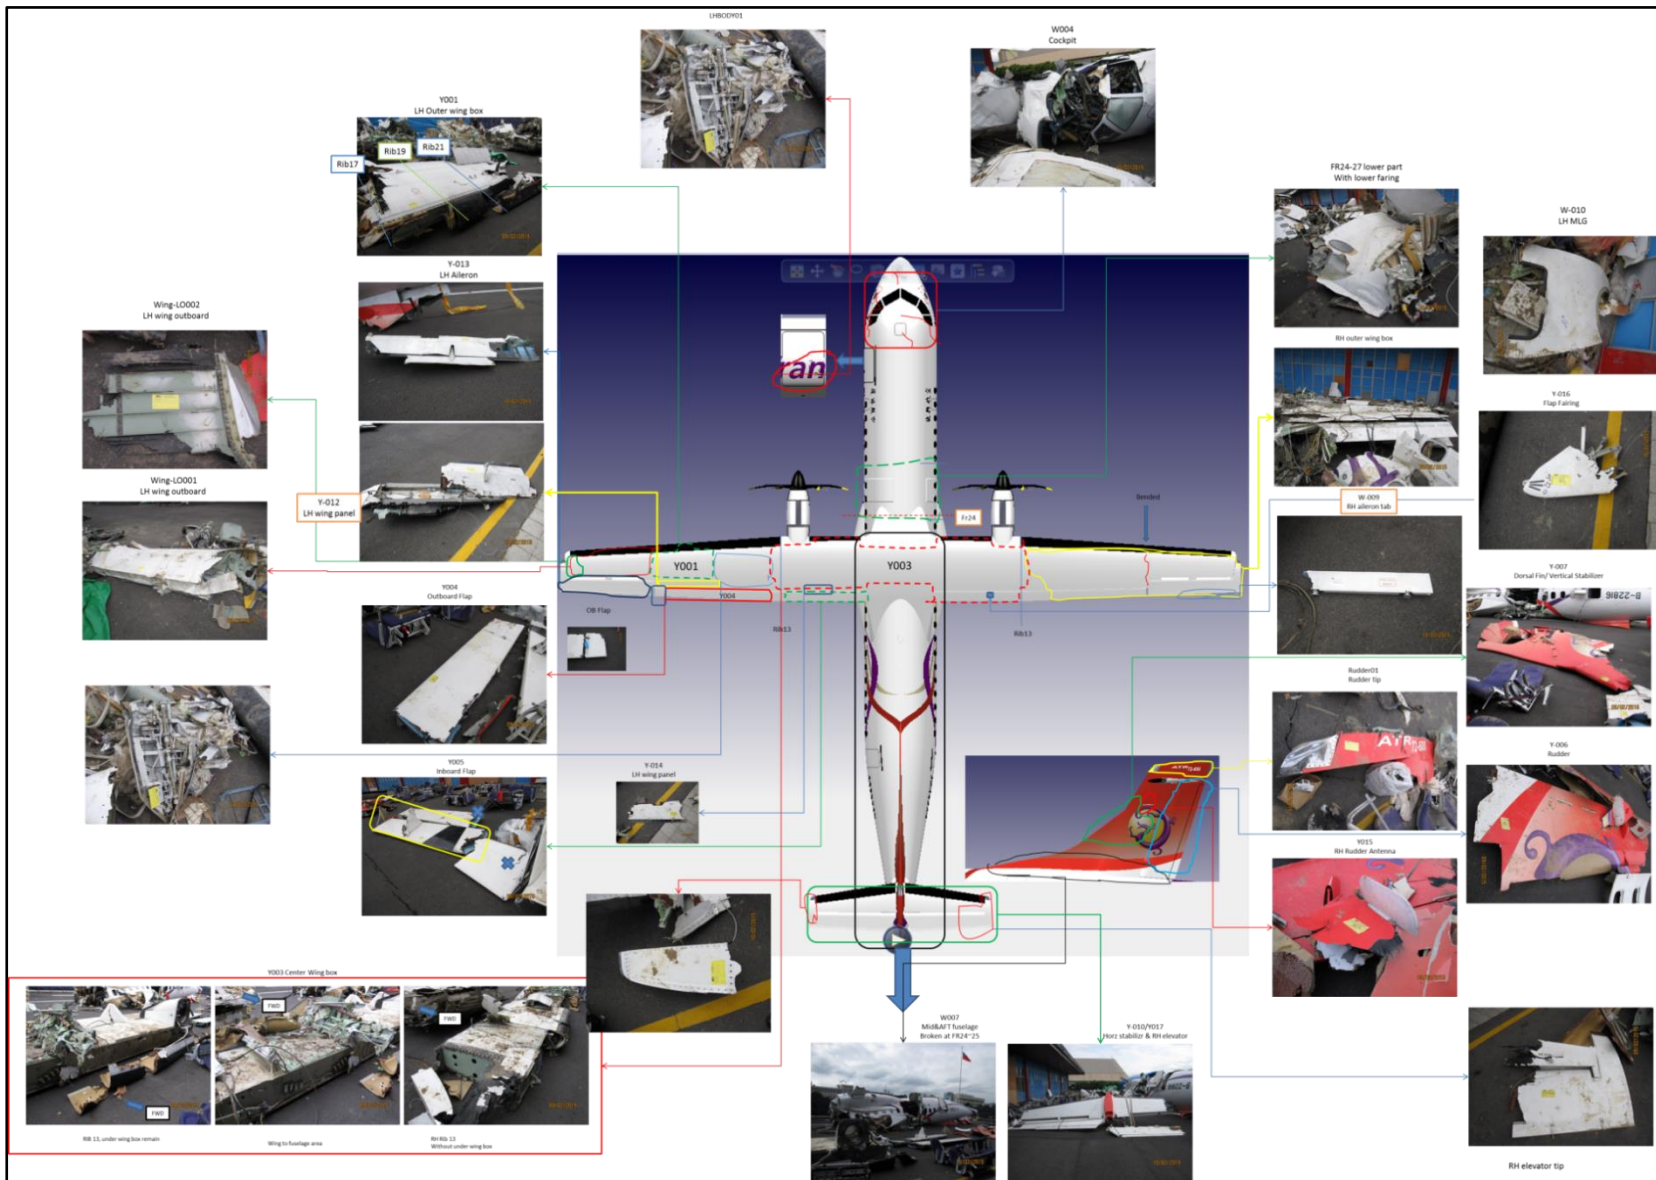
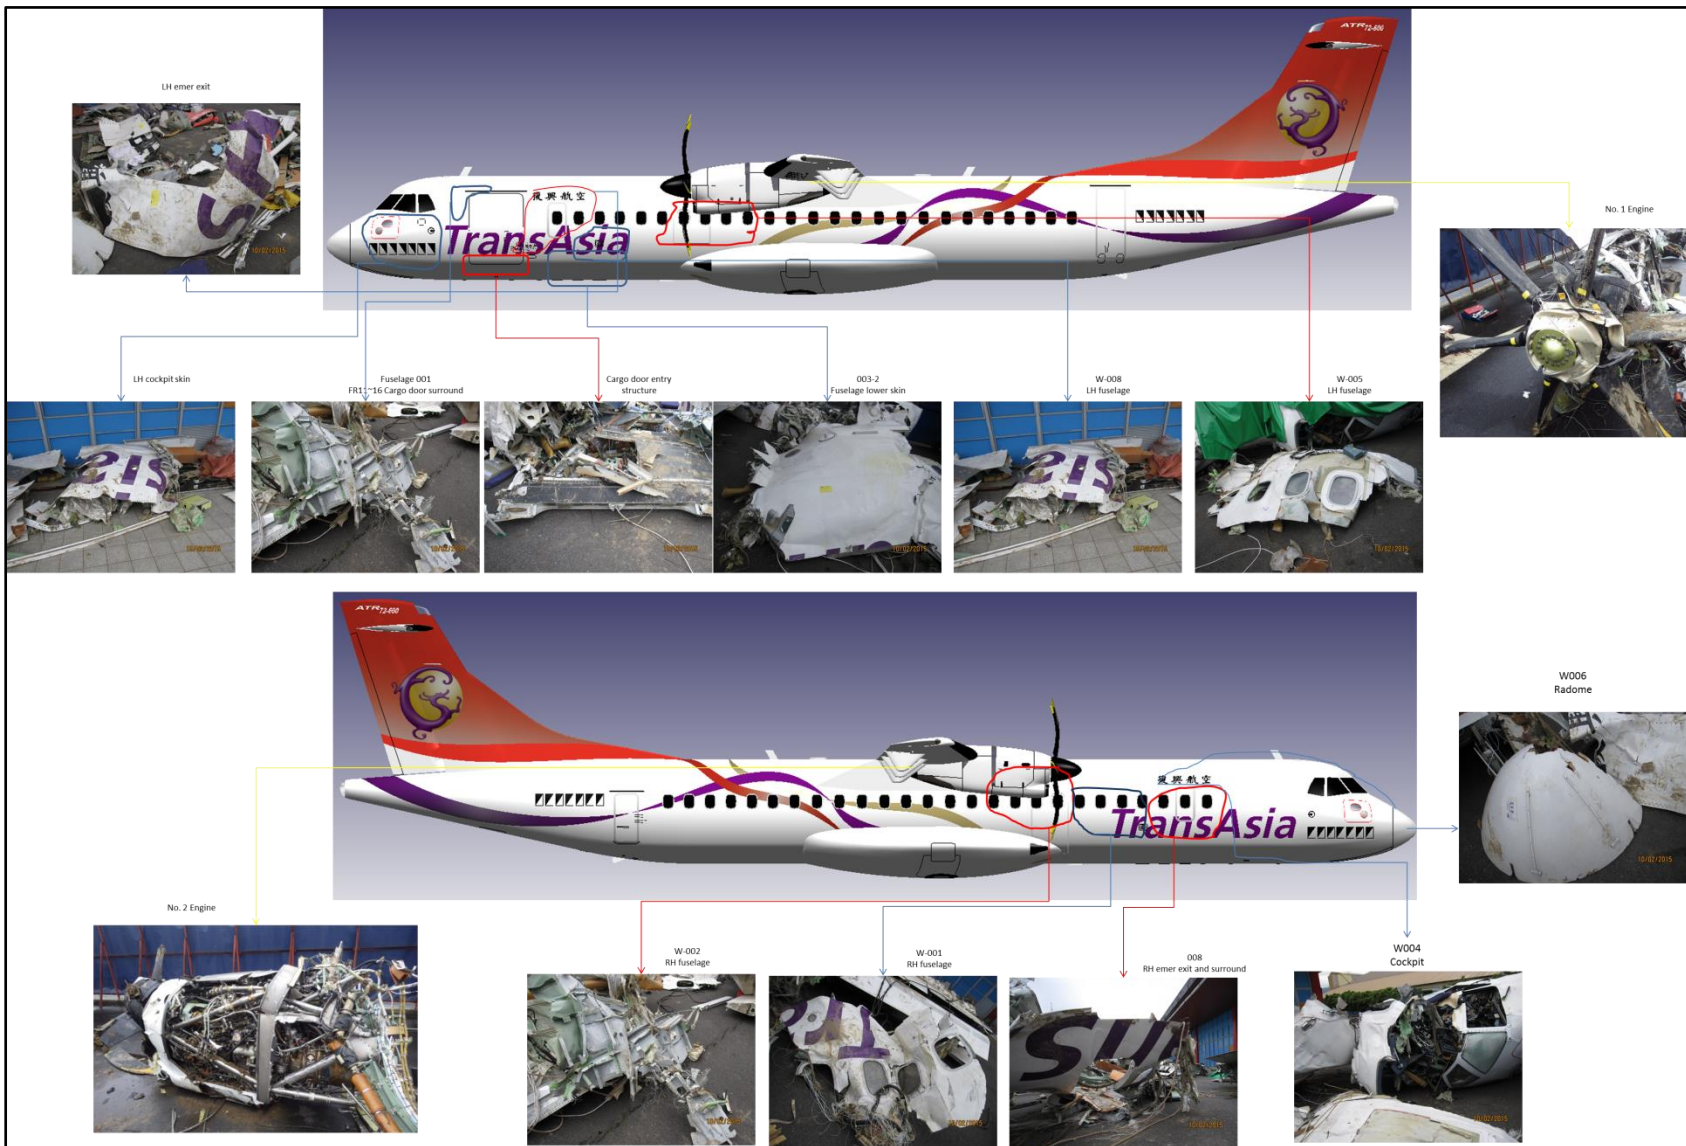
Figures 1.12-2 and 1.12-3 identify and map the major sections and components of the aircraft that were recovered. The recovered wreckage represented approximately 85% of the whole aircraft. The remaining unrecovered

15% of the aircraft was primarily in the area aft of the cargo area and forward of the ice shield area.

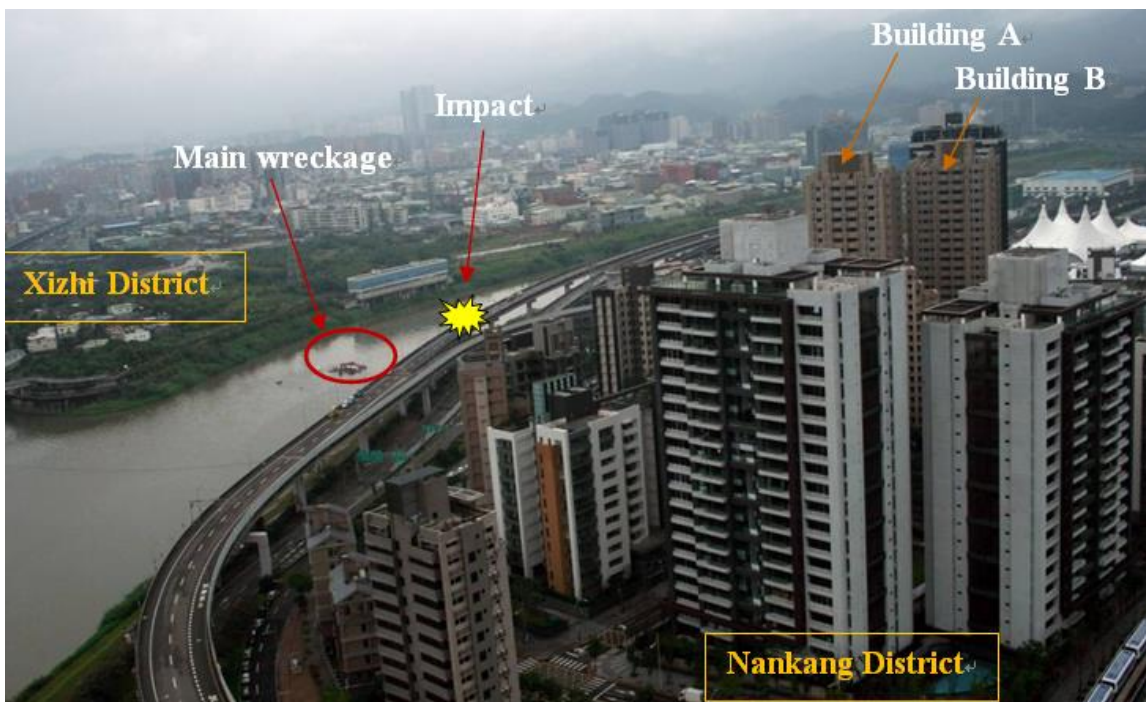
Figure 1.12-7 Aerial photo of occurrence site taken from a rescue helicopter

The main wreckage was near inverted in the middle of the Keelung River on a heading of about 025 degrees magnetic. The primary wreckage site's reference position was N25°3'48.54", E 121°37'3.13".

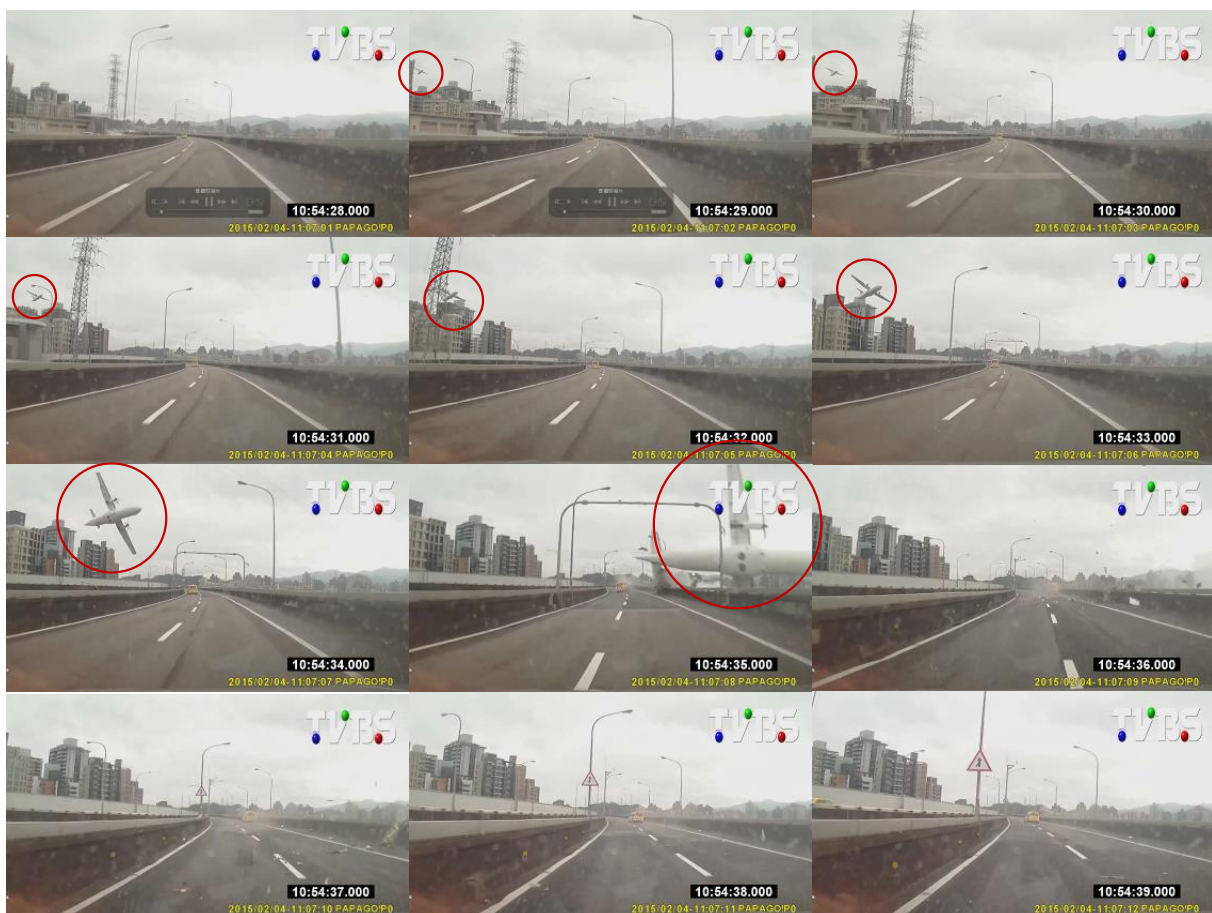
Figure 1.12-8 Snapshots extracted from the motor vehicle's dashboard camera

probable sound of impact with the taxi and overpass heard on the CVR and captured by the motor vehicle's dashboard camera at 1054:34.8. Relevant video snapshots of the aircraft from the car's dashboard camera have been annotated with CVR times and are shown in Figure 1.12-8<sup>34</sup>.

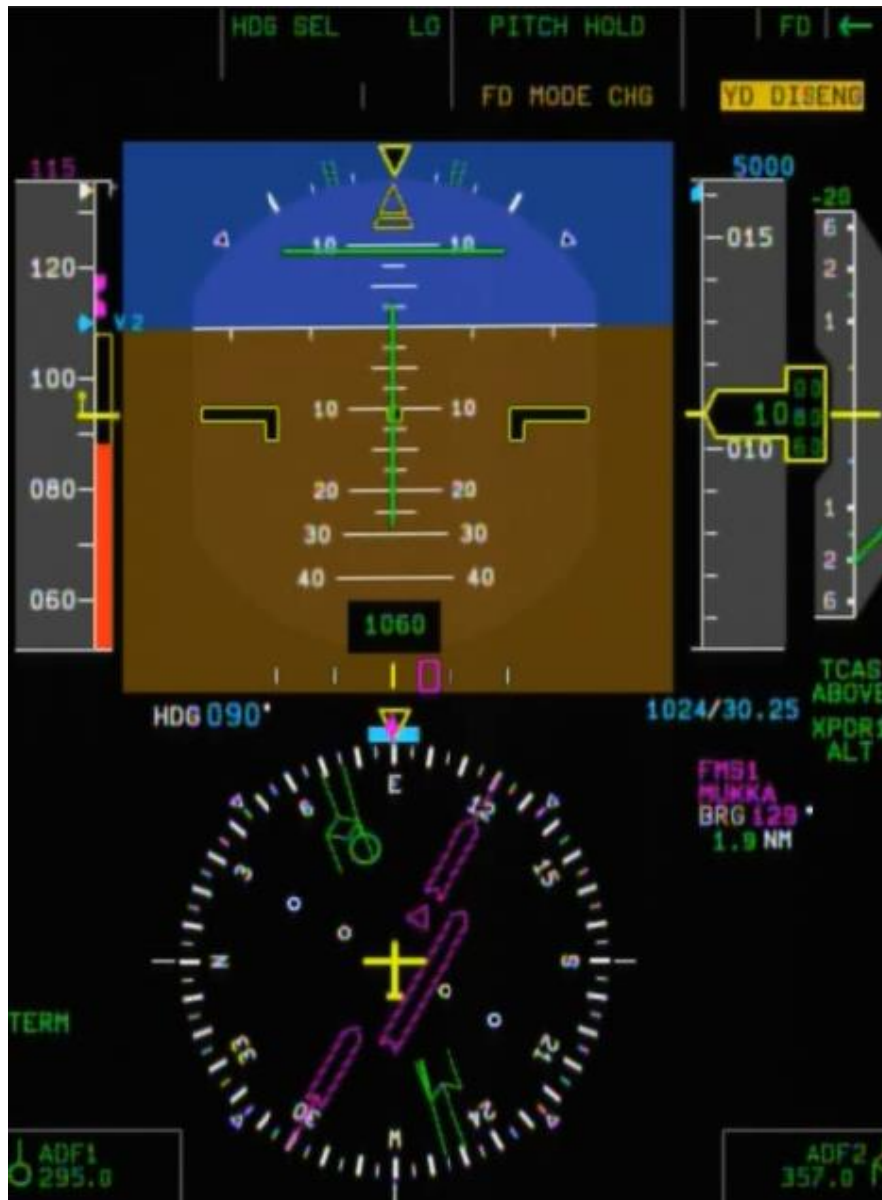
Figure 1.16-1 PFD display while the stick pusher activated

- The stall test results showed that the stick shaker and stick pusher worked as designed. It took approximately 10 seconds and 400 feet of altitude to recover the simulated aircraft from stick pusher activation at 93 knots until the aircraft acquired 118 knots. If the stall recovery maneuver was conducted immediately after stick shaker activation at 99 knots, it took the test crew approximately 6 seconds and less than 100 feet of altitude to recover the aircraft and increase the airspeed to 118 knots. There is another phenomenon has been observed in the stall test; as the FMA vertical mode had previously reverted to "PITCH HOLD" mode, the flight director (FD) bars provided guidance to maintain a pitch target of 8°. When the stick shaker and subsequently the stick pusher activated the aircraft pitch was consequently decreased to approximately 10° nose-down while the FD bars were still showing a nose-up guidance on the primary flight display (PFD) according to the "PITCH HOLD" mode.(Ref Fig. 1.16-1)

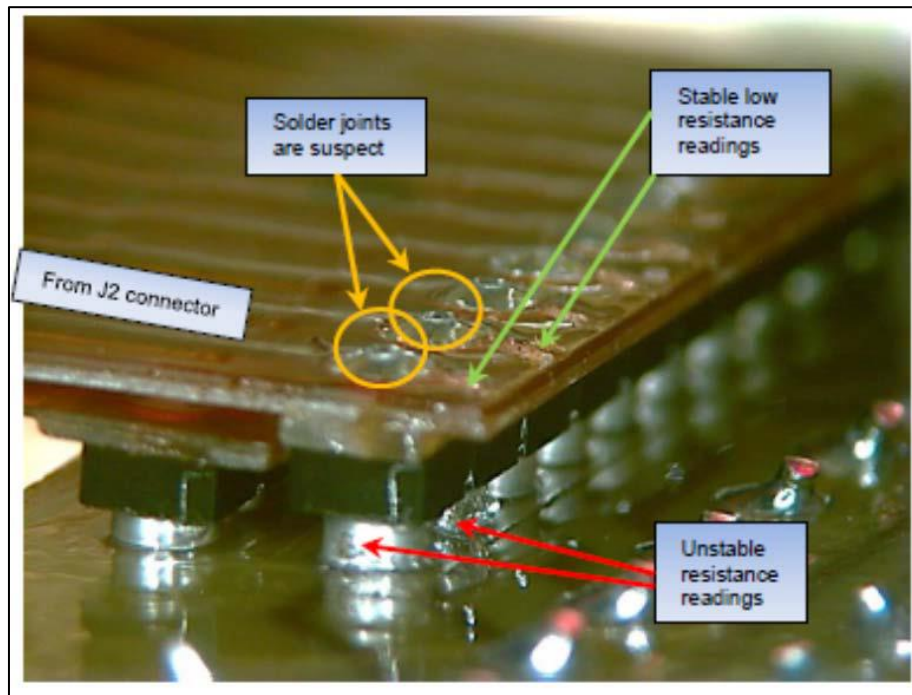
Figure 1.16-3 Continuity check of pin J and A2 board

AFU No. 2 failed to pass the continuity test. The measured resistance values for connector pins J and H<sup>47</sup> fluctuated from 1 to 20 ohms when the ribbon was moved by hand. The resistance was higher than the CMM<sup>48</sup> values threshold of 0.35 ohms for pins J and H. These two pins connected to the torque sensor. An X-ray examination of AFU No. 2 was performed and no defect was found. In order to identify the source of the increased resistance between J2 connector pins J/H and the A2 board strip contact (contact points No. 34/33), a new test procedure for assessing AFU No. 2 was proposed and agreed to by all attendees.

It was noted that the first time  $R_{J2}$  and  $R_{H2}$  were measured, both were unstable. Repeated resistance testing of pins J and H resulted in only one stable result for  $R_{J2}$  and/or  $R_{H2}$ . The continuity failures detected on pins H and J were located inside the header strip connector (end of the ribbon, opposite the J2 socket). The discontinuity was observed to be intermittent. The test results with the new test procedure are summarized in Table 1.16-3.

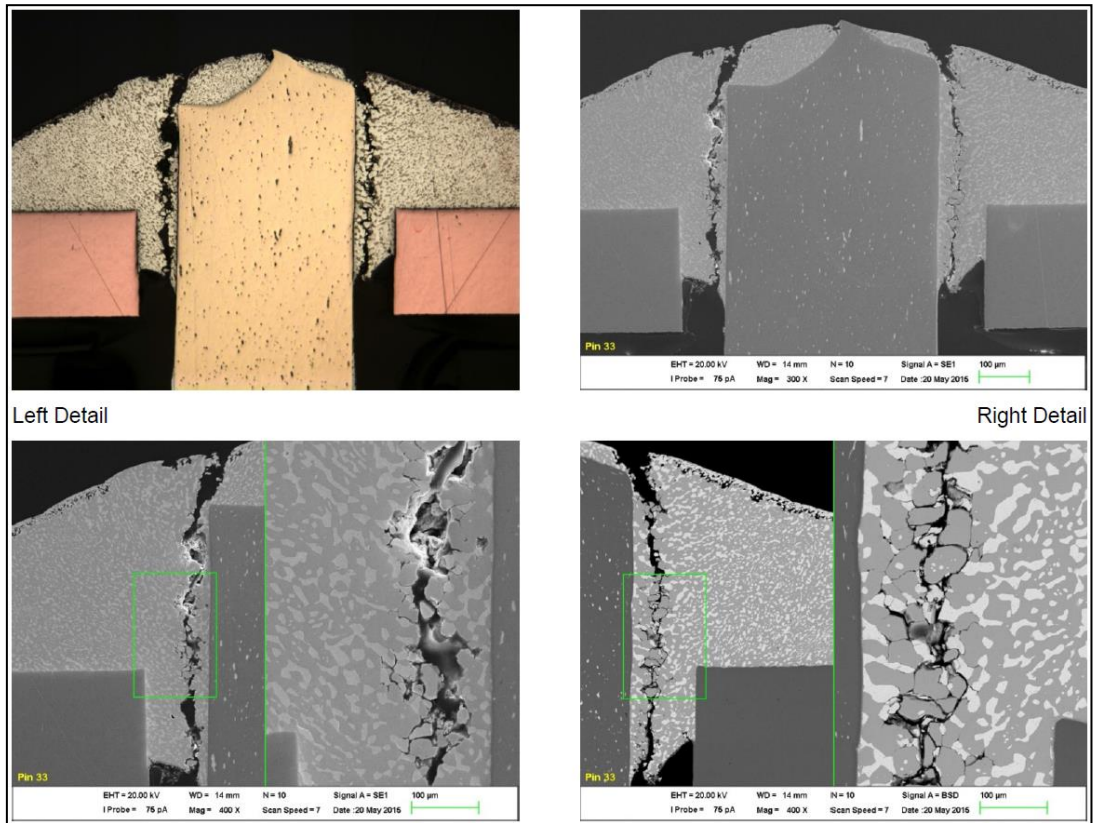
Figure 1.16-5 Cross sectioned pin to flex solder joints of pins 33

A CT-Scan (computed tomography) of the J2 solder joints was subsequently performed and potential solder cracking was identified. A destructive test was performed to find the possible root cause of continuity failures inside the J2 flex circuit 90° connector. The J2 flex circuit was cut out of the circuit card assembly (CCA) and housing. J2 flex circuit pins 33-42 were examined using an optical

- Continuity failures (resistance values above the CMM threshold) existed between J2 connector pin H and the circuit board, and between pin J and the circuit board;
- Continuity failures (resistance values above the CMM threshold) were located at the solder joint interface between the J2 flex circuit and the header pin;
- Continuity failures (resistance values above the CMM threshold) were intermittent; and
- The solder microstructure was consistent with enlargement, coarsening and cracking in a stress zone adjacent to the solder joint interface between the flex circuit and the header pin.

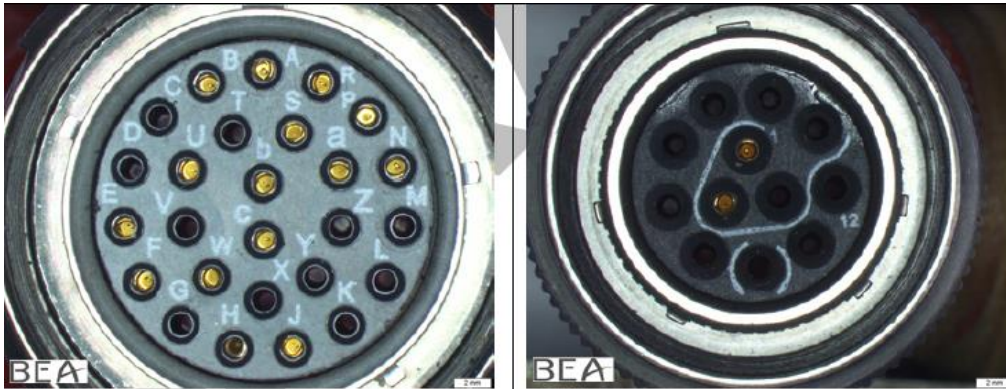
Figure 1.16-7 Connectors of AFU (left) and torque sensor (right)

The wiring harnesses connecting the No. 1 torque sensors to the AFUs of both engines were removed from the occurrence aircraft and dispatched to BEA for further examination. A visual or macroscopic inspection and X-ray examination were conducted. The connection between the torque sensor and the AFU was achieved through (see Figure 1.16-7):

- Pin H and pin J on the AFU connector; and
- Pin No. 1 and pin No. 2 on the torque sensor connector.

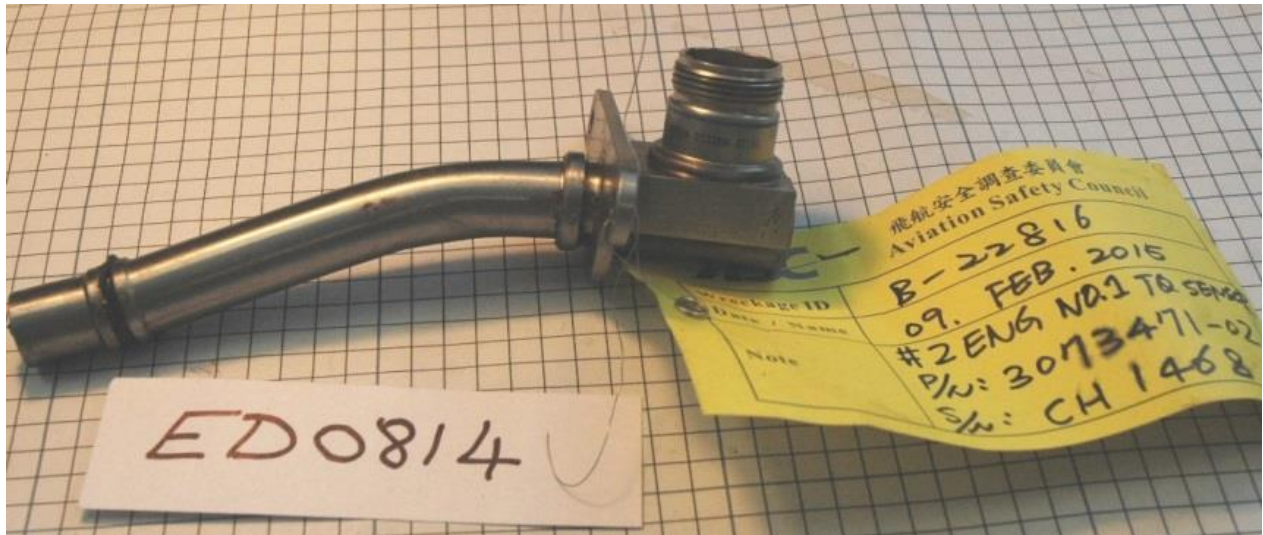
Figure 1.16-10 External view of ENG 2 torque sensor left S/N CH1468

3D X-ray analysis (see Figure 1.16-11) of the sensor indicated that the coil wires had broken at the outside of the bend due to the impact.

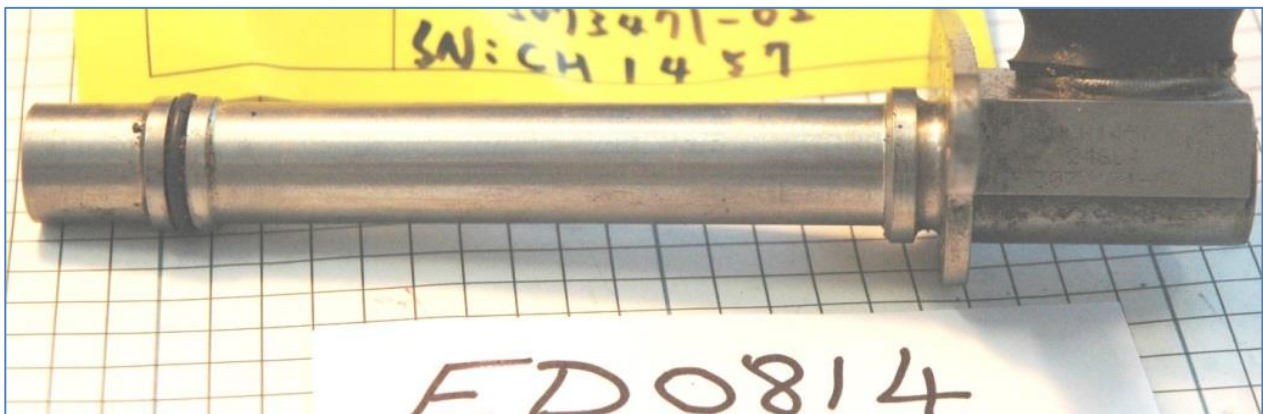
Figure 1.16-12 External view of ENG 2 torque sensor right S/N CH1457

- Test point 6.2 Dynamic test: with the sensor installed with an air gap of 0.035in from the phonic-wheel, and the wheel speed set at 639RPM the voltage between pin 1 and 2 was 1.49 volts peak-to peak. This was slightly below the test point minimum limit of 1.5 volts peak-to peak.
- Test point 6.3 Dynamic test: with the sensor installed with an air gap of 0.035in from the phonic-wheel, and the wheel speed set at 4263RPM the voltage between pin 1 and 2 was 8.5 volts peak-to peak. This was slightly below the test point minimum limit of 8.9 volts peak-to peak.
