PB90-910401  
NTSB/AAR-90/01

# NATIONAL TRANSPORTATION SAFETY BOARD

## AIRCRAFT ACCIDENT REPORT

UNITED AIRLINES FLIGHT 811  
BOEING 747-1 22, N47 13U  
HONOLULU, HAWAII  
FEBRUARY 24, 1989

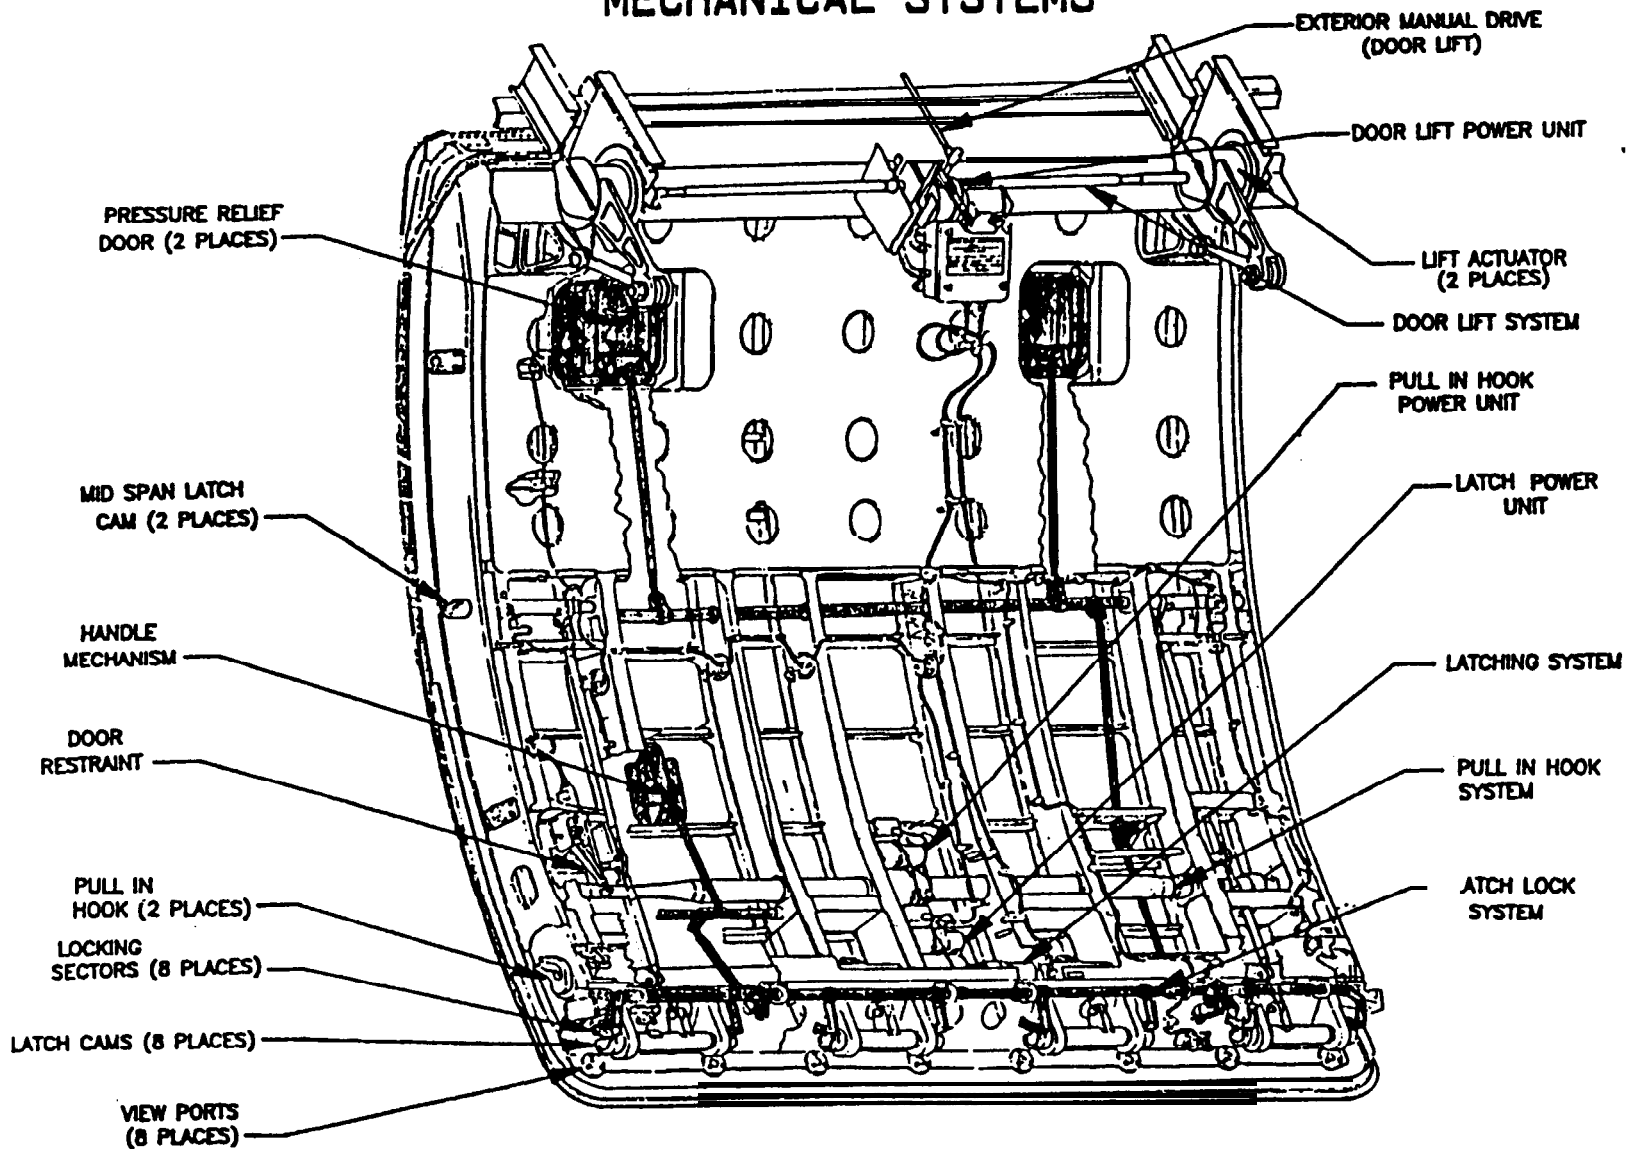
Figure 4. -- Boeing 747 lower lobe forward cargo door.

The cargo door and its associated hardware are designed to carry, circumferential (hoop) loads arising from pressurization of the airplane. These loads are transmitted from the piano hinge at the top of the door, through the door itself, and into the eight latches located along the bottom of the door. The eight latches consist of eight latch pins attached to the lower door sill and eight latch cams attached to the bottom of the door. The cargo door also has two midspan latches located along the fore and aft sides of the door. These midspan latches primarily serve to keep the sides of the door aligned with the fuselage. There are also four door stops which limit inward movement of the door. There are two pull-in hooks located on the fore and aft lower portion of the door, with pull-in hook pins on the sides of the door frame. (See figure 4 for cargo door components.)

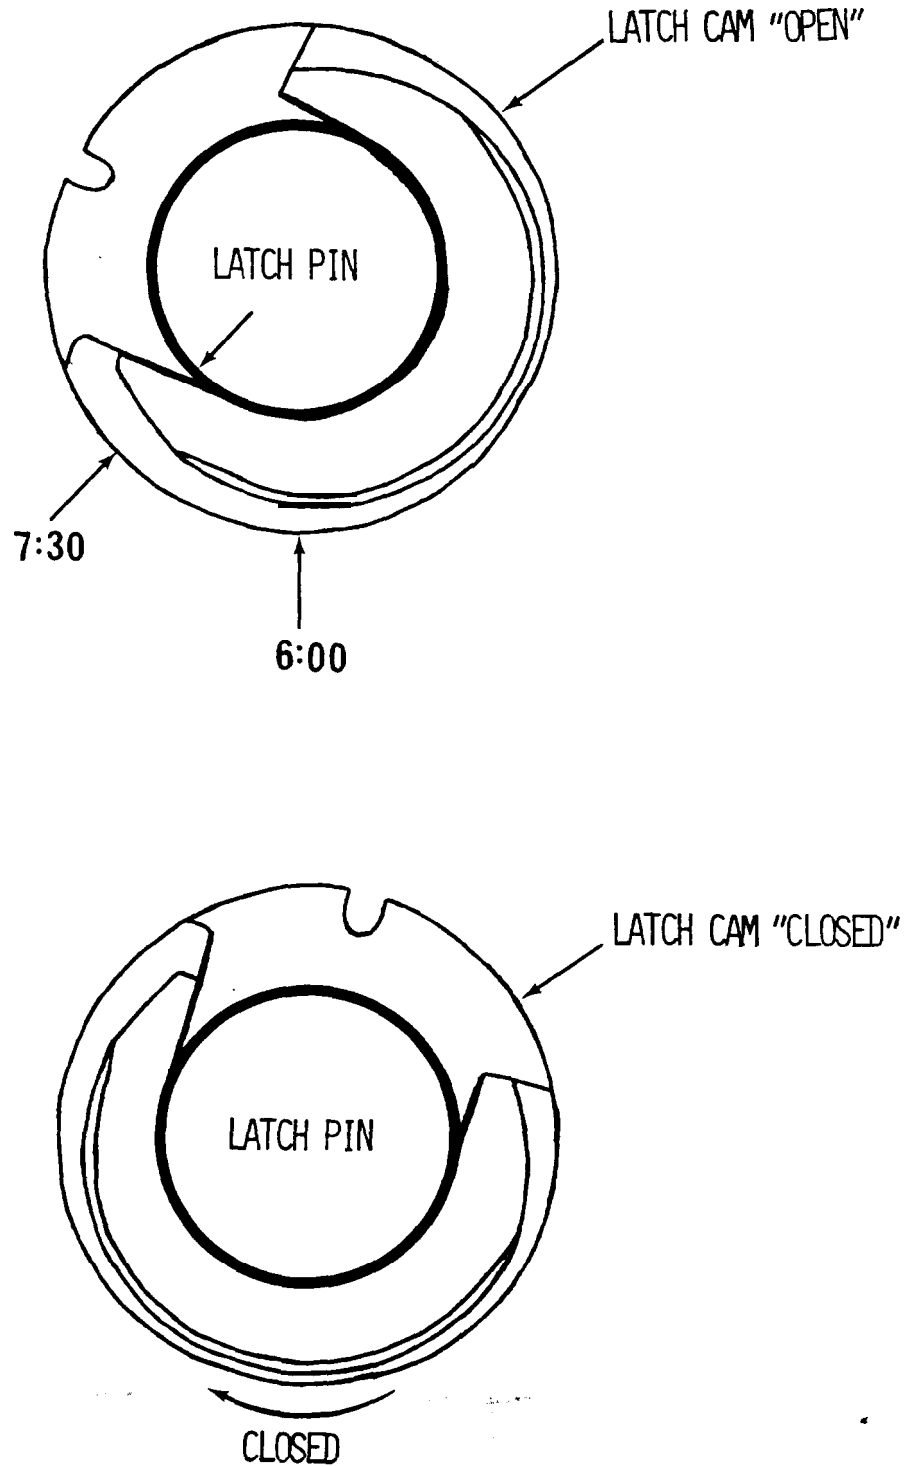
Figure 5. -- Diagram of cargo door latch cam in open and closed positions.

The cargo doors on the B-747 have a master latch lock handle installed on the exterior of the door. The handle is opened and closed manually. The master latch lock handle simultaneously controls the operation of the latch lock sectors, which act as locks for the latch cams, and the two pressure relief doors located on the door. Figure 5 depicts a latch pin and latch cam in an unlocked and locked condition.

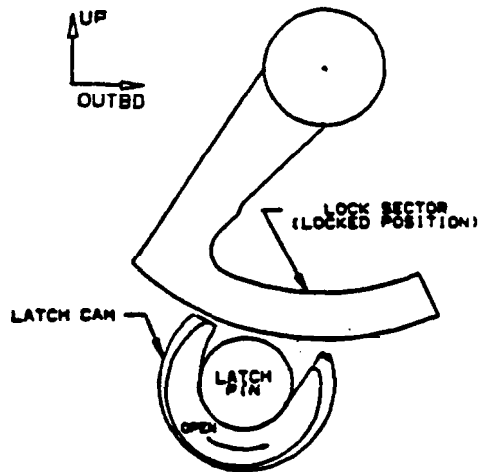
Normal positions of cam and lock sector in a fully latched and locked condition. Cam-pin contact area is approximately 4:00 to 10:00.

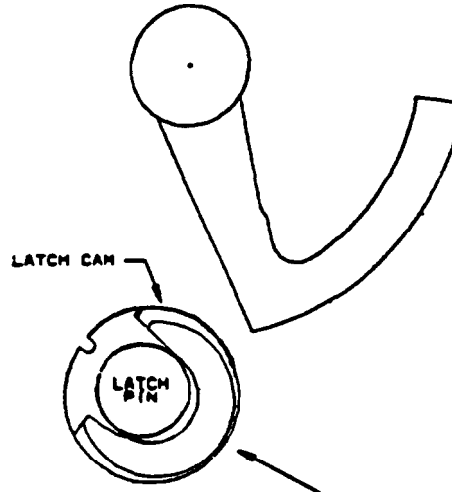
Position of cam at first contact with latch pin during closing. Cam-pin contact area is approximately 1:15 to 7:15.
