**COMMON CAUSE FAILURES,
PARTICULAR RISKS AND ZONAL SAFETY
ANALYSIS**

1 Common Cause Failures

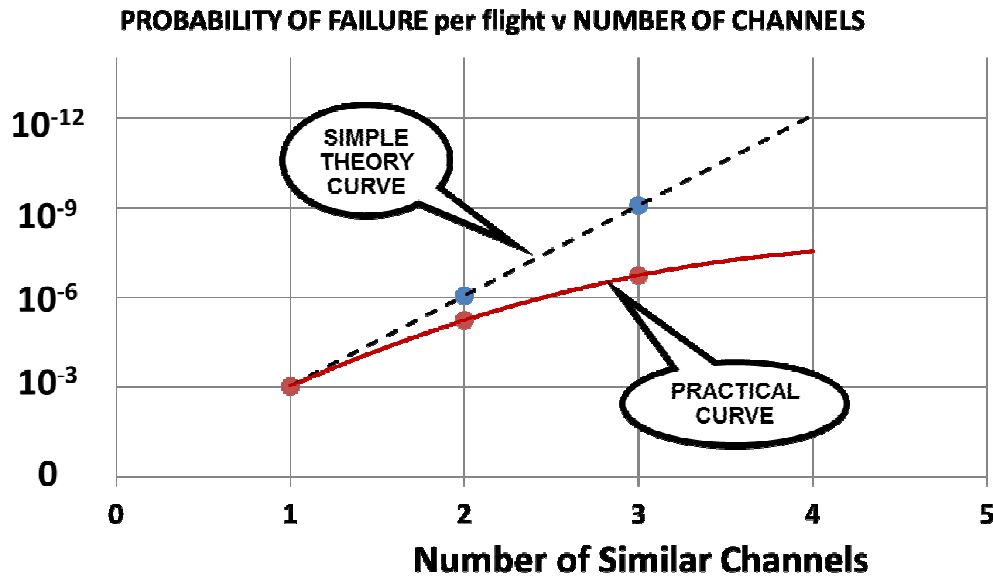
Figure 1 - Probability of Failure against number of channels for an aircraft electrical power generation system

However, when the in-service record for the subject aircraft was investigated it was found that multi-channel failures occurred at a much greater frequency than predicted by this simple theoretical approach. A comparison between what might be expected if failures were totally independent and what was actually achieved on the in-service aircraft is illustrated in Figure 1. (The curve for the failure probability of the in-service aircraft has been adjusted to account for there being three ways in which two channels may fail in a three channel system.)

It can be seen from Figure 1 that for the three-channel system the frequency of total system failure is several hundred times greater than the simple theory suggests. A further study carried out by Hawker Siddeley Aviation relating to hydraulic systems illustrated that the difference between the simple theory and what is actually achieved was also exhibited by aircraft hydraulic systems as illustrated in Figure 2.

However, the primary reason for the differences between the simple theoretical curve and the practical curve shown in Figure 1 is that channel failures are not totally independent and that Common Cause Failures have a significant influence on the probability of total system failure actually achieved.

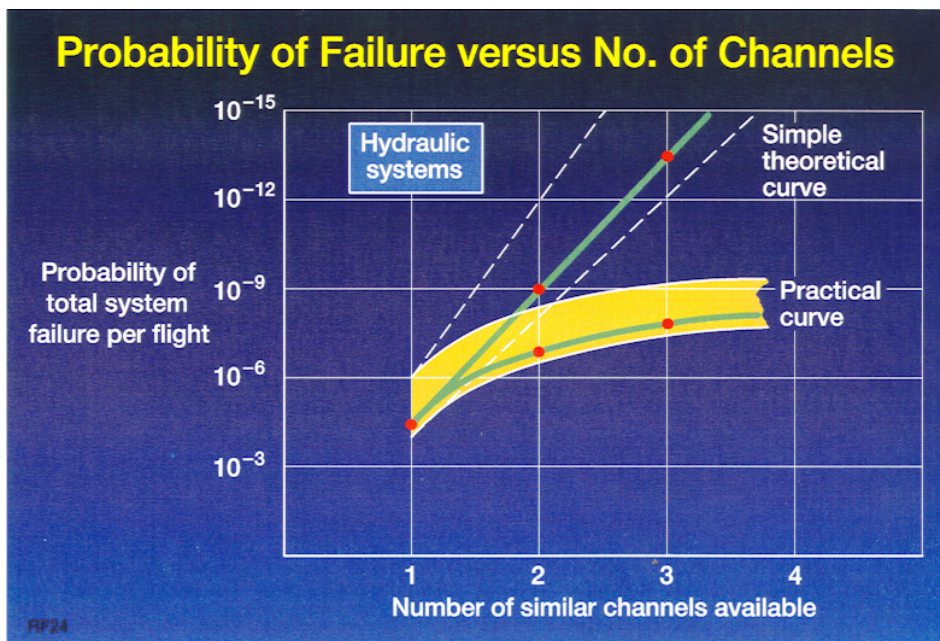
Figure 2 - Probability of Failure against number of channels for aircraft hydraulic systems

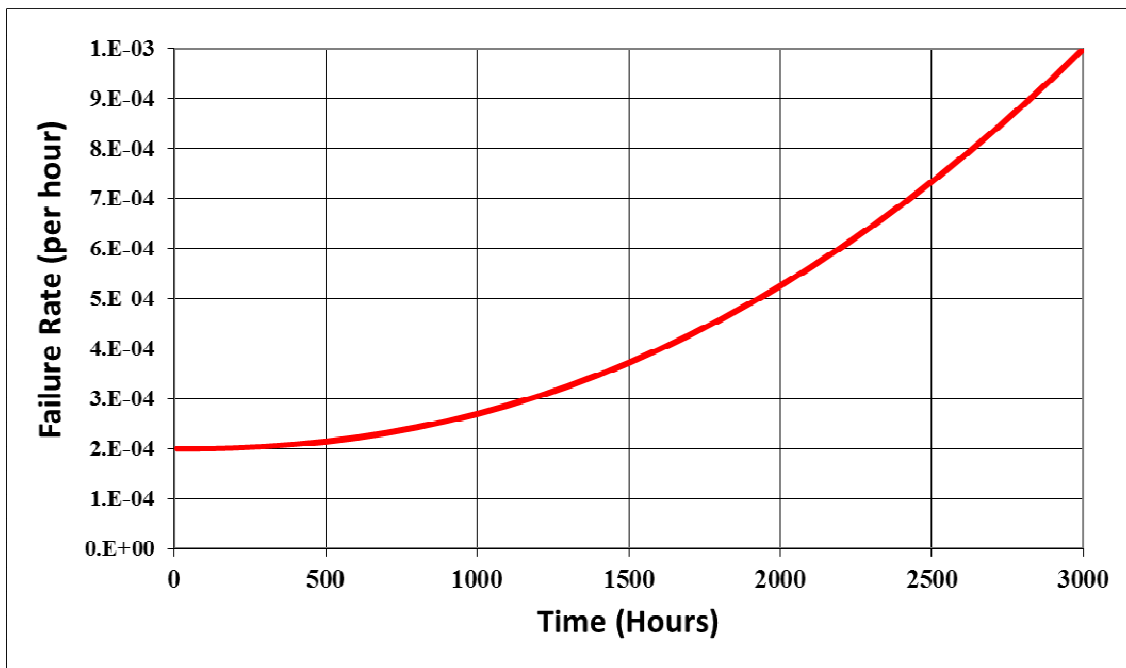
Figure 3 - Component exhibiting “wear-out” characteristics

Consider a component in a two-channel system exhibiting the failure rate characteristics shown in Figure 3.

When the aircraft first enters service, the component has a failure rate that is approximately 2×10^{-4} per hour. However, if the component survives in both of the channels for 3,000 hours their failure rates increase to approximately 1×10^{-3} per hour. For an aircraft that has an average flight time of one hour the probability of both channels failing due to this component, when the aircraft first enters service, is approximately $(2 \times 10^{-4})^2$ - equal to 4×10^{-8} per hour.

However after the aircraft has been in service for 3,000 hours the probability of both channels failing due to this component is approximately $= (1 \times 10^{-3})^2$ equal to 1×10^{-6} per hour. Hence, the probability of both channels failing due to this component has increased by a factor of **25**. A similar situation exists if the component exhibits an infant mortality failure rate characteristic, perhaps resulting from manufacturing or maintenance induced defects.

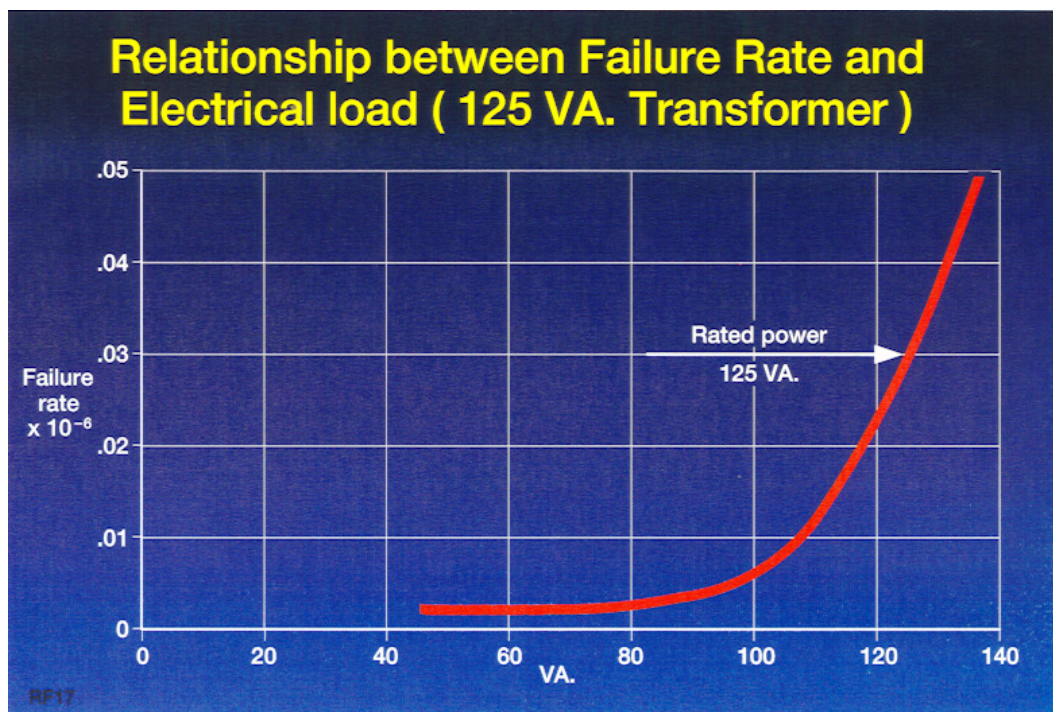
Figure 4 Relationship between Failure rate and Electrical Load for a 125 VA Transformer

Attempts have been made to quantify the relationship between load and failure rate for electrical components - the results of this work are contained in MIL-HDBK-217 "Reliability Prediction of Electronic Equipment." Figure 4 shows the relationship between failure rate and load for a 125 VA transformer using the data from MIL-HDBK-217. It may be seen that for this particular component there is a marked difference between the predicted failure rate at rated power, 125 VA, and half-rated power. Most components will demonstrate an adverse relationship between failure rate and load, although not necessarily as severe as the example shown in Figure 4.

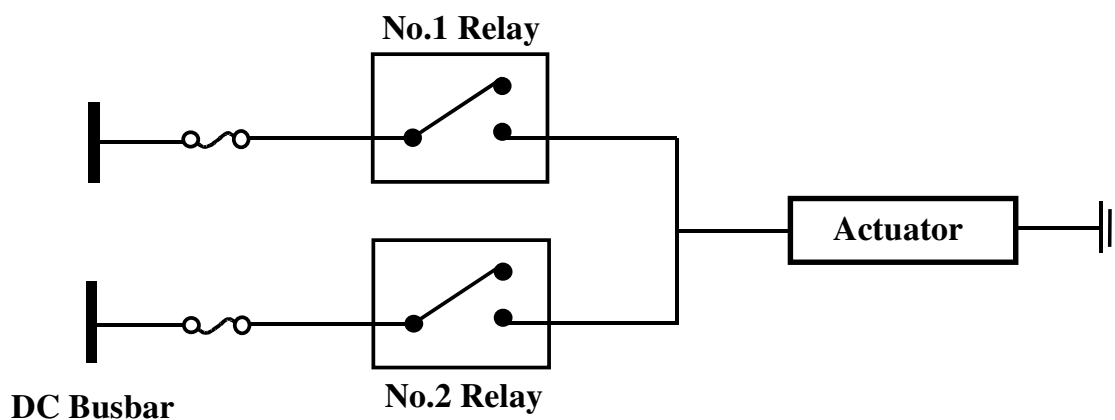
Figure 5 Electrical System Single Element Failures

Considering the system shown in Figure 5, the circuit has been duplicated upstream of the actuator terminal block in order to improve the reliability of operation. However, any single short circuit in the system, loss of the earth, busbar failure, or disconnect of the power supply to the actuator will result in loss of the entire system. The probability of this occurrence is likely to be significantly greater than that of independent failures in the two relay channels.

Of course, in practice, the effects of short circuits would be limited by the addition of diodes, but this does have the disadvantage of increasing the potential for failure in the system.

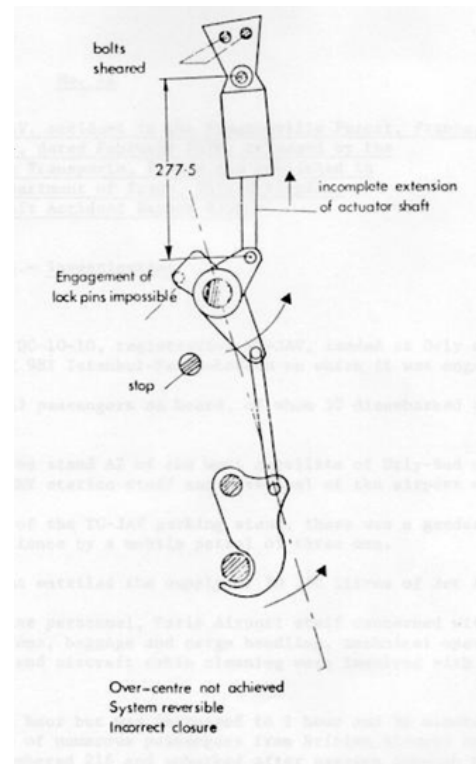
Figure 6 DC 10-10 Door Locking Mechanism

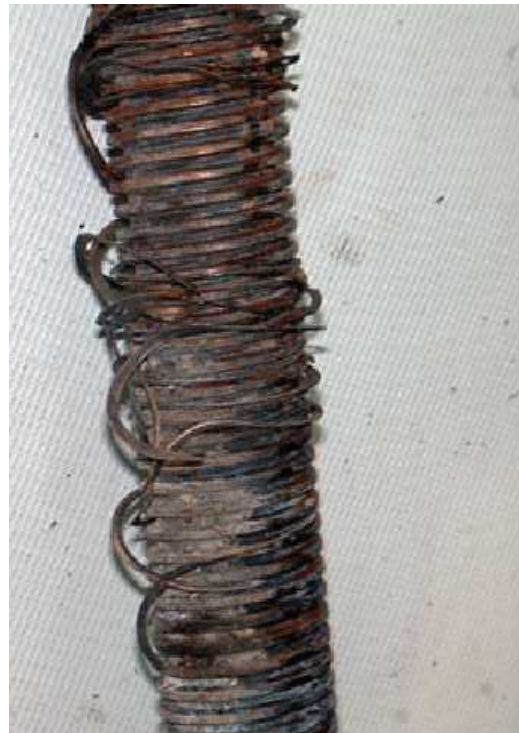
Figure 7 MD-83 horizontal stabilizer trim system jackscrew

The NTSB determines that the probable cause of this accident was a loss of airplane pitch control resulting from the in-flight failure of the horizontal stabilizer trim system jackscrew assembly's acme nut threads. The thread failure was caused by excessive wear resulting from Alaska Airlines' insufficient lubrication of the jackscrew assembly.

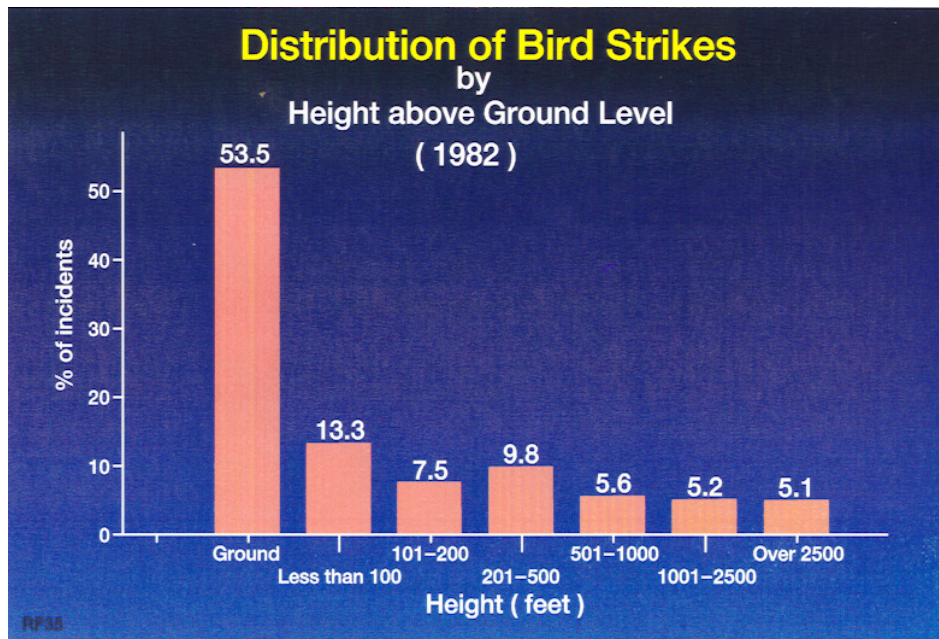
Figure 8 - UK Distribution of Bird Strikes by height above ground level

Based on a study carried out by the UK CAA, published in 1982, the distribution of bird strikes by height above ground level is as illustrated in Figure 8.

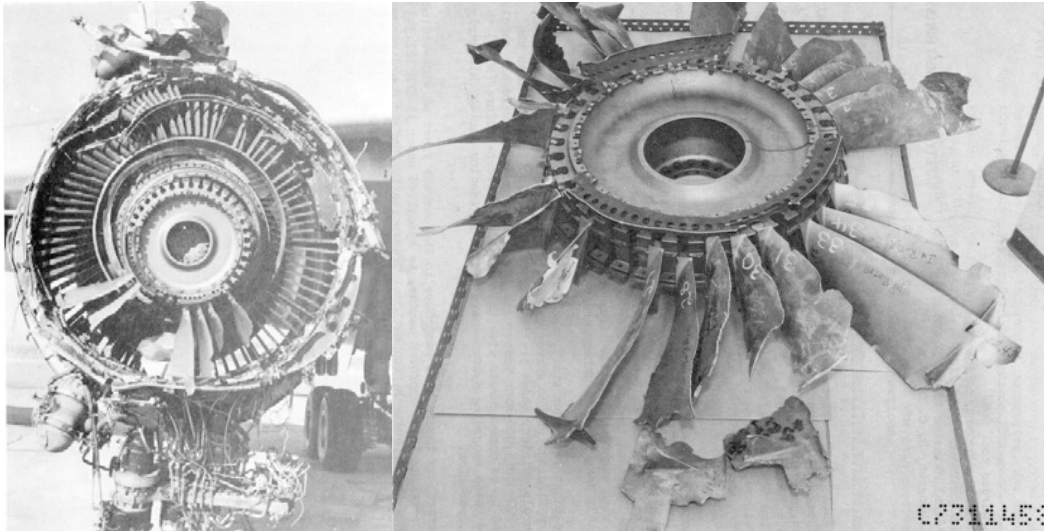
Figure 9 - Albuquerque DC-10-10 November 1973 - Number 3 engine fan assembly

The resultant damage caused decompression of the aircraft cabin and the loss of certain electrical and hydraulic services. One cabin window, which was struck by a fragment of the fan assembly, separated from the fuselage and the passenger who was sitting next to that window was forced through the opening and ejected from the aircraft.

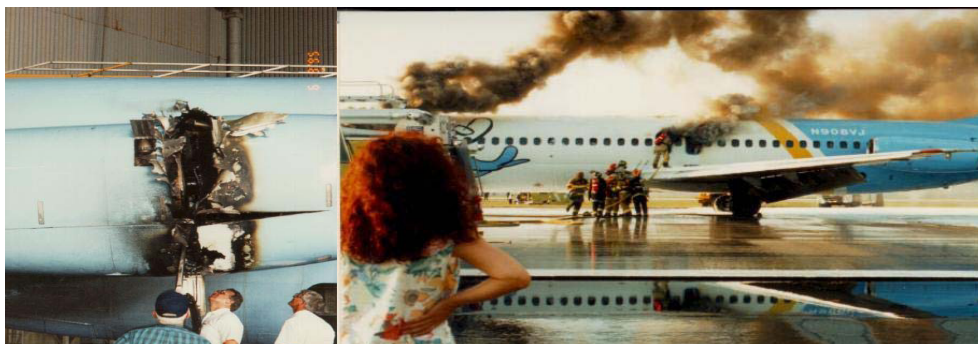
Figure 10 - Atlanta DC-9

“On 08-Jun-1995 a ValuJet DC-9-32 registered as N908VJ was taking off from the William B. Hartsfield Atlanta International Airport, Atlanta, Georgia. As the aircraft began its takeoff roll, a loud "bang" was heard by the aircraft occupants and air traffic control personnel. The right engine fire warning light illuminated. The flight crew of a following aircraft reported to the ValuJet crew that the right engine was on fire and the takeoff was rejected. Shrapnel from the right engine penetrated the fuselage and the right engine main fuel line and a cabin fire erupted. The aircraft's fuselage was destroyed. There were 5 crew and 57 passengers on board. 1 flight attendant suffered serious injuries. Another flight attendant and 5 passengers suffered minor injuries.”

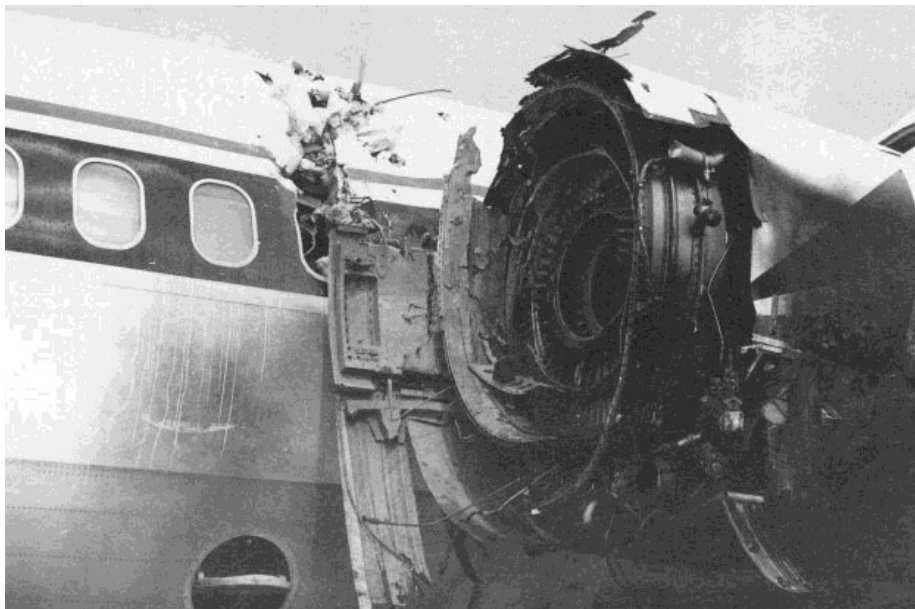
Figure 11 - Pensacola MD-88

During the initial part of its takeoff roll, the aircraft experienced an engine failure. Uncontained engine debris from the front compressor front hub (fan hub) of the left engine penetrated the left aft fuselage. The takeoff was rejected and the aircraft stopped on the runway.

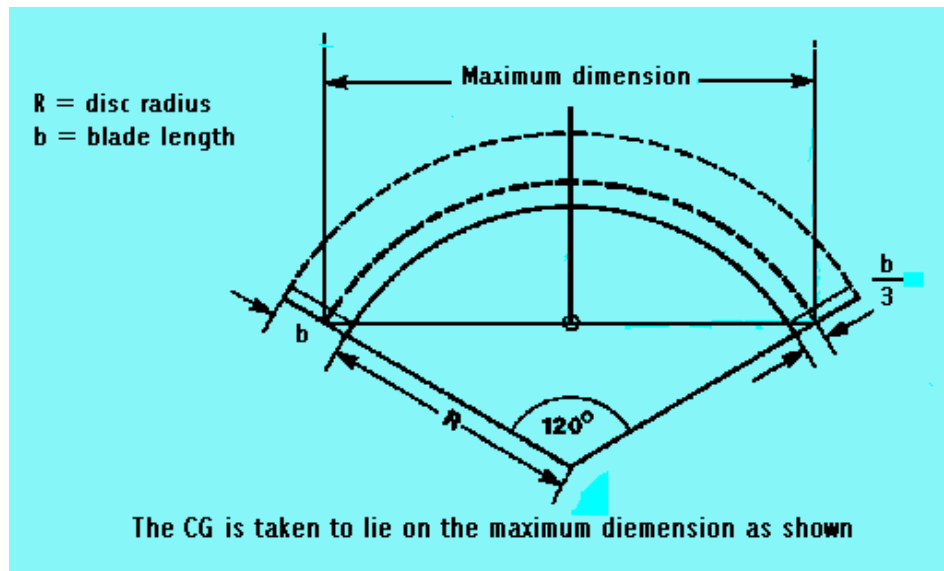
Figure 12 - Dimensions for a Single one third Disc Fragment

The one third and intermediate fragment sizes are shown diagrammatically in Figure 12 and Figure 13.

The maximum dimensions specified are critical to the extent of the damage to the aircraft and systems that may be incurred from the release of debris.

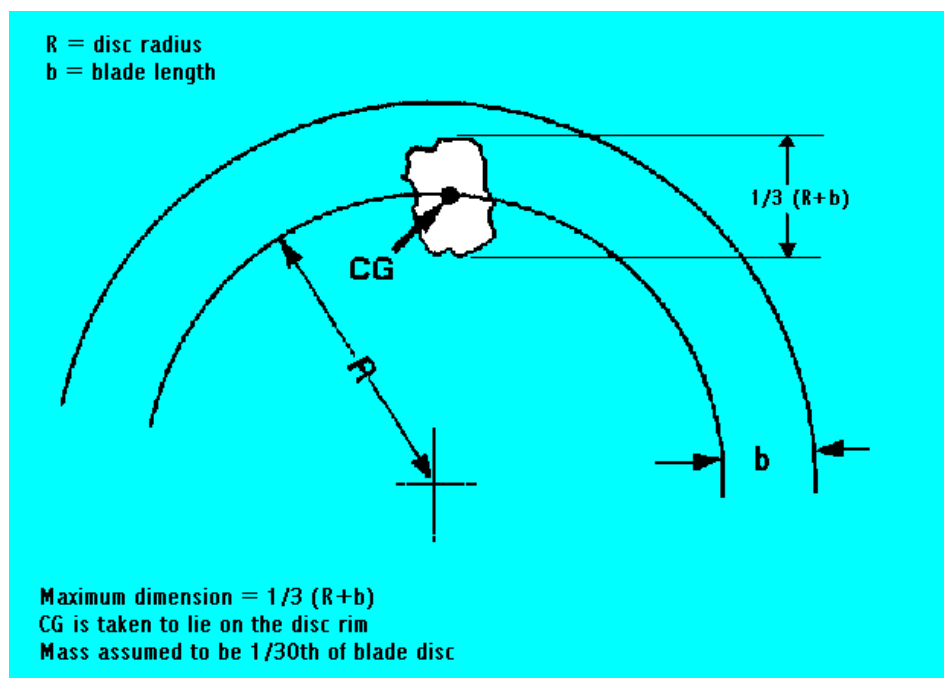
Figure 13 - Dimensions for an Intermediate Fragment

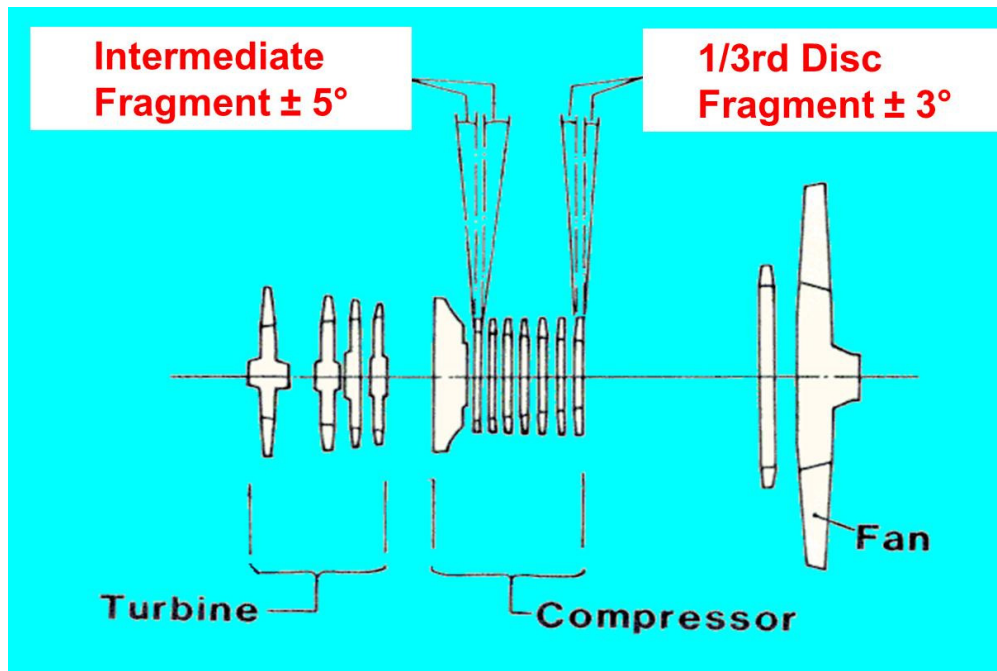
Figure 14 - Spread Angles for a one-third of a disc and an Intermediate fragment

The spread angles shown in Figure 14 are relative to the plane of rotation of the disc.

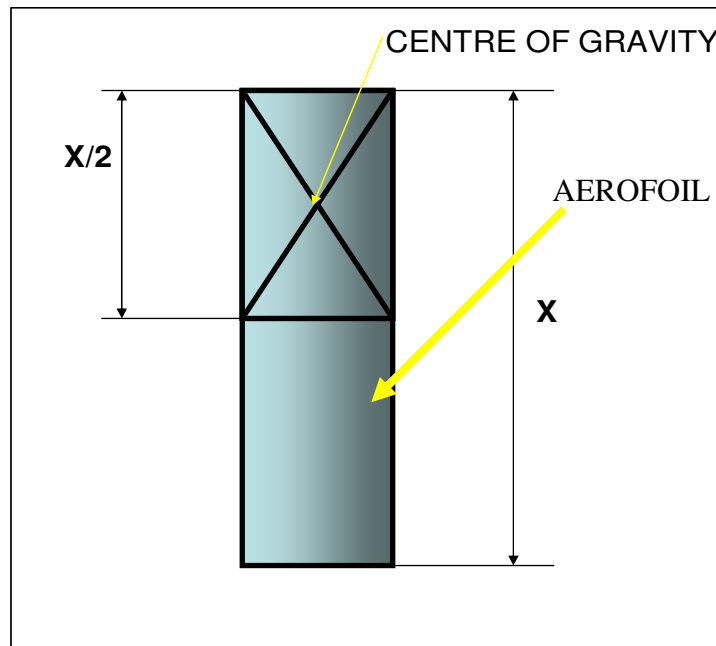
Figure 15 - Small Fragment maximum dimension

The small fragment maximum dimension of half the aerofoil height is shown in Figure 15.

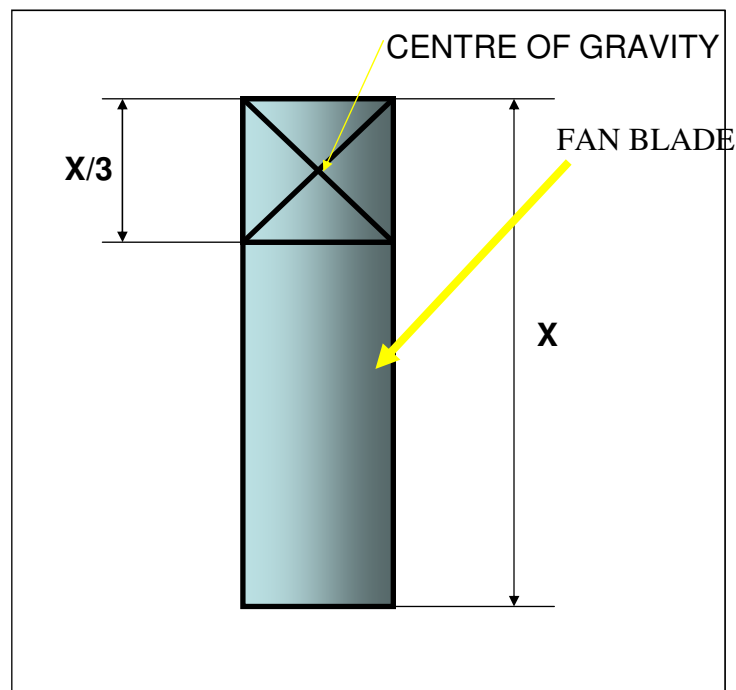
Figure 16 - Fan Blade Fragment Definition

The fan blade fragment maximum dimension of half the aerofoil height is shown in Figure 16.

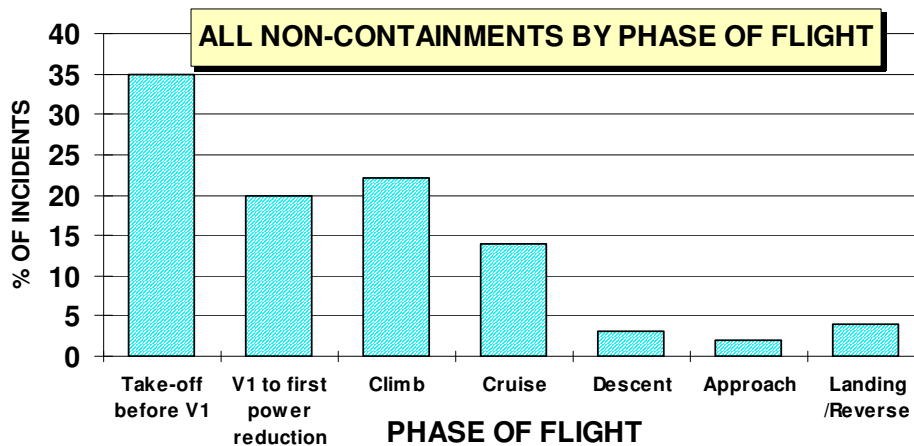
Figure 17 - Non-Containment by Phase of Flight

Figure 17 shows the distribution of non-containments by phase of flight contained in the AMC 20-128A. Data such as these may be used for assessing the risk of a critical non-containment during specific phases of flight.

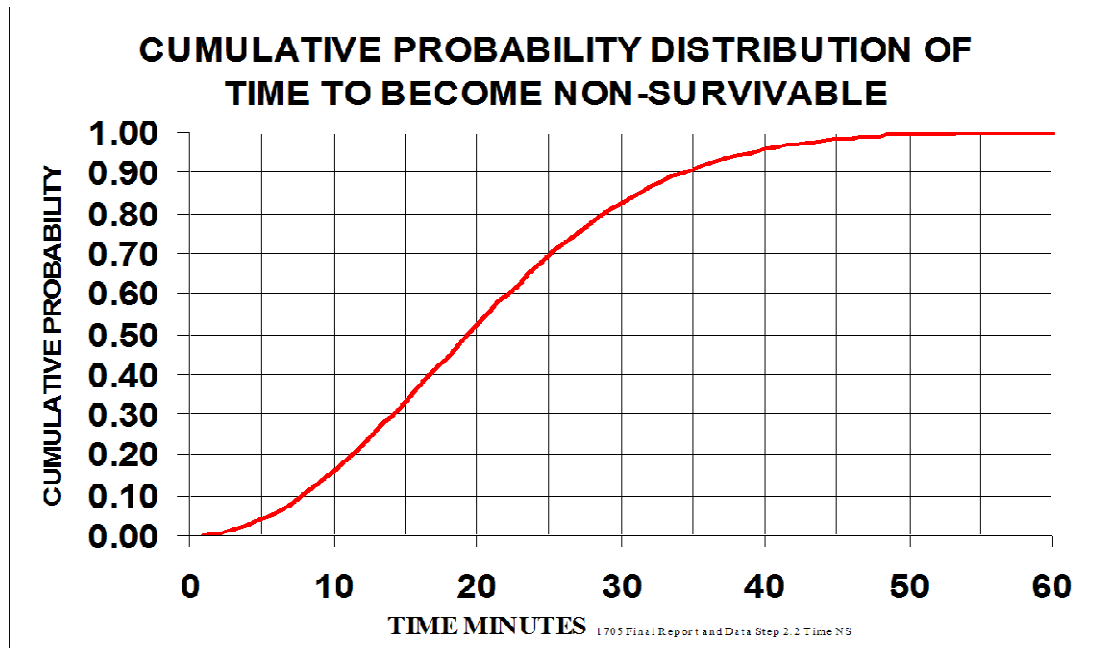
Figure 19 Cumulative Probability Distribution of Time to become non-survivable following an in-flight fire occurrence.

Based on a study of past accidents carried out for the FAA the assessed distribution of the time, for a potentially catastrophic in-flight fire becoming non-survivable is as shown in Figure 19.
